# Certificate of Appropriateness

## Property Description of work

### 1060 E Juneau First Ward Triangle HD

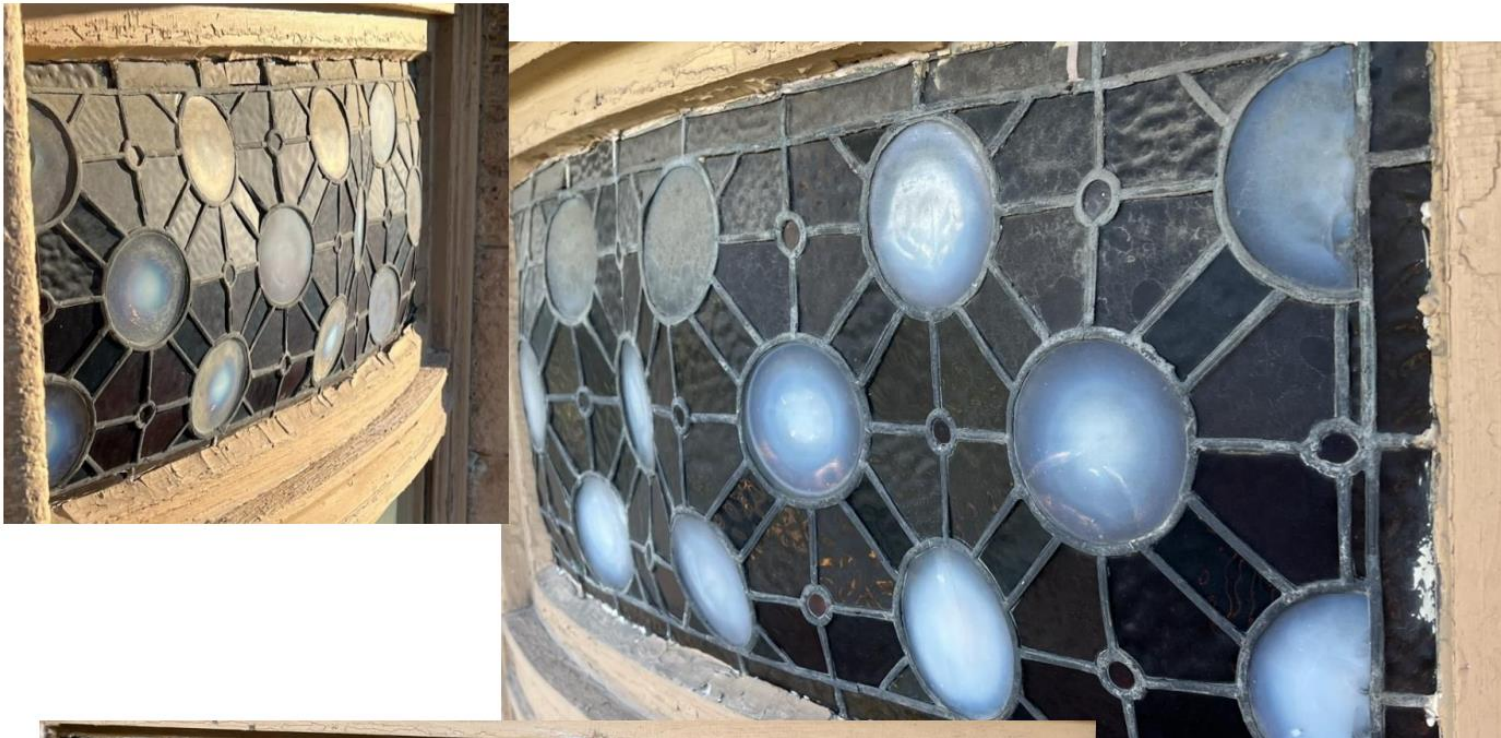
**Photos of Existing Damaged Units**

There are nine stained glass transom windows at the 2nd floor Front, East, and West Sides of the building. These windows are visible from the street but not visible at the interior. It is believed units were plastered over during a remodel of the interior in the 1910's. Because the glass has been subject to temperature differentials the leaded coming has become unstable and presenting a danger of the stained glass falling out.

Typical damage,  
note outward  
bulge of glass

We propose to expose the windows from the interior, have Conrad Schmitt Restoration remove the existing sashes and repair the stained glass. They will also build and install new storm windows to protect the repaired glass from the exterior. Storm windows to be milled from Douglas Fir and match previously completed units (see photos)

The interior will be cased using the same profiles as existing. The exterior storms and sashes will be primed and painted in the same color as existing.

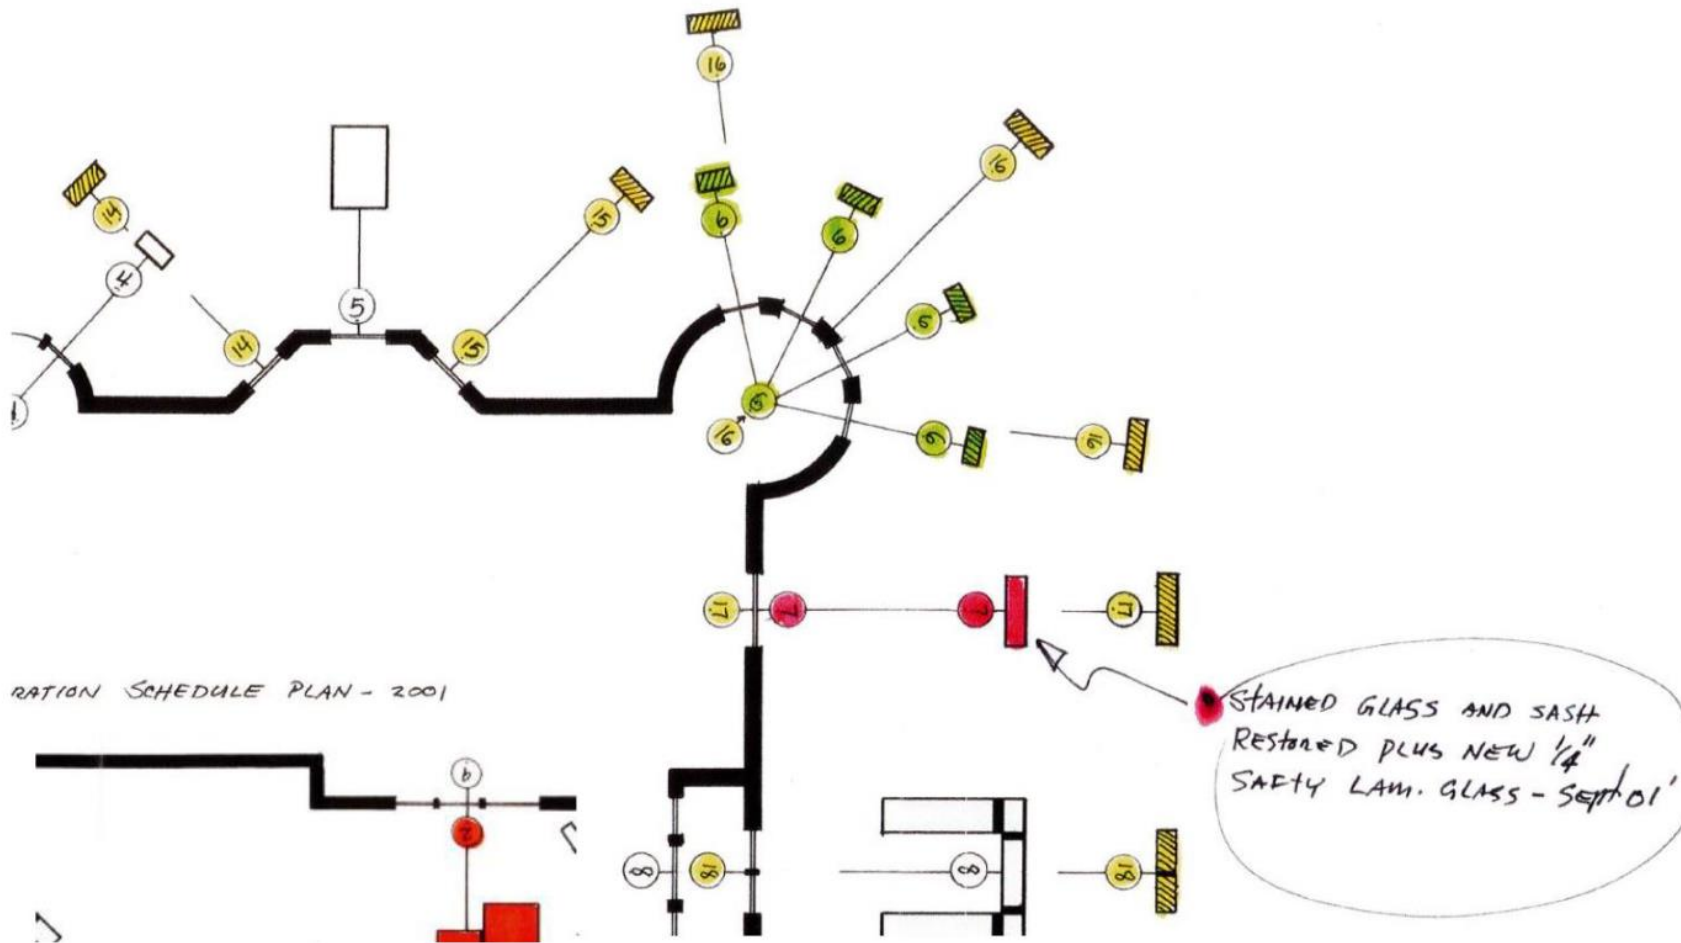
# Diagram of Units to Be Repaired

NUMBERS 14, 15, 16, 17, and 18, plus One Transom on the West Side
