CERTIFICATE OF APPROPRIATENESS APPLICATION FORM

2658 North Hackett Avenue, Milwaukee, WI 53211

CERTIFICATE OF APPROPRIATENESS APPLICATION IMAGES

2014 Masonry Stabilization and Restoration

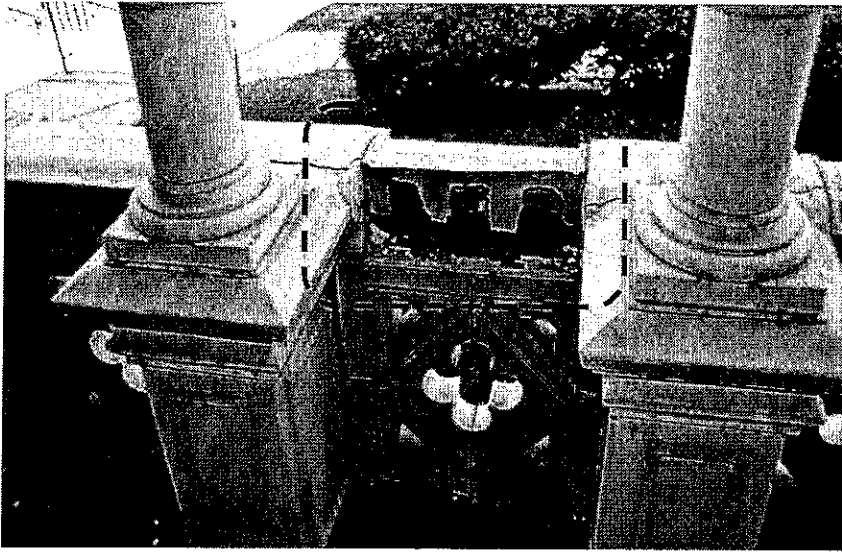
Image B: Terra cotta units are almost completely missing in several locations. These units can be temporarily plugged with clay but eventually require permanent replacement with custom-made units.

Stabilization Treatment 2: Temporary repair of badly broken or missing units.

- a. Remove broken portions of unit carefully, including loose and deteriorated terra cotta, to avoid damaging surrounding intact units.
- b. Catalog and carefully document or store any original fragments that might be needed to faithfully reproduce units in the future.
- c. Clean the area with clean water and a bristle brush to remove any loose particles.
- d. Create a clay plug, carefully fitting the remaining void to prevent any further water infiltration or cover with ice and water shield membrane.

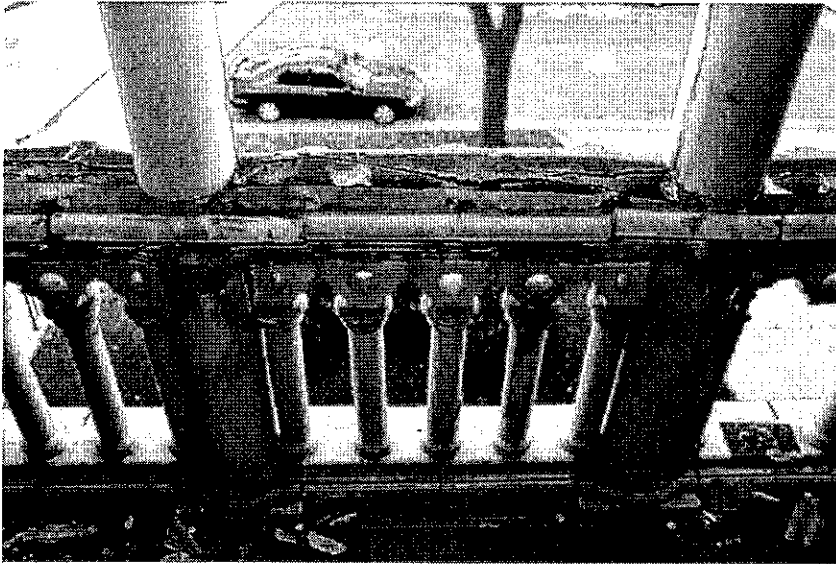
Image E: Multiple prior repairs have attempted to address cracking along the railing of the second-floor loggia. All remnants of prior repair attempts need to be removed before proceeding with new repairs.

Stabilization Treatment 1: Temporary repair of large cracks/voids.

- a. Carefully remove material from any previous repair attempts.
- b. Cut away all loose and deteriorated terra cotta (retain and tag any pieces that can be repaired at a later date).
- c. Clean the area with clean water and a bristle brush to remove any loose particles.
- d. Install a backer rod inside the crack to reinforce terra cotta and sealant.
- e. Seal crack with an elastomeric sealant, such as Sonneborn NP1, color to match terra cotta.
- f. On certain horizontal (skyward) facing cracks, cover terra cotta units with ice and water shield membrane along the length of the crack to further prevent water infiltration.

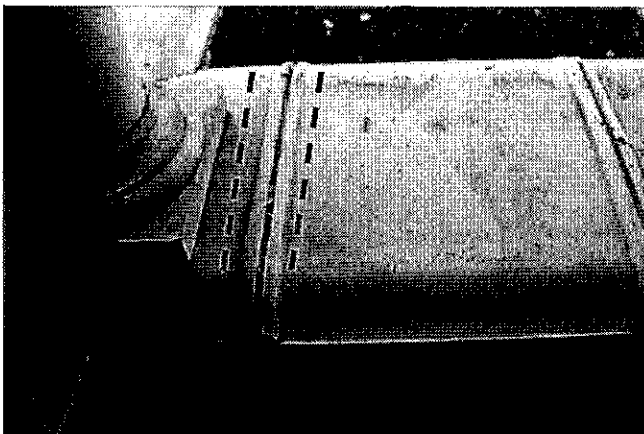
Figure F: Open joints between railing units allow water to seep into railings and walls, hastening the deterioration of terra cotta and masonry below.

SEALING HORIZONTAL (SKYWARD) FACING JOINTS AT LOGGIA

Areas of work: Projecting loggia cornice, west elevation and loggia railing wall coping, 1st floor west elevation.

1. Cut and reseal cracked and open horizontal (skyward) joints and their returns where appropriate.
 - a. Remove existing sealant in cracked and open joints down to bedding mortar.
 - b. Hand cut and use pneumatic chisels to remove any remaining sealant, using care not to damage surrounding units.
 - c. Install an elastomeric sealant, such as Sonneborn NP-11, color to closely match surrounding units, to reseal all exposed joints.
