## 1119 E Charles F. Forsythe House, Peltz Gallery

### Submittal for Exterior Enhancements and Alterations

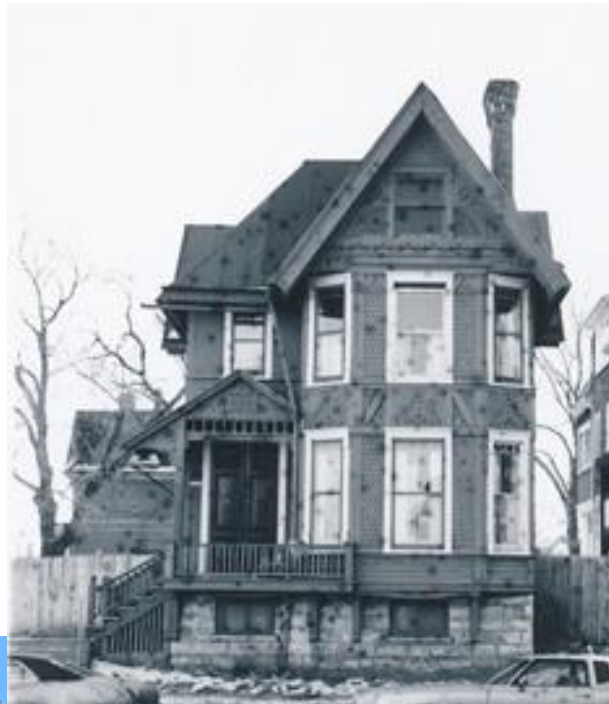
Cedar, with decorative cut-out to match the existing at 1241 N Franklin Place

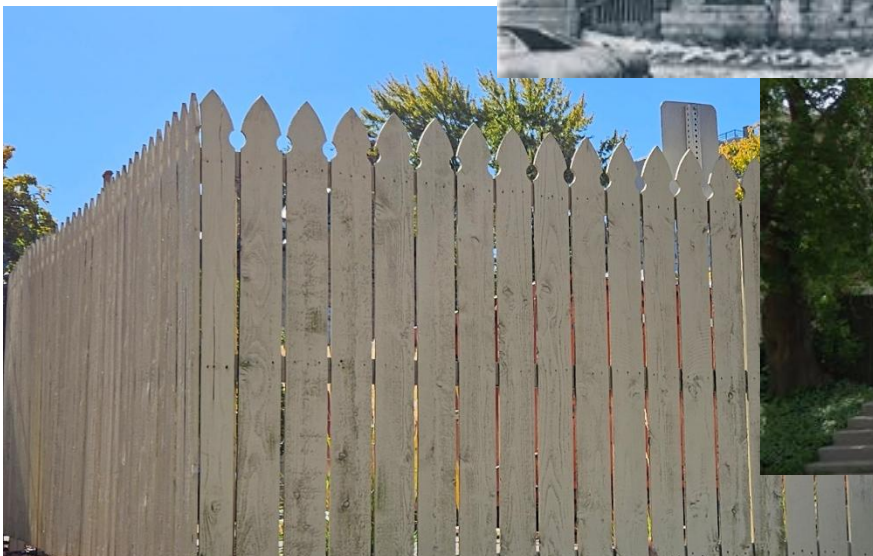
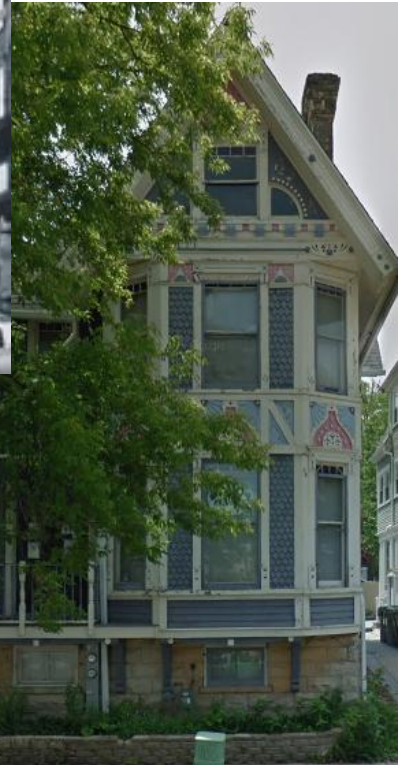
Proposed:

#### **Proposed New Fence:**

**Intention:** Return fence to North Side of Property. Provide secure parking access and screening for tenants of the building

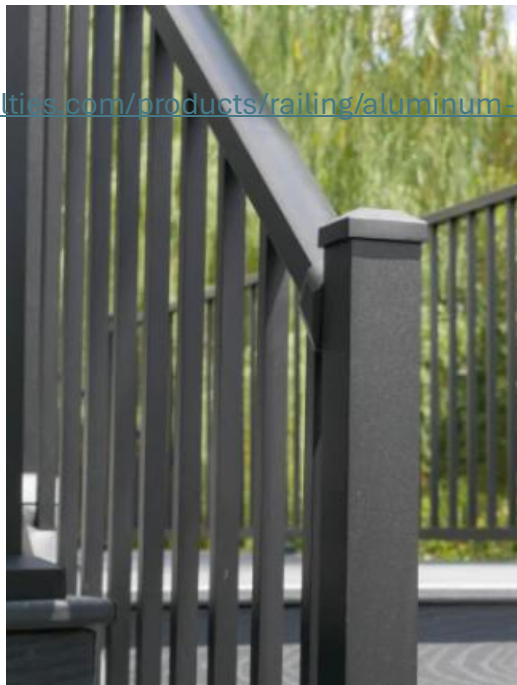
### **Proposed:**

Intention: At some point a metal railing was removed at the front steps. We seek to install a new rail per current residential building code. We would like to use a system to match the existing wooden rails at the stairs. The new system is aluminum, painted black and will not rust.

<https://diggerspecialties.com/products/railing/aluminum-railing/>

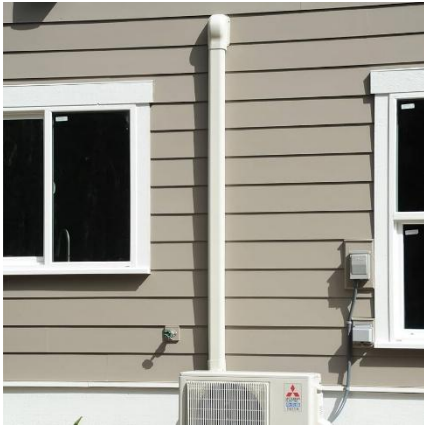
**Example of Conduit Product (can be painted)**

**Proposal:** Relocate them to the rear of the property facing a parking lot. We intend to conceal electrical behind an enclosed conduit
