# Certificate of Appropriateness

733 W. HISTORIC MITCHELL ST.

PTS ID 115092 COA: masonry repairs

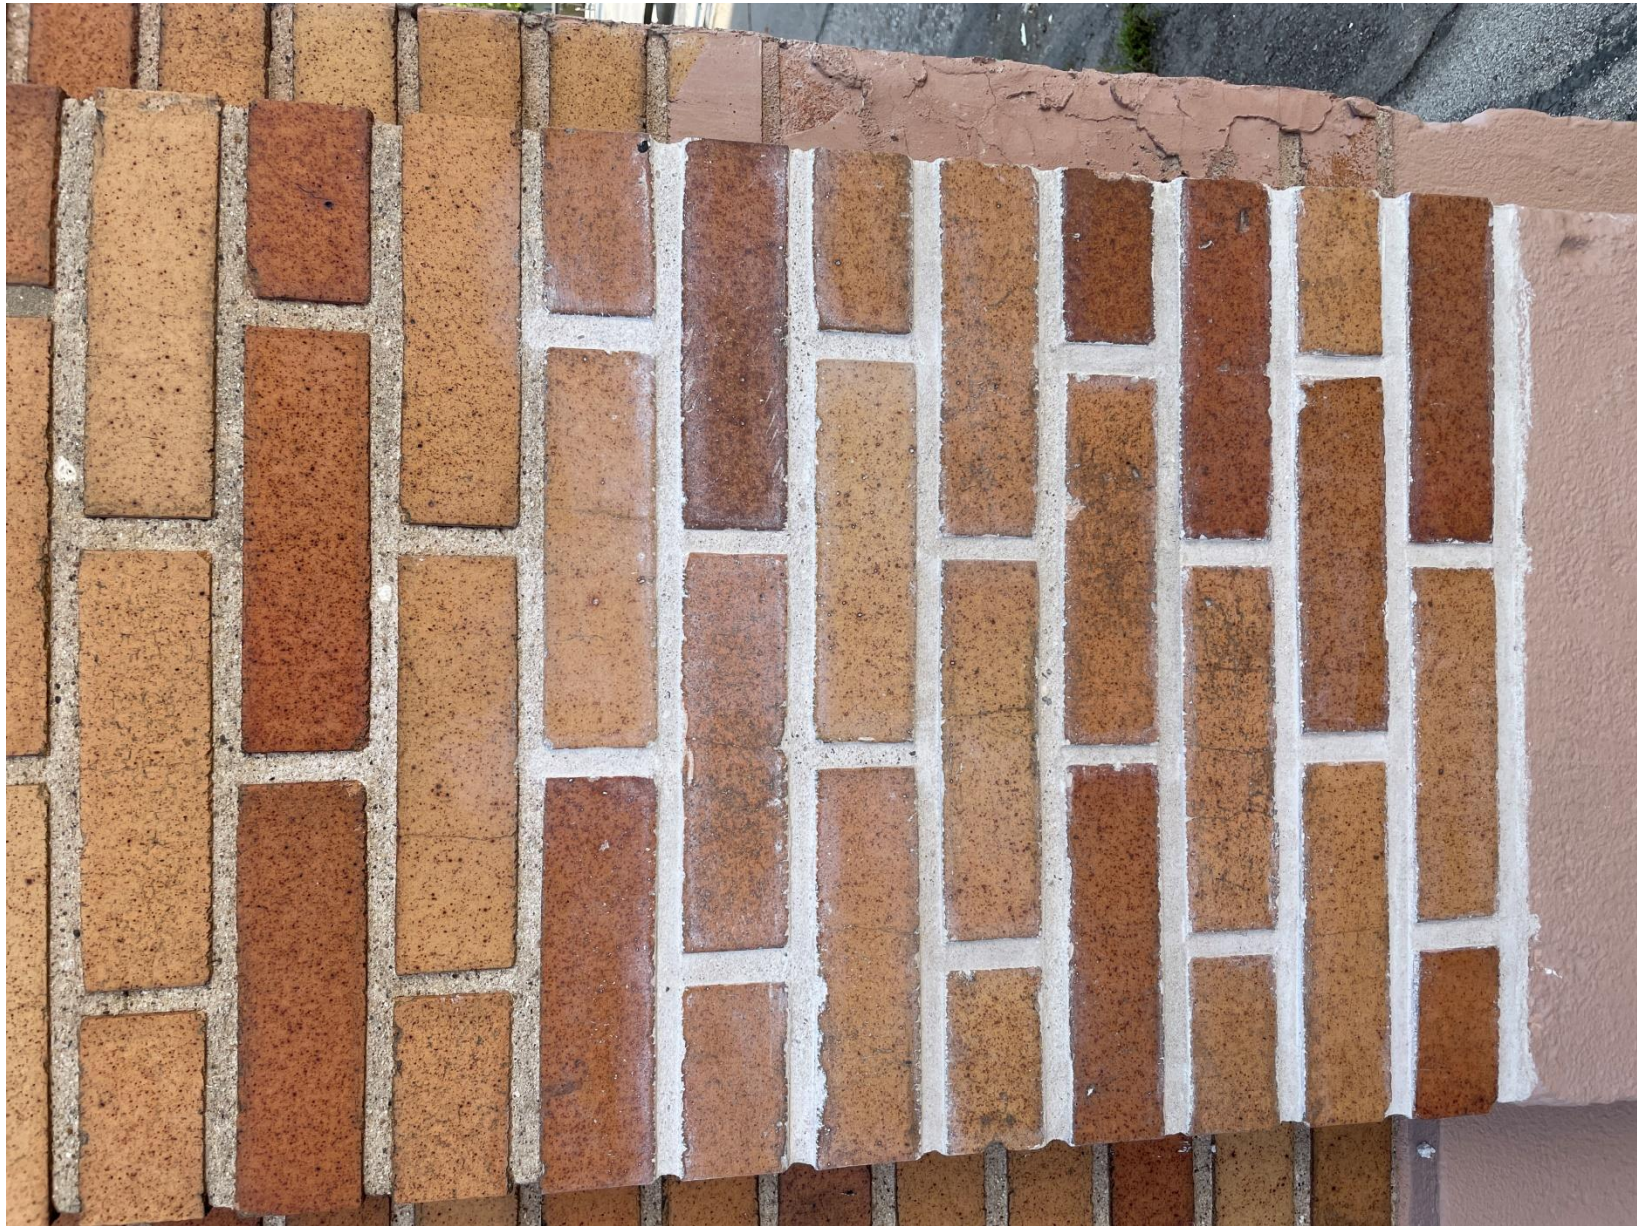
Approved mortar sample. Photo taken July 2, 2021. Note texture from coarse sand.

Reconstruct second floor Mitchell Street façade to original conditions with matching mortar, joint profiles, and best possible match of brick. Brick is to be Belden light range per attached onsite comparison photo. Brick to be laid in Common/American bond with coursing matching original, joints are to be raked, and mortar shall be tinted with a significant proportion of coarse sand. Bricks are to be woven in a random color arrangement per original. Dark brick above the stone lintels may remain in place. All field brick in pilasters and between windows is to be redone with new Belden brick.

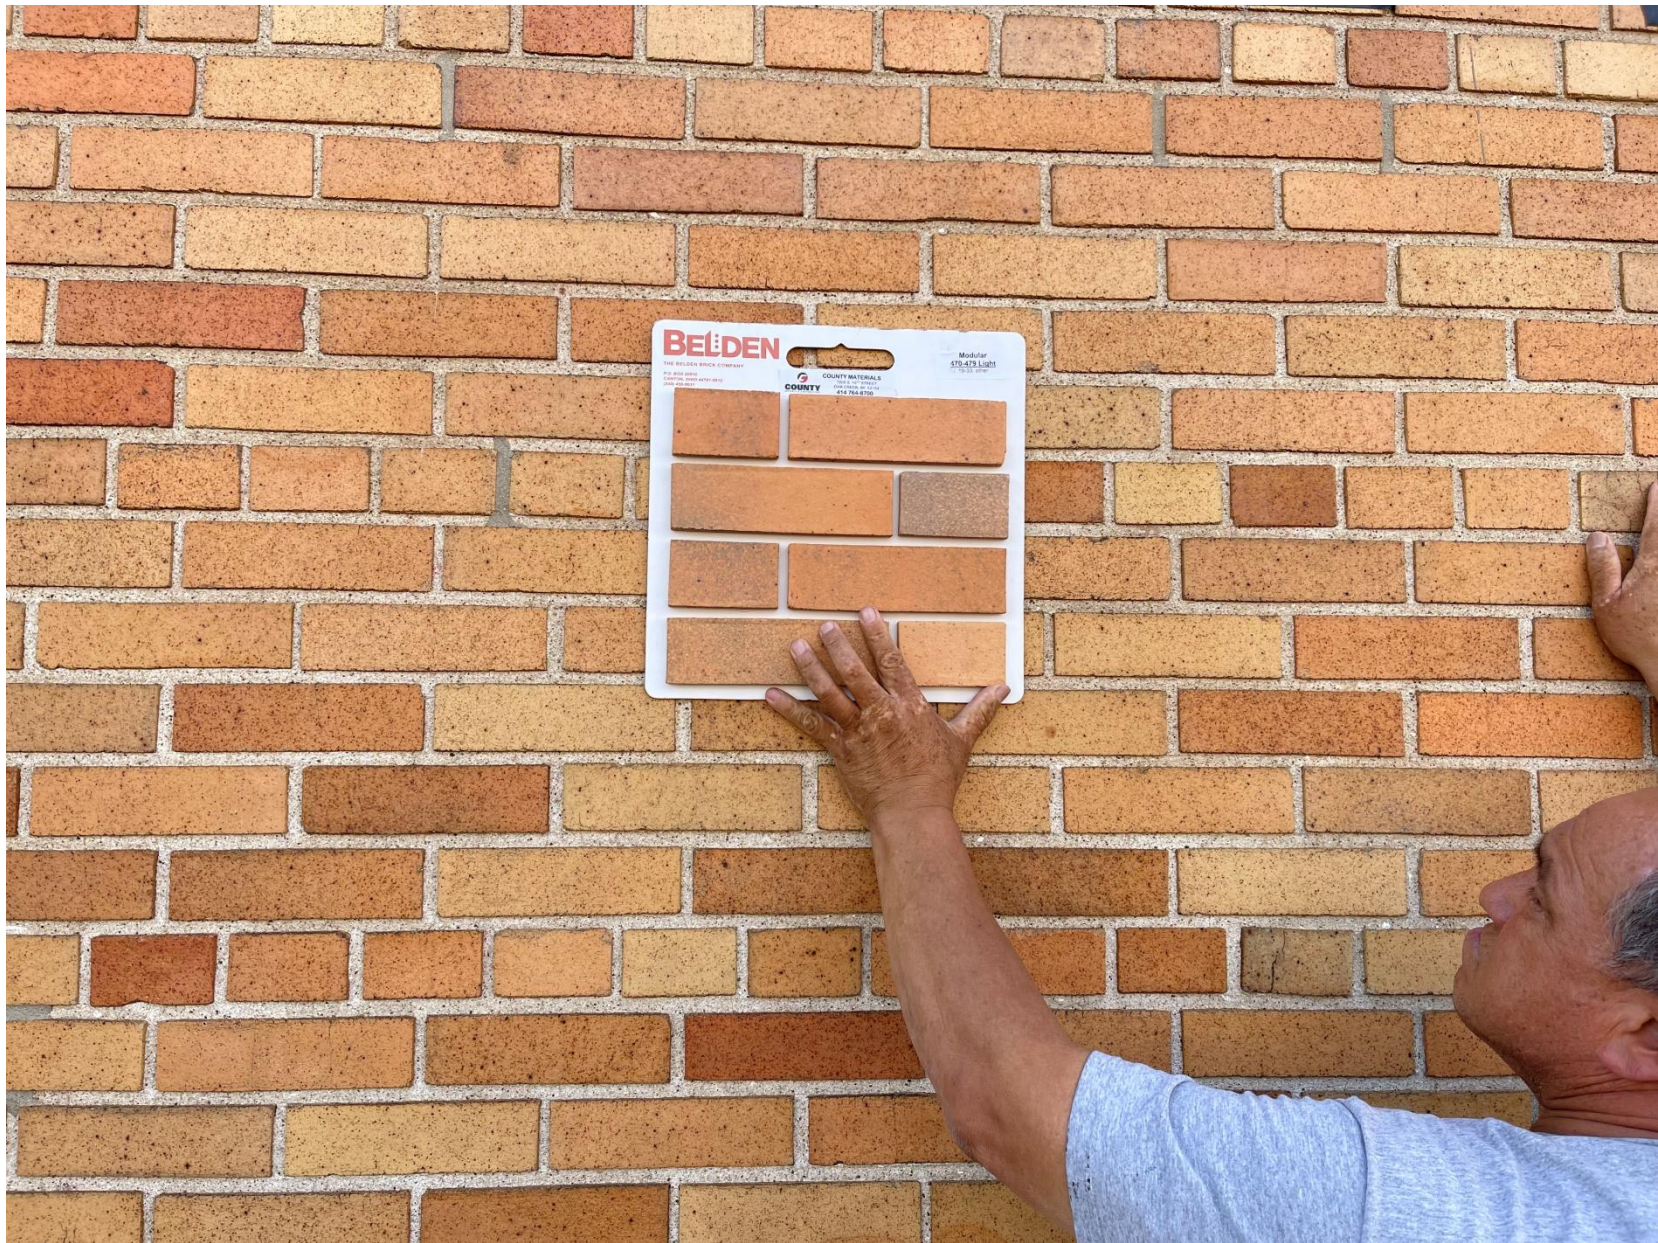
Belden Brick comparison

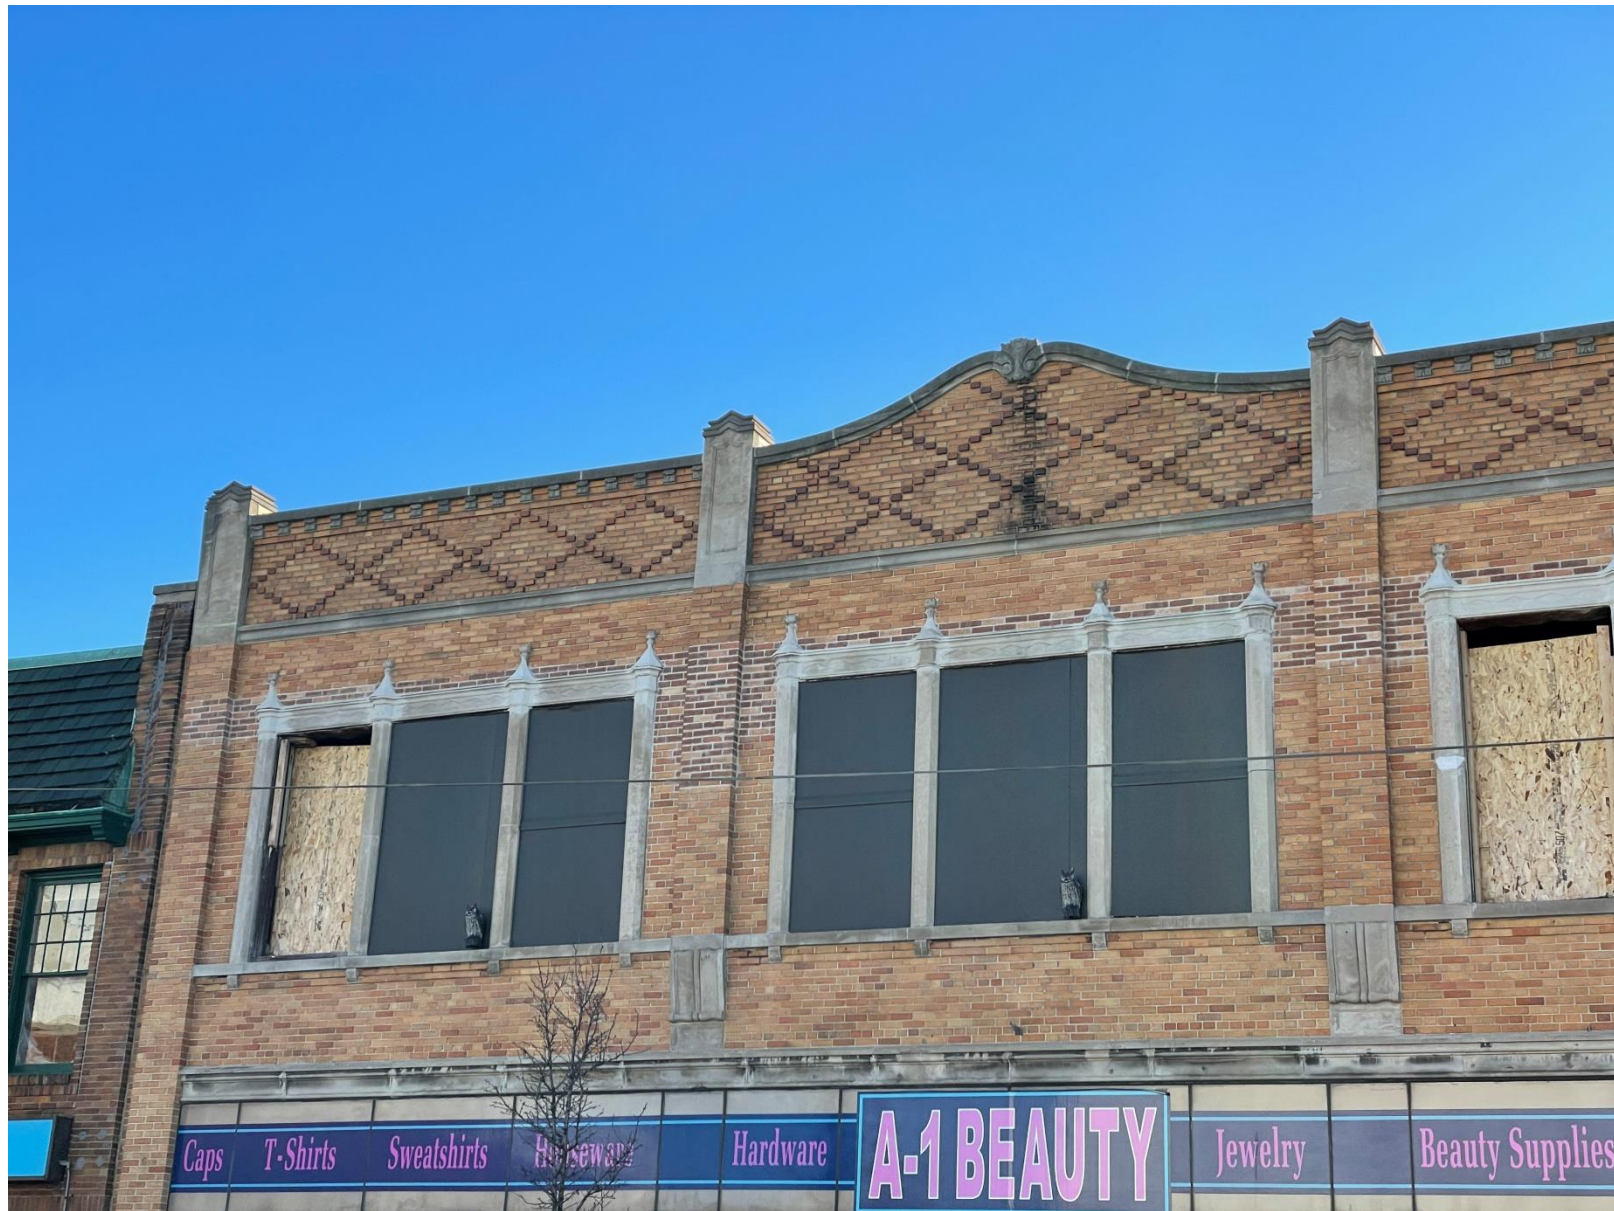
Brick above lintels may remain, but must be repointed with new mortar. Brick in pilasters and between banks of windows **MUST** be replaced with new Belden brick.

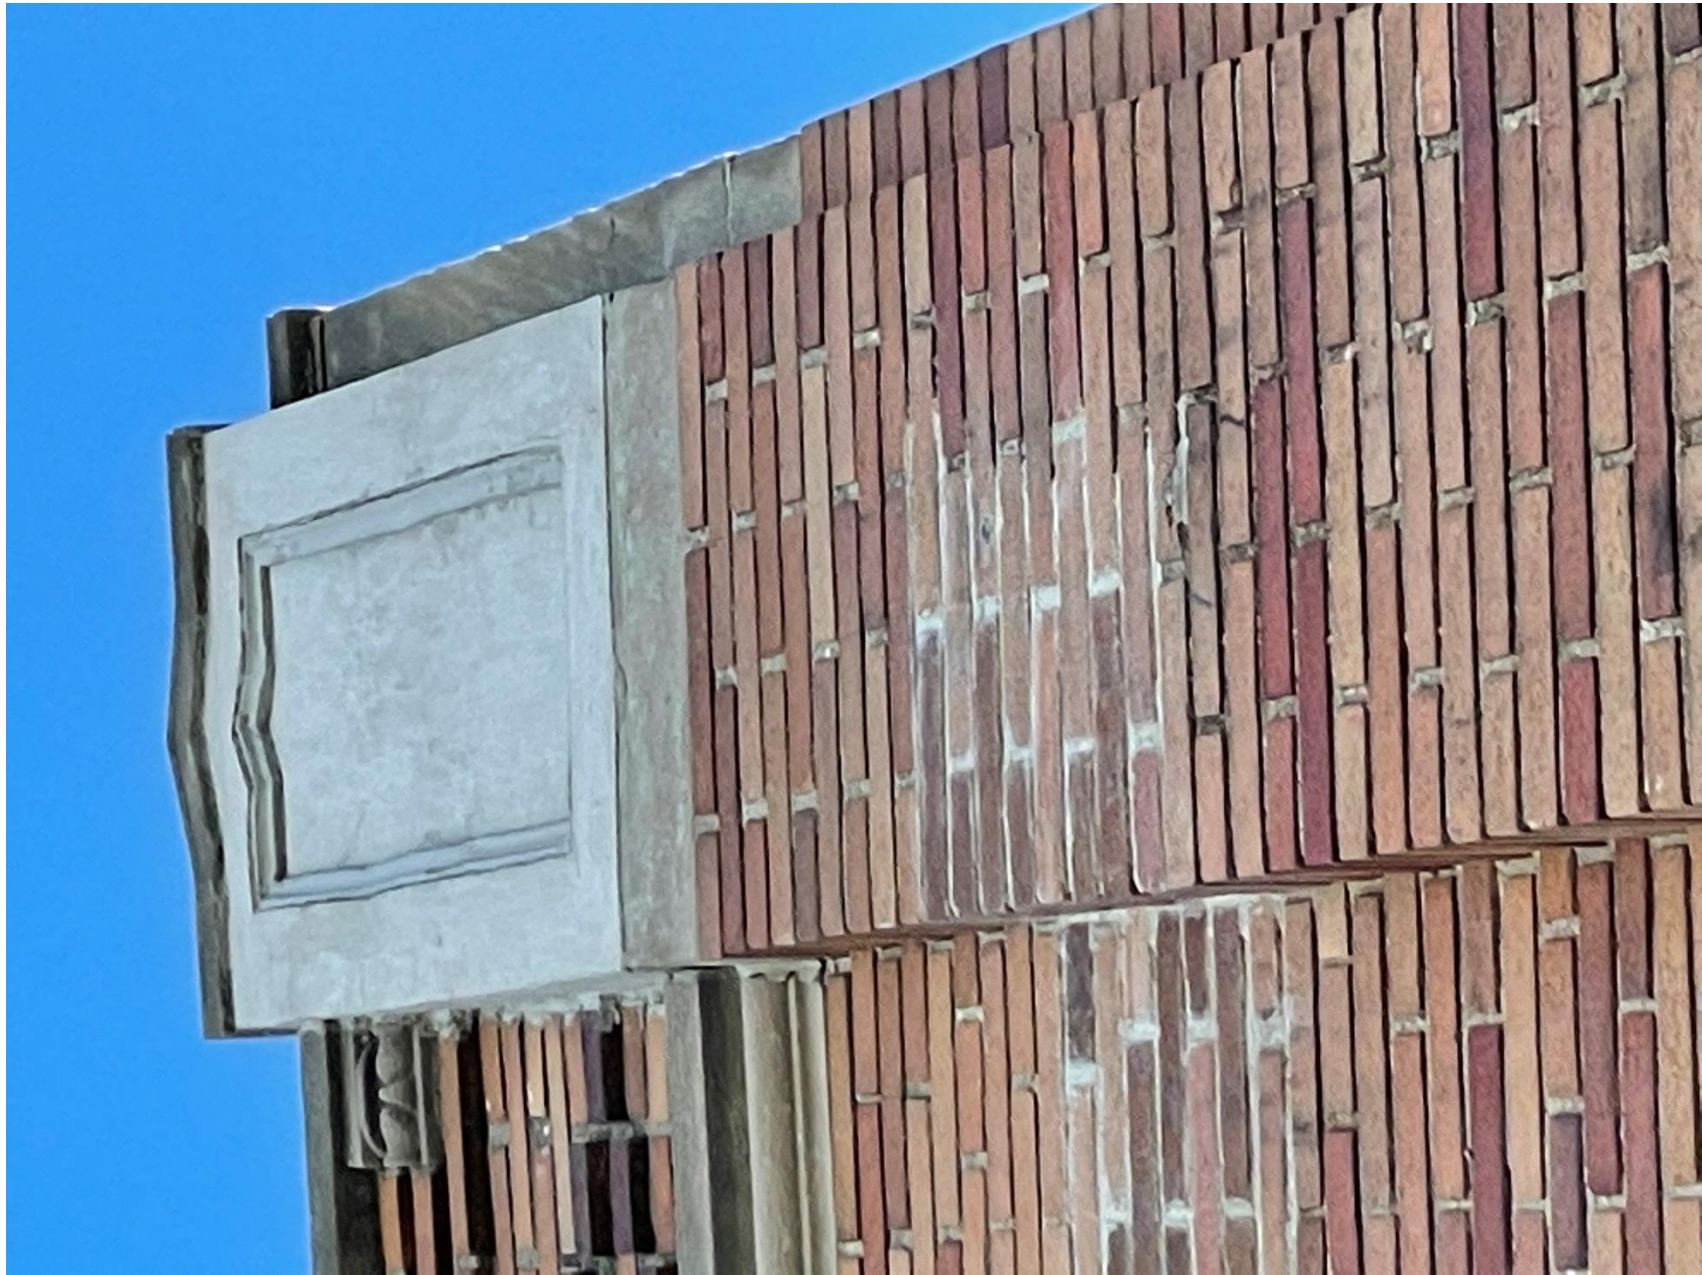
Replace concrete capital shown here with stone capital. Redo all recent brickwork in this section.

Install stone replica capital at northwest corner of building using same mortar as for brickwork. Clean window lintels with soft brush and calcium water to blend in acid damage and prior cleaning efforts.
