PROPOSED 2023 NEW WINDOW SCOPE

1922 CONVENT DRAWINGS

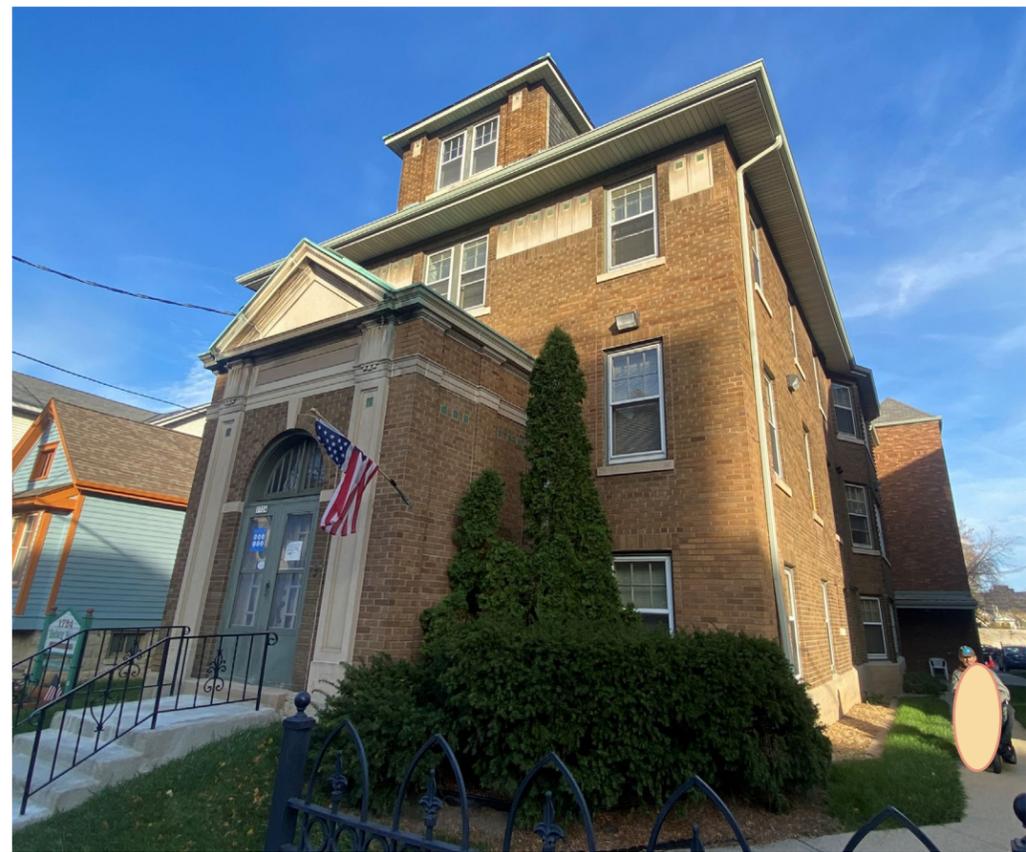
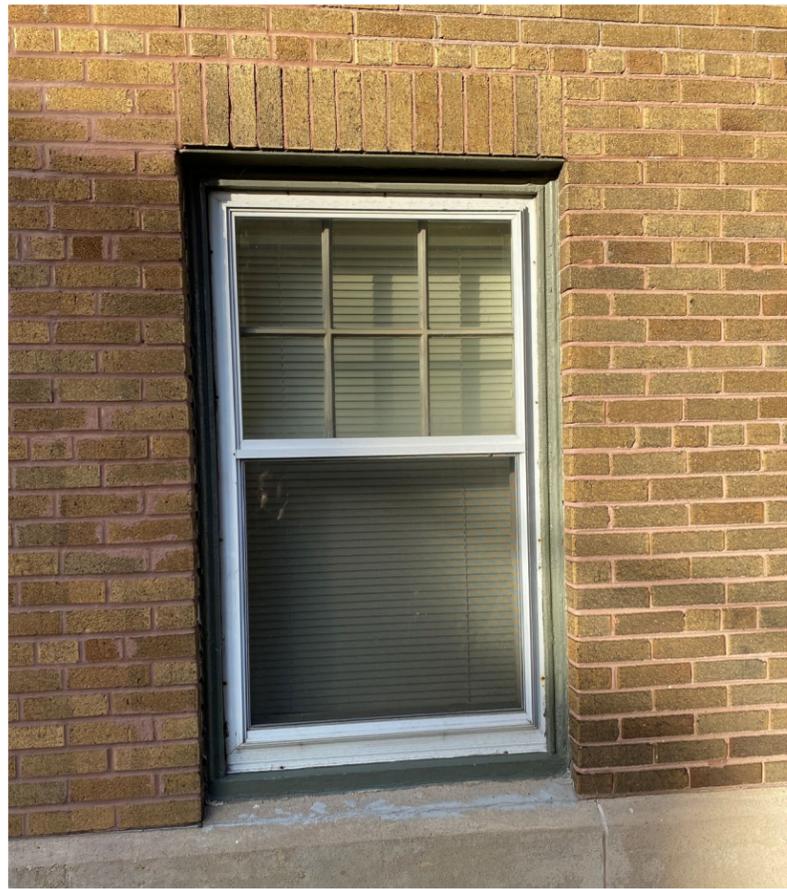
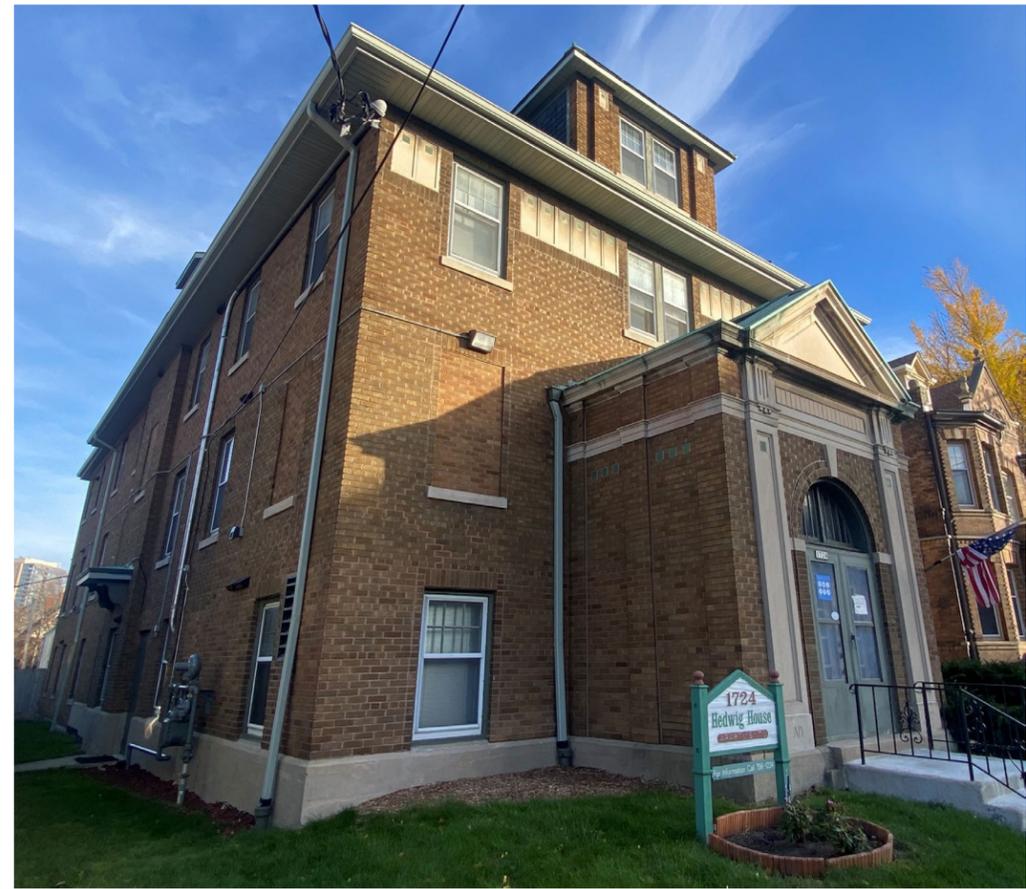
DORMER GRID PATTERN DOES NOT MATCH DORMERS ON NORTH ELEVATION.

1922 DRAWINGS CALLED FOR THE 1ST AND 2ND FLOOR WINDOWS TO HAVE EQUAL SASHES. THE 3RD FLOOR WINDOWS WERE TO BE UNEQUAL "COTTAGE" SASHES.

THE AS-BUILT CONDITIONS ARE 1ST FLOOR UNEQUAL SASHES, WHEREAS THE 2ND AND 3RD FLOOR HAVE EQUAL SASHES. TYPICAL ON ALL ELEVATIONS

SHORT DORMER WINDOWS TO RETURN TO 1922 DESIGN INTENT FOR 2 VERTICAL SDLS / NO HORIZONTALS, WHICH IMPROVE GLASS PROPORTIONS AND AESTHETICS

CHAMFERED WINDOWS ON EACH SIDE OF BAY WINDOW TO RETURN TO 1922 PATTERN WITH 1 VERTICAL SDL / 1 HORIZONTAL SDL TO MATCH FRONT BAY WINDOWS.

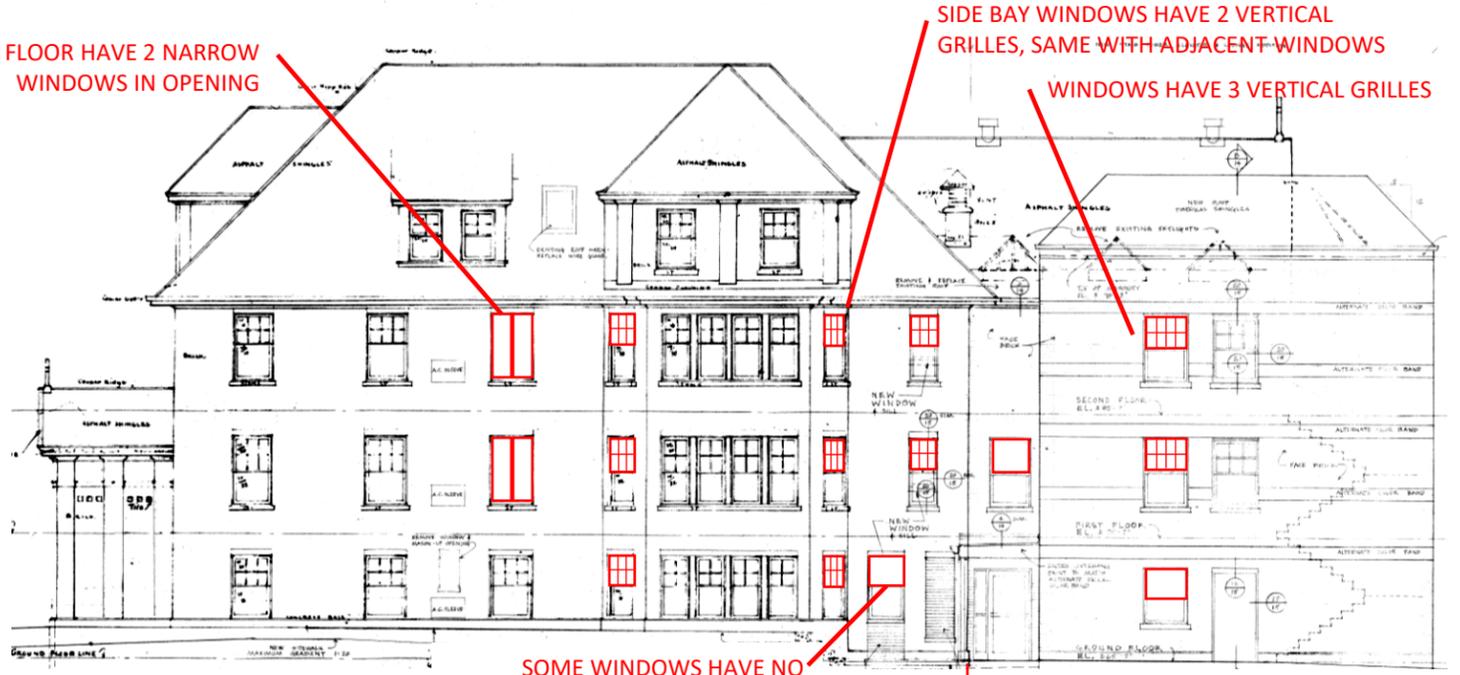
2ND, 3RD FLOOR HAVE 2 NARROW WINDOWS IN OPENING

SIDE BAY WINDOWS HAVE 2 VERTICAL GRILLES, SAME WITH ADJACENT WINDOWS

WINDOWS HAVE 3 VERTICAL GRILLES

SOME WINDOWS HAVE NO GRILLES ABOVE THE SASH

ELEVATOR / STAIR ADDITION

1984 RENOVATION / ADDITION – AFFORDABLE HOUSING REFLECTS PRESENT DAY "AS-BUILT" CONDITIONS

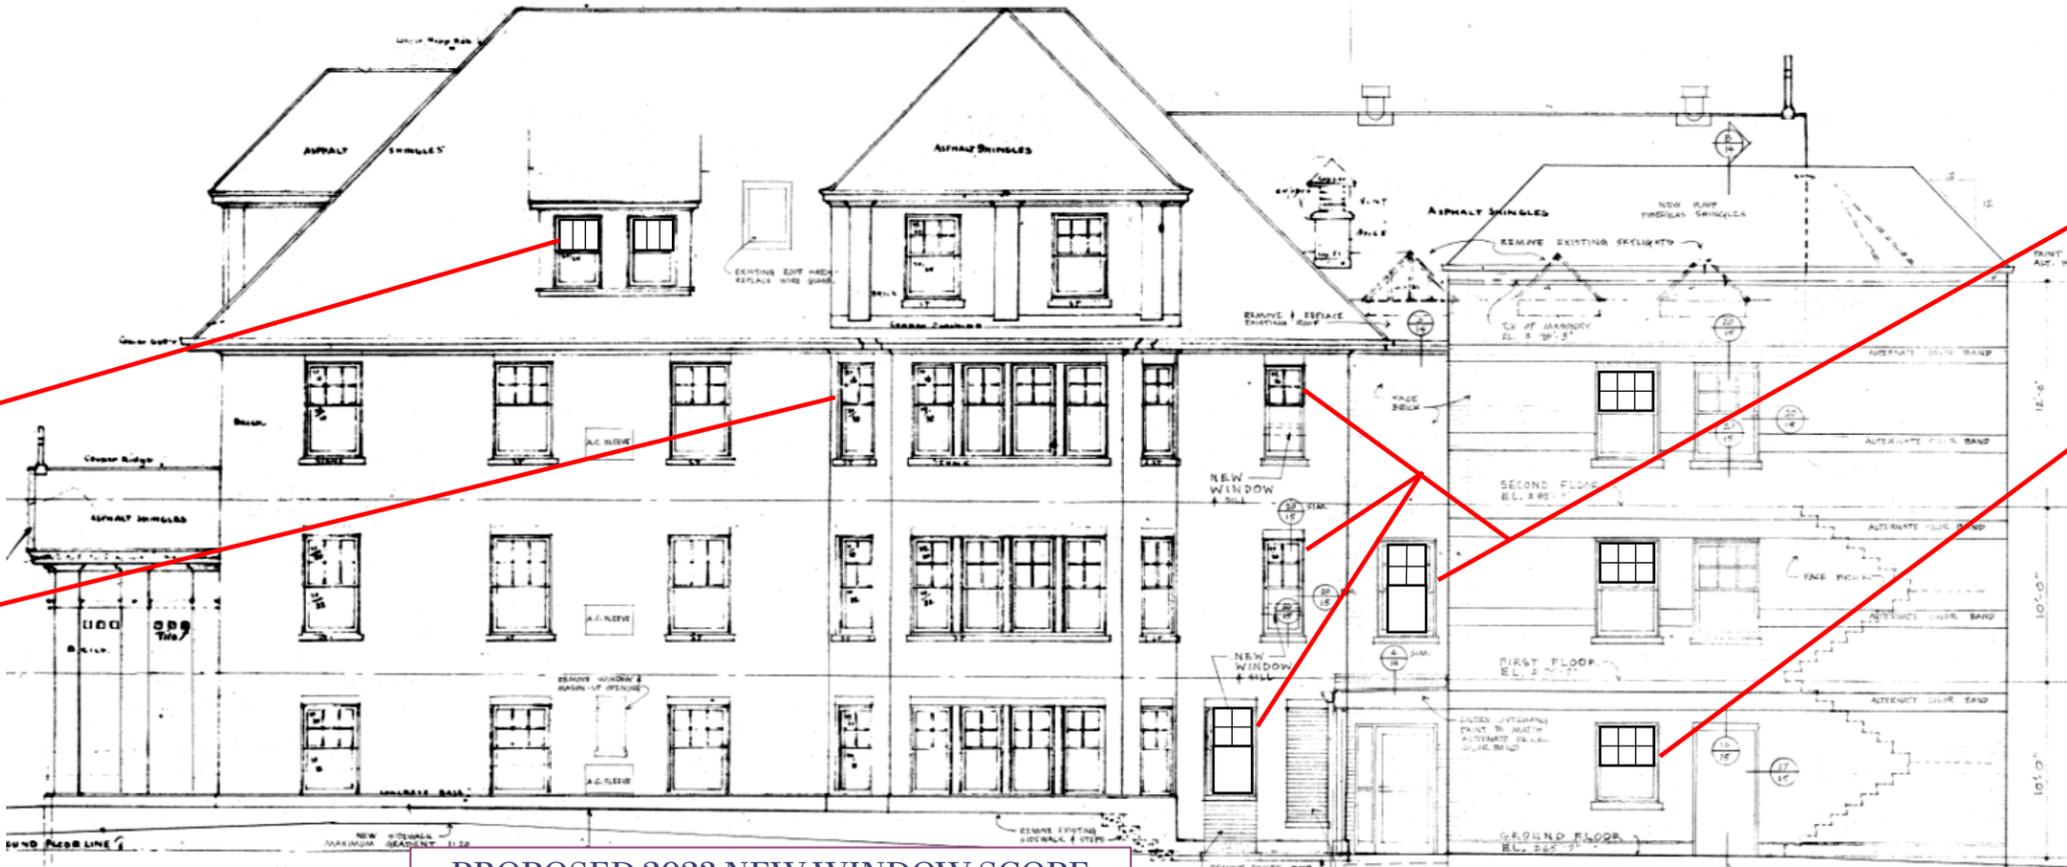
PROPOSED 2023 NEW WINDOW SCOPE

NARROW WINDOWS SHALL BE RETURNED TO MATCH THE 1922 DRAWINGS WITH 1 VERTICAL SDL / 1 HORIZONTAL SDL ABOVE SASH

VERTICAL STACK OF WINDOWS SHALL MATCH ADJACENT WINDOWS WITH 2 VERTICAL SDL / 1 HORIZONTAL SDL, TO MATCH PROPORTIONS OF REMAINING BUILDING INCLUDING 1ST FLOOR COTTAGE SASHES

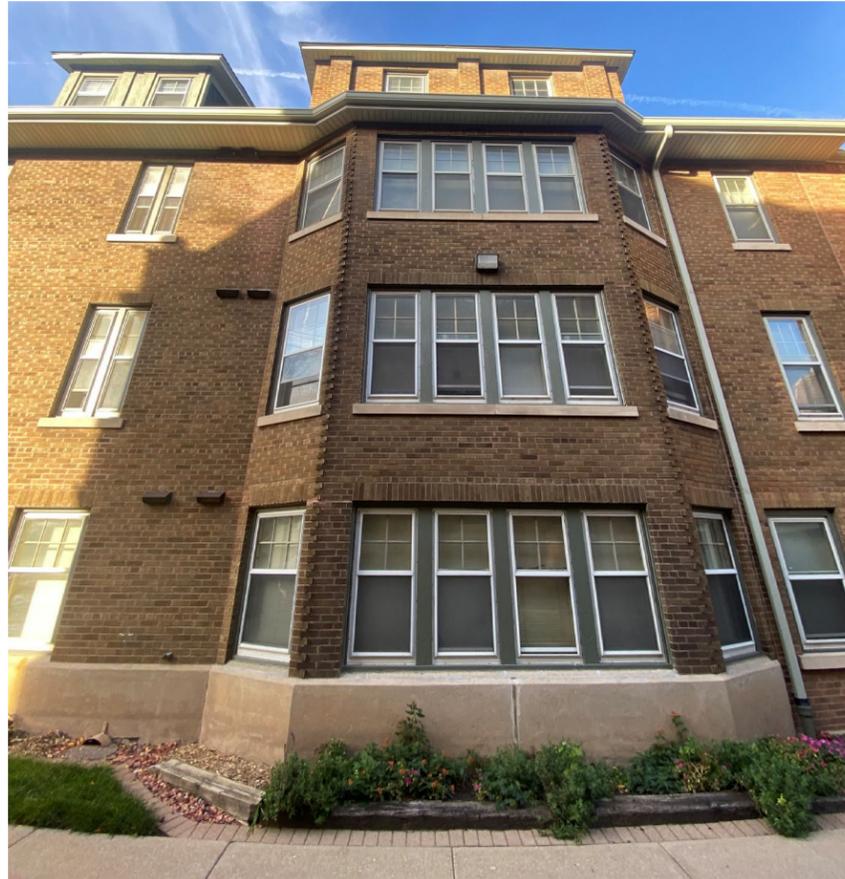
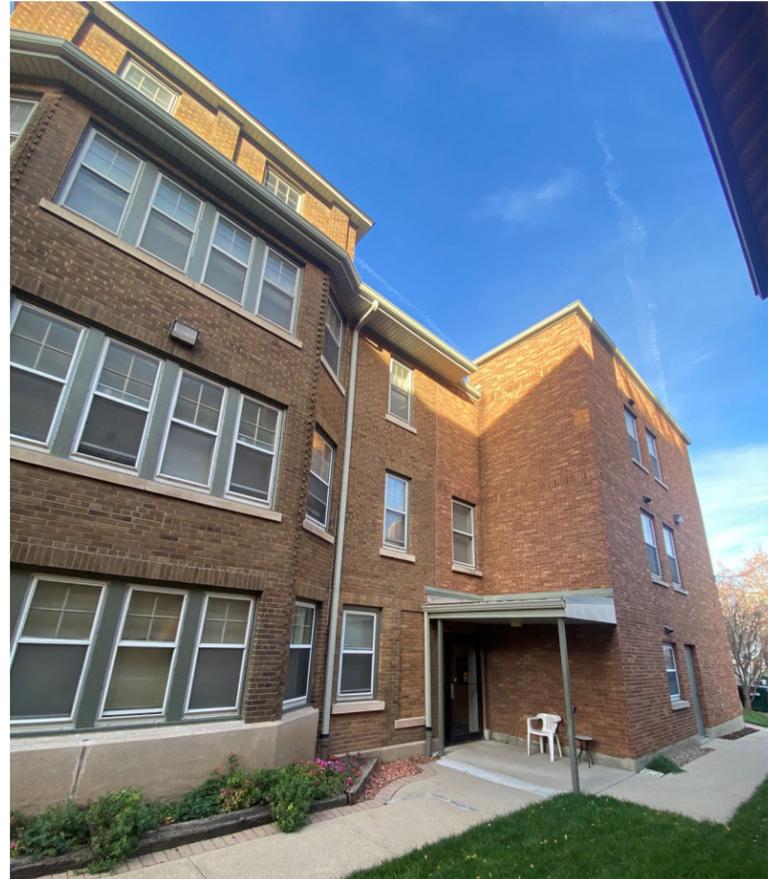
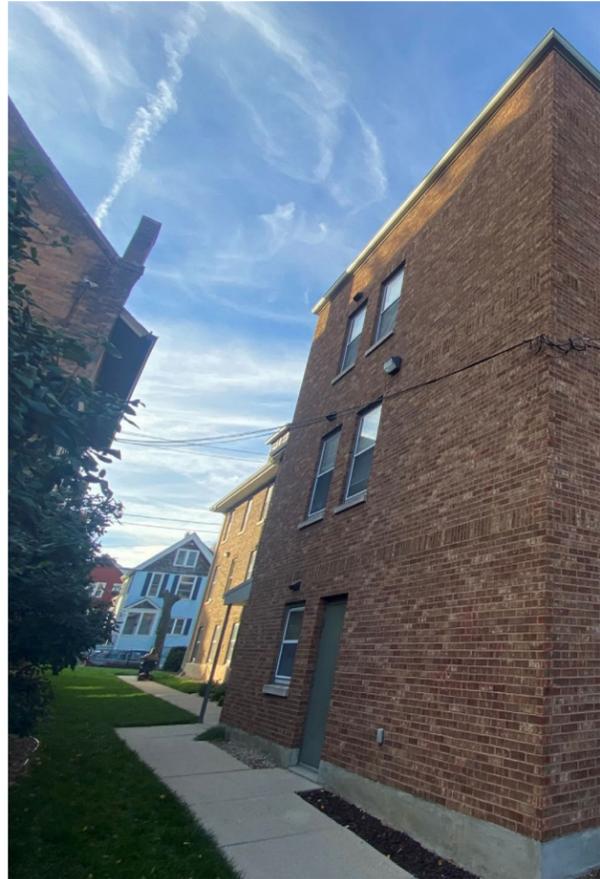
SHORT DORMER WINDOWS TO RETURN TO 1922 DESIGN INTENT FOR 2 VERTICAL SDLS / NO HORIZONTALS, WHICH IMPROVE GLASS PROPORTIONS AND AESTHETICS

CHAMFERED WINDOWS ON EACH SIDE OF BAY WINDOW TO RETURN TO 1922 PATTERN WITH 1 VERTICAL SDL / 1 HORIZONTAL SDL TO MATCH FRONT BAY WINDOWS.

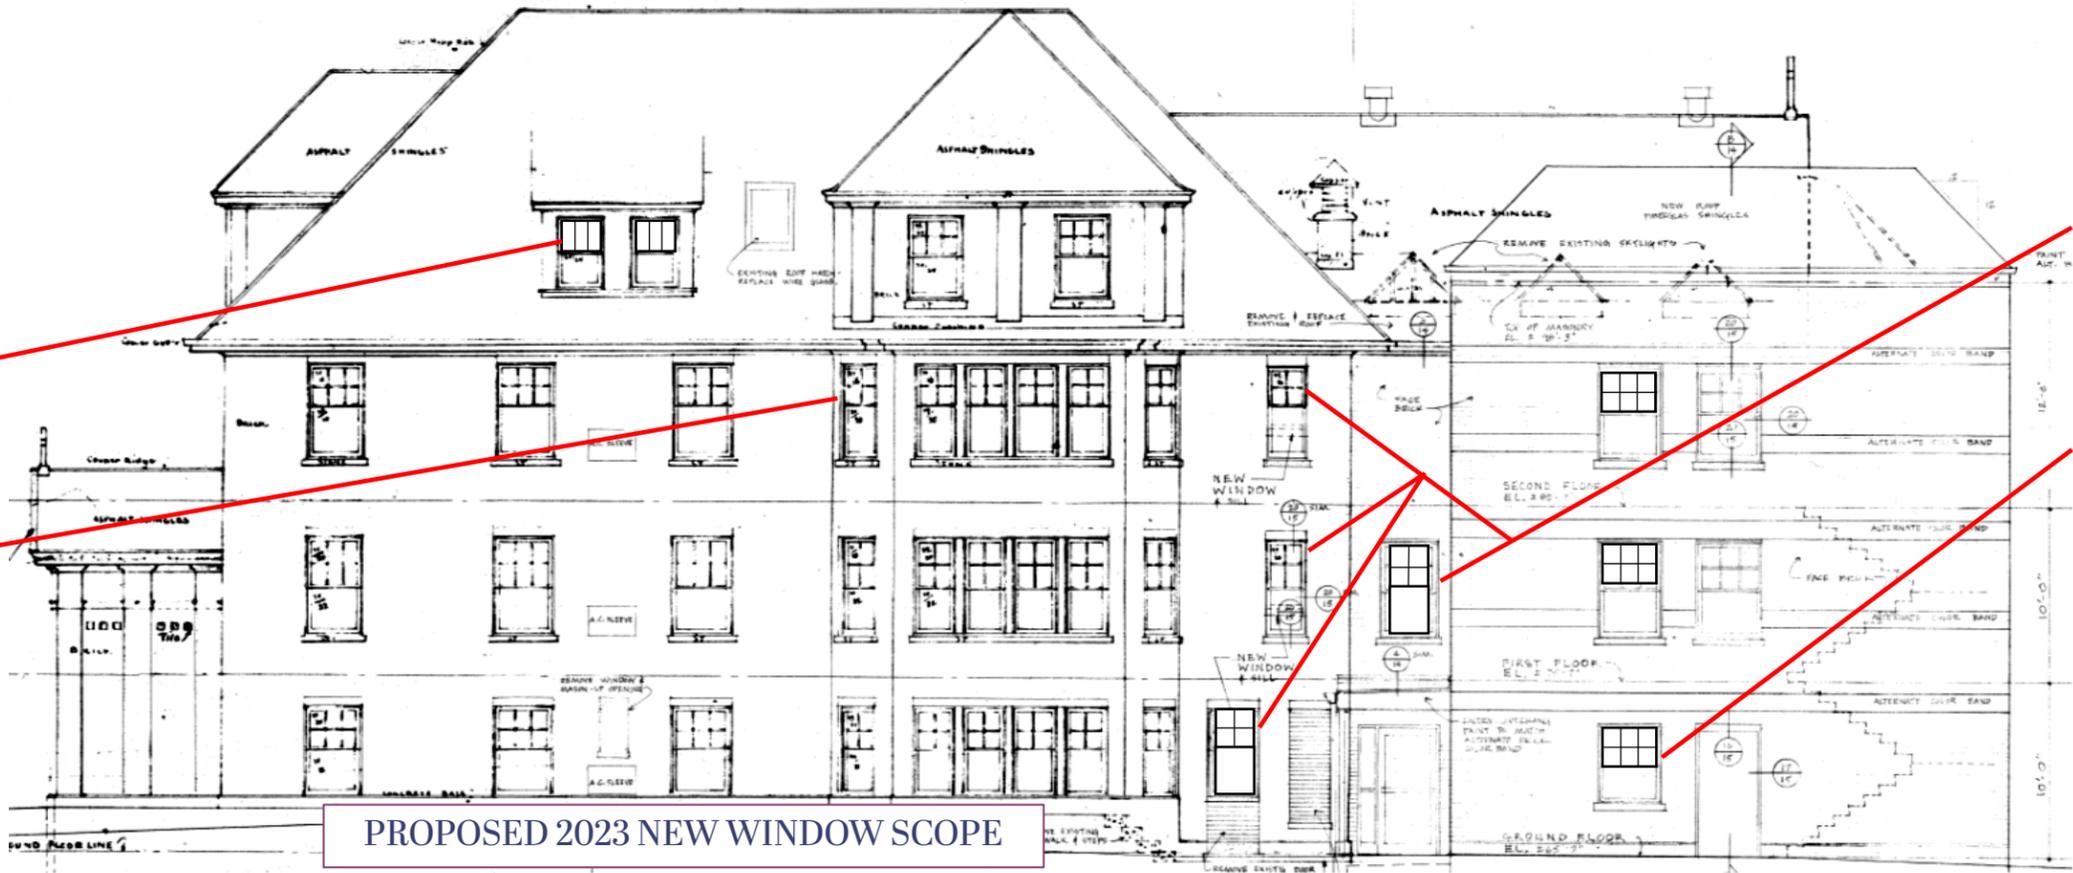
PROPOSED 2023 NEW WINDOW SCOPE

NARROW WINDOWS SHALL BE RETURNED TO MATCH THE 1922 DRAWINGS WITH 1 VERTICAL SDL / 1 HORIZONTAL SDL ABOVE SASH

VERTICAL STACK OF WINDOWS SHALL MATCH ADJACENT WINDOWS WITH 2 VERTICAL SDL/ 1 HORIZONTAL SDL, TO MATCH PROPORTIONS OF REMAINING BUILDING INCLUDING 1ST FLOOR COTTAGE SASHES

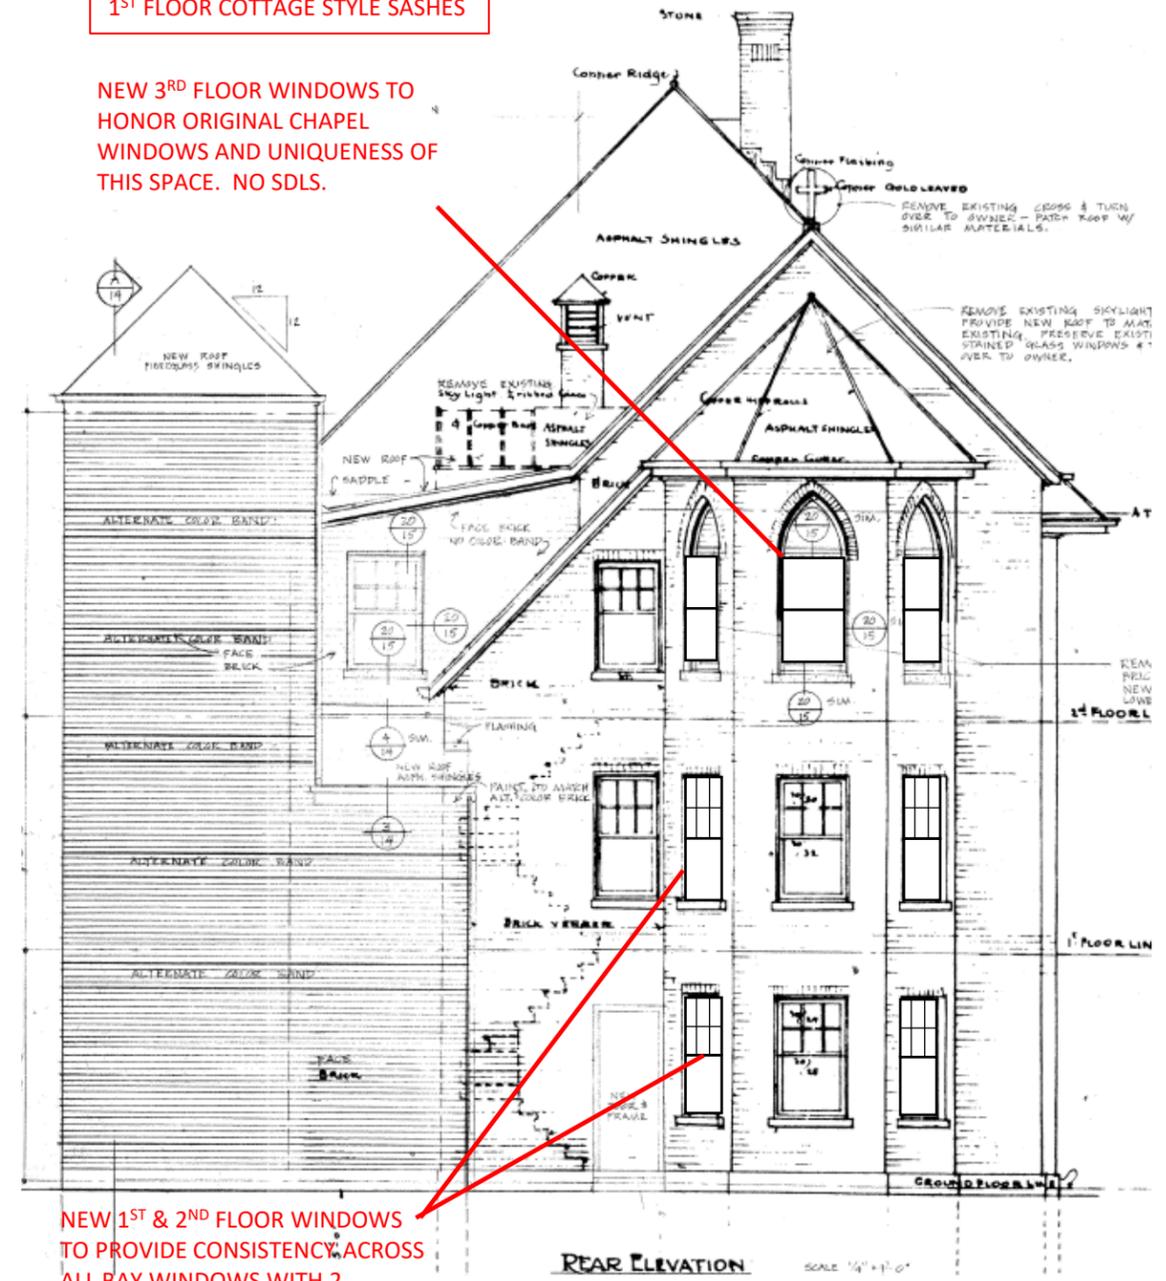
PROPOSED 2023 NEW WINDOW SCOPE

NEW 3RD FLOOR WINDOWS TO HONOR ORIGINAL CHAPEL WINDOWS AND UNIQUENESS OF THIS SPACE. NO SDLs.

NEW 1ST & 2ND FLOOR WINDOWS TO PROVIDE CONSISTENCY ACROSS ALL BAY WINDOWS WITH 2 VERTICAL SDL / 1 HORIZONTAL SDL; 1ST FLOOR TO HAVE COTTAGE STYLE SASHES

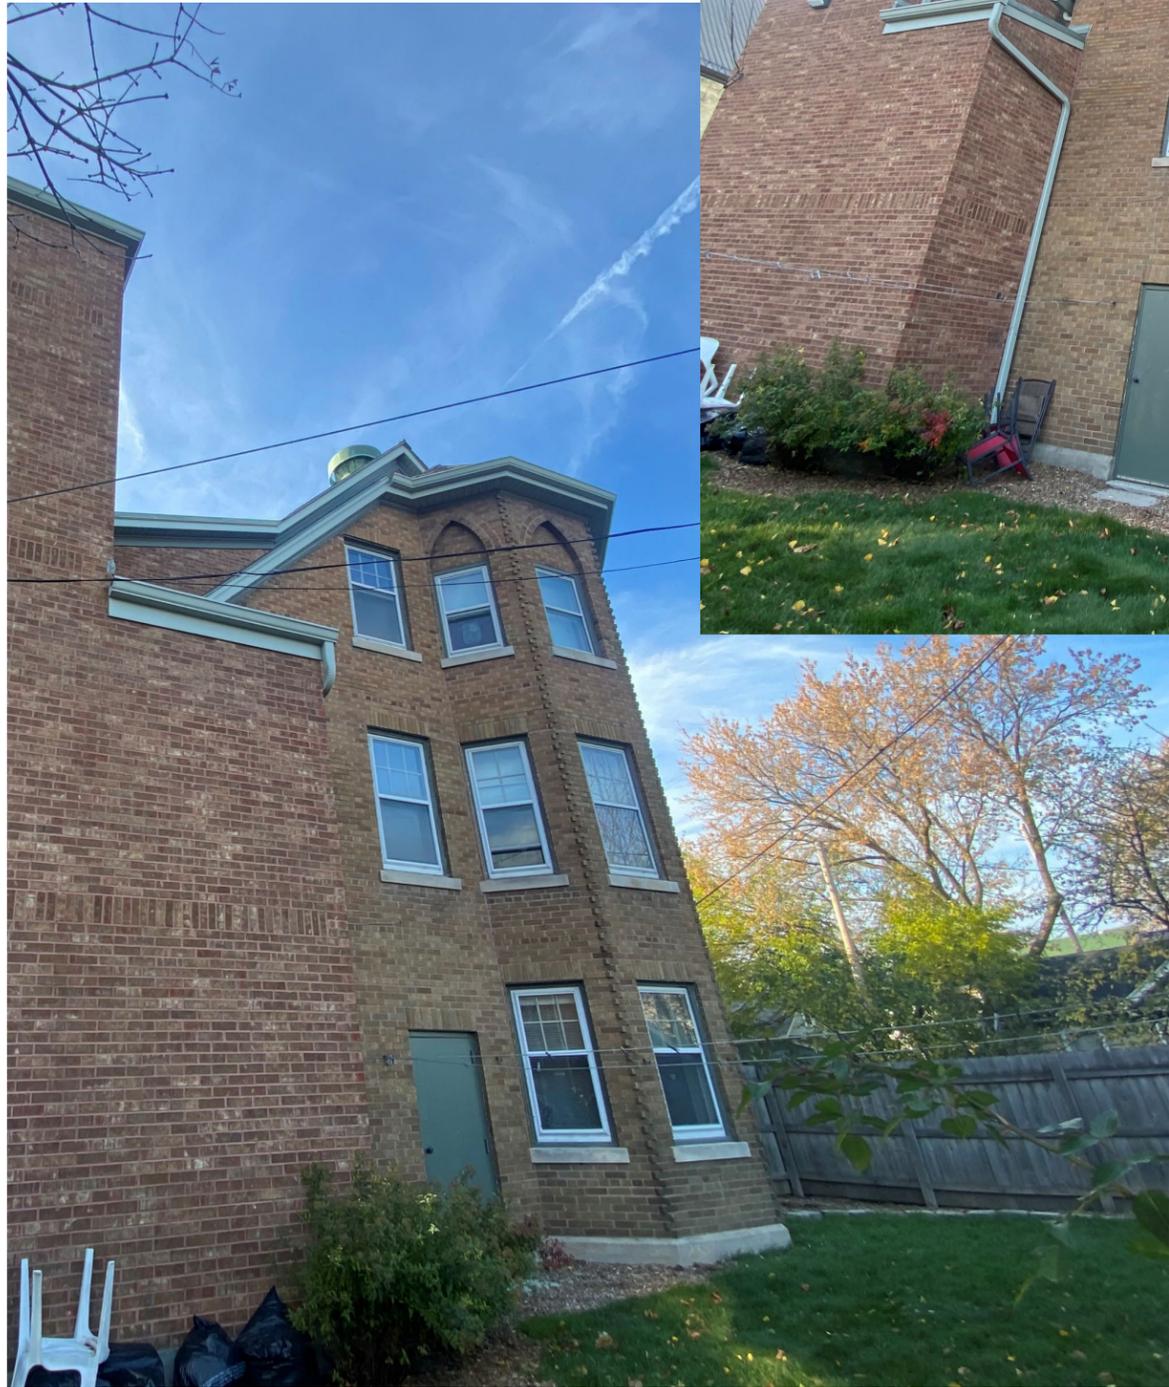
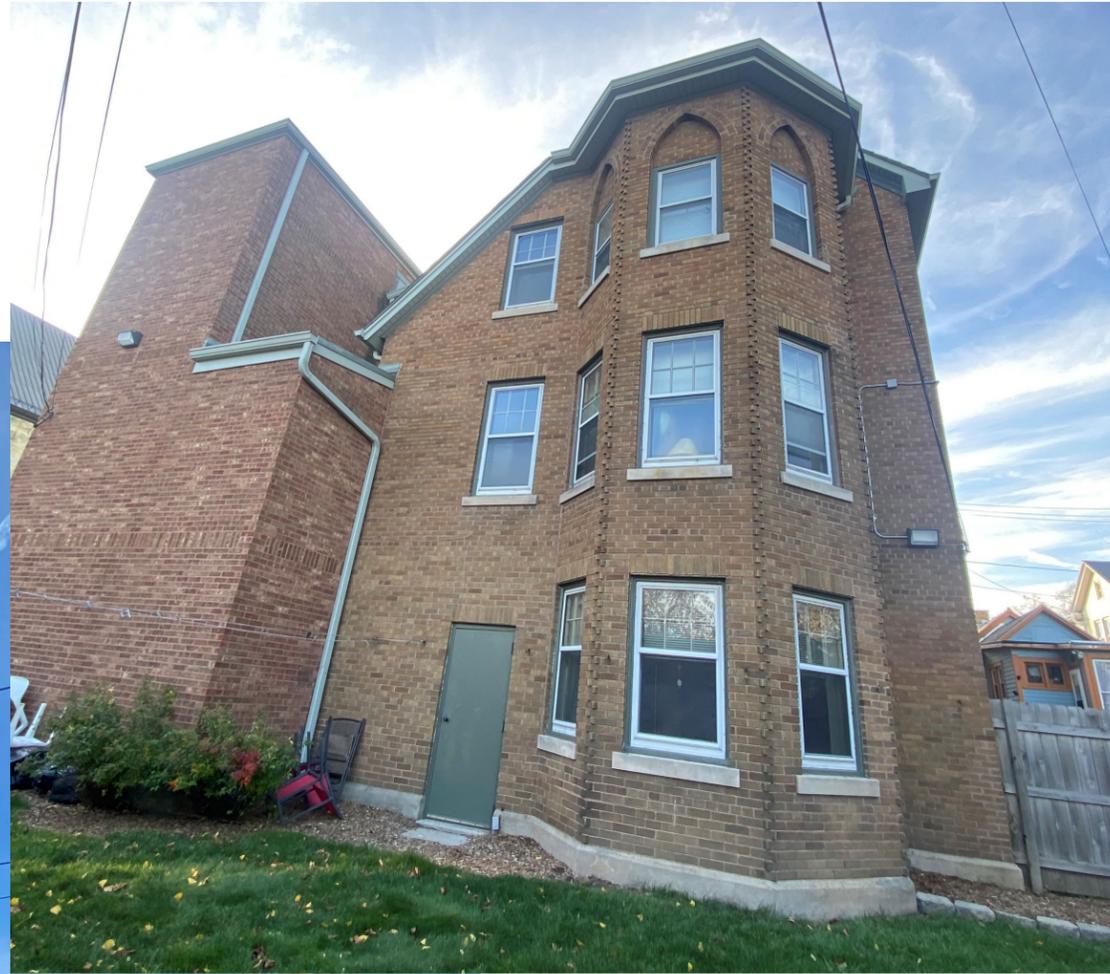
NOTE: UNLESS SPECIFICALLY IDENTIFIED, ALL EXISTING WINDOWS TO BE REPLACED TO MATCH "LIKE FOR LIKE" EXISTING ORIGINAL WINDOWS; INCLUDING 1ST FLOOR COTTAGE STYLE SASHES

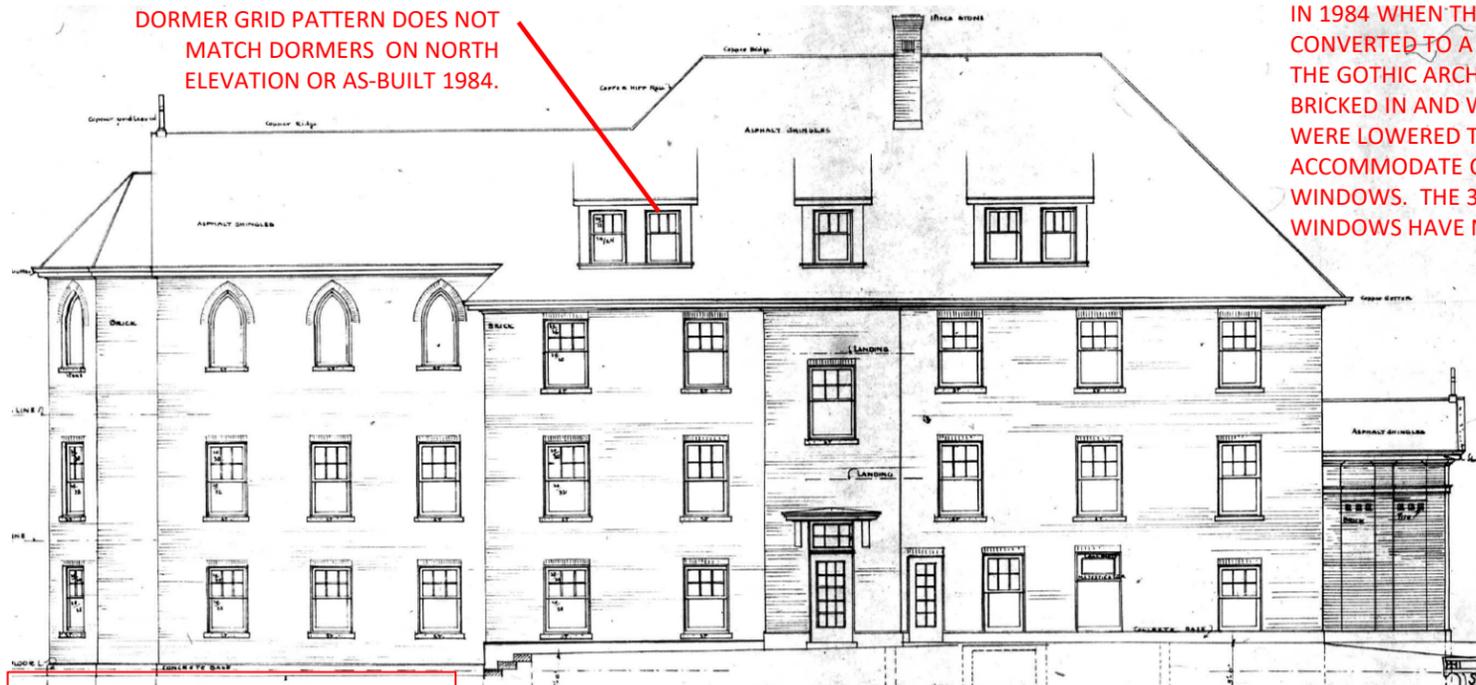
NOTE: ALL 1ST FLOOR WINDOWS WERE INSTALLED WITH UNEQUAL 'COTTAGE STYLE' SASHES, WHILE THE 2ND AND 3RD FLOORS HAVE EQUAL SASHES

IN 1984 WHEN THE CHAPEL WAS CONVERTED TO A DWELLING UNIT, THE GOTHIC ARCHES WERE BRICKED IN AND WINDOW SILLS WERE LOWERED TO ACCOMMODATE OPERABLE WINDOWS. THE 3RD FLOOR WINDOWS HAVE NO GRILLES.

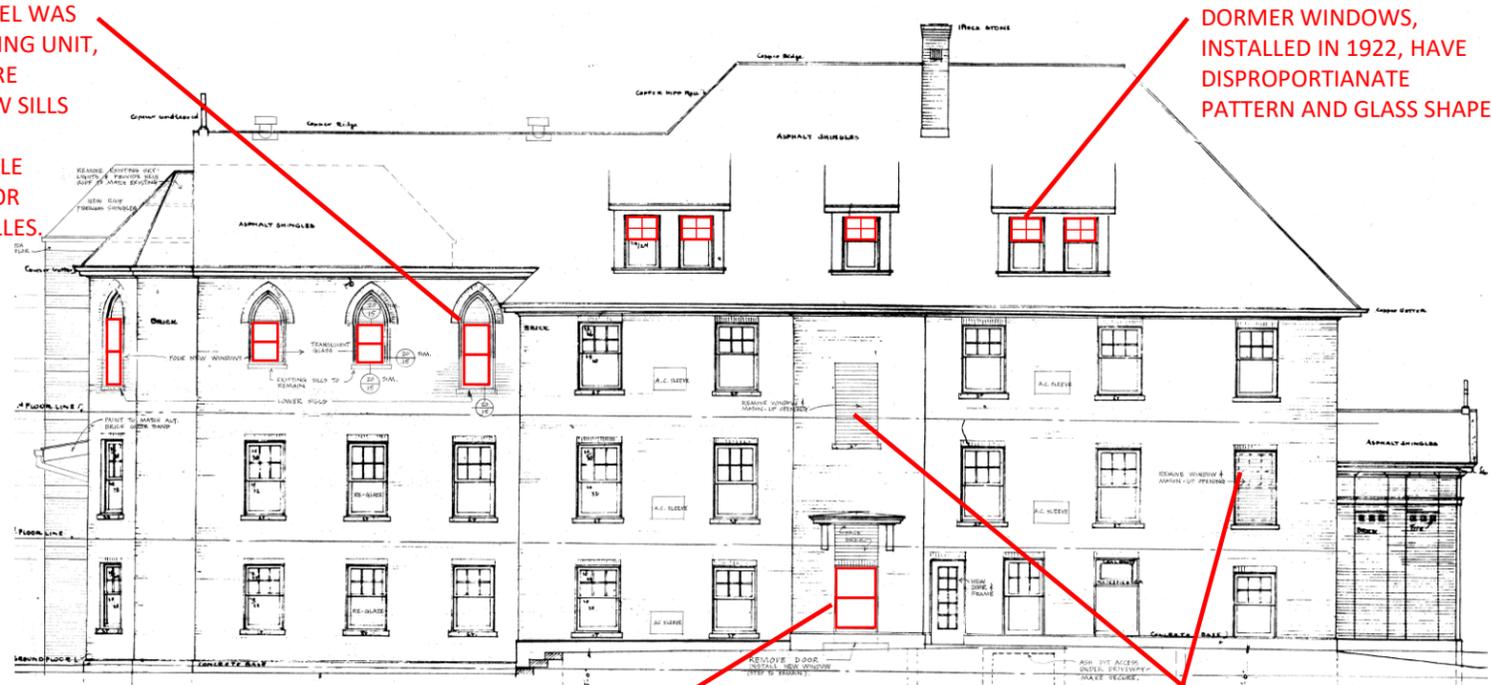
NO GRILLES

WINDOW WAS BRICKED OVER IN 1984 TO CREATE A COMMUNITY LAUNDRY ROOM AND DWELLING PARTY WALL

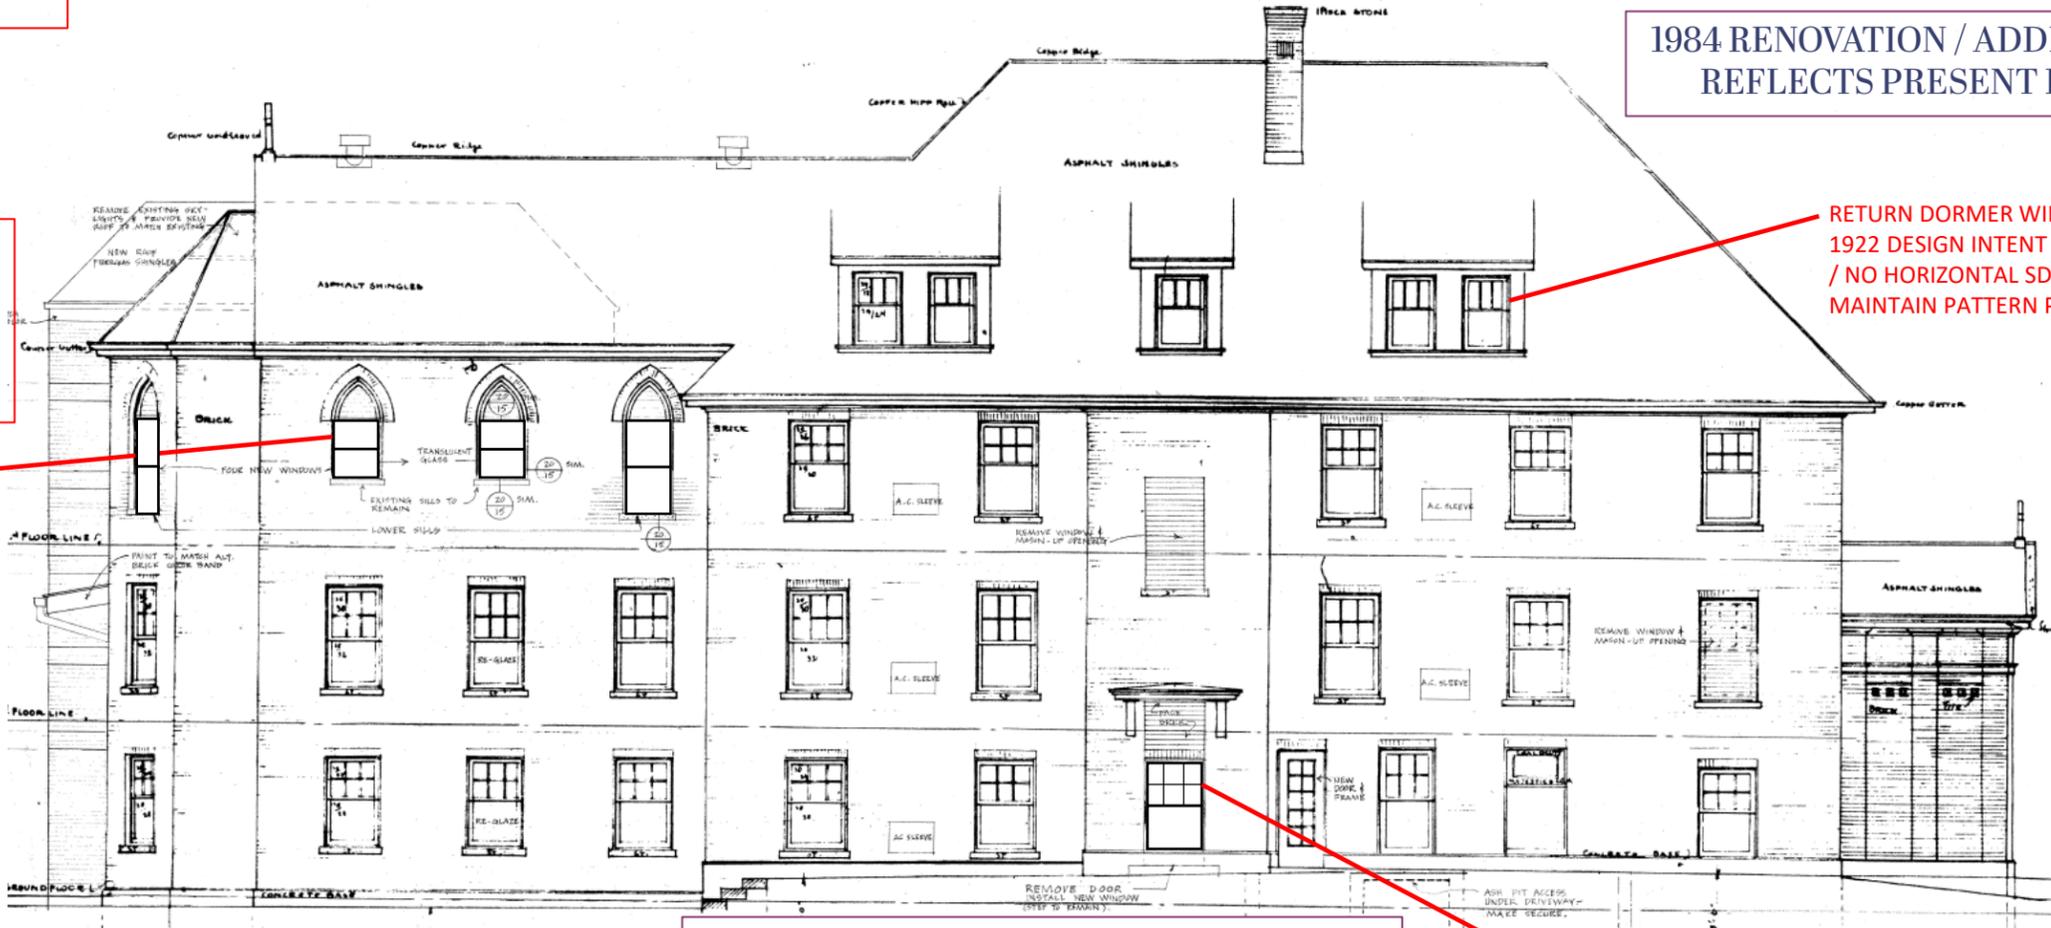
PROPOSED 2023 NEW WINDOW SCOPE

RETURN DORMER WINDOWS TO ORIGINAL 1922 DESIGN INTENT WITH 2 VERTICAL SDLS / NO HORIZONTAL SDL, WHICH WILL MAINTAIN PATTERN PROPORTIONS

MATCH SDLS, TYP AND COTTAGE SASH

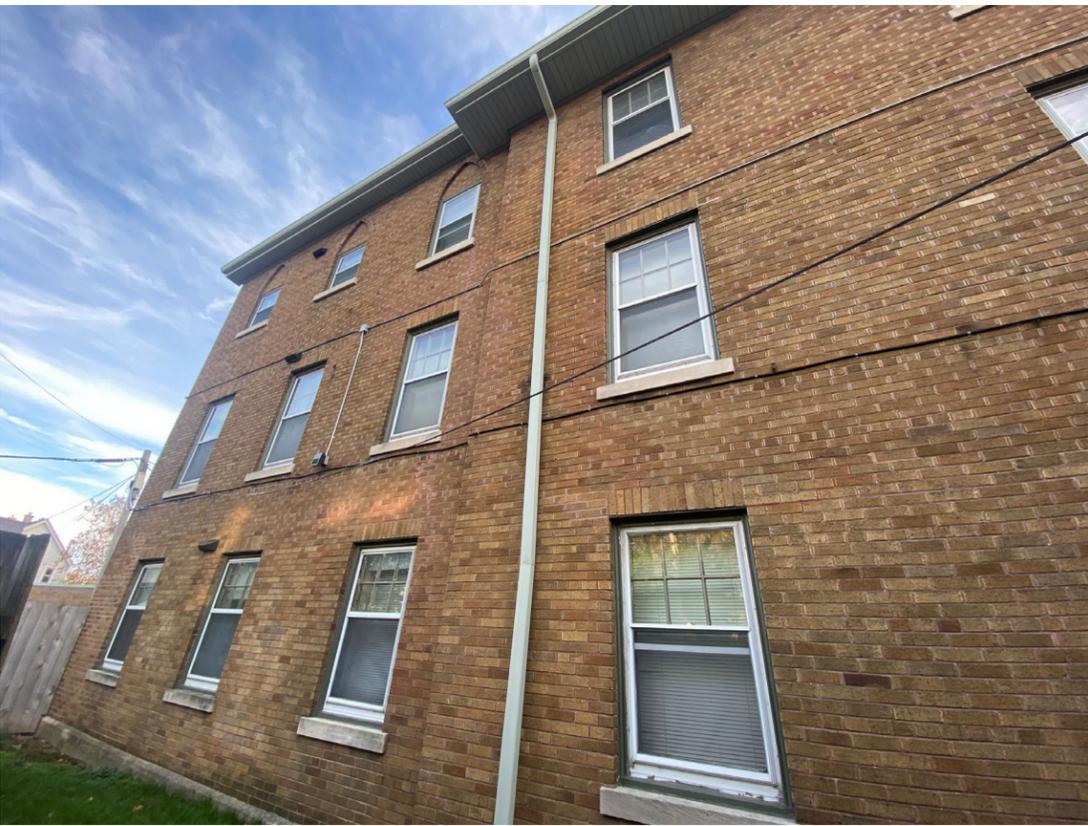
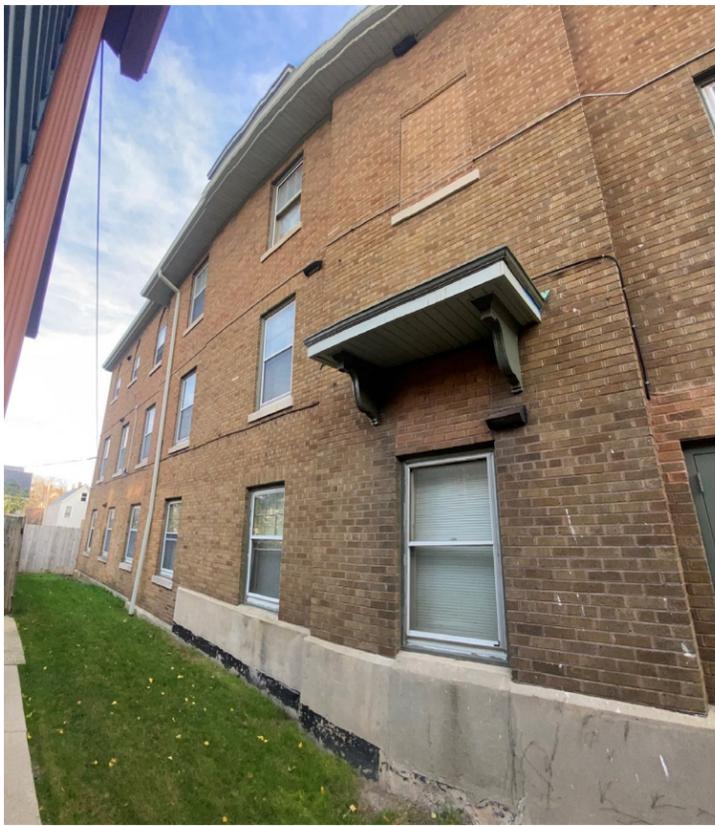
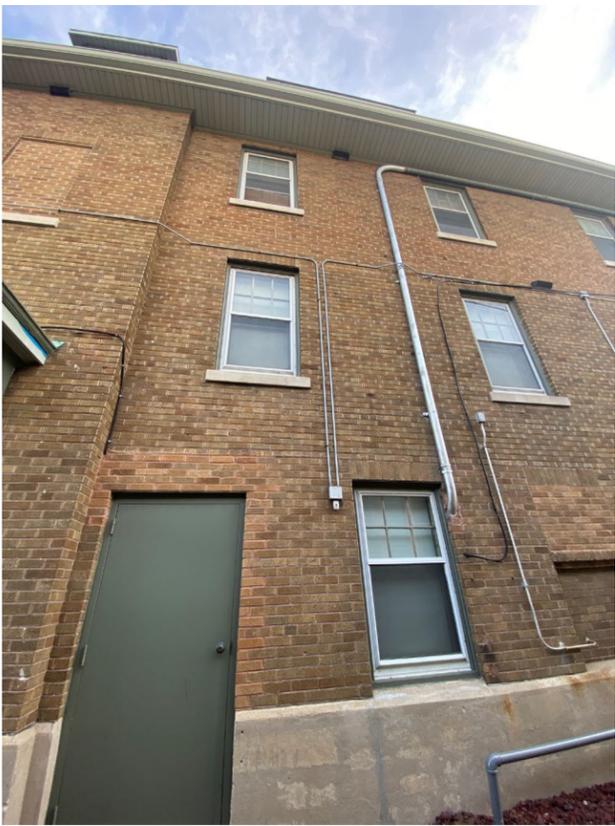
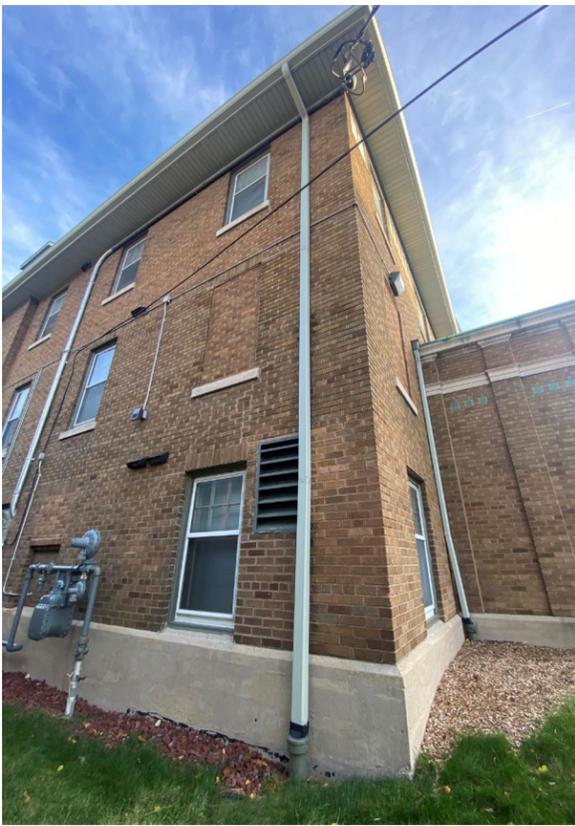
NOTE: UNLESS SPECIFICALLY IDENTIFIED, ALL EXISTING WINDOWS TO BE REPLACED TO MATCH "LIKE FOR LIKE" EXISTING ORIGINAL WINDOWS; INCLUDING 1ST FLOOR COTTAGE STYLE SASHES

NEW 3RD FLOOR WINDOWS TO HONOR ORIGINAL CHAPEL WINDOWS AND UNIQUENESS OF THIS SPACE. NO SDLs.

RETURN DORMER WINDOWS TO ORIGINAL 1922 DESIGN INTENT WITH 2 VERTICAL SDLs / NO HORIZONTAL SDL, WHICH WILL MAINTAIN PATTERN PROPORTIONS
