PROPOSED 2023 NEW WINDOW SCOPE

1922 CONVENT DRAWINGS

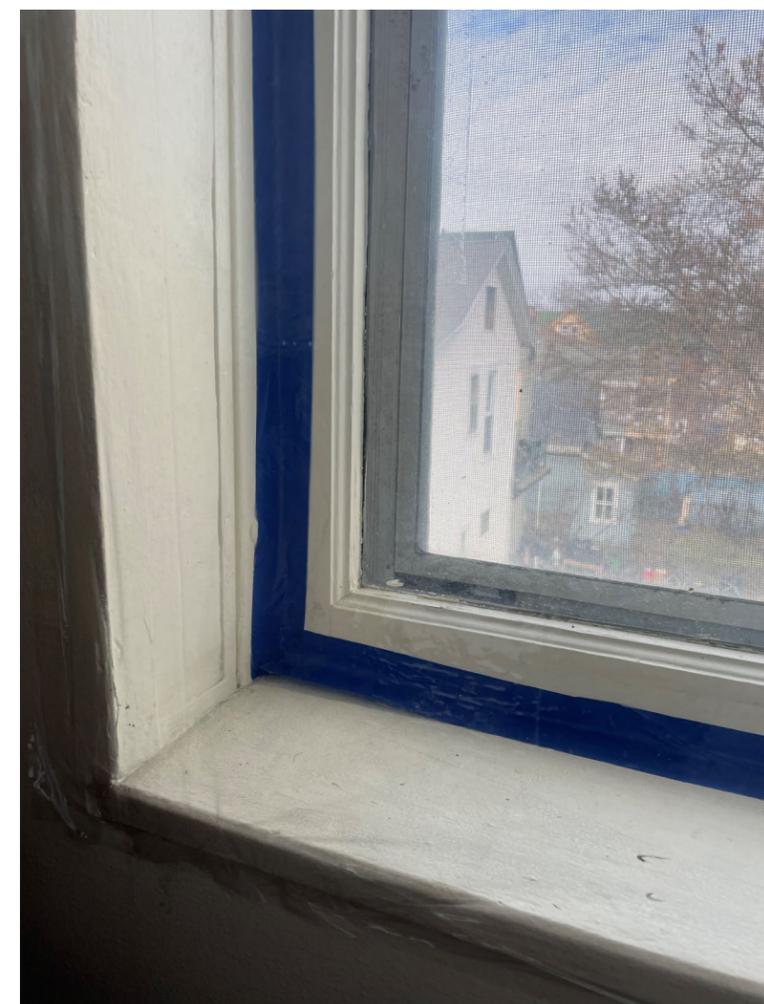
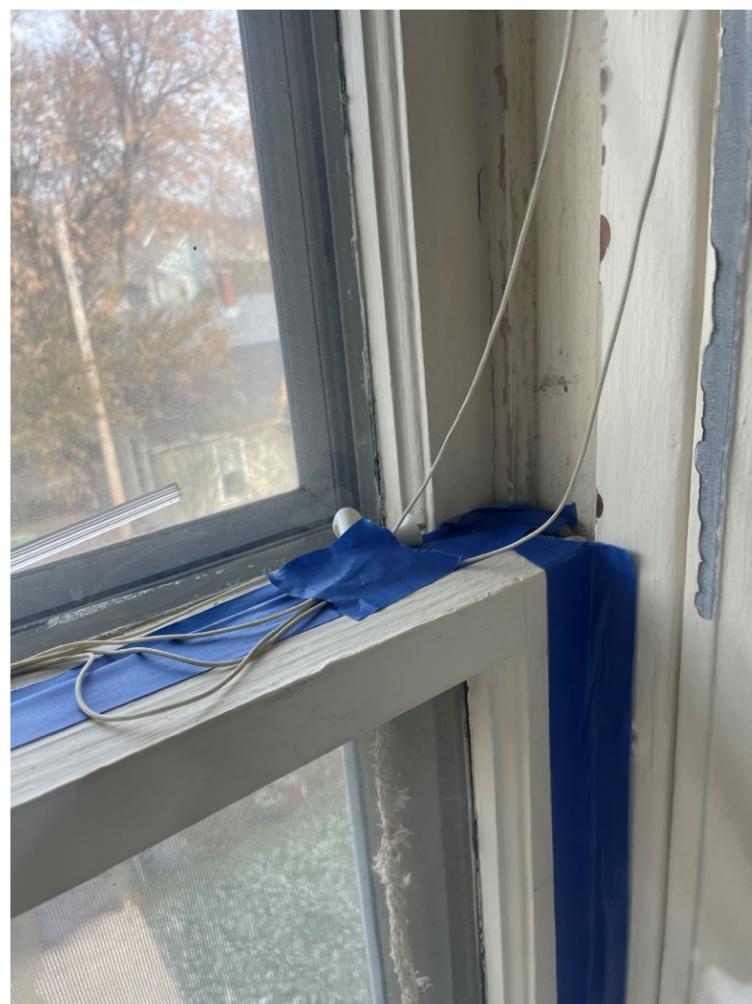
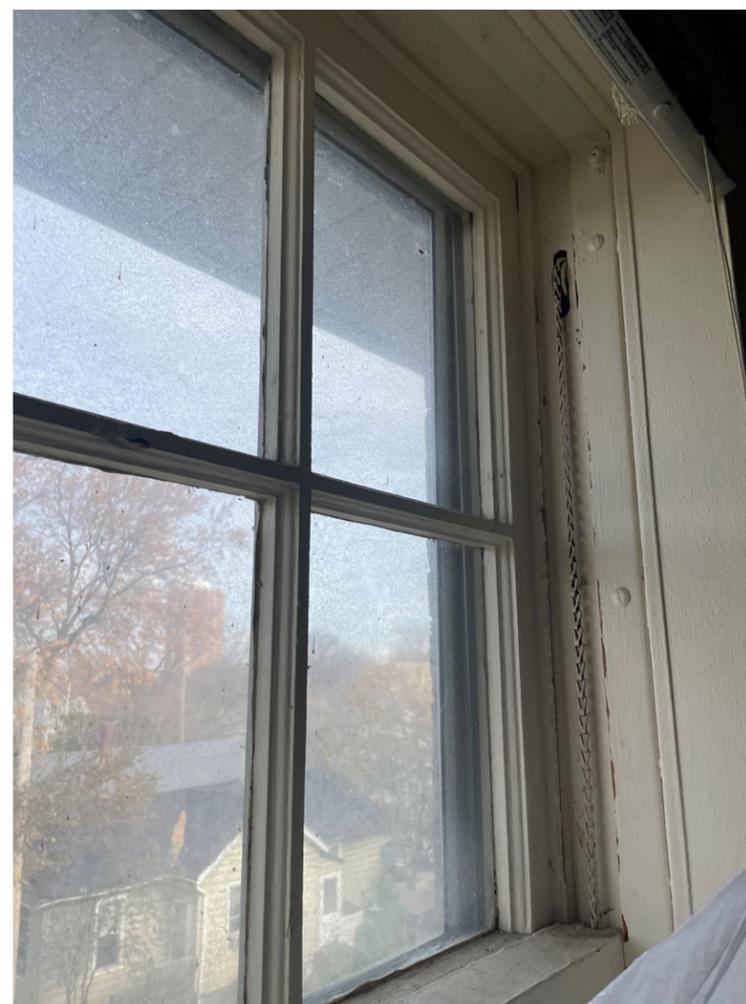
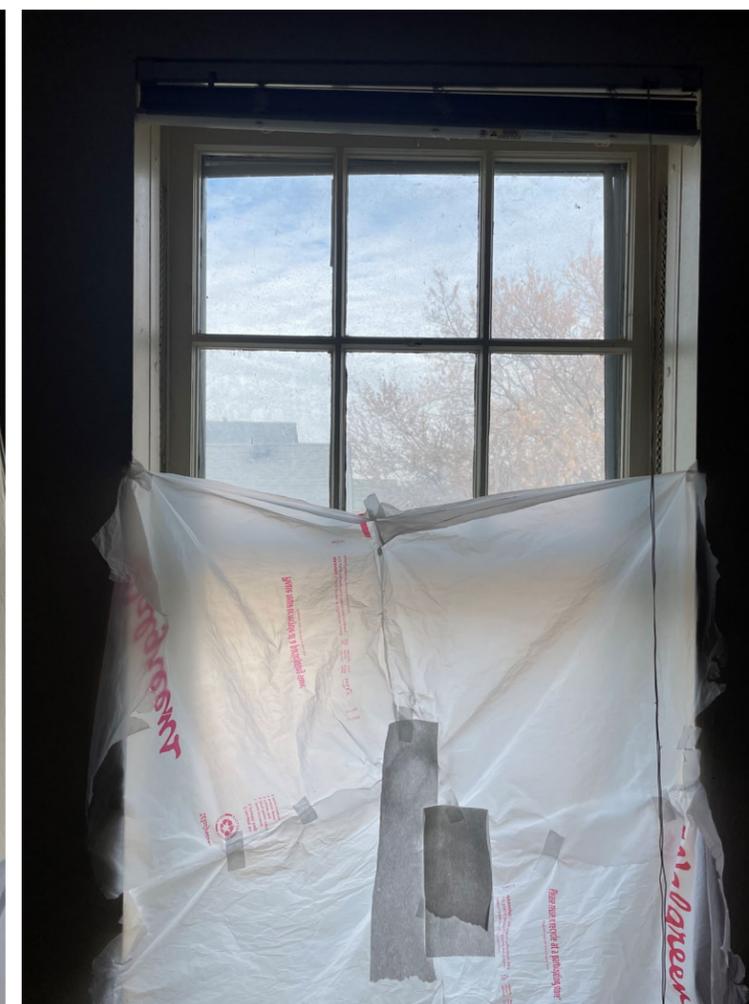
Storm windows are outfitted on all windows to temper the heat transfer with the single-pane glass windows. Despite this, the draft through the windows is extremely uncomfortable for the senior aged residents. The property manager uses painter's tape to seal all the window joints. This particular tenant used plastic bags to create an additional weather barrier.

The windows do not operate well – the weights and balances are off. Some windows have severed ropes making it unsafe to be opened. The property has continued to invest capital in fixing the ropes, chains, but it has become time intense to manage this ongoing problem. From the exterior, window frames are rotting and some windows have dropped over 2" in their frame.

It is difficult for residents to operate the windows with the weight system, with summer swell, and to obtain fresh air.

It is a fire and life safety concern to residents that are unable to operate windows during an emergency.

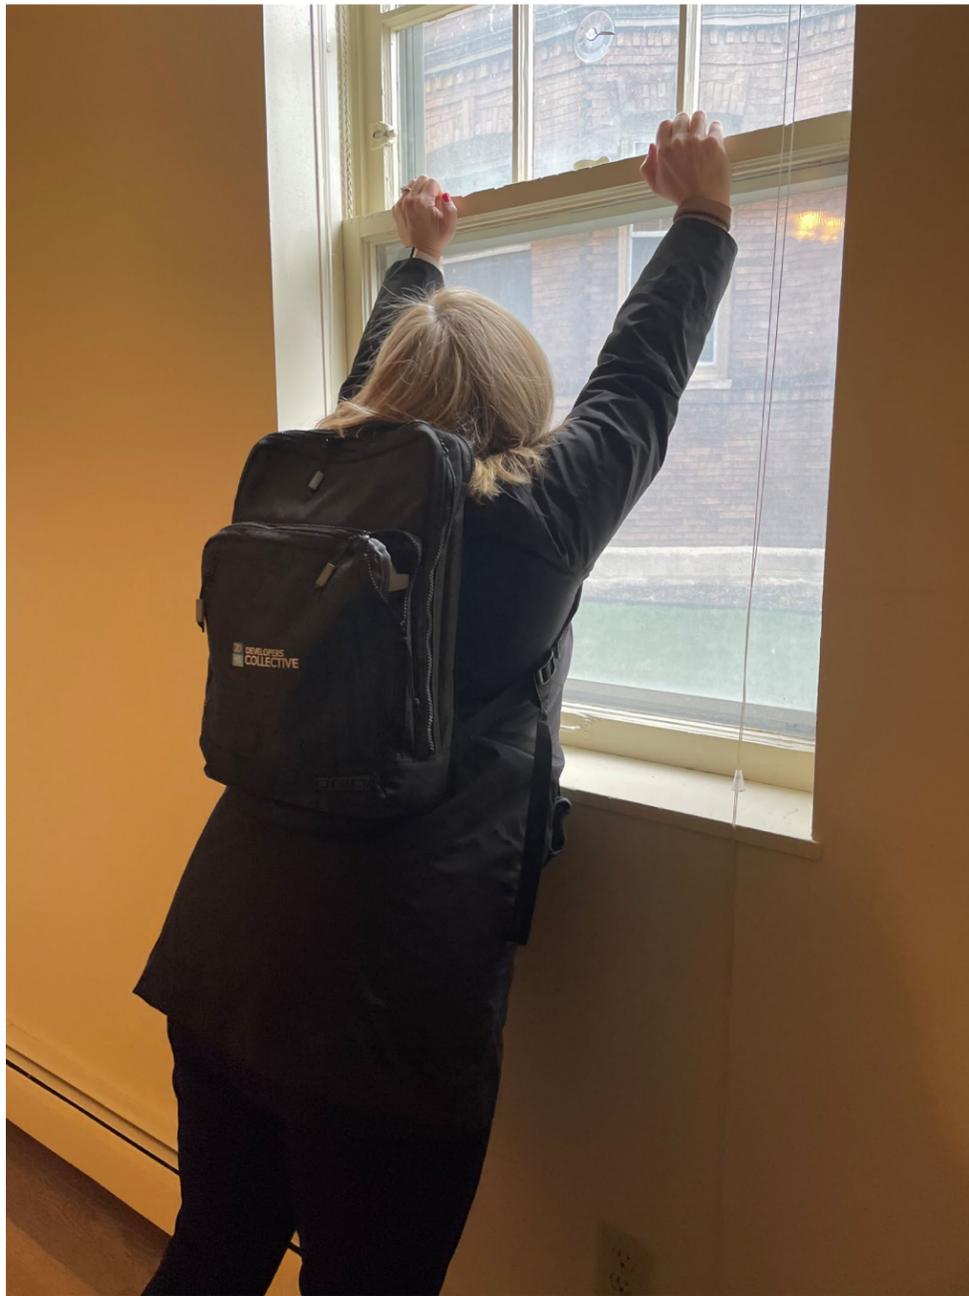
Window latch is released. Trying to force window open but unsuccessful.

Windows frequently swell with humidity in the summer or painting seals the sash.

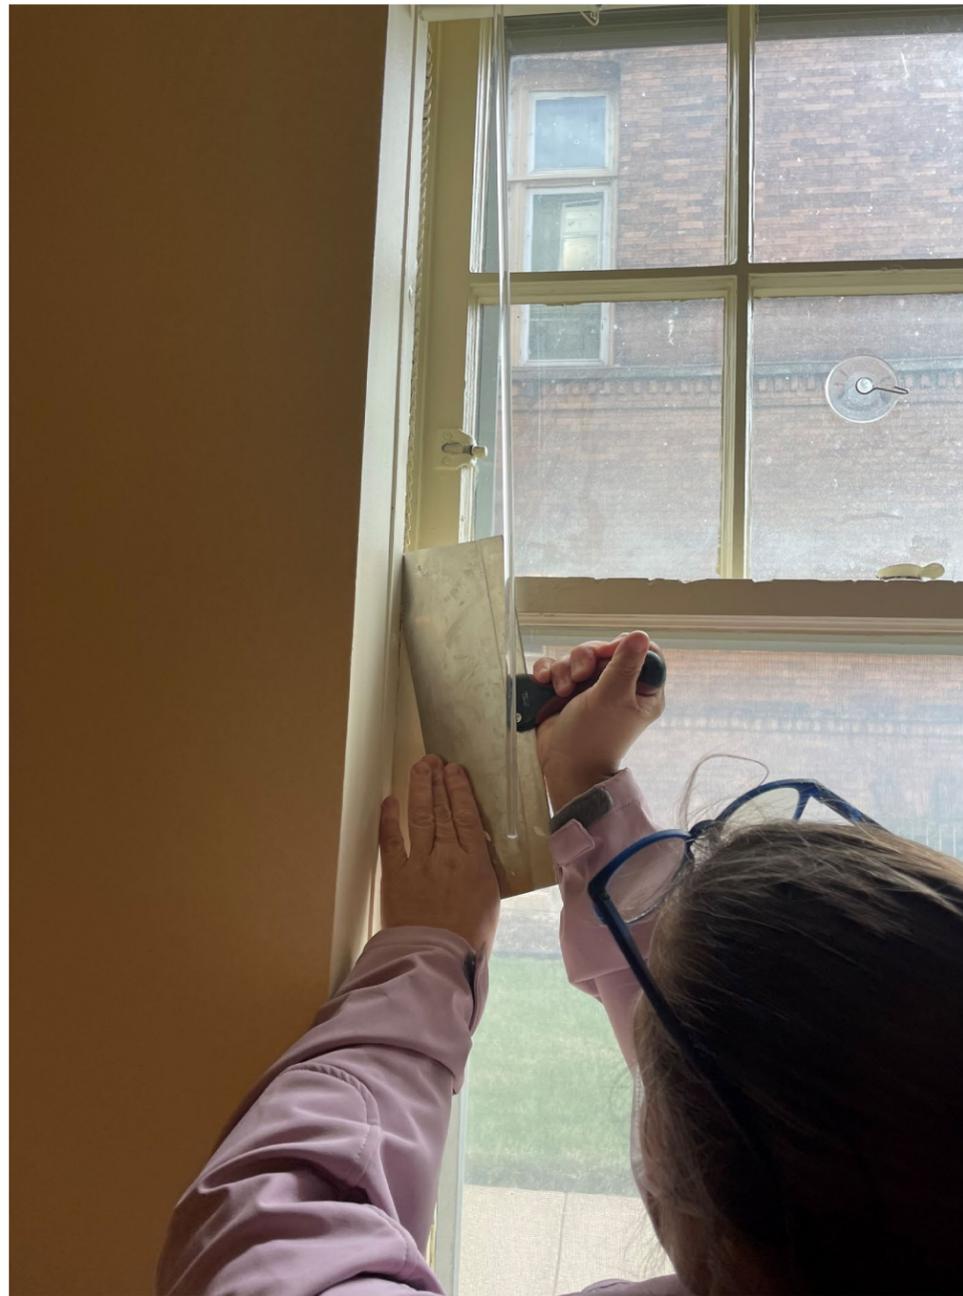
The property manager uses a putty knife to loosen the joints to improve the operation. She was unsuccessful with this window so she will need to contact the maintenance man from another property.

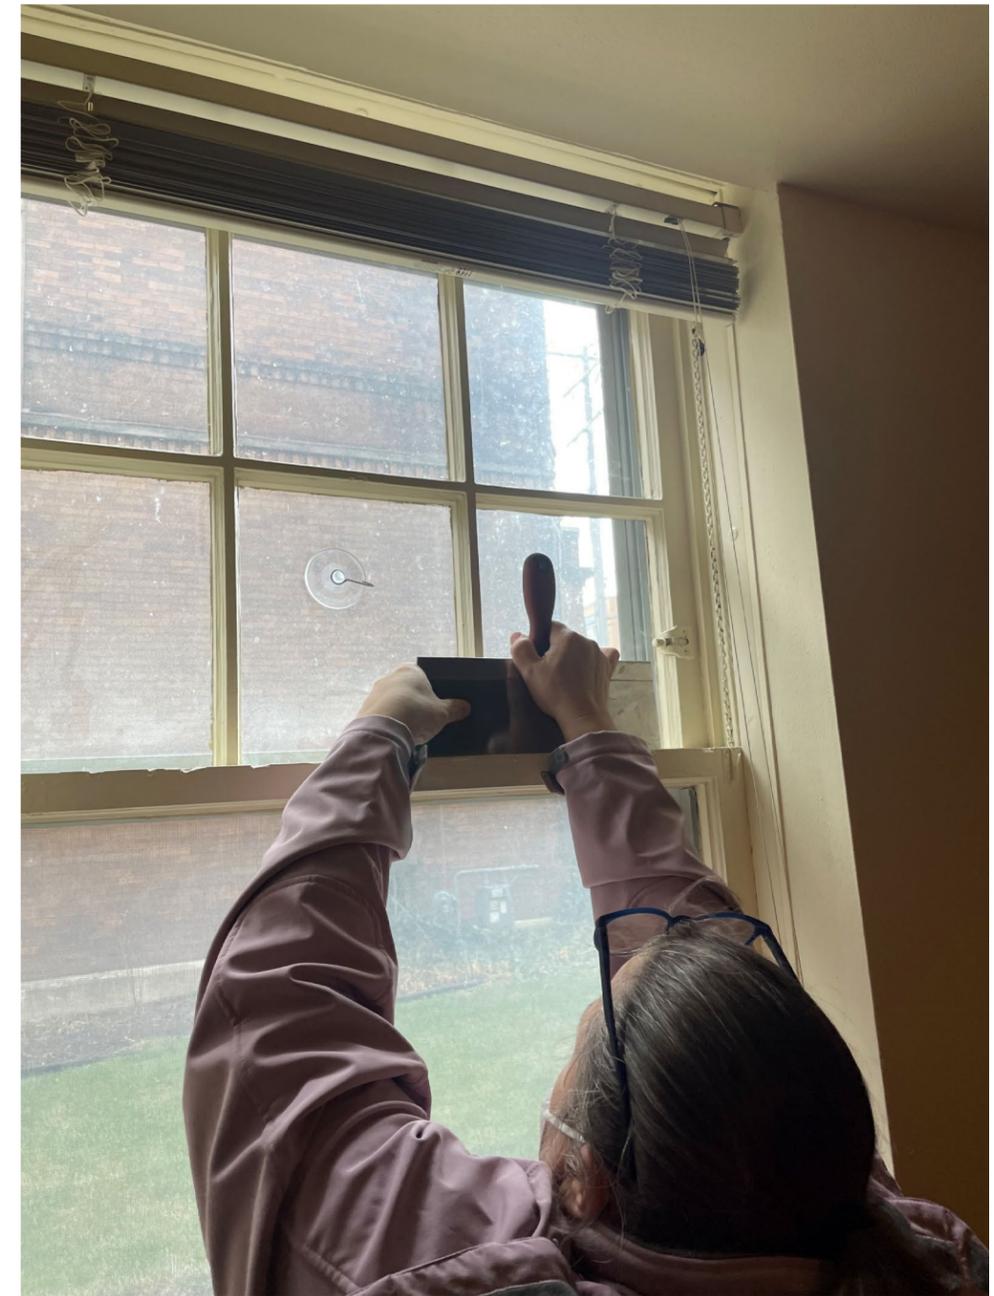
DOUBLE HUNG WINDOWS

Weather Shield's all-wood double hung windows offer ultimate aesthetic flexibility, as they can be made from a variety of wood species to create warmth and classic elegance. Sash tilt in or can be removed for easy cleaning.

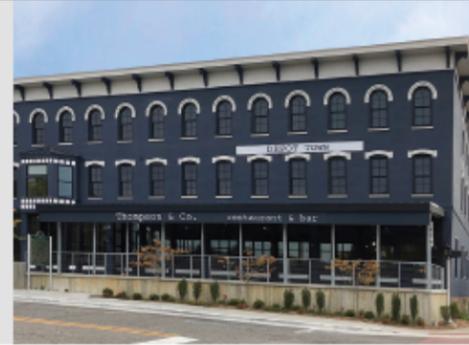
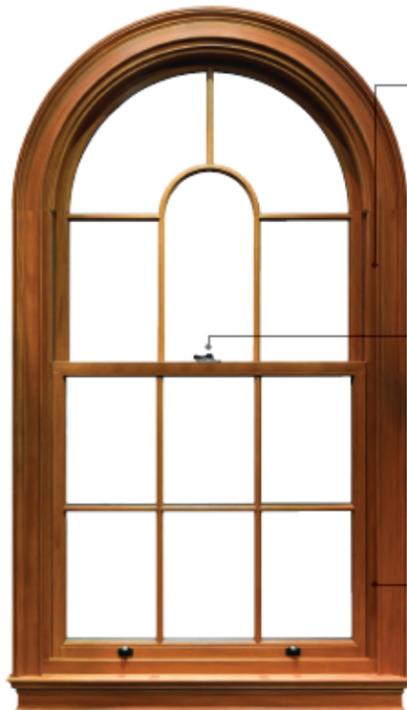
A wood jambliner covers all mechanical balance systems to create a tailored aesthetic.

The single dual action lock allows the sash to be unlocked and tilted easily with one hand. Tilt release latches are concealed leaving the sash clear of visible latches.

The Symmetry Balance System is nestled just inside the sub-frame and hidden from view, this uniquely engineered constant force balance system is constructed with flat stainless steel coil that is paired with a casing made from corrosion resistant materials.

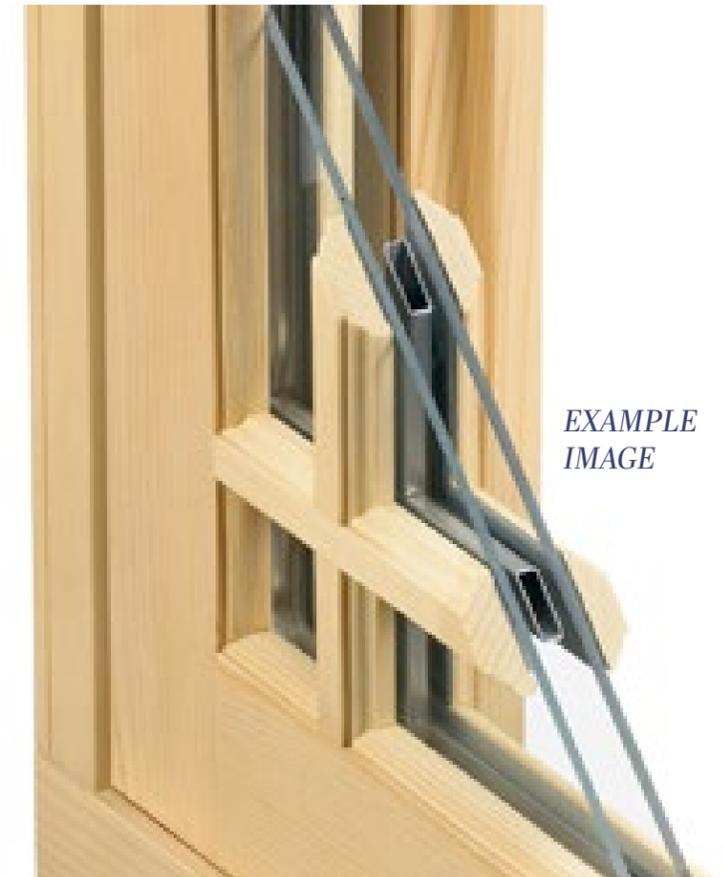
EXAMPLE
IMAGE

The internal bars are available in black, if requested by the Historic Preservation Commission.
