LIVING WITH HISTORY

Certificate of Appropriateness

Property 1034 N. 4TH ST. Turner Hall
Description of work Replace plywood on 12 ground floor windows on north elevation. Provide proper trim for plywood and replace plexiglass covers for all upper sashes. Paint all woodwork.
Date issued 7/10/2018 PTS ID 114566 COA: ground floor north windows

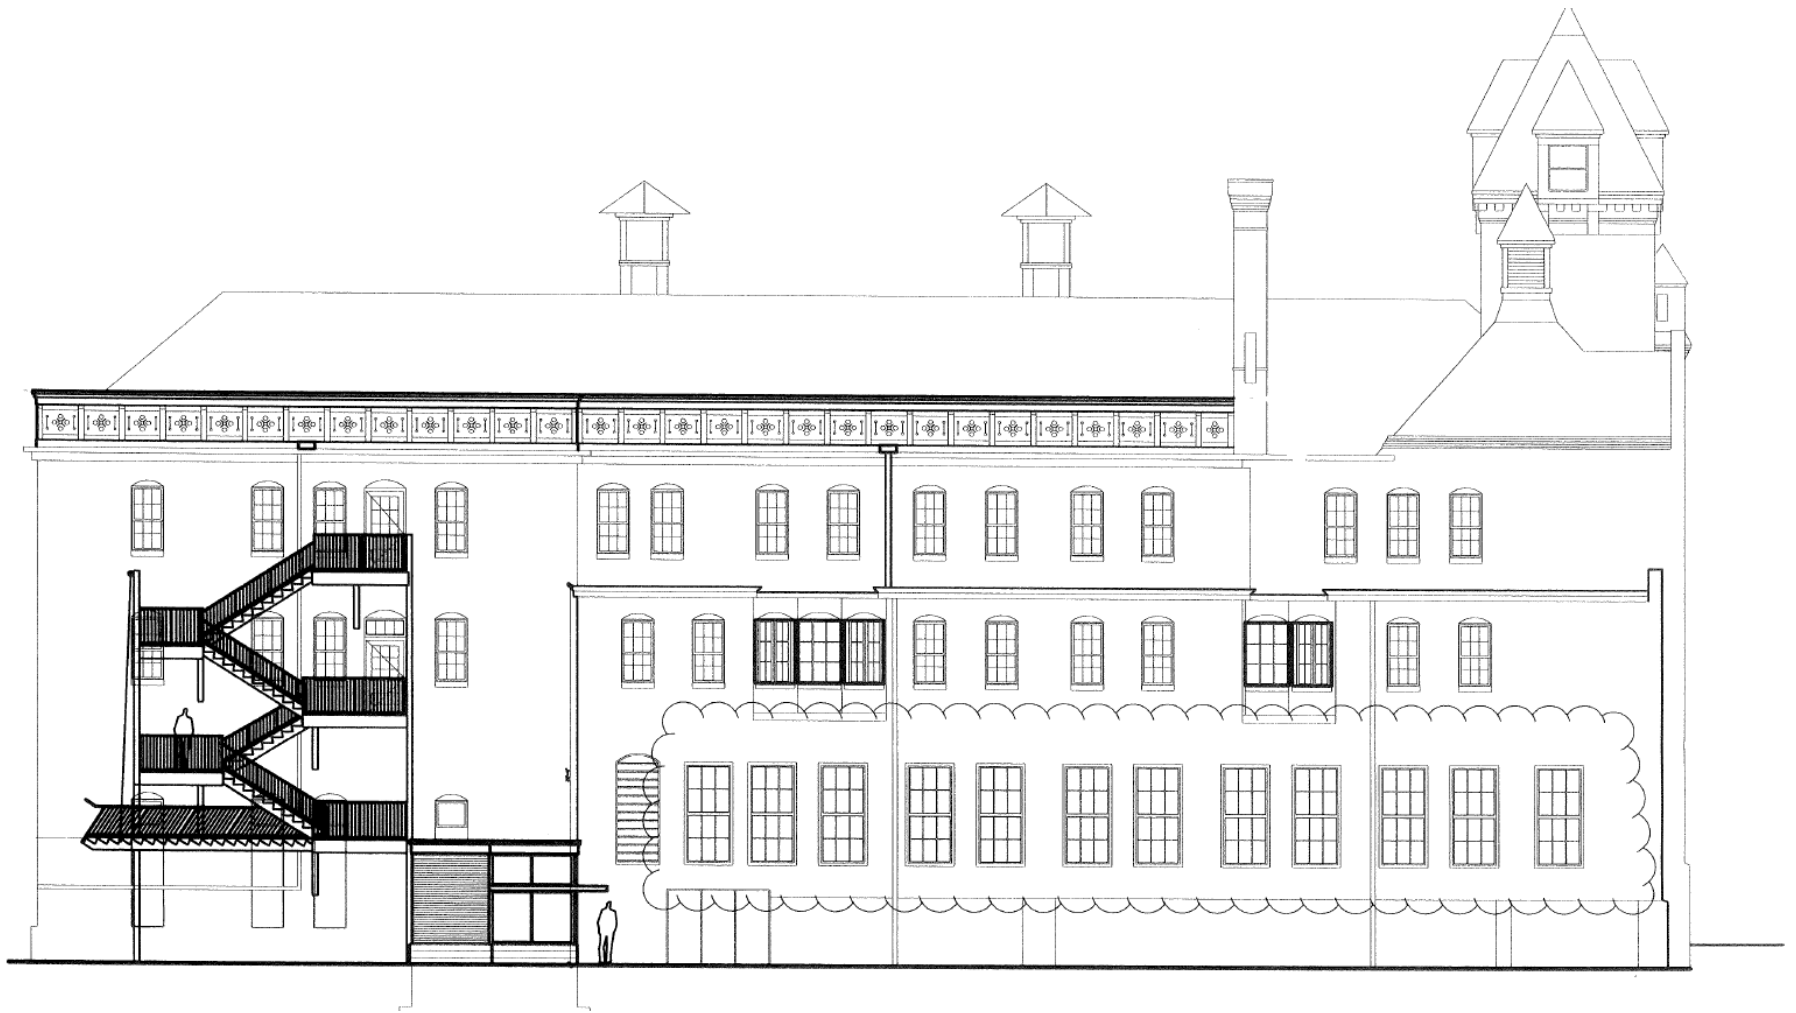
North elevation with subject windows in cloud.

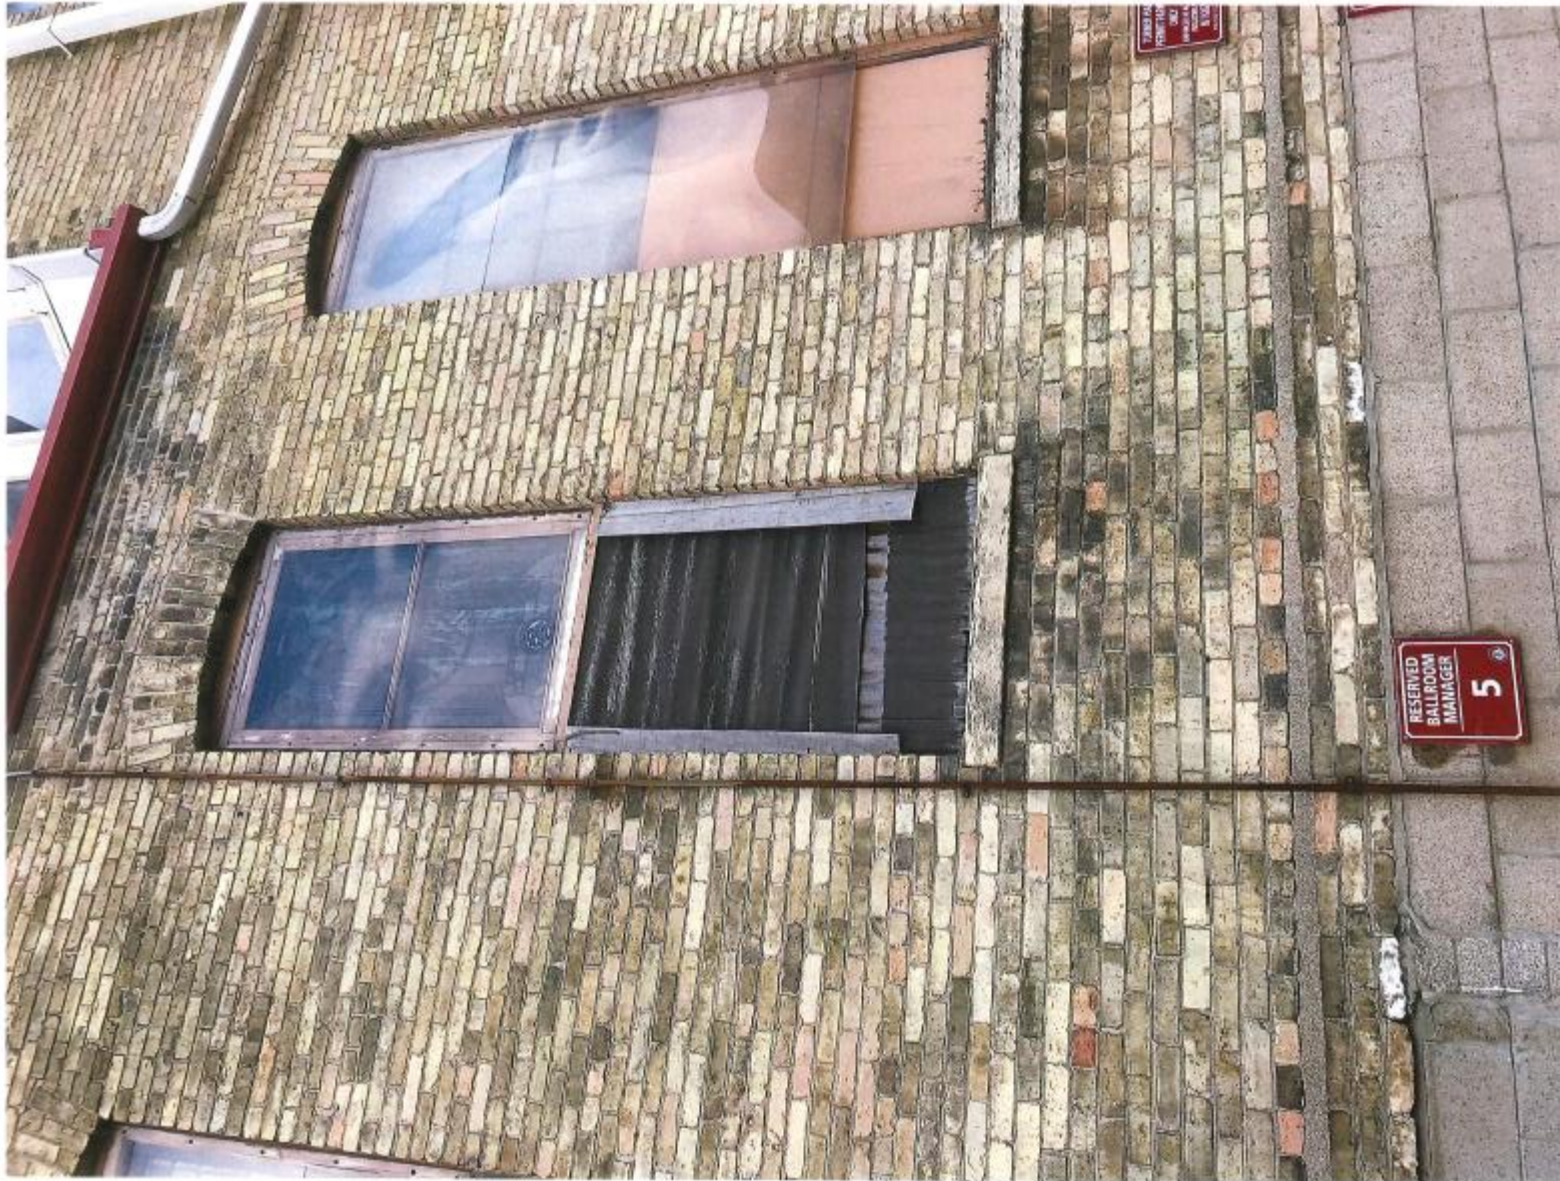
Typical existing conditions
