# EVALUATION OF THE CONVERGING CHEVRON PAVEMENT MARKING PATTERN

at one Wisconsin  
Location

*July, 2003*

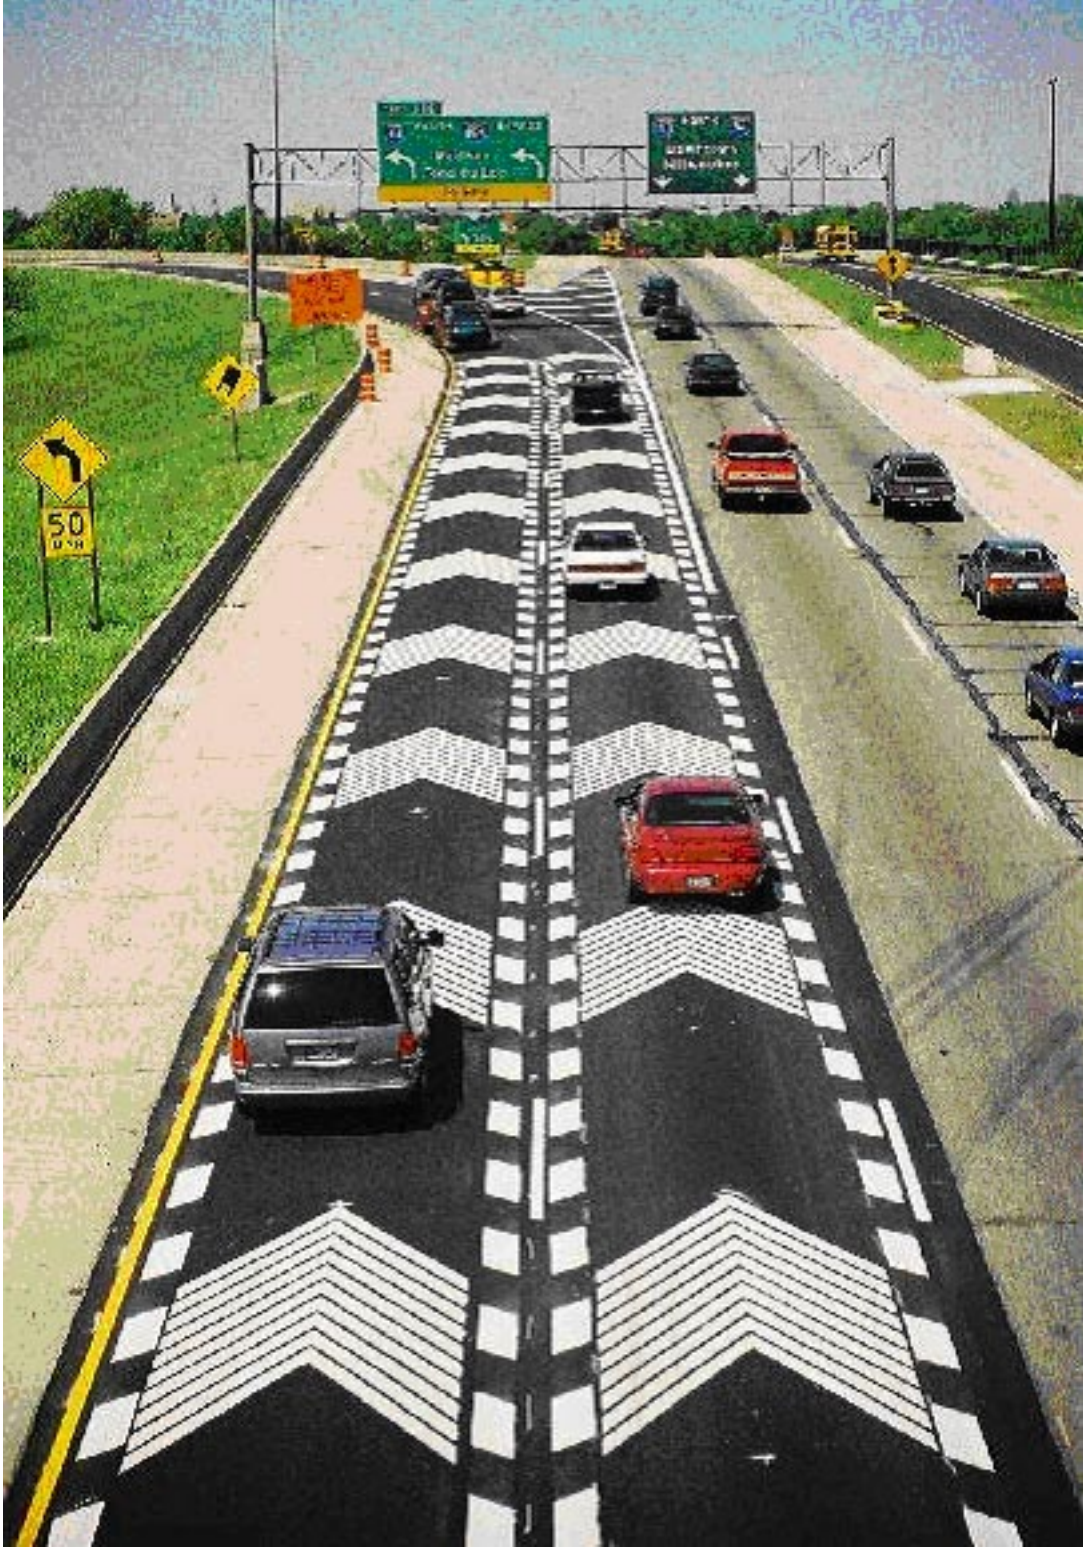
**Figure 1:** Evaluated device, as installed on the Northbound ramp of the Mitchell Interchange. Courtesy of Frank Both, Century Fence Company, Pewaukee, WI.

Figure 1 shows a series of white chevrons painted on the road surface. The chevrons are placed increasingly close together as a driver moves into the pattern. As the motorist crosses progressively larger numbers of chevrons per unit of time, the driver receives an impression of traveling faster than the vehicle’s actual speed. The length of each individual pattern is based on the initial speed of vehicles entering the pattern, the desired speed when exiting, brake reaction time, and constant deceleration once brakes are applied (see Appendix). To determine chevron placement in this study, the experts used an assumed entering speed of 65 mph and a desired exiting speed of 50 mph (the posted speed limit and the advisory speed for the test ramp).

The pattern was 610 feet long from the tip of the first chevron set to the tip of the last set and consisted of 16 sets of chevrons. The precise chevron location can be seen in Figure 2. A total length of 640 feet is indicated on this figure (beginning of the first set to the end of the 16<sup>th</sup> set).

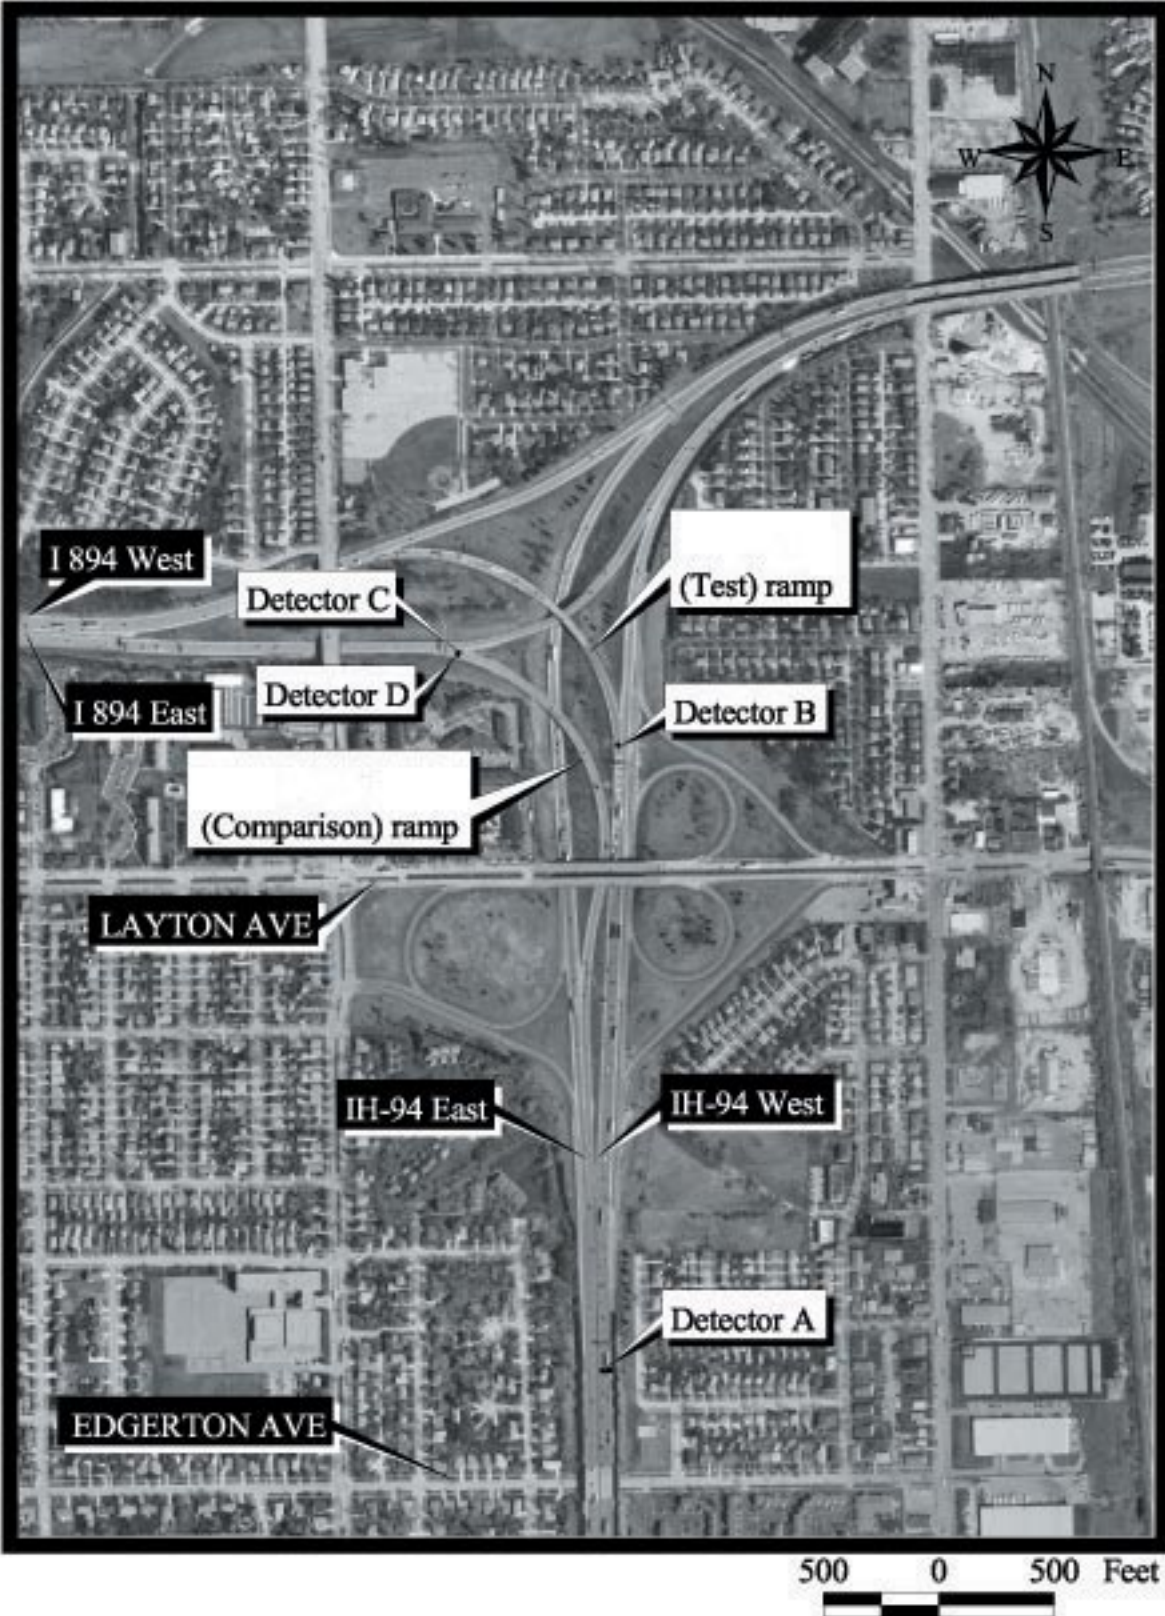
**Figure 3:** Mitchell Interchange

The ramp selected for the treatment on I-94 has four northbound lanes approaching the study location. The two lanes closest to the median branch out from the two northbound lanes at the Mitchell Interchange and follow a curve to the left to continue west to I-894 (test ramp lanes). The chevrons were installed on each of the two northbound lanes just before the ramp that heads west (**Figure 3**).

vehicle speeds or vehicle classification information. The locations of the four detectors (**A**, **B**, **C** and **D**) are shown in **Figure 3**.

The Mitchell Interchange is a directional Y-type urban interchange that provides for all directional movements through high-speed ramps. Study ramps had two 12-foot asphalt traffic lanes and 12-foot concrete shoulders. The speed limit approaching the study ramps and the advisory speed limit for the ramps were 50 mph throughout the evaluation period.
