**Feasibility Report  
Regarding the Request for Enhanced Water Service  
from  
The Village of Greendale**

PROJECT: Elevated Storage Tank Replacement

RE: Recommended Plan

RE: Preliminary Project Cost Estimate

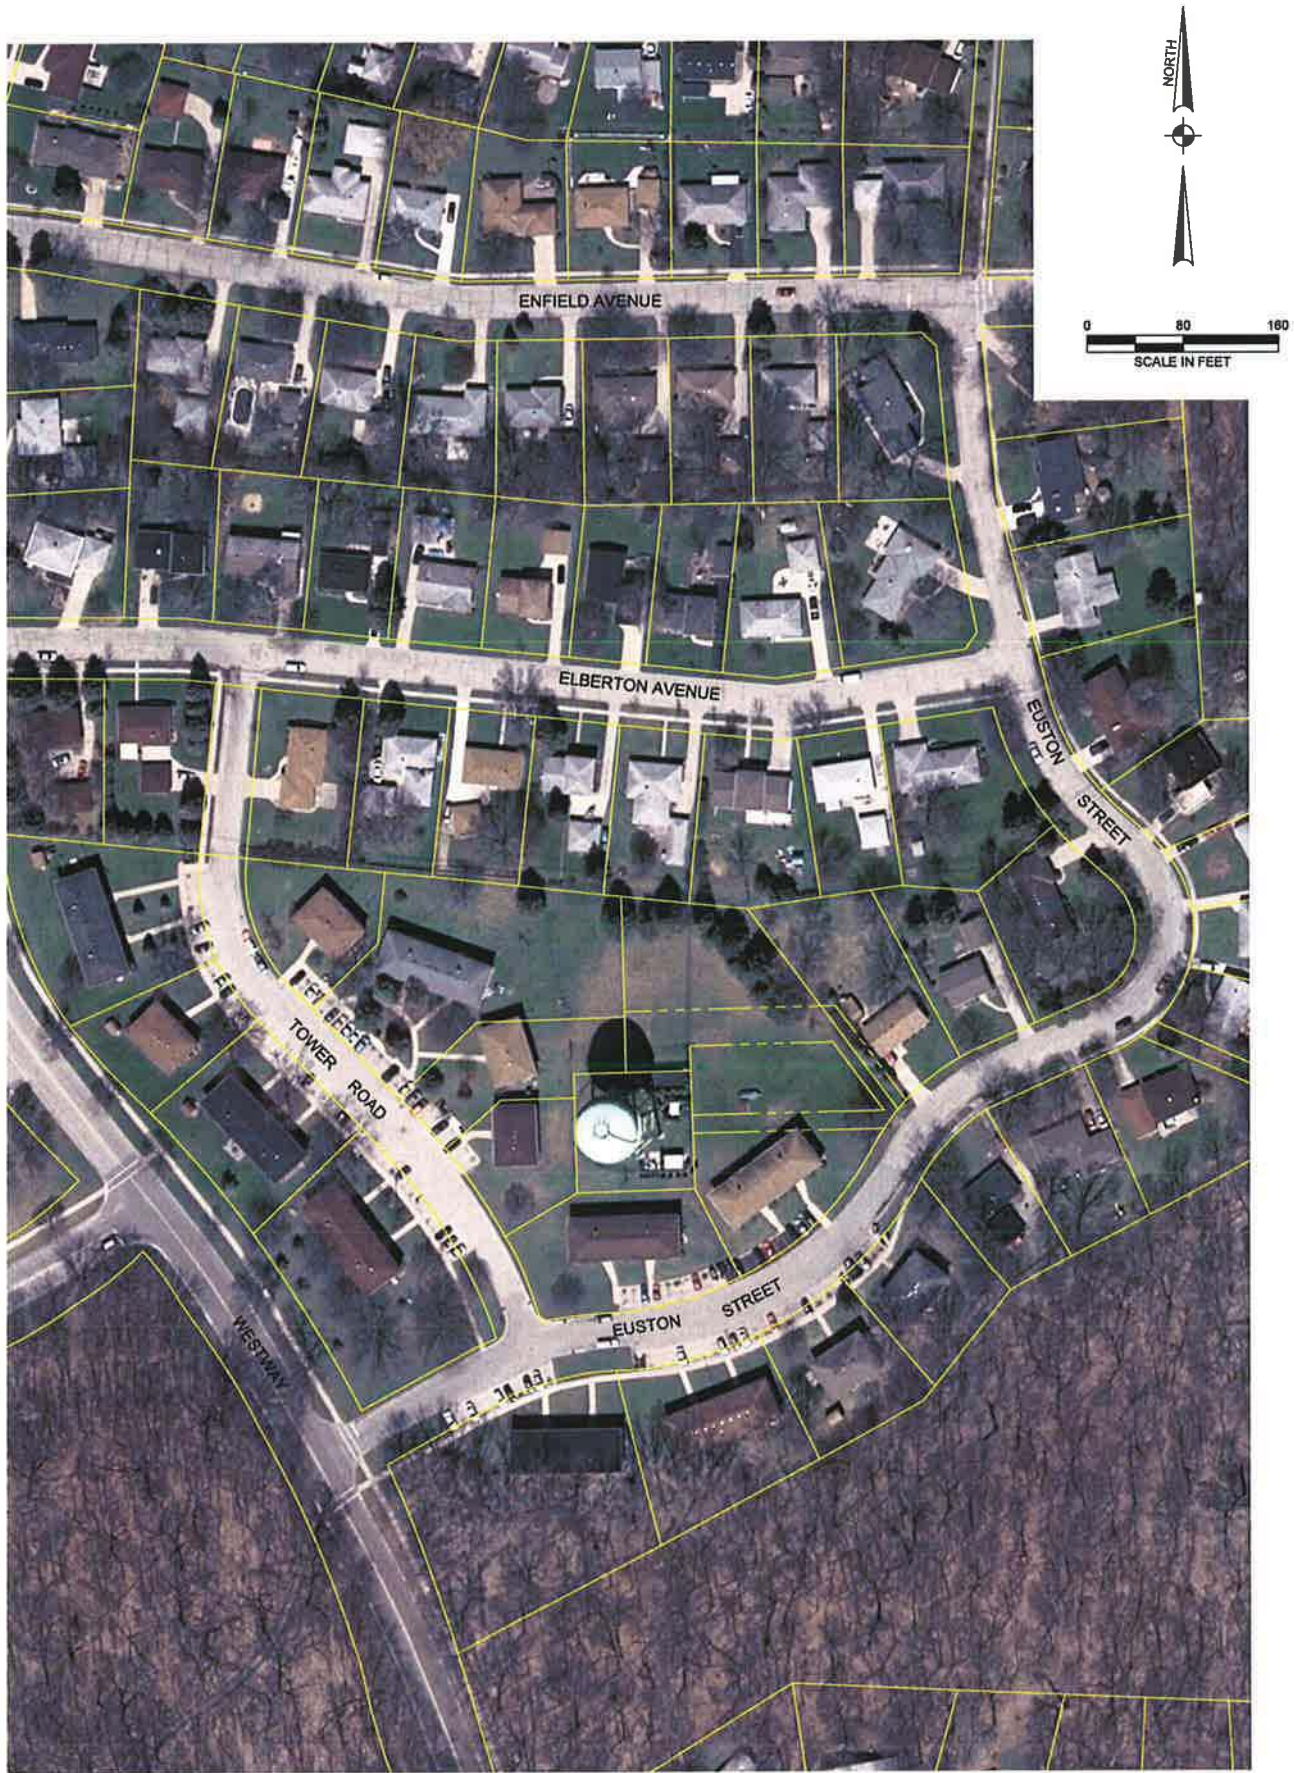
Fig. 1 Land Use at Present  
Elevated Storage Tank Site

The Greendale Water System is served by a single elevated storage tank. The tank is located northeast of the intersection of Tower Road and Euston Street in the central portion of the Village. The tank site is surrounded by single-family and multi-family development as shown in Figure 1. The elevated storage tank is located on a 100-foot square site. The existing site has poor access for operation and maintenance. Access to the tank is provided through a permanent egress/ingress easement as shown in Figure 2.

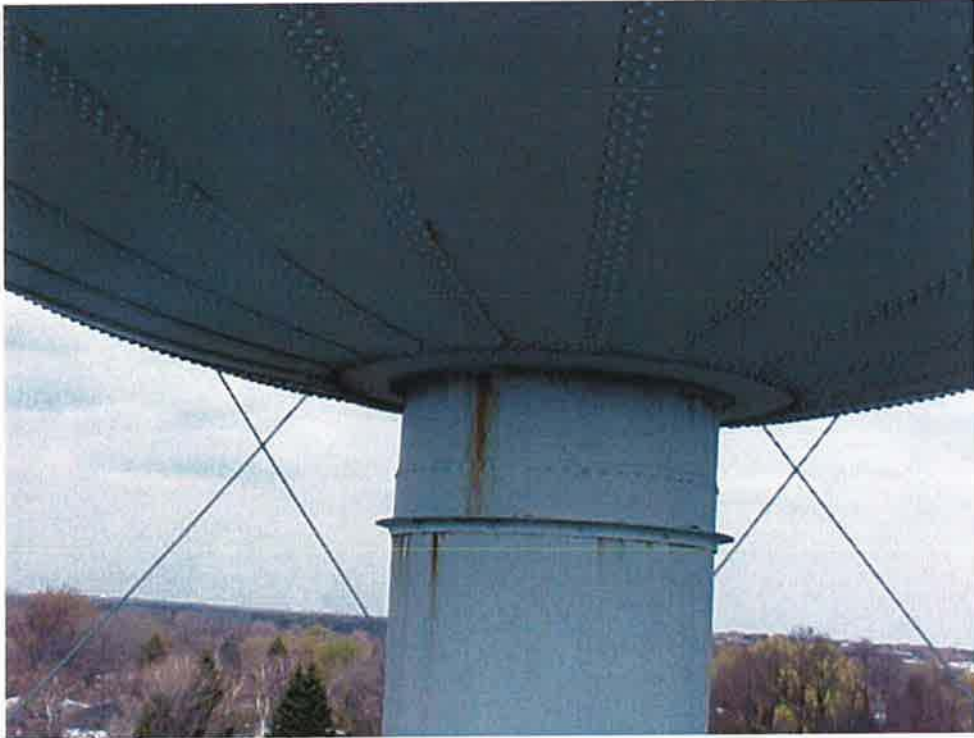
Fig. 3 Elevated Storage Tank Leak Location

The elevated storage tank is in very poor condition. Leaks have occurred where the 6-foot diameter riser connects to the bottom of the elevated storage tank as shown in Figure 3 and Figure 4. Liquid Engineering, Inc. installed a flexible coating system in the interior of the tank in 2001 to temporarily seal a leak. The water utility staff identified a leak in December of 2009 that resulted from a failure of the temporary flexible coating system. CB&I repaired the leak in April of 2010. CB&I performed a series of spot welds to repair the leak.

John Fischer, CBI, welded repairs to the leaking 72" diameter riser at the joint with the tank bottom circle plate. The cracks in the riser are along the angle vertex of the flange that connects by rivets to the circle plate. The design thickness of the riser is 1/4" thick steel and the circle plate is 5/8". The riser thickness in line with the weld repairs is about 1/8" and one measurement adjacent to a 10" long horizontal built-up weld is 0.018". The two-man lift equipment used to weld and observe the riser was in close proximity to horizontal rod bracing and we were not able to get access to the entire circumference of the riser for the purpose of measuring steel thickness.

Water pressure induced tension stress in the riser requires a minimum plate thickness that is less than about 25 per cent of the original thickness. Observed failure of the riser plate is due to corrosion and thermal movement and not necessarily water pressure. The lining, steel coating on the interior surface, has evidently failed in the immediate area of the connection between the tank bottom circle plate and the 1/4" standpipe plate where the standpipe is angled to form the connection flange.

Differential thermal movement caused by a difference in length and temperature between the eight support columns and the riser is estimated by analysis to be 3/8". Variables include ambient air temperature and water temperature. Relative vertical movement of the tank with respect to the riser will cause excessive bending stress and flexing in the riser plate and circle plate. Building up the plate thickness with weld where it fails will make the joint stiffer and this will to some extent hasten the formation of cracks by making the joint less flexible.

The tank wall thicknesses and the standpipe thicknesses in the vicinity of the weld repair were determined using a Krautkramer-Branson Model CL204 ultrasonic thickness gage. An approximately 1/4" diameter transducer with plastic delay line was used, which permits the thickness measurement of materials in the range of approximately 0.010" to 0.450". Six measurements were taken approximately 4 feet above the catwalk around the tank circumference, which range from 0.312" to 0.358" as shown in Table 1. Three additional measurements were taken adjacent to the vertical ladder on the tank, which range from 0.262" at the top of the safety cage, to 0.187" midway between the top of the safety cage and the top of the ladder, to 0.178" at the top of the ladder. This thickness variation is consistent with the use of different thickness plates towards the top of the tank during the initial fabrication. Additional measurements were also taken adjacent to the weld repair, where the remaining stand pipe thickness is as low as 0.018".

These results indicate that significant wall thinning has occurred in the vicinity of the leak at the junction of the vertical stand pipe and the bottom of the tank that is consistent with corrosion of the inside surface. Unless these areas can be protected from corrosion by application of a continuous and crack-free barrier coating, such as a paint or sealant, these areas will continue to corrode and result in additional leaks. If required, Metallurgical Associates could perform additional ultrasonic thickness measurements around the stand pipe circumference and along its length to determine the extent of the corrosion.

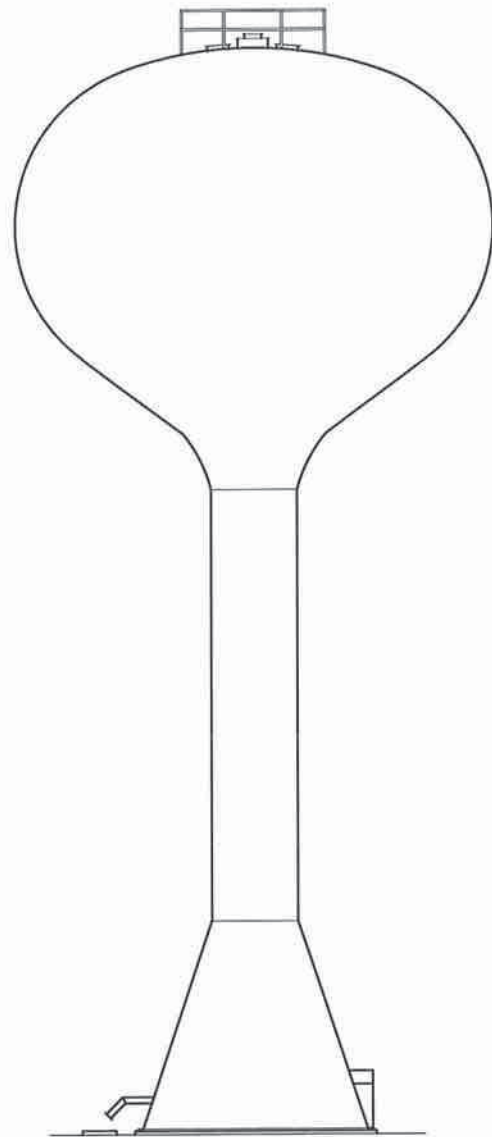
Fig. 7 Single Pedestal Elevated Storage Tank

The single pedestal style elevated storage tank is most suitable for capacities of up to 750,000 gallons. It has the lowest painting costs of the steel tanks. This is the most common style of tank for the small size range.

There are four (4) tank styles that are suitable for the size elevated storage tank that will be needed by the Village of Greendale. The four (4) styles of tanks are shown in Figures 7, 8, 9, and 10.

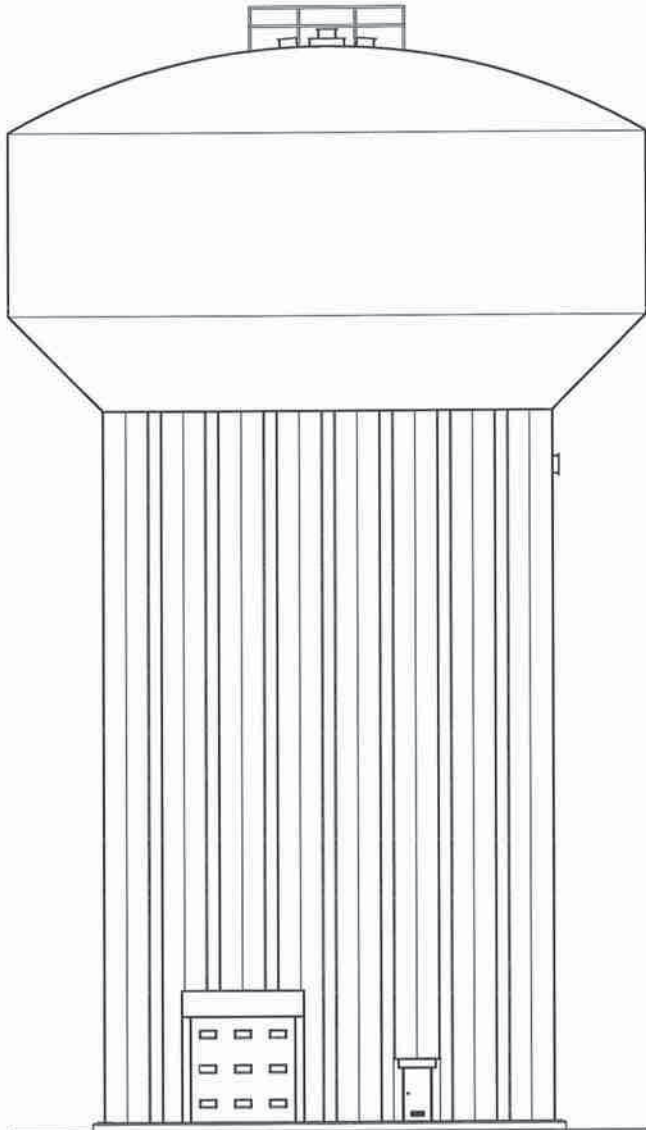
Fig. 8 Fluted Pillar Elevated Storage Tank

The fluted pillar style elevated storage tank is most suitable for capacities of 750,000 to 2,500,000 gallons. It has the highest painting costs of the steel tanks. The interior can be used for storage of equipment and materials. This is the most common style of tank for the large size range.

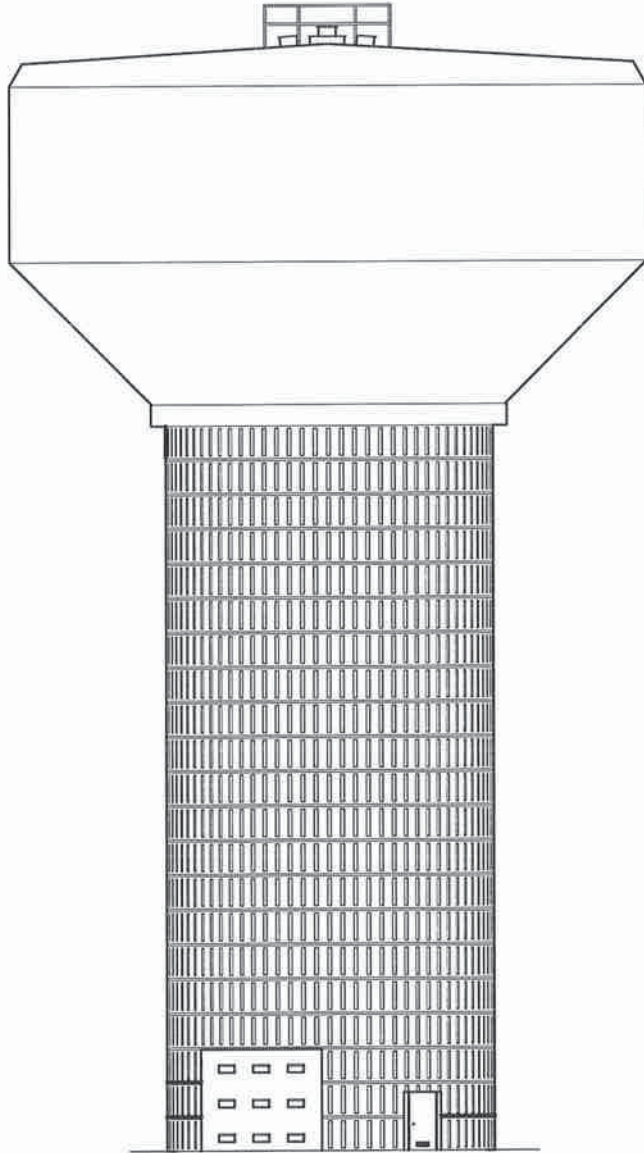
ELEVATION  
NTS

The composite style elevated storage tank is suitable for capacities of 500,000 to 2,500,000 gallons. It has a concrete pedestal and a steel tank which minimizes painting costs. The interior can be used for storage of equipment and materials. The composite tank is more expensive to construct than the steel tanks, but it has lower operating and maintenance costs. The composite style is becoming a widely used type of tank.

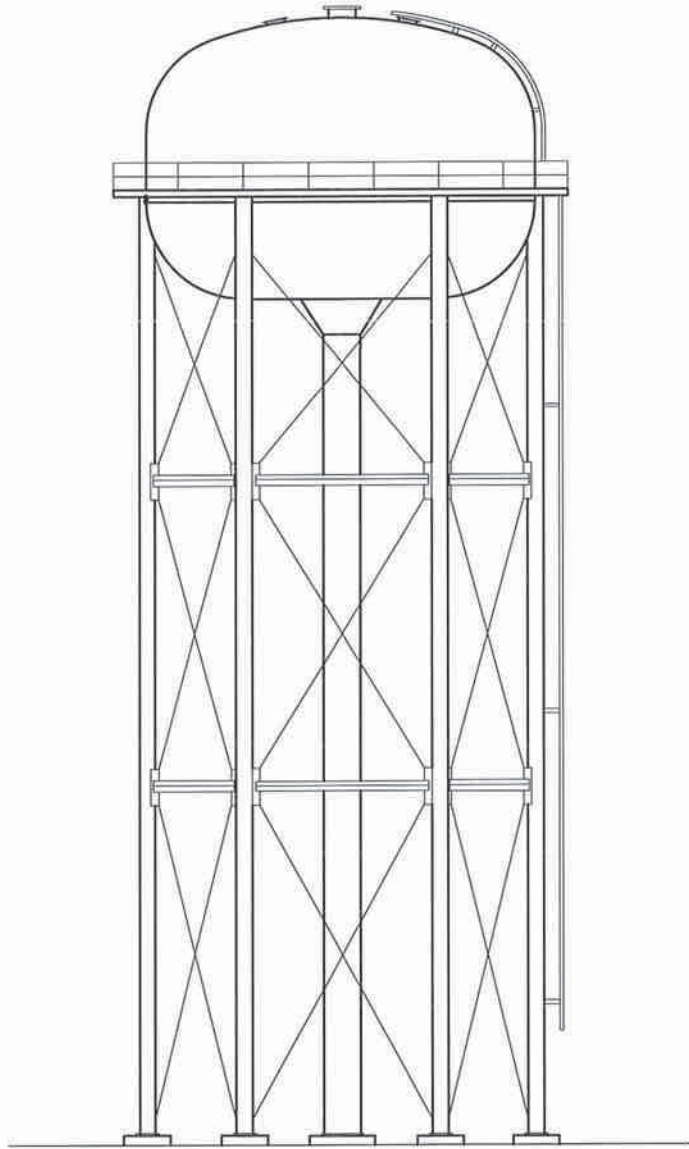
ELEVATION  
NTS

The multi-column style elevated storage tank is suitable for all capacities. It is the least costly tank to construct and painting costs are similar to the single pedestal style tank. This style of tank was widely used in the past until it was replaced in popularity by the single pedestal and fluted column tank styles, which were more aesthetically pleasing to a majority of people.

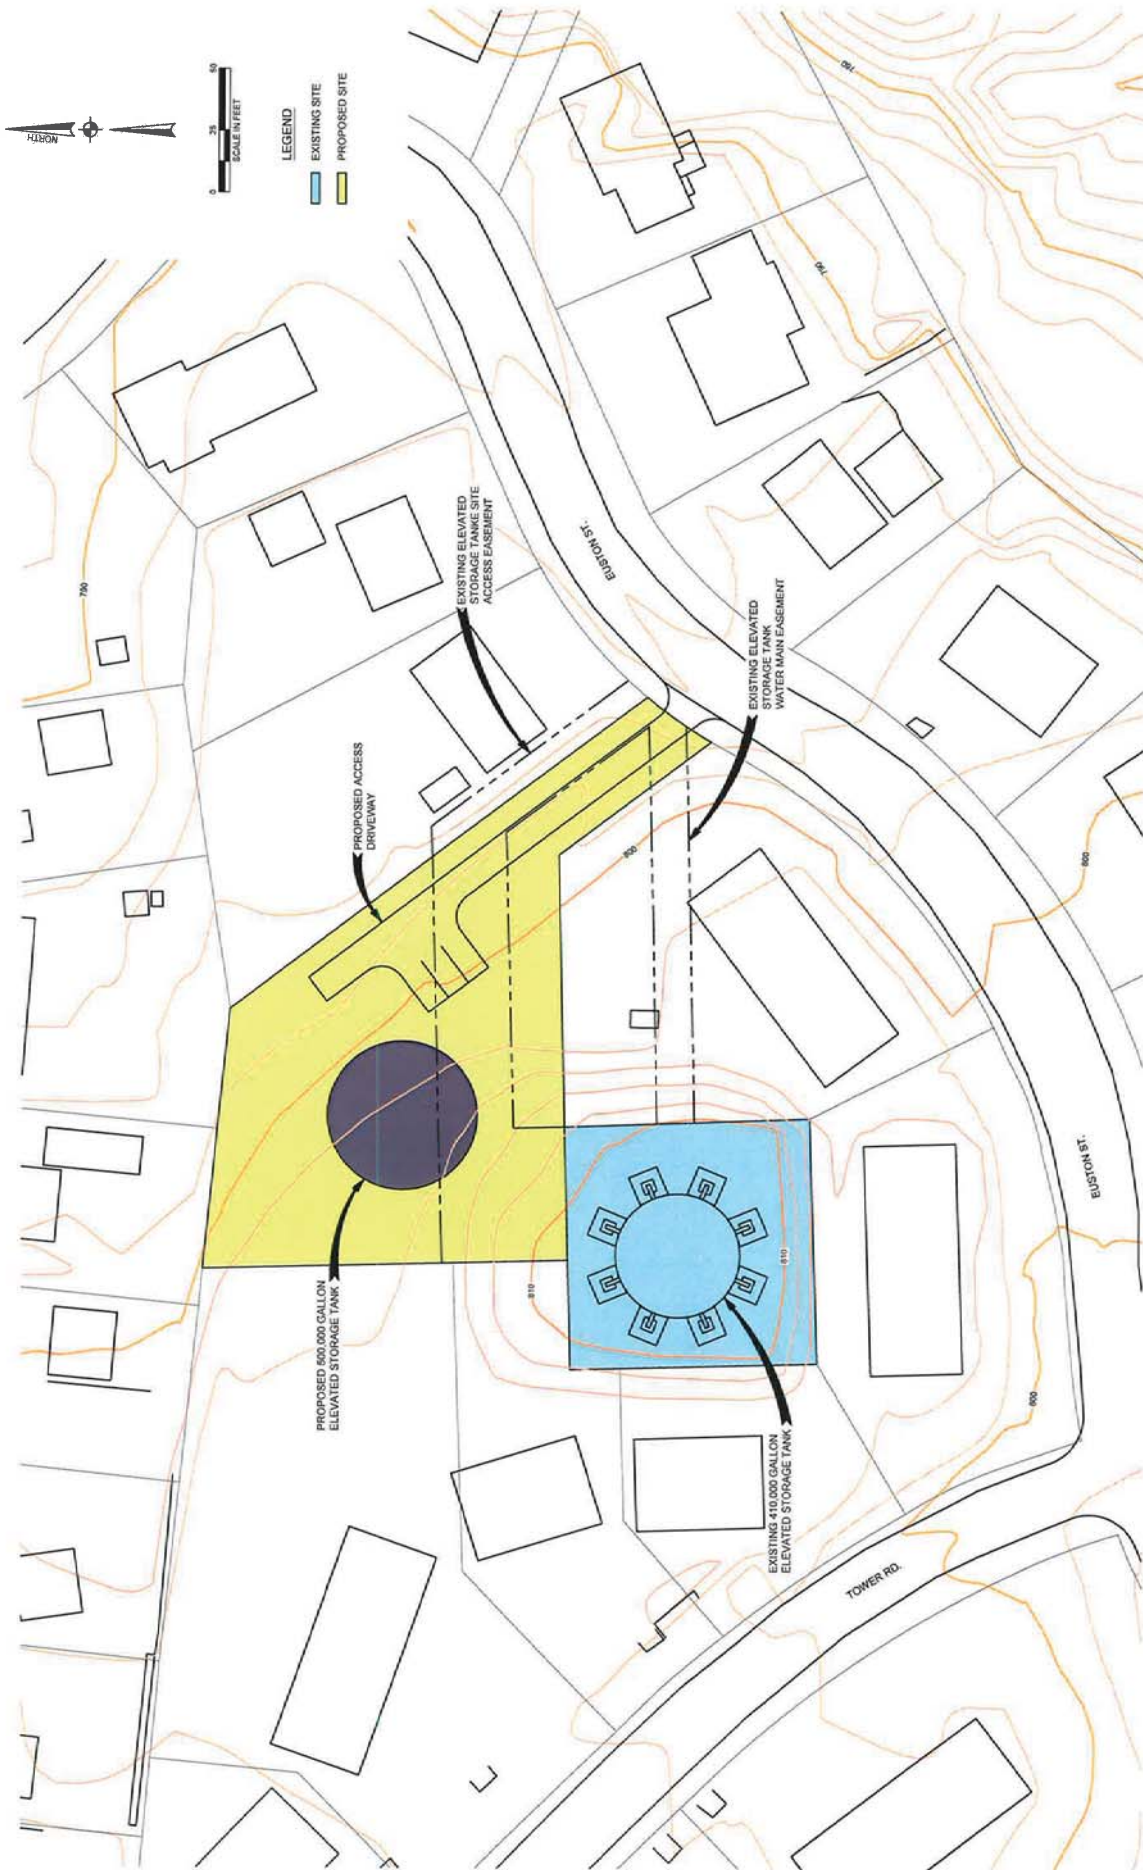
Fig. 1 Preliminary Arrangement for a 500,000 Gallon Elevated Storage Tank at the Existing Site

A preliminary site arrangement for a 500,000 gallon elevated storage tank at the existing site is shown in Figure 1. The site layout is based on a 500,000 gallon elevated storage tank with a tank diameter of 60 feet. A 12-foot wide paved driveway with three parking spaces would be provided for access to the elevated storage tank for routine operation and maintenance. The existing electric service would be reused for the new elevated storage tank. A 12-inch water main would be provided to connect the elevated storage tank to the 12-inch water main in Euston Street. A fire hydrant would be provided on the connecting water main to drain the elevated storage tank.

The project would require acquisition of approximately 0.53 acres of additional property from one of the adjacent property owners. It would be necessary to obtain temporary easements for construction of the new elevated storage tank and demolition of the old elevated storage tank from five of the adjacent property owners. It would be possible to abandon the existing water main easement and abandon the site of the old elevated storage tank after the old elevated storage tank was demolished. The project cost for a new 500,000 gallon elevated storage tank at the existing site is estimated to be \$2,121,100. Details of the cost estimate are summarized in Table 1.

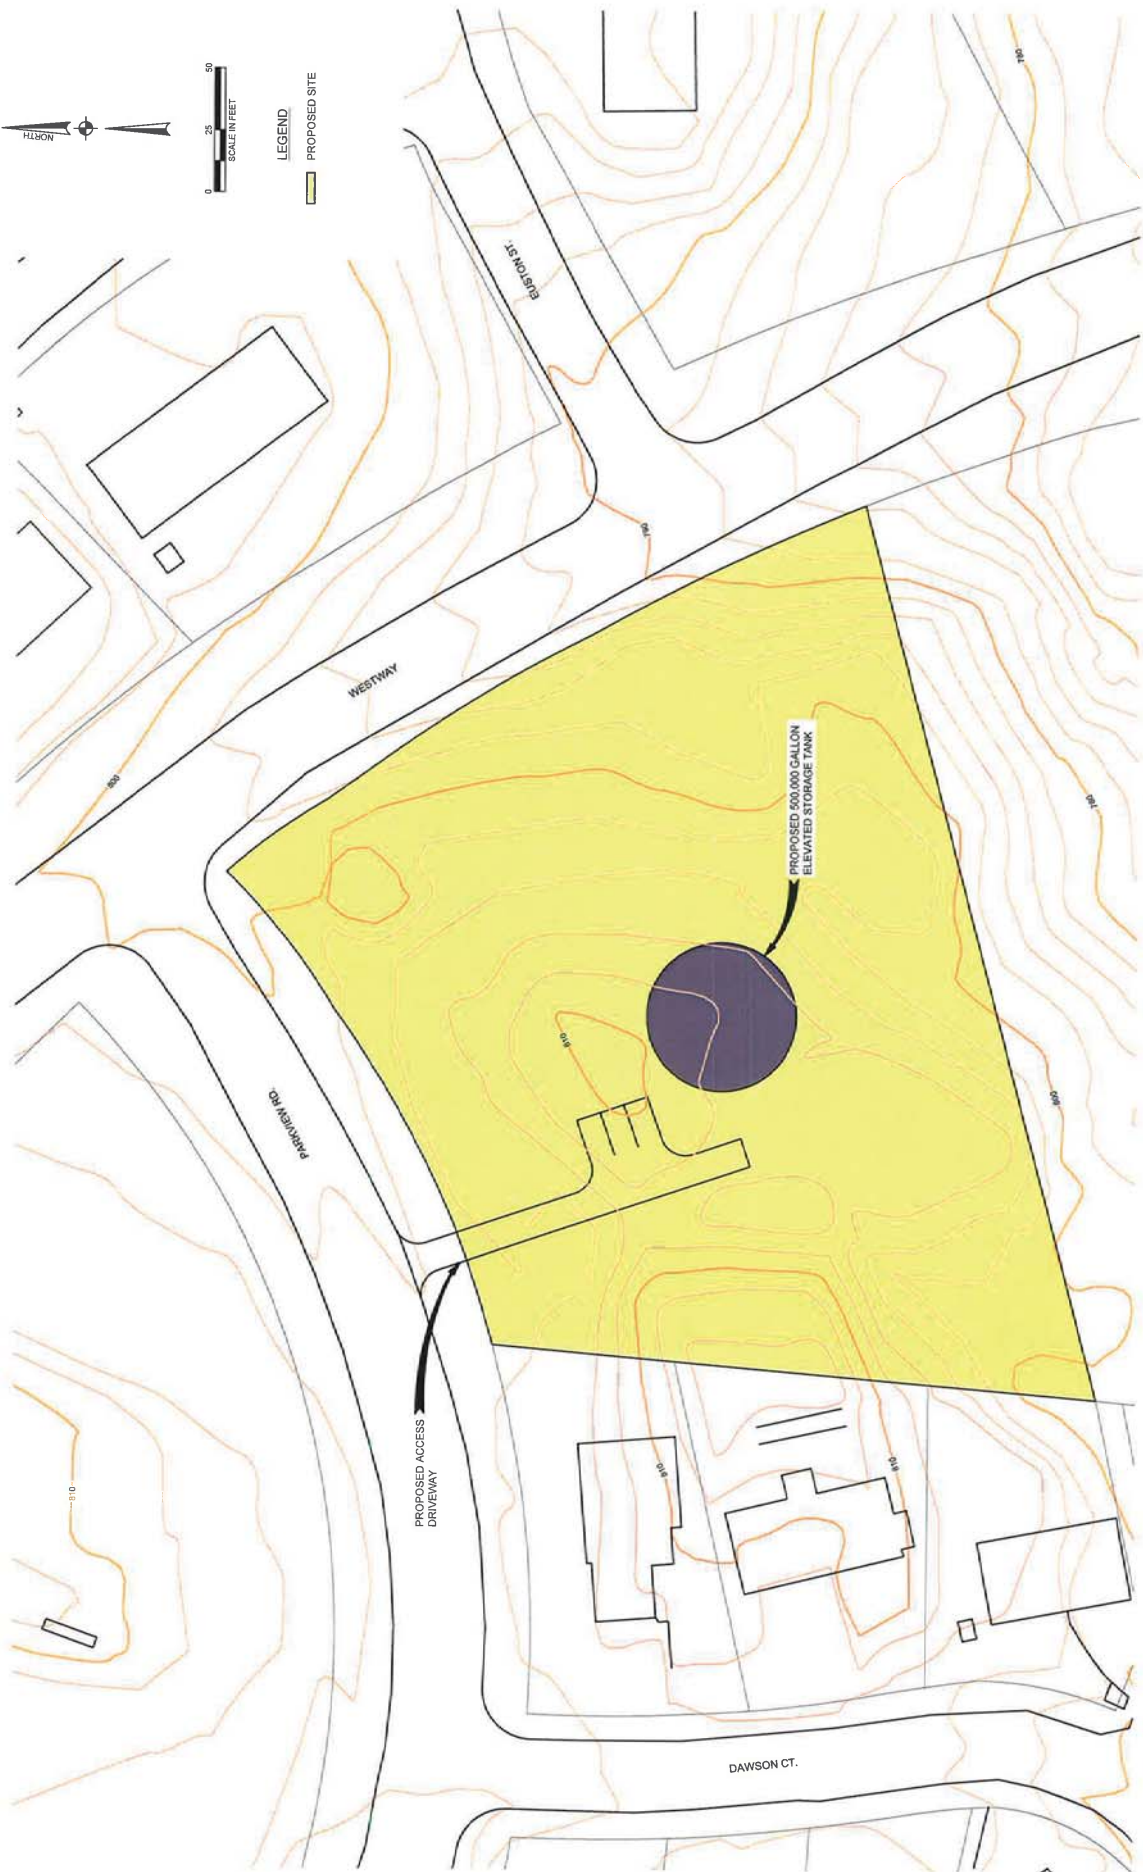
Fig. 3 Preliminary Arrangement for a 500,000 Gallon Elevated Storage Tank at the Proposed New Site

A preliminary site arrangement for a 500,000 gallon elevated storage tank at the proposed new site is shown in Figure 3. The site layout is based on a 500,000 gallon elevated storage tank with a tank diameter of 60 feet. A 12-foot wide paved driveway with three parking spaces would be provided for access to the elevated storage tank for routine operation and maintenance. An electric service would be installed for the new elevated storage tank. A 12-inch water main would be provided to connect the elevated storage tank to the 12-inch water main in Parkview Road. A fire hydrant would be provided on the connecting water main to drain the elevated storage tank.

The project would require acquisition of 1.80 acres of Village owned property for use by the Water Utility. Approximately 50 percent of the site would be disturbed during construction. It would be necessary to obtain temporary easements for demolition of the existing elevated storage tank from five of the adjacent property owners. It would be possible to abandon the existing water main easement and abandon the site of the old elevated storage tank after the old elevated storage tank was demolished. The project cost for a new 500,000 gallon elevated storage tank at the proposed new site is estimated to be \$1,910,000. Details of the cost estimate are summarized in Table 3.

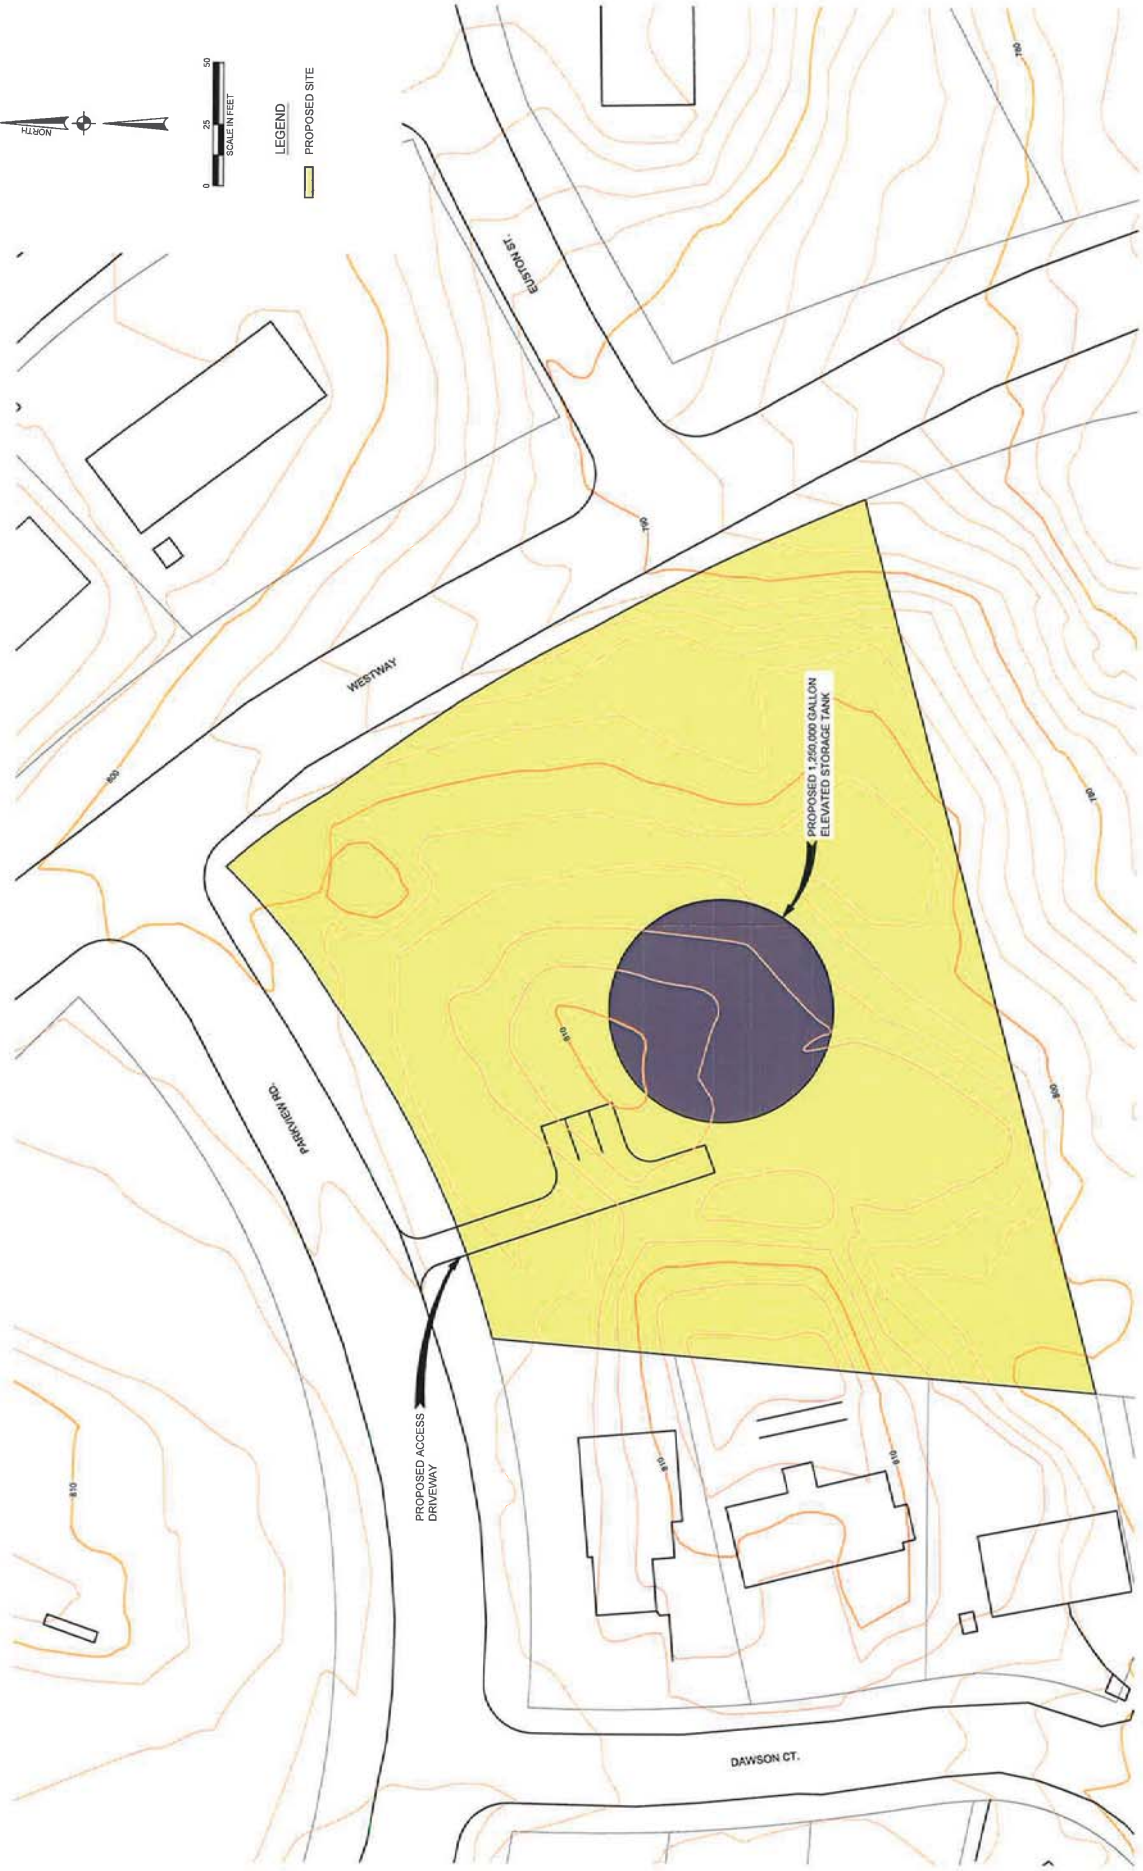
Fig. 4. Preliminary Arrangement for a 1,250,000 Gallon Elevated Storage Tank at the Proposed New Site

A preliminary site arrangement for a 1,250,000 gallon elevated storage tank at the proposed new site is shown in Figure 4. The site layout is based on a 1,250,000 gallon elevated storage tank with a tank diameter of 90 feet. A 12-foot wide paved driveway with three parking spaces would be provided for access to the elevated storage tank for routine operation and maintenance. An electric service would be installed for the new elevated storage tank. A 20-inch water main would be provided to connect the elevated storage tank to the 12-inch water main in Parkview Road. A fire hydrant would be provided on the connecting water main to drain the elevated storage tank.

The project would require acquisition of 1.80 acres of Village owned property for use by the Water Utility. Approximately 60 percent of the site would be disturbed during construction. It would be necessary to obtain temporary easements for demolition of the existing elevated storage tank from five of the adjacent property owners. It would be possible to abandon the existing water main easement and abandon the site of the old elevated storage tank after the old elevated storage tank was demolished. The project cost for a new 1,250,000 gallon elevated storage tank at the proposed new site is estimated to be \$3,836,500. Details of the cost estimate are summarized in Table 4.
