Certificate of Appropriateness

3402 W. ST PAUL AV., Weinstock historic house

PTS ID 73060 COA, NEW SHINGLE ROOF

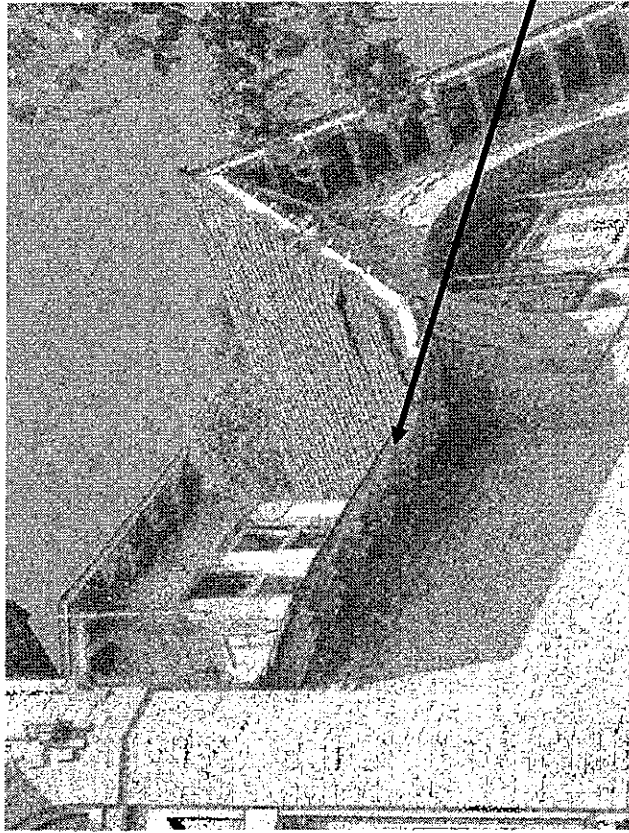
3. Closer view of roof damage on side gable taken from the south east

Description of work Remove existing layers of roofing. Install new architectural shingles roof, GAF timberline natural shadow shingles in pewter gray color.

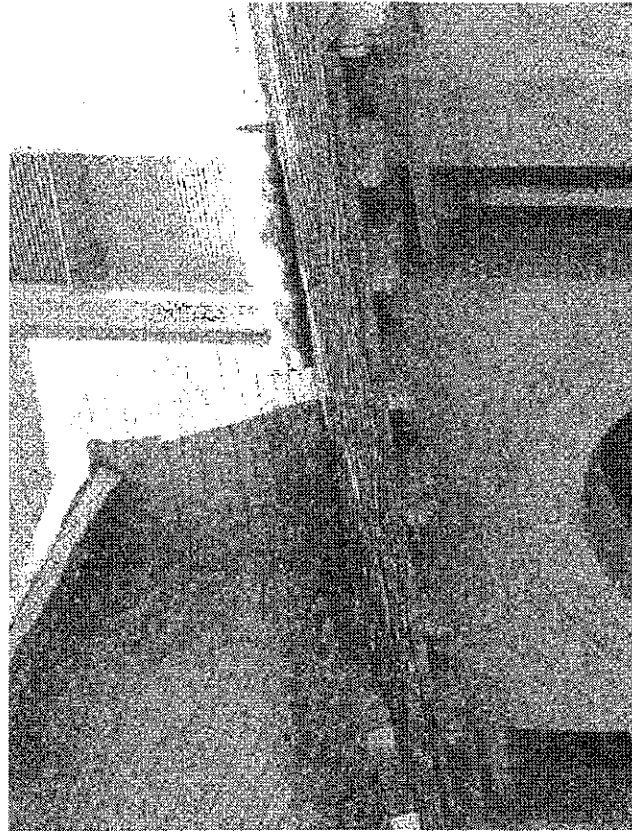
4. Closer view of the north east porch roof

Because of the rafter tails, a quarter round high-back gutter or half-round high-back gutter is recommended. A tracing should be made of the roof edge and sent to the gutter company for a final recommendation. K-style gutters should not be used.
