Milwaukee Police Department Facility Capital Improvement Analysis

November 2012

Facilities Condition Assessment Program

Facilities Development and Management

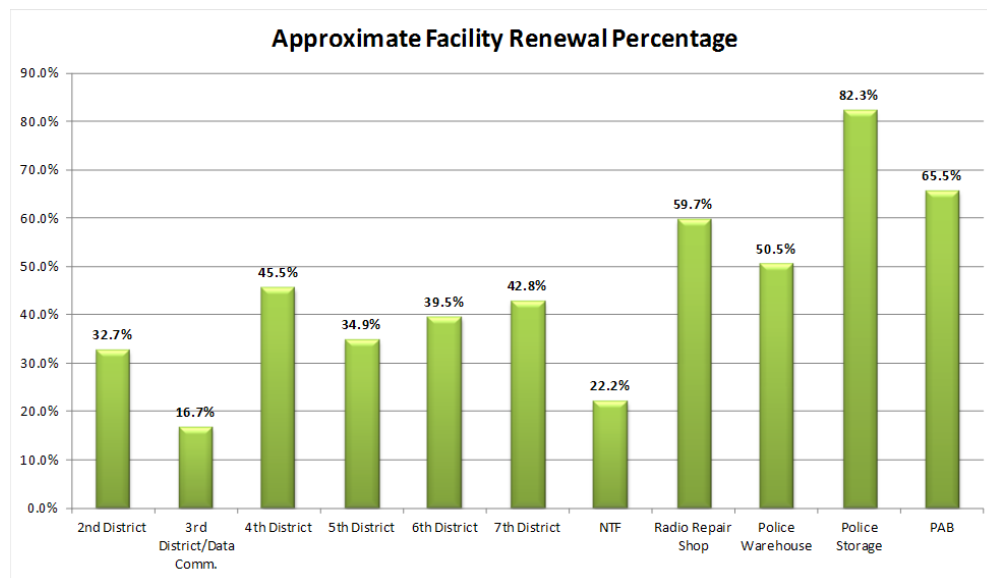
The approximate facility renewal percentage (AFRP) over the course of twenty years is determined by taking the median year (2022) CRV divided by the 20 year total cost. Each facility is assumed to have, on average, half of its expenditures from 2012 through 2022, and half of its expenditures from 2023-2032. Year 2022 is chosen as the median year to derive the AFRP, which is a measurement of the amount of rehabilitation each facility is anticipated to receive during the 20-year analysis.

The AFRP varies at each facility. Three facilities are at/near 60% AFRP:

- Radio Repair Shop (59.7%) - Governed by inclusion of property site features
- PAB (65.5%) - Near term rehabilitation
- Police Storage (82.3%) - CRV is relatively low in comparison to projects

The AFRP for each facility is depicted below.
