I am submitting a formal claim for property damage at 2330 E. Back Bay, Milwaukee, caused by negligence during City work on or near this property. The enclosed materials detail damage to the lateral sewer line beneath a recurring street sinkhole, resulting in sewage backups into both units of our duplex.

2. Summary

The property owner at 2330 East Back Bay was forced to investigate and repair a recurring sinkhole at their own expense after the City declined to act. Professional excavation confirmed that a large rock—lodged directly on the property's lateral sewer pipe—had caused a hole, leading to sewage backups into both units of the duplex.

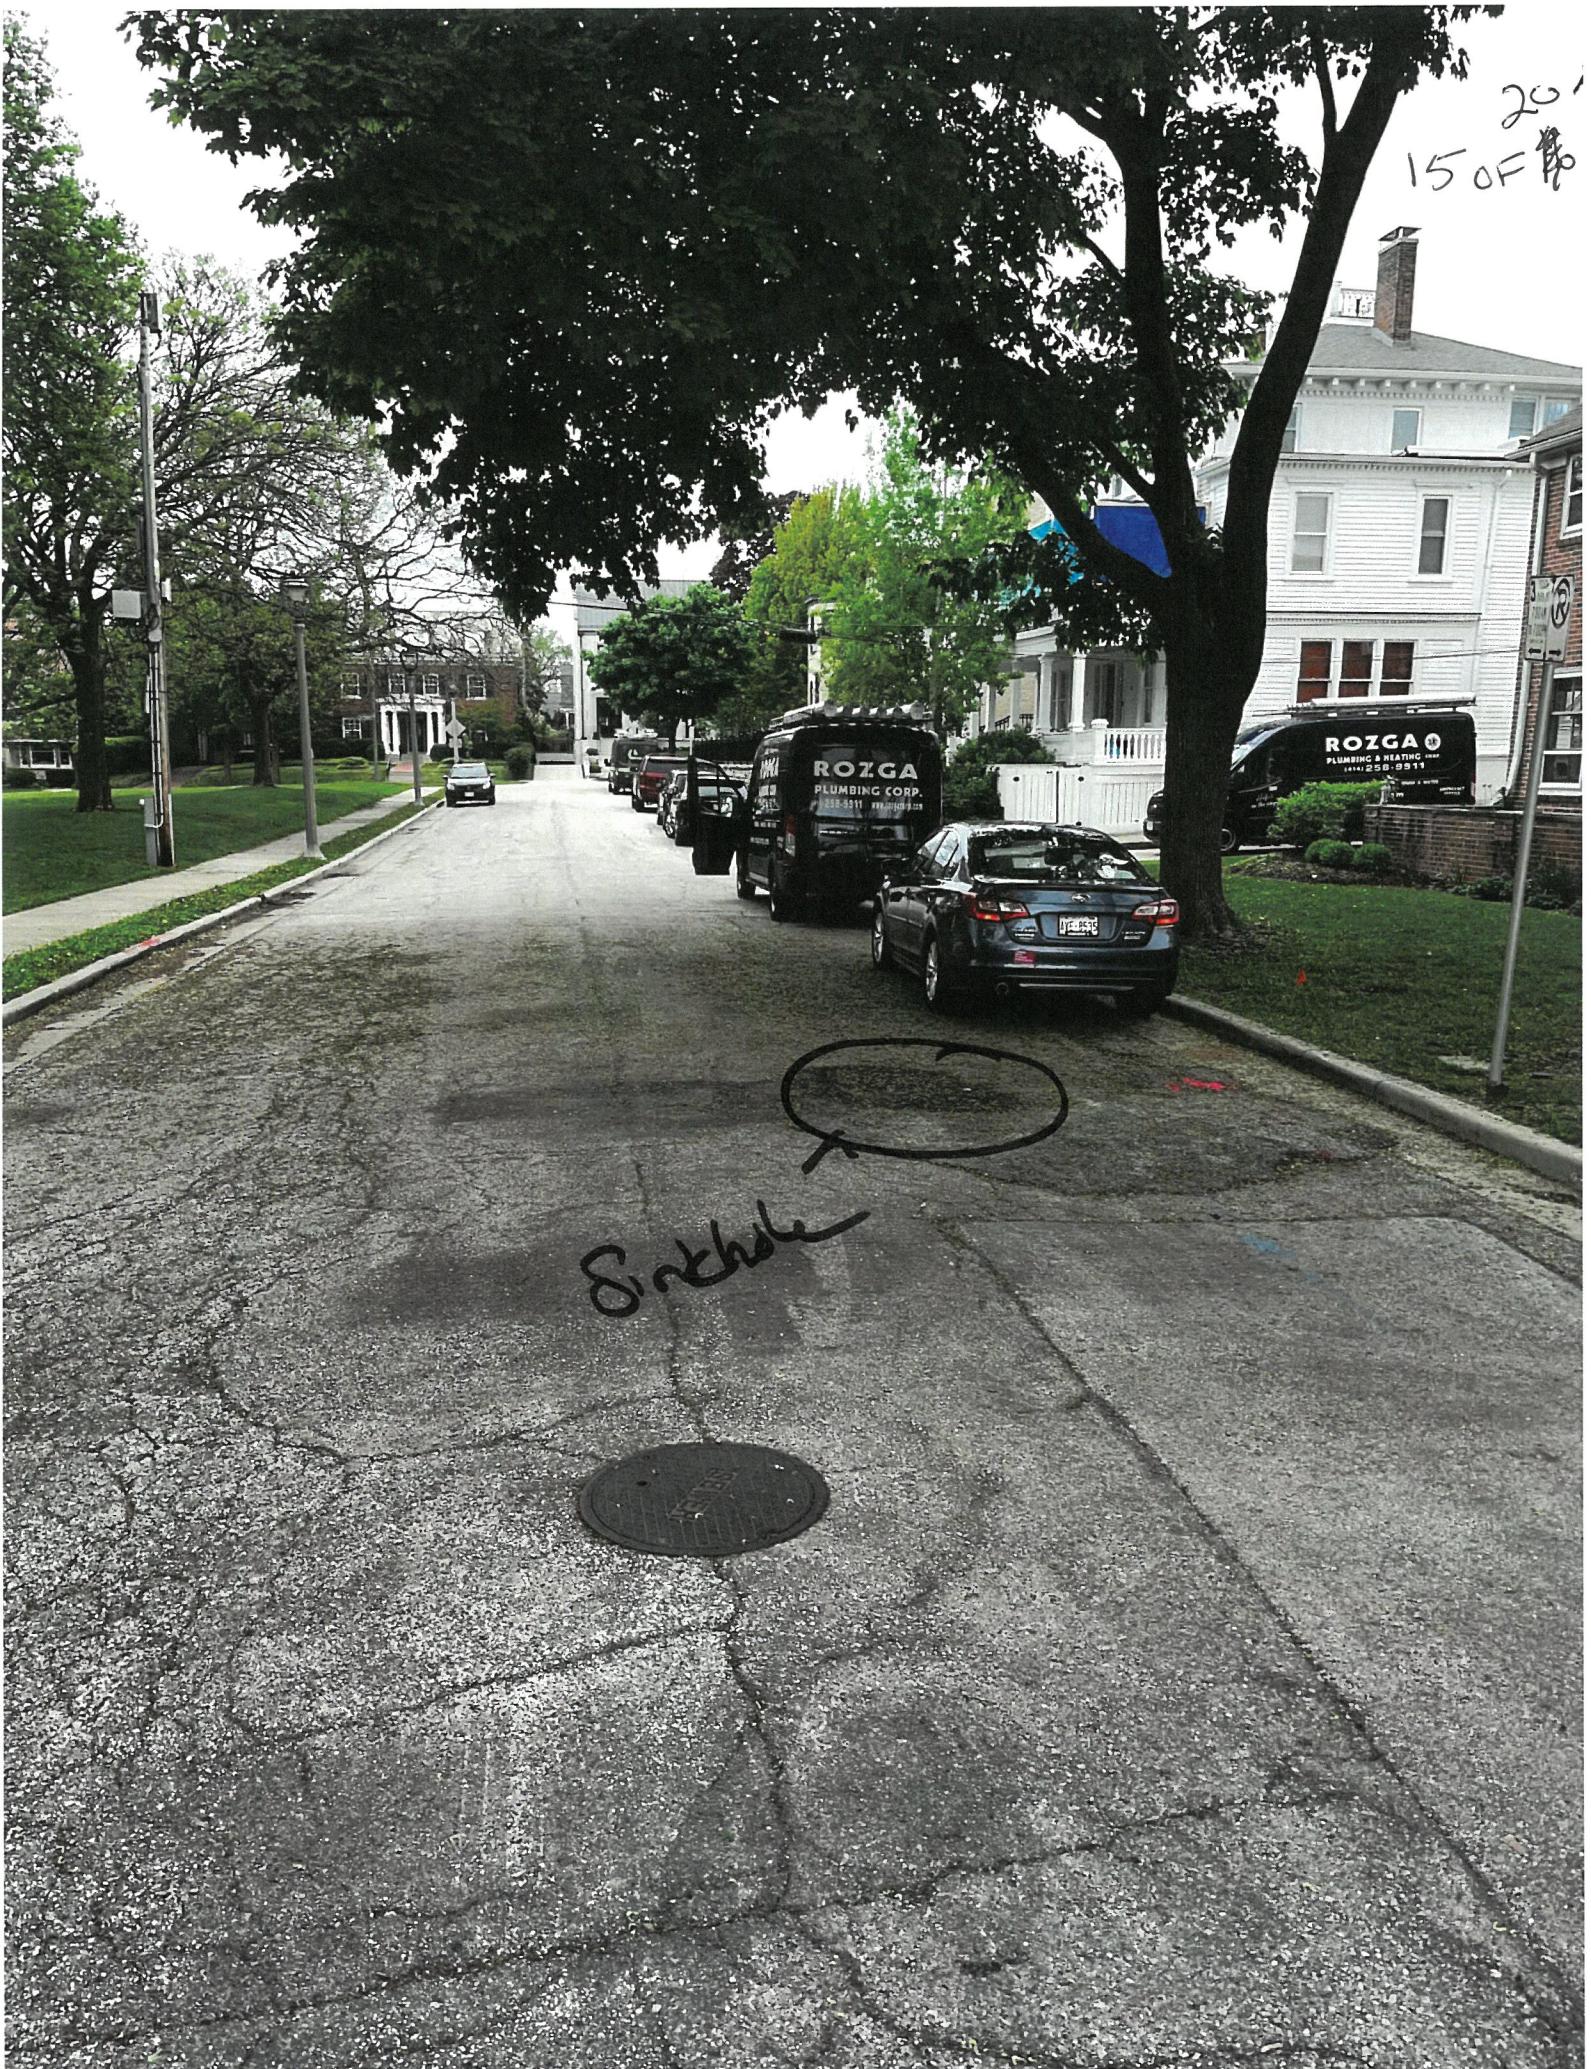
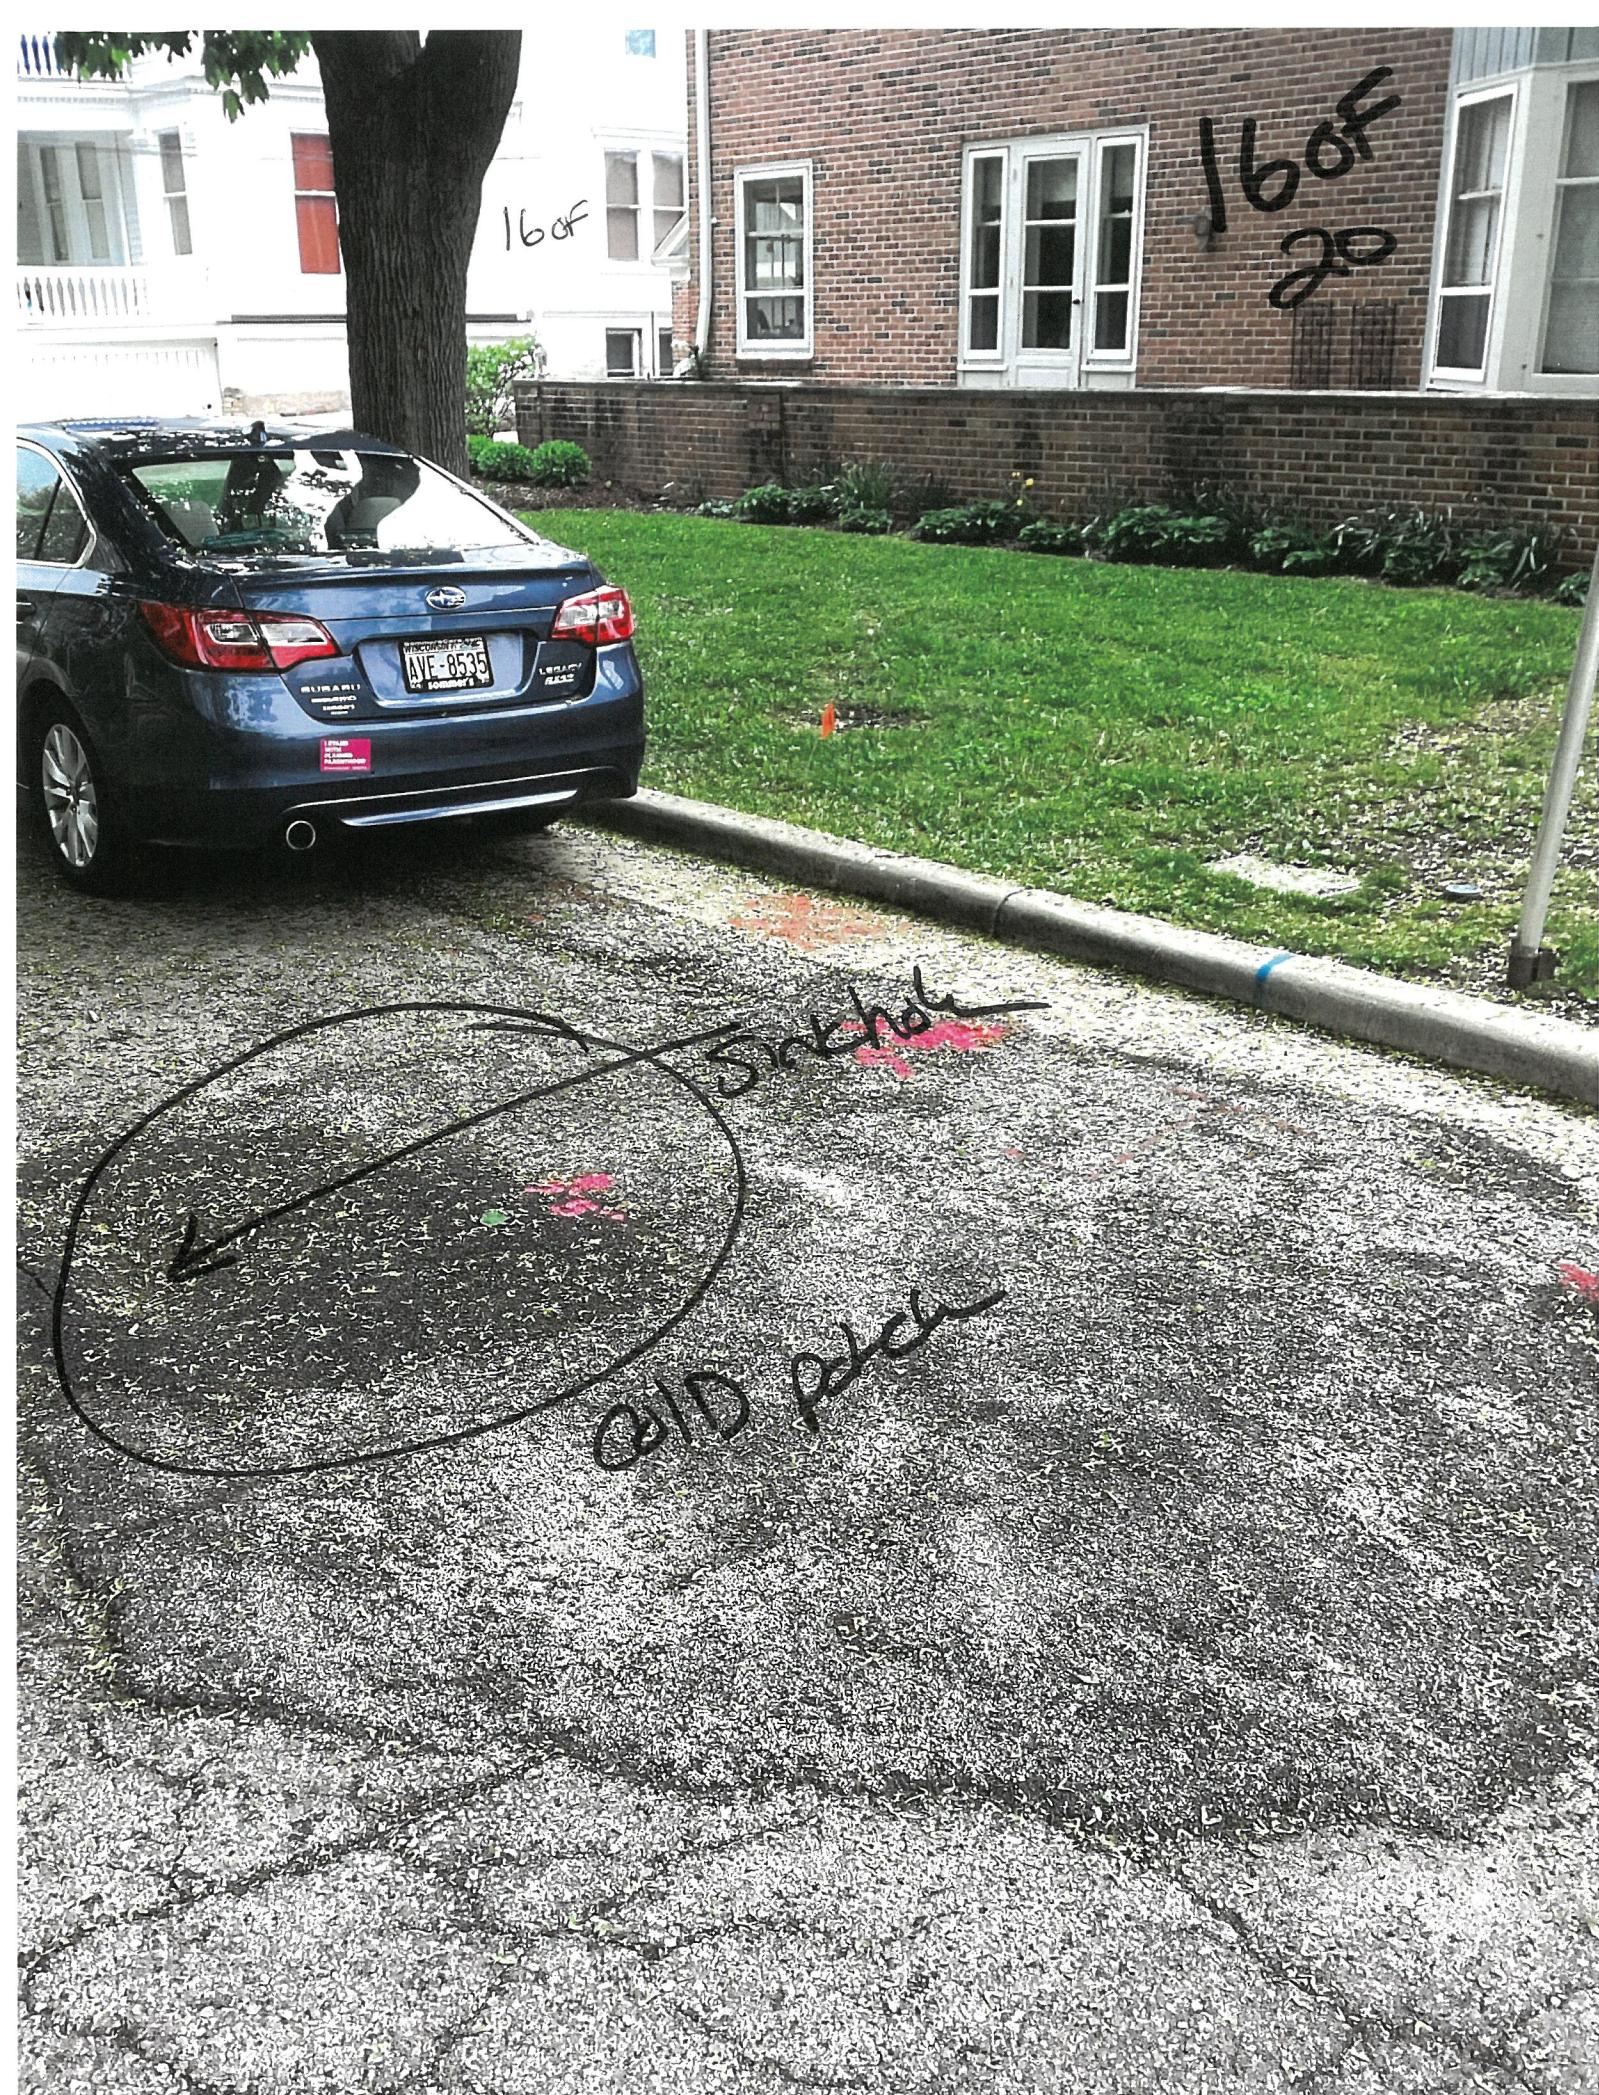
2330 E. Back Bay

Cold patch

Sink hole

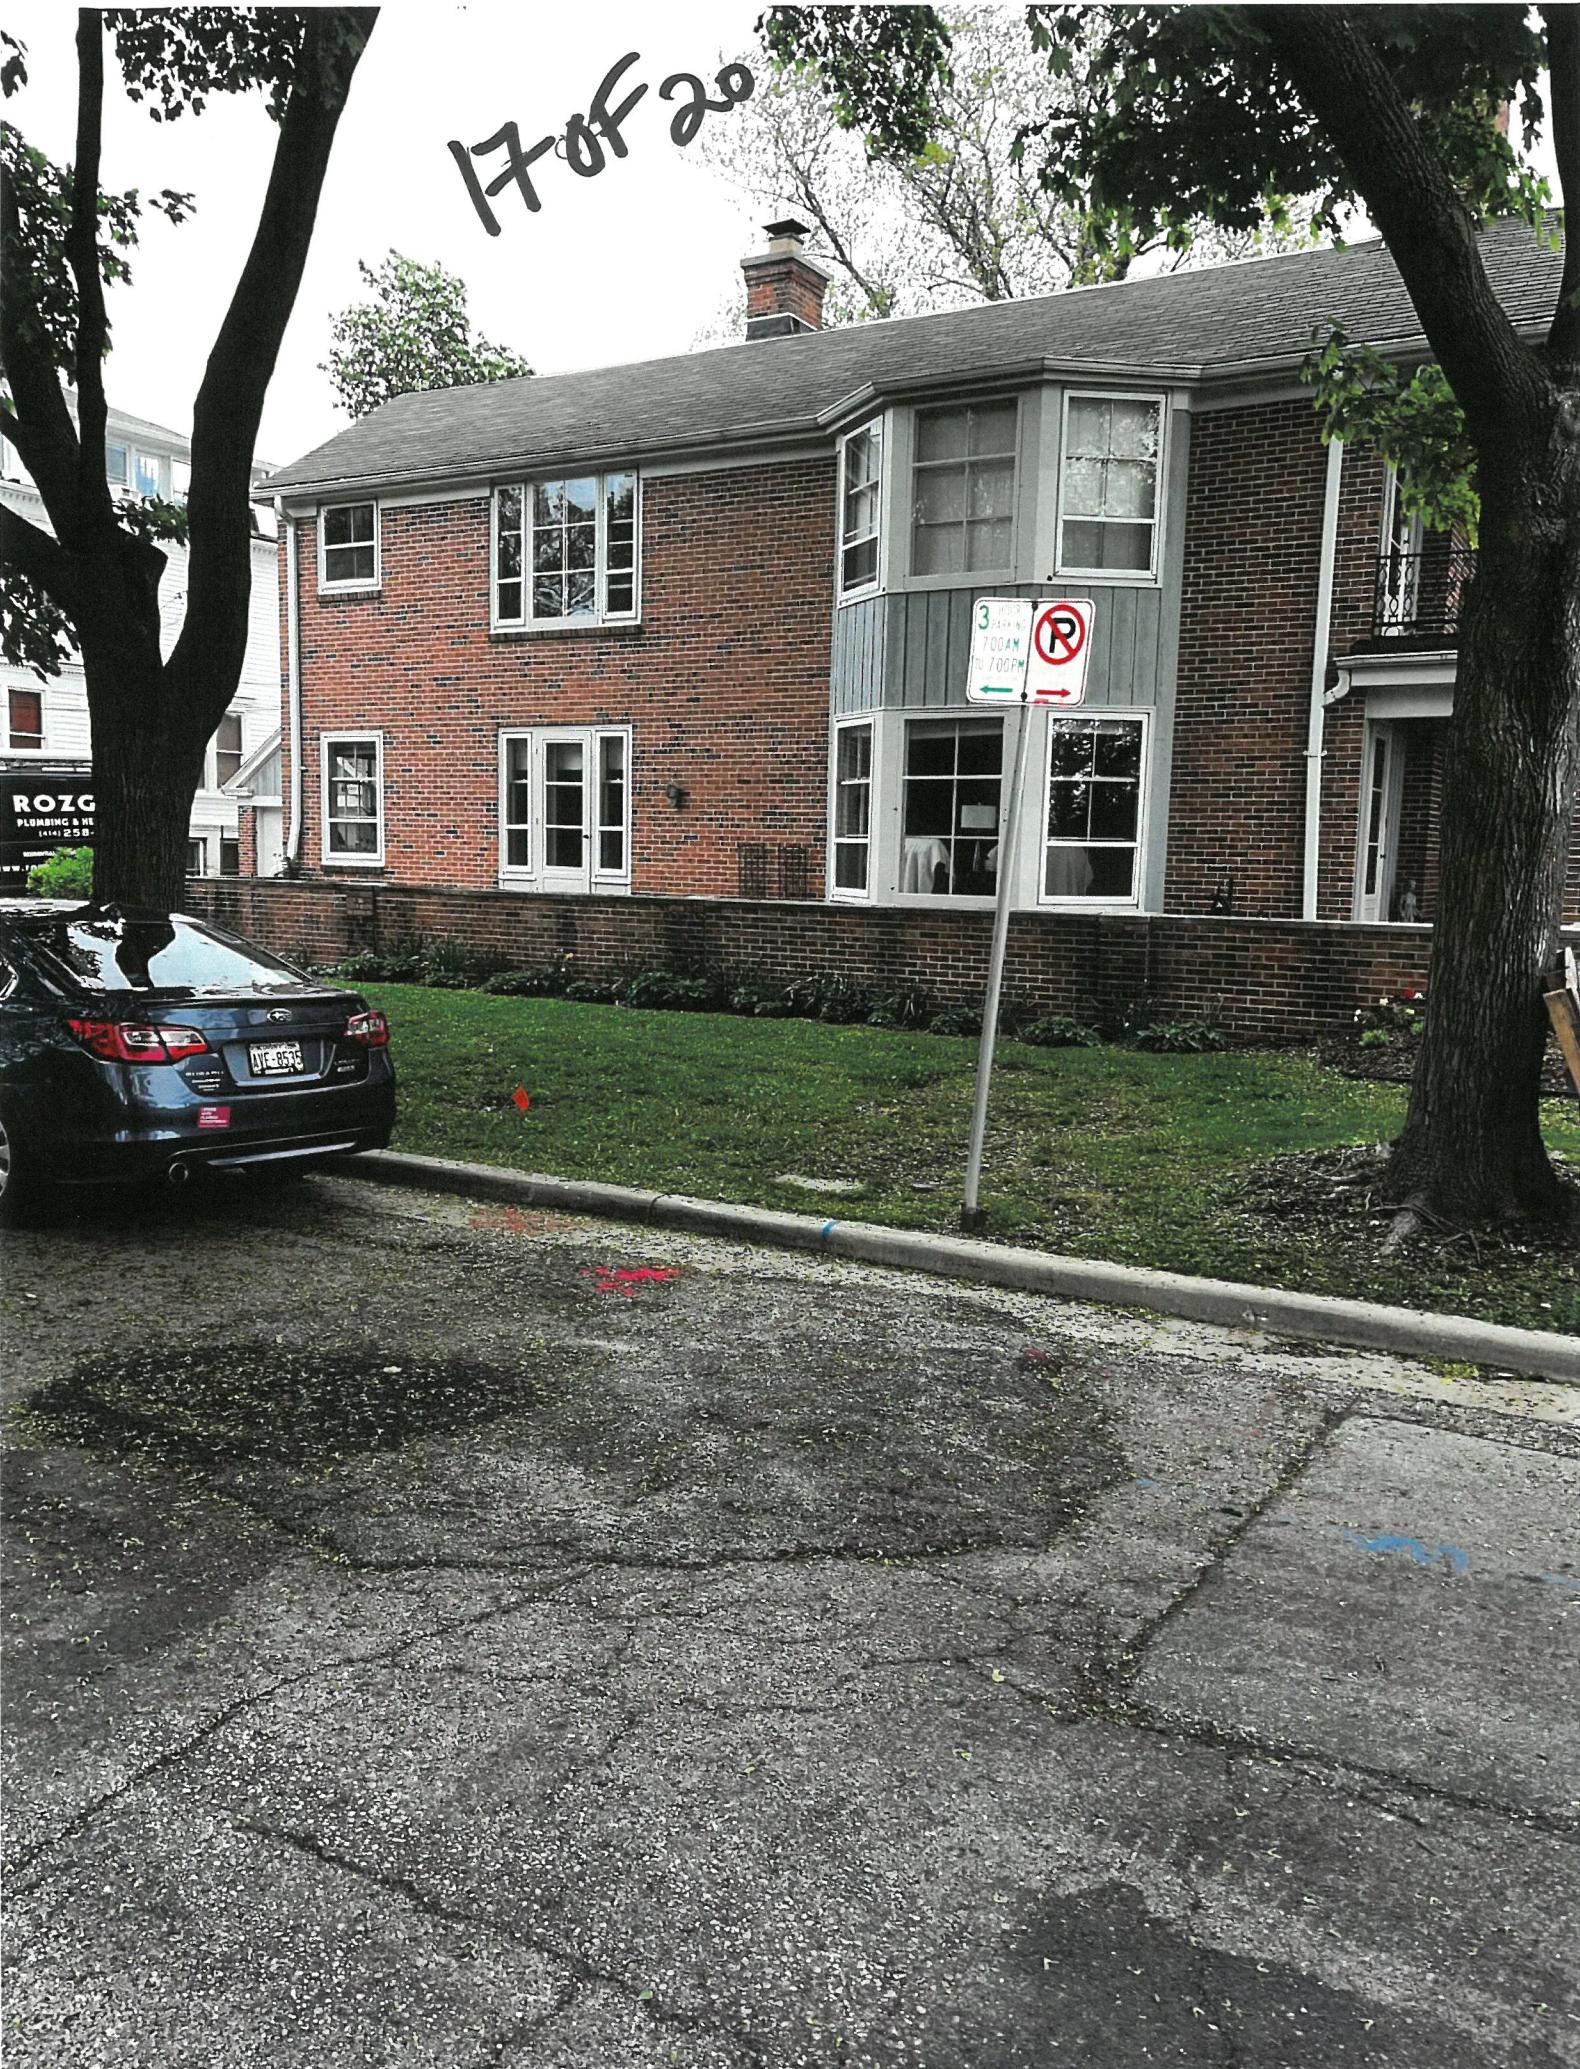
2330 E. Back Bay,

Sinkhole
cold pool

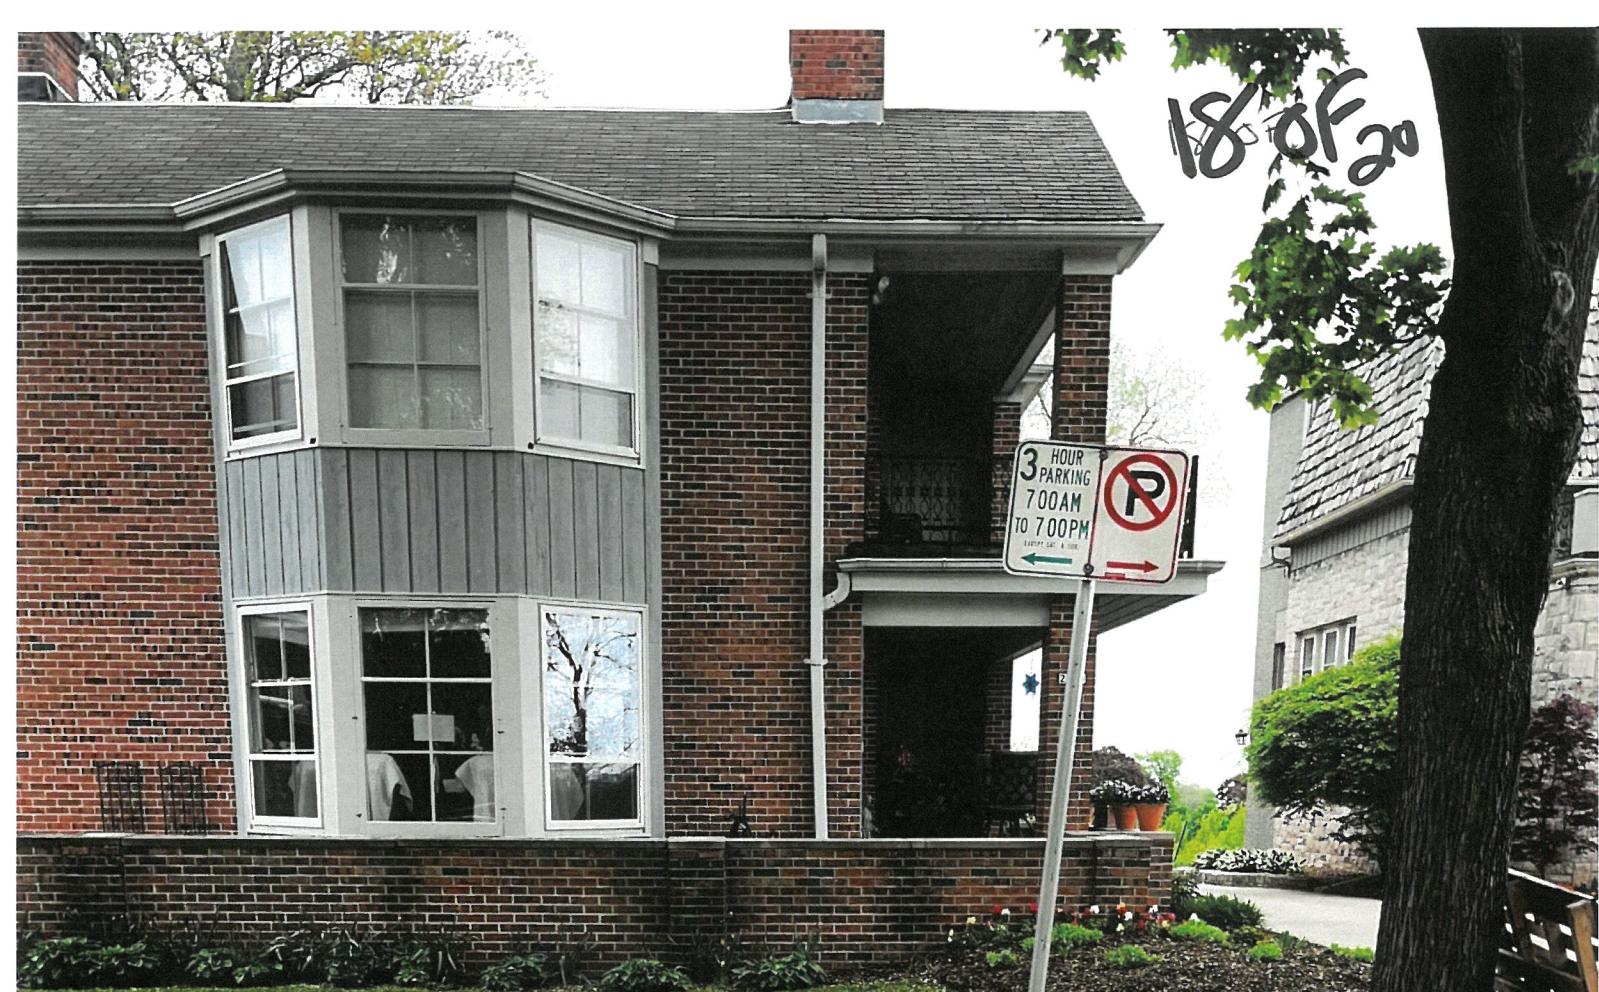
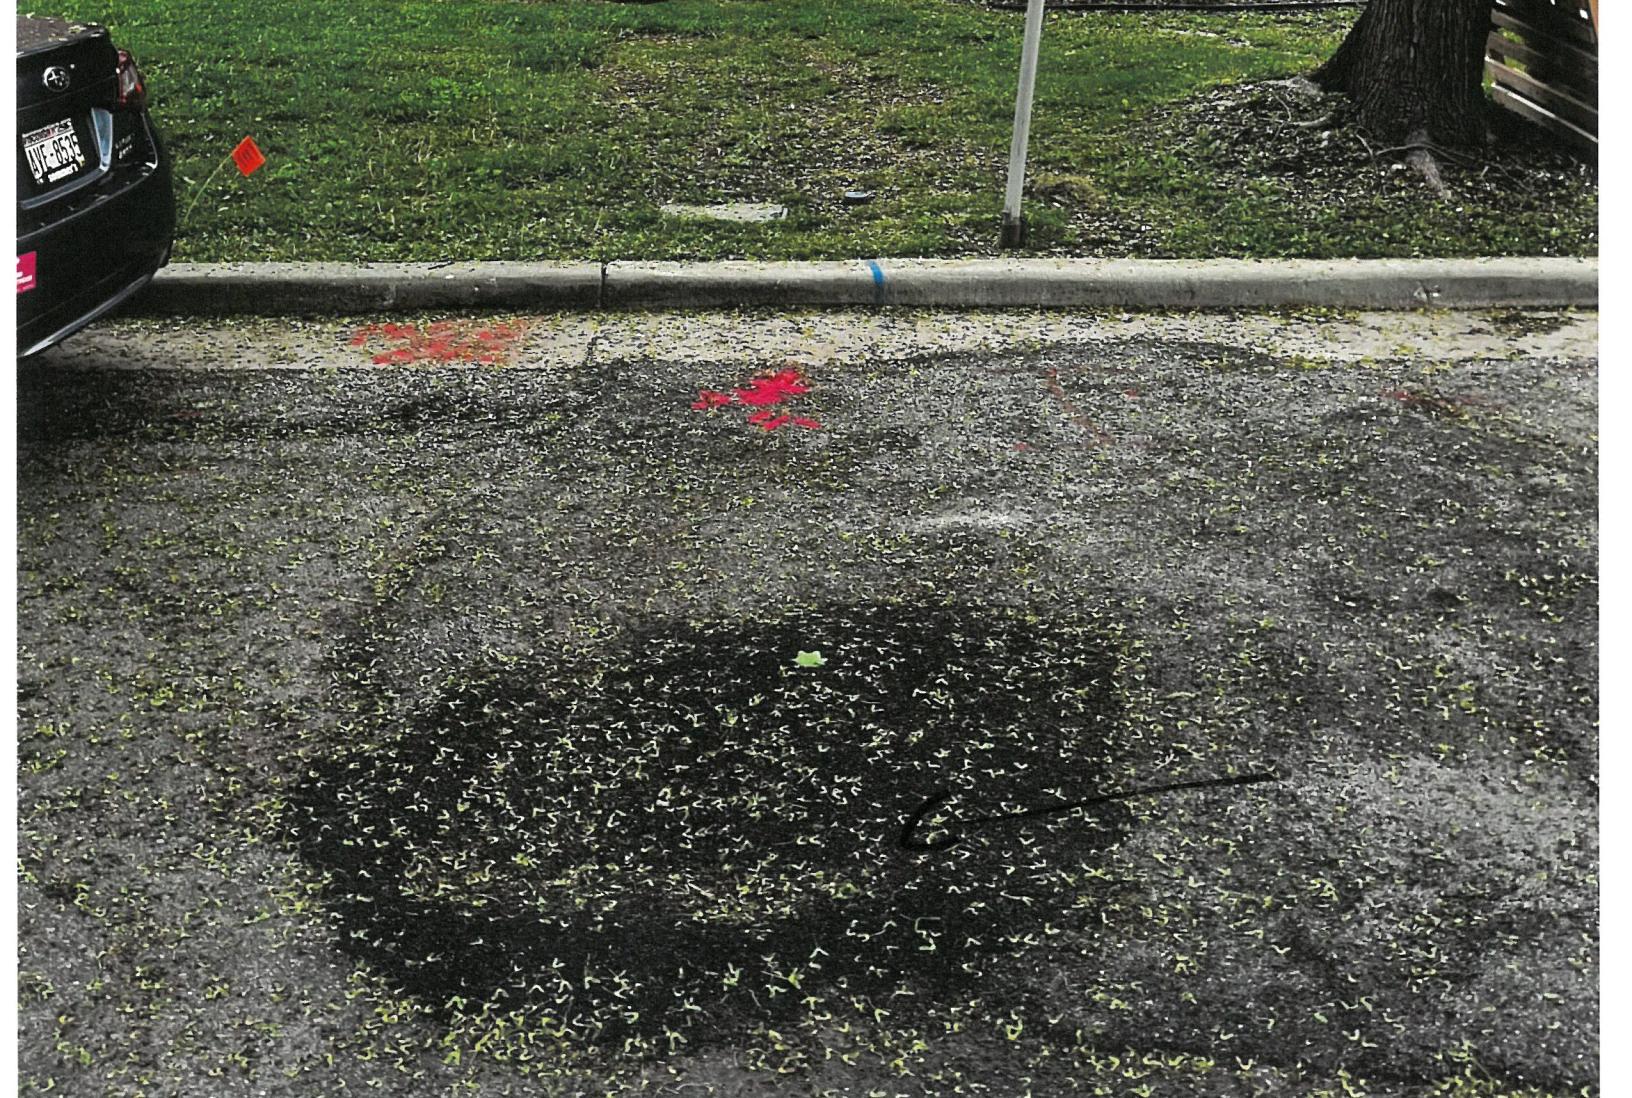
2330 E. Back Bay

Sink hole
