Certificate of Appropriateness

2908 W. MC KINLEY BL. Cold Spring Park Historic District

10/31/2016 PTS ID 114139 COA-Front porch repair

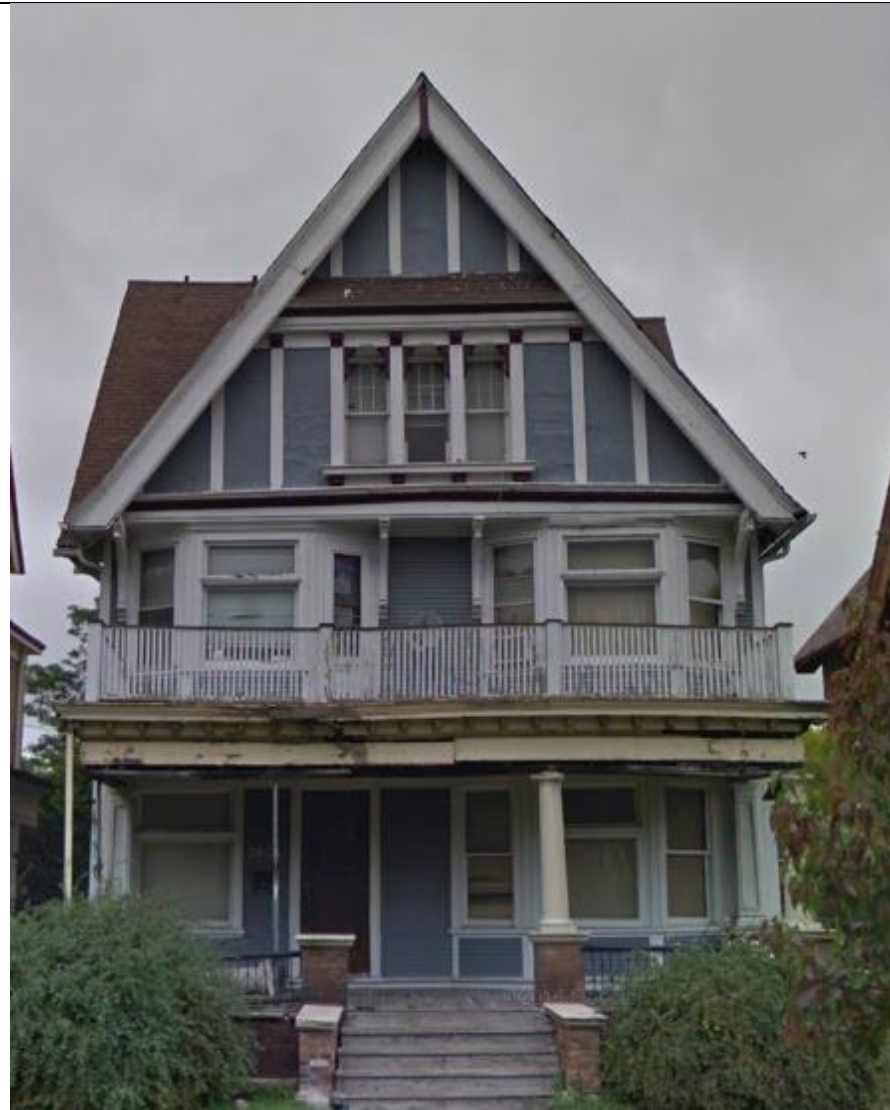
Current conditions with round column that was denied at the October 2015 meeting.

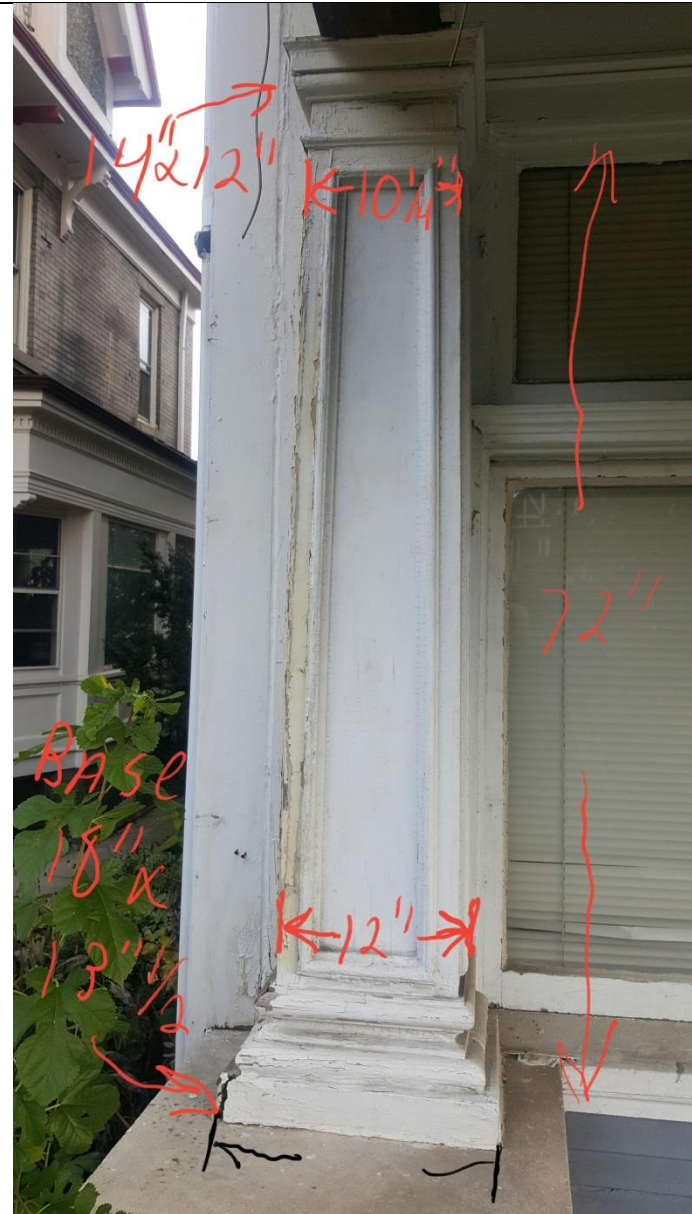
Detail photo of extant pilaster. New columns shall replicate this.

Columns are to be an exact replica of the historic columns. Pilasters remaining attached to the house may serve as models for the measurements. *Attached drawings show only the structure, not the proposed column design.* Wood must have a smooth finish. Recommend use of decay-resistant wood such as cedar, white oak, cypress, redwood, etc. Related structural work must preserve or replicate all moldings on the entablature.

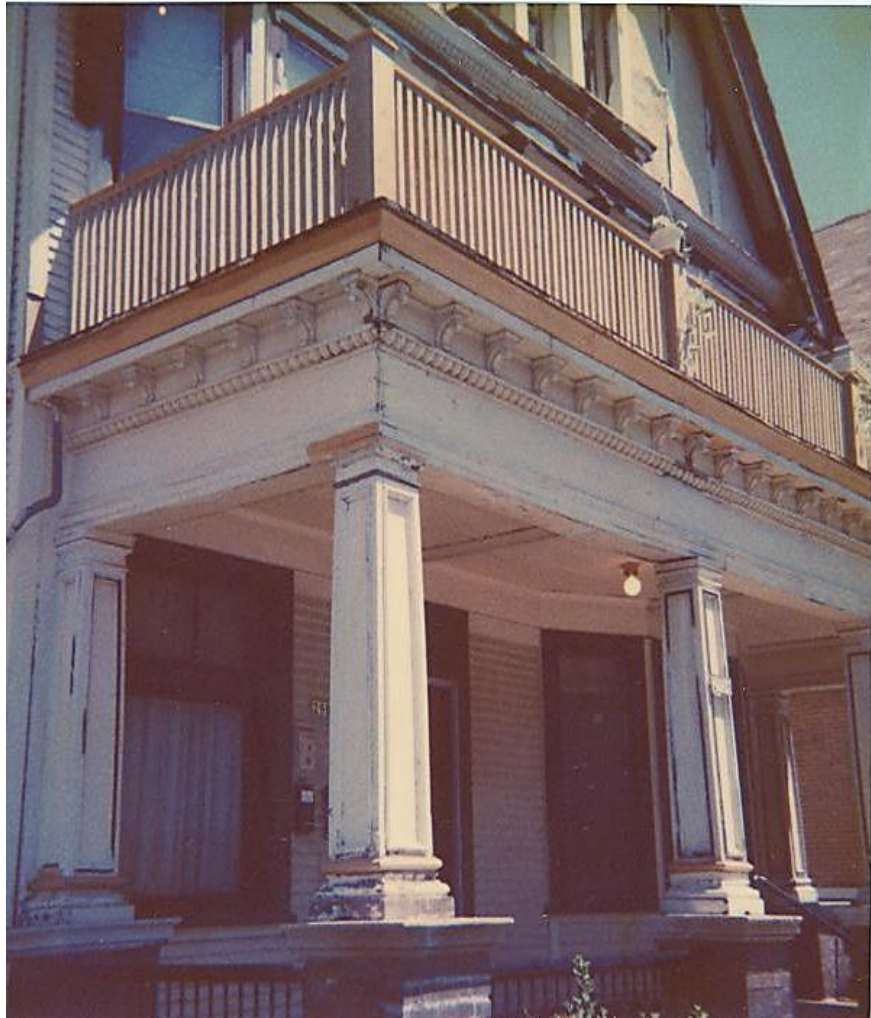
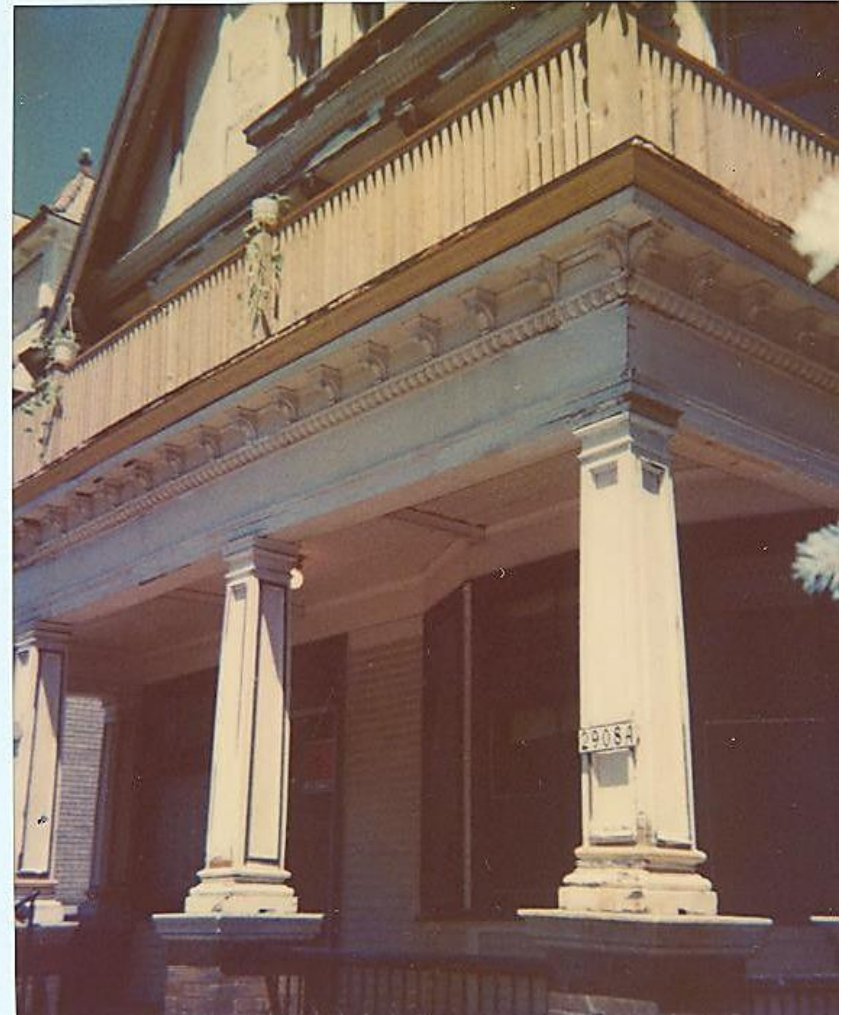
Deteriorated columns, date unknown (c. 2007).

Owner will restore missing columns to match historic appearance. Columns will be Tuscan in style and made of wood. They are to be square in shape, with applied molding panels on each side and a hypotrachelium. Related structural work is approved (see conditions).

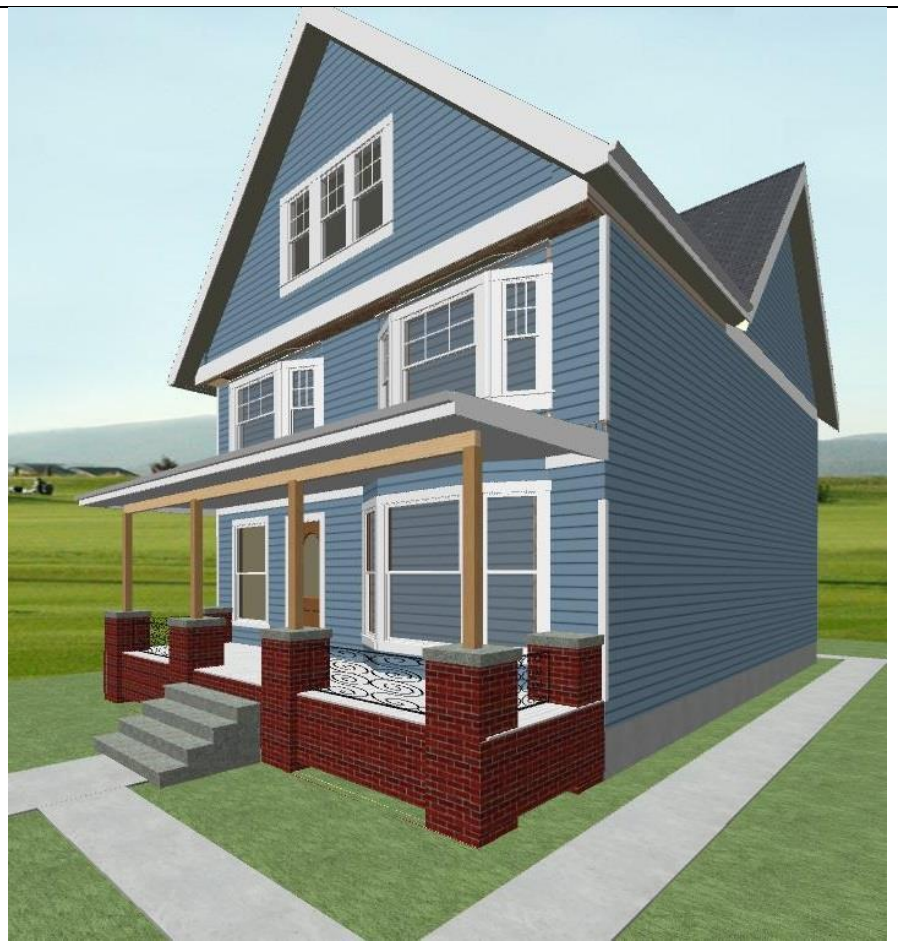
NW perspective view

Structure:

Double 1 3/4" x 11 7/8" LVL

2 Pcs each length,

Stagger lapped over

6x6 Treated Post columns.

Columns anchored to concrete cap

via standoff anchor brackets and

fastened to top with Simpson clips.

Decorative facade:

Applied over structure

per historical requirements.
