# Certificate of Appropriateness

**2844 N. Sherman Boulevard, Sherman Boulevard Historic District**

New EPDM rubber roof for the east back porch and bay window, flashing, and posts, per the attached scope of work.

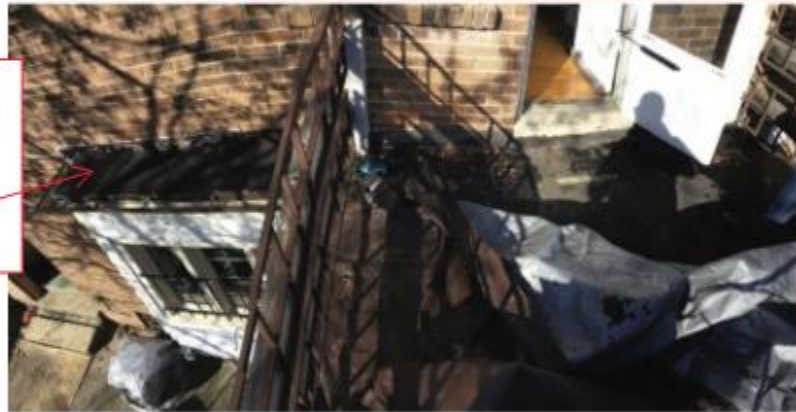
This photo shows a portion of the flat roof that is need of repair. The old tar over tin roof has deteriorated, causing leaking in the home below.

Remove existing roofing material, flashings at wall and gutter and underlying sheathing; dispose. Inspect conditions, document and discuss with owner our observations. (\*) As needed, perform any necessary repairs to underlying framing/or damaged trim on the basis of time and materials, added to price below. Any time and materials work necessary to be performed in consultation with owners.

Roll out and fully adhere 60 mil EPDM rubber on flat roof running up roof to wall intersection and door stoop, pressure sealed at door stoop. In concert with the new epdm membrane, install new 2 new pressure treated 4x4 railing posts in similar locations as existing at edge of roof and 2 new half posts with a chamfered top at wall installed into brick for railing re-installation. Posts will be flashed into rubber roof, and sealed for water tightness.

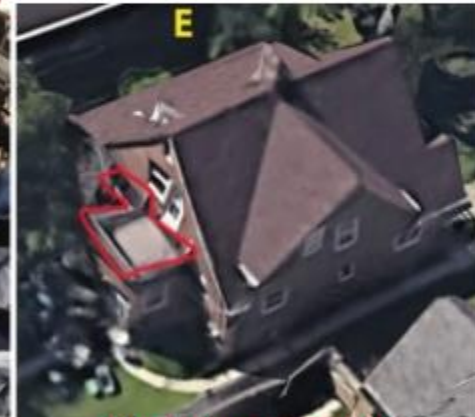
This portion of roof and flashing will also be repaired, as the current flashing has come away from the brick exterior.

Install custom cut and bent heavy gauge aluminum counterflashing over rubber at roof to wall intersection, cut into existing mortar and sealed. Counter flashing to match gutter color as closely as possible.
