3337 N SHERMAN BLVD REAR PORCH - SIDE VIEW

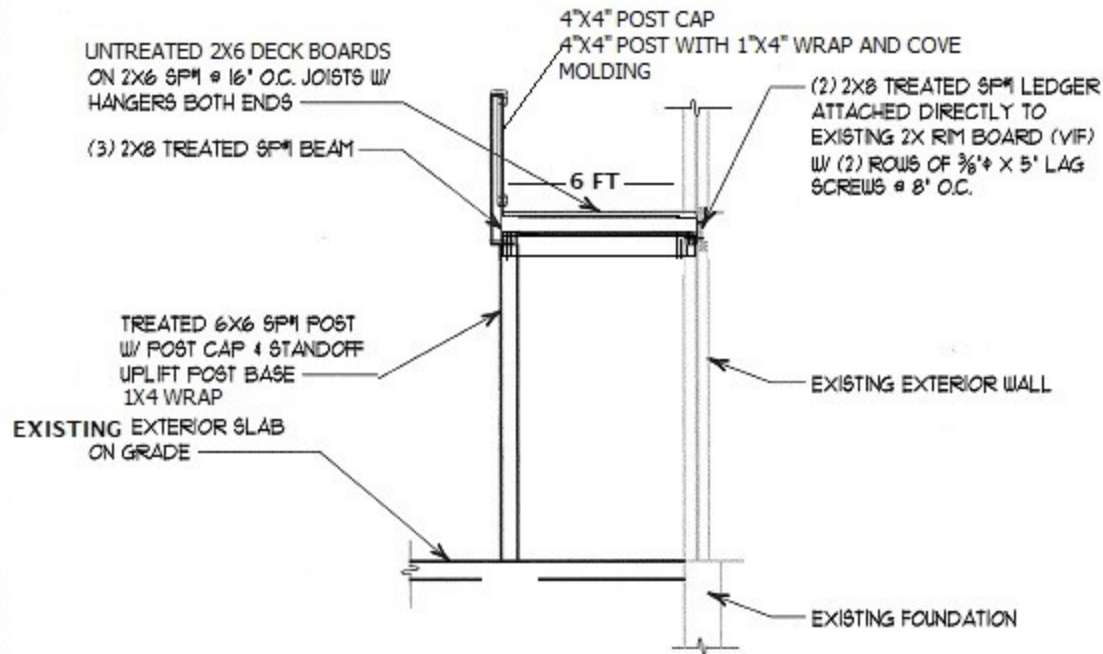
NOTE: LEDGER TO ATTACH DIRECTLY TO EXISTING WOOD WALL FRAMING, NOT BRICK VENEER. VERIFY EXISTING SUPPORT OF BRICK VENEER IN THE FIELD. PROVIDE FLASHING & CAULKING AFTER INSTALLATION.
