CERTIFICATE OF APPROPRIATENESS APPLICATION IMAGES

LION HOUSE

3209 WEST HIGHLAND BOULEVARD

2014 Masonry Stabilization and Restoration

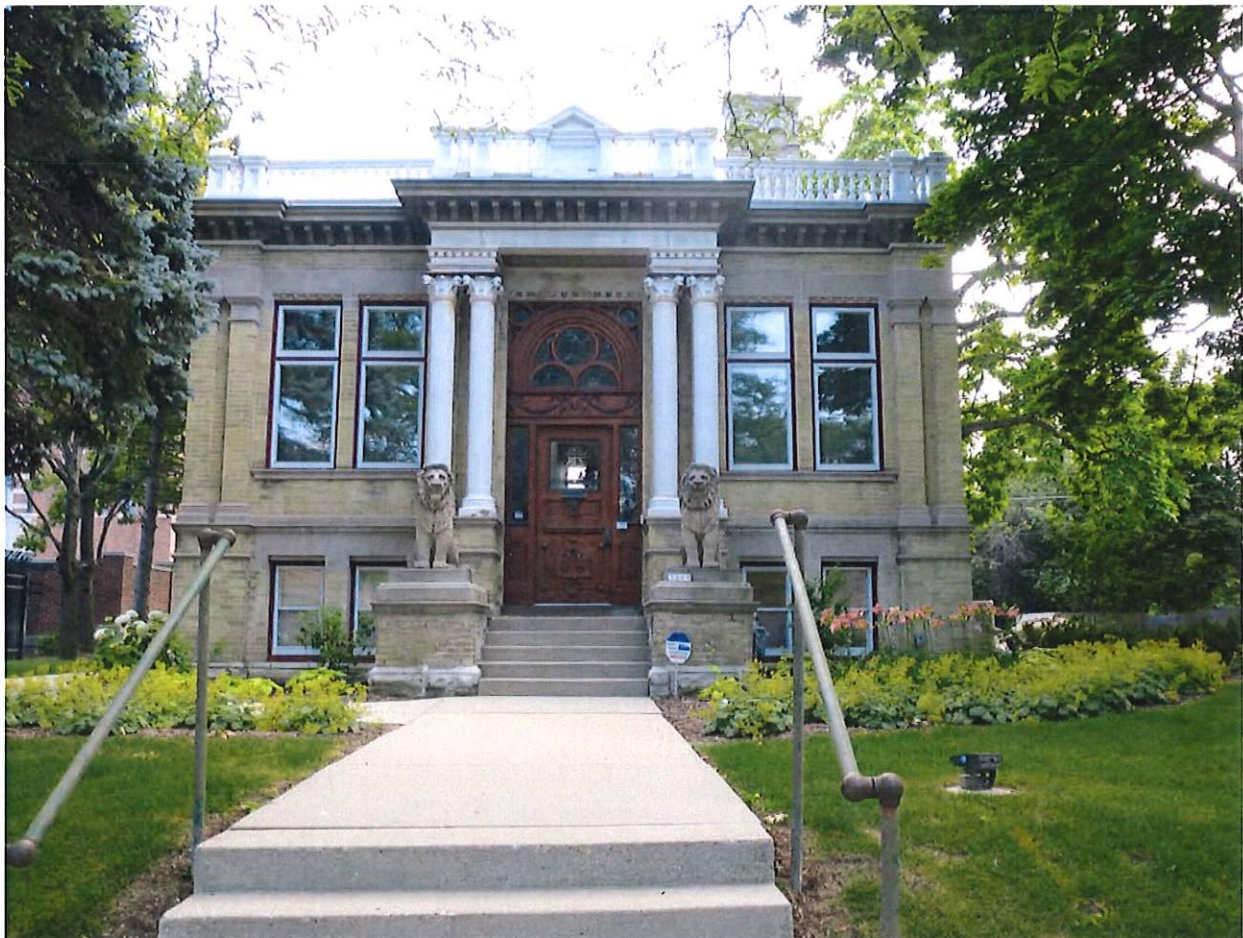
Image A: North façade of the Lion House showing the entry stair and flanking lions.

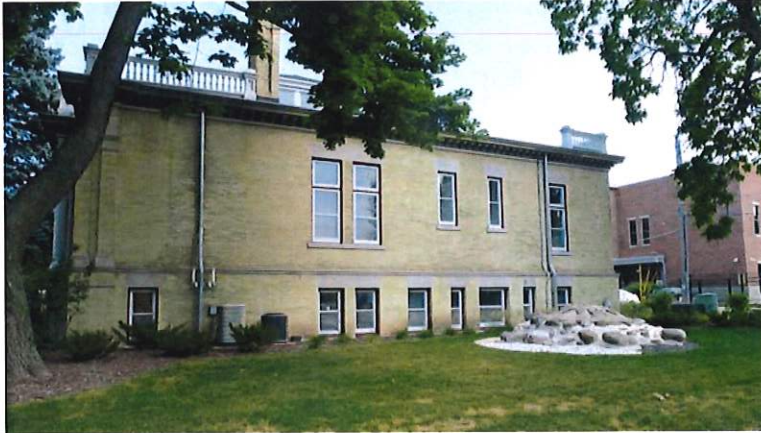
Image B: East façade select bricks at the basement level will be replaced with historic matching units.

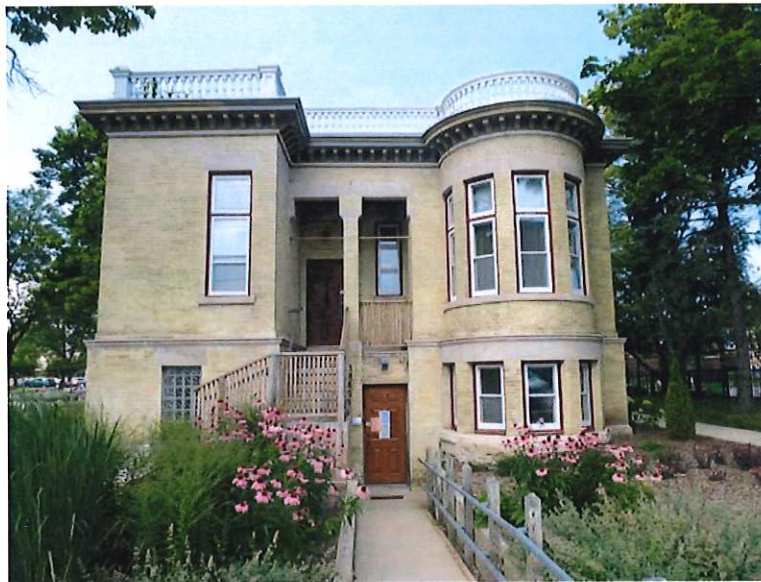
Image C: South façade, select bricks at the basement level will be replaced with historic matching units.

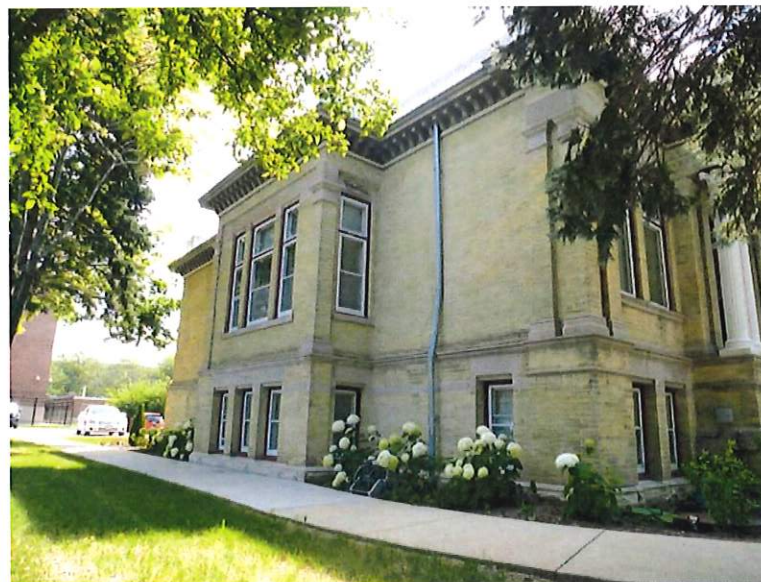
Image D: West façade, select bricks at the basement level only will be replaced with historic matching units.

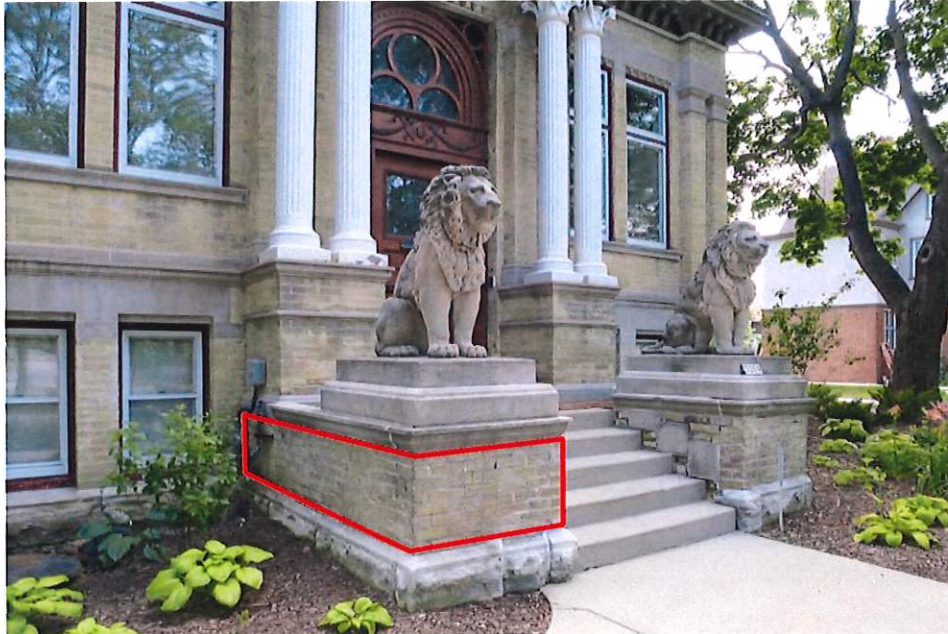
Image E: East pier – The area outlined in red will be spot repointed using a mortar matching the original. Due to severely decomposed bedding mortar, brick may require removal and resetting in new bedding mortar.

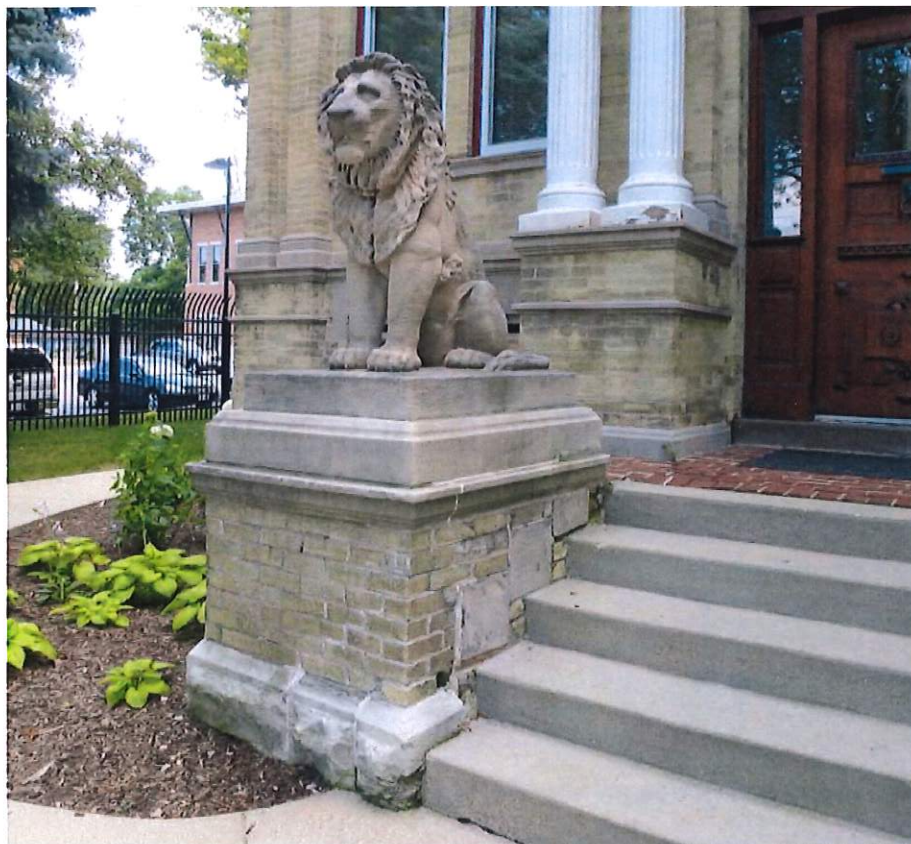
Image F: East pier – The brick solid railing wall/pier will be spot repointed using a mortar matching the original. Due to severely decomposed bedding mortar, brick may require removal and resetting in new bedding mortar. Spalling brick will be replaced with salvaged matching units. Stone units at each stair and base of pier will be reset as needed.

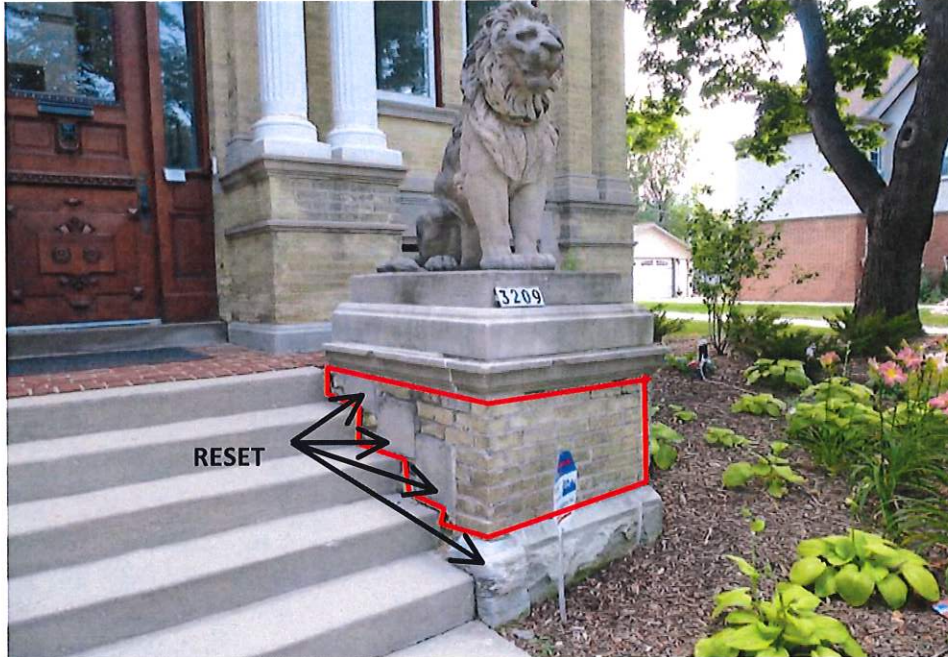
Image G: West pier – The area outlined in red will be spot repointed using a mortar matching the original. Due to severely decomposed bedding mortar, brick may require removal and resetting in new bedding mortar. Spalling brick will be replaced with matching salvaged units. Stone units at each stair and base of pier will be reset as needed.

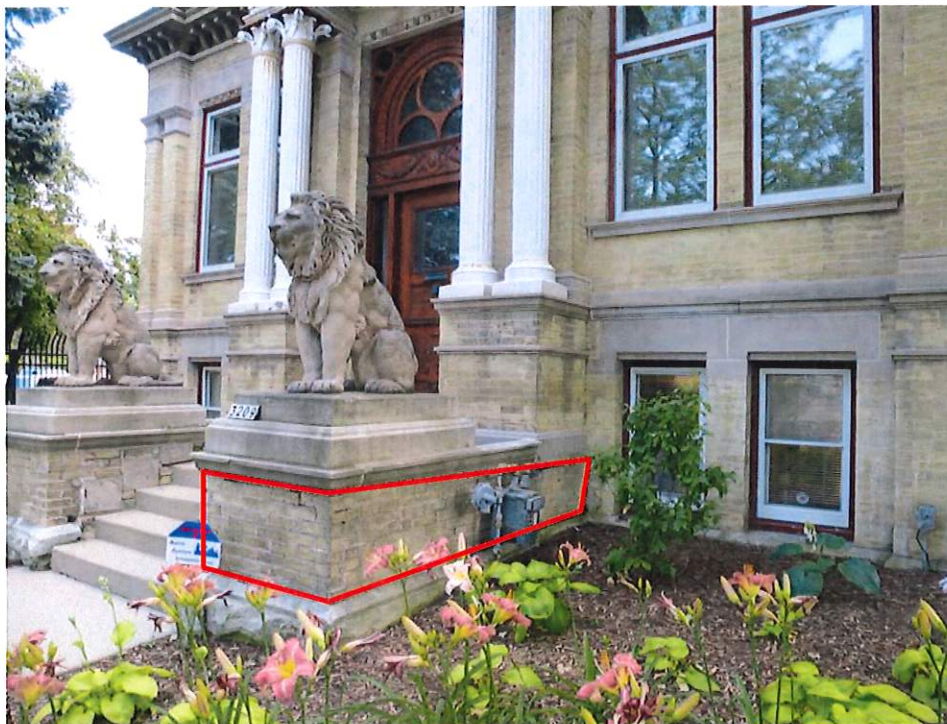
Image H: West pier – The area outlined in red will be spot repointed using a mortar matching the original. Due to severely decomposed bedding mortar, brick may require removal and resetting in new bedding mortar. Spalling brick will be replaced with salvaged matching units.
