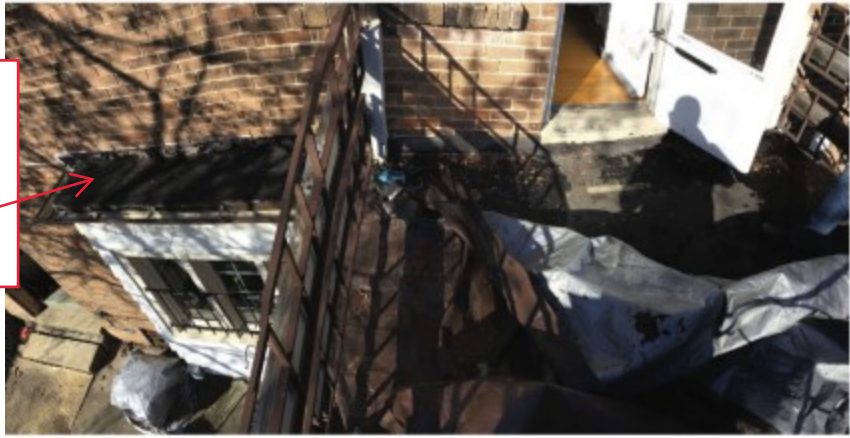
This photo shows a portion of the flat roof that is need of repair. The old tar over tin roof has deteriorated, causing leaking in the home below.

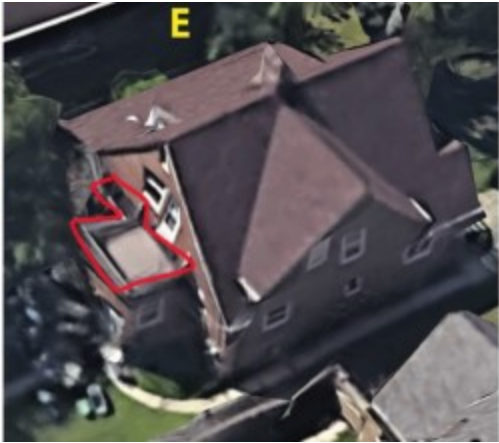
This portion of roof and flashing will also be repaired, as the current flashing has come away from the brick exterior.

Ariel view of where repairs will be limited to.
