SOUTH ELEVATION (FRONT)

Christenson Residence Restoration
 3320 North Lake Drive
 Milwaukee, Wisconsin 1/10/2022 1/3

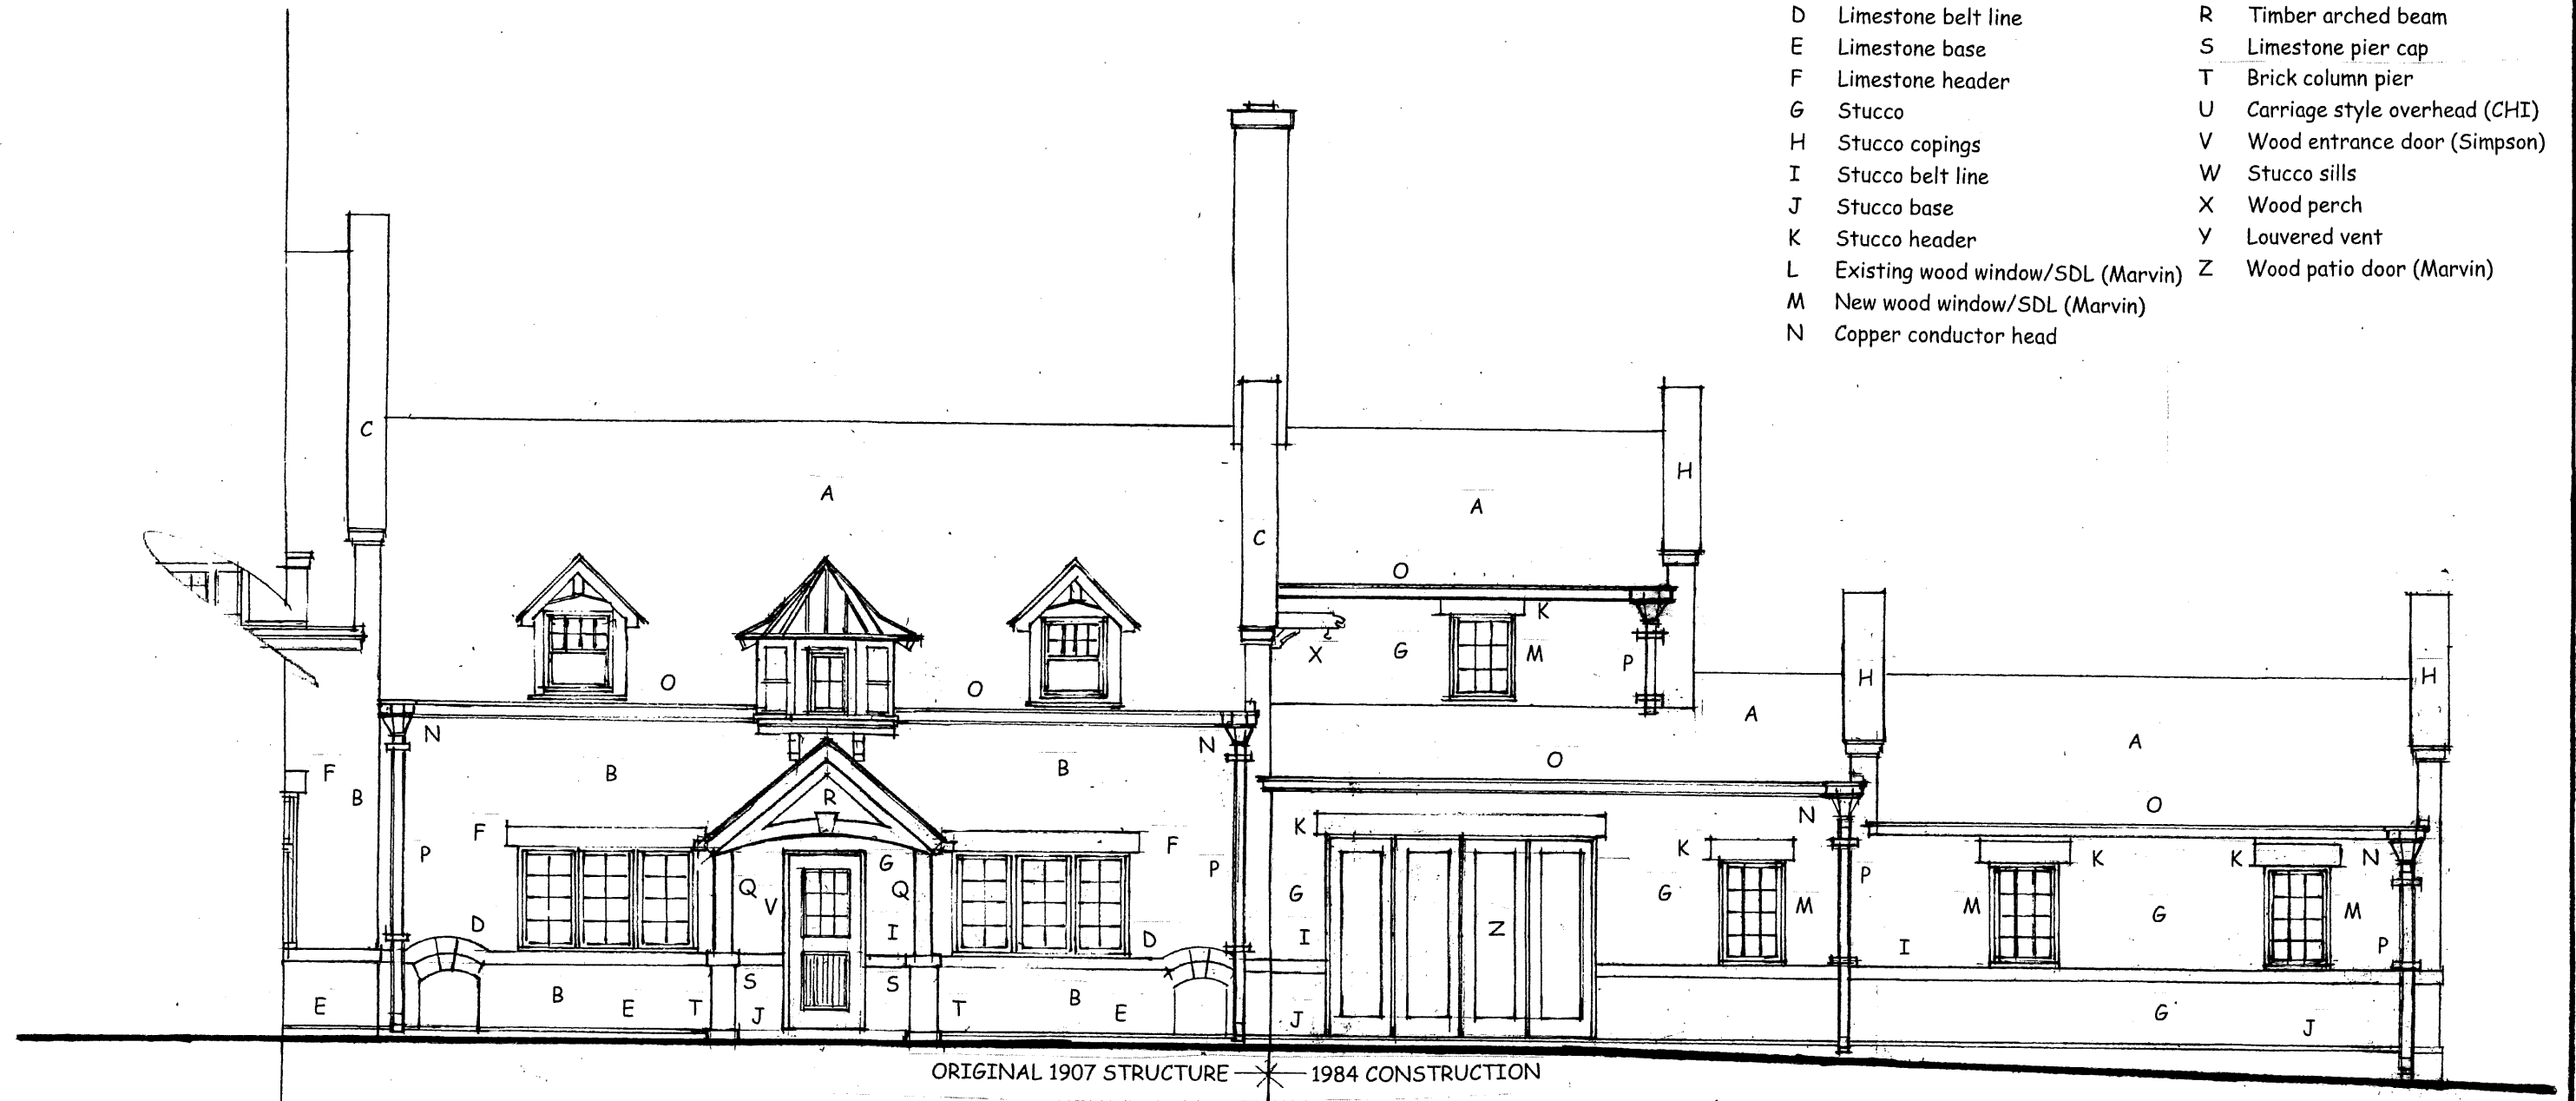
ORIGINAL 1907 STRUCTURE — 1984 CONSTRUCTION

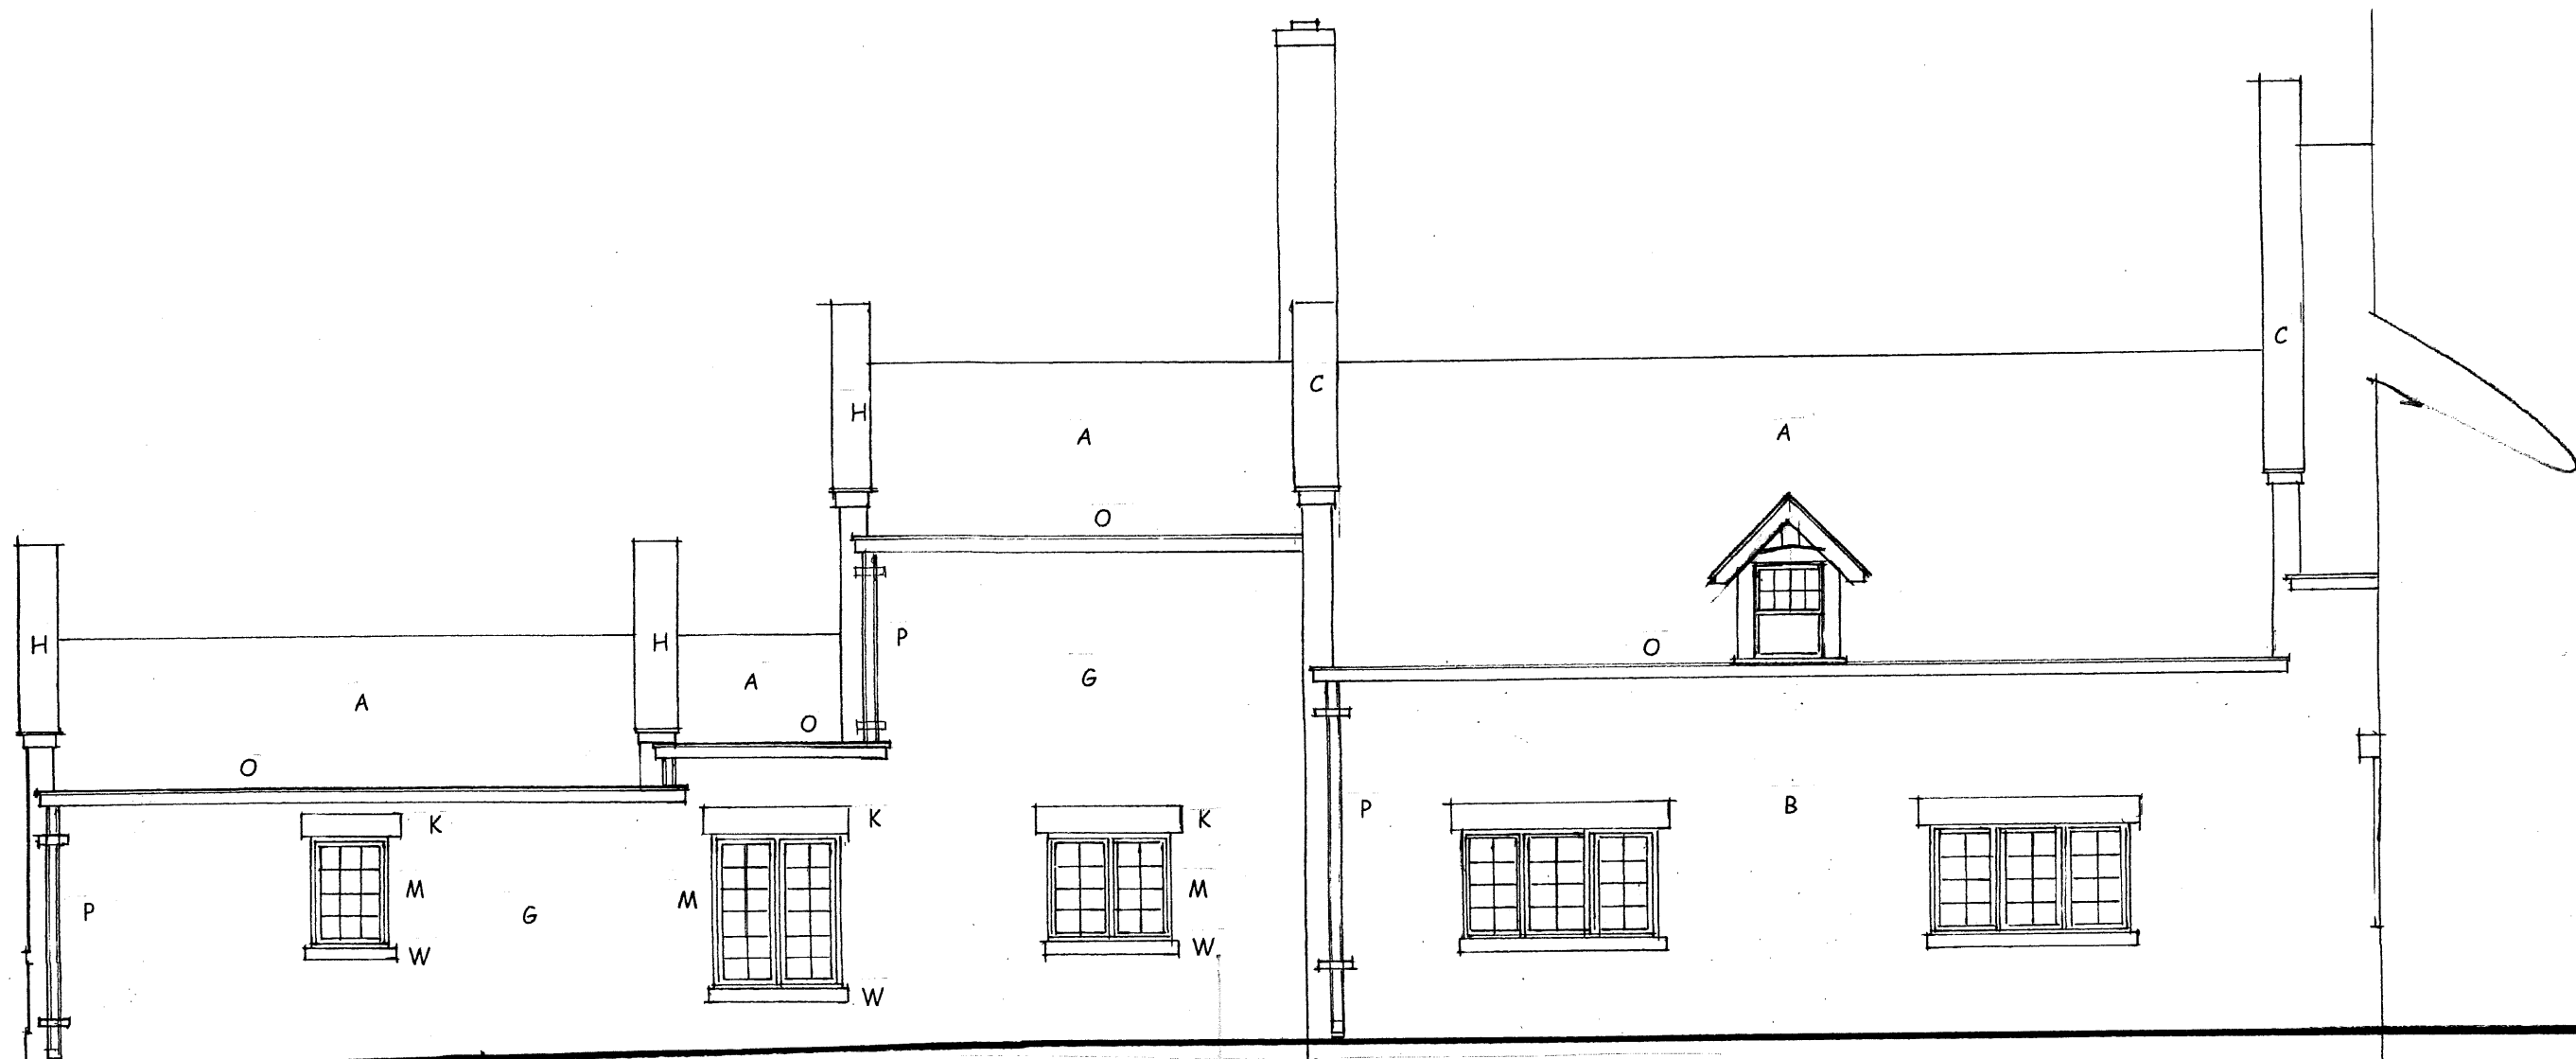
NORTH ELEVATION (REAR)

1984 CONSTRUCTION * ORIGINAL 1907 STRUCTURE
