Understanding Traditional and Modern Paints and Stains for Exterior Wood | 2014-01

Anthony & Associates, Inc. for Association for Preservation Technology International

NCPTT Grant No. MT-2210-11-NC-01

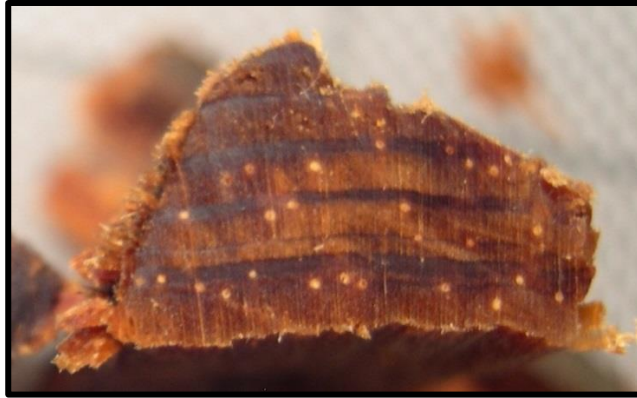
Figure 2.1. Cross section (end grain) of southern yellow pine, showing dark latewood bands.

Under a hand lens or low-power light microscope, the cross section of wood somewhat resembles a bundle of straws packed tightly together. These “straws” are the tubular sapwood and heartwood cells whose long axes run parallel to the long axis of the tree trunk. The cells are made of cellulose and are bonded together by lignin, a cementing substance. The direction of these tubular cells is referred to as the grain of the wood; grain direction is very important to understanding how a piece of wood behaves when subjected to various environmental conditions because the properties of wood, such as shrinkage or swelling, with parallel grain differ significantly from wood with perpendicular grain. Most trees exhibit a pattern of concentric circles when viewed in cross section; these circles are bands of light and dark wood and represent the growth rings of the tree over the course of its life. The dark bands, called latewood, are denser and thinner than the light-colored bands, as they represent the growth of the tree in the fall and winter (Figure 2.1). The light-colored rings are generally much wider than the dark rings and represent the faster growth that occurs in spring and early summer. This earlywood is less dense and weaker in structure than latewood growth.

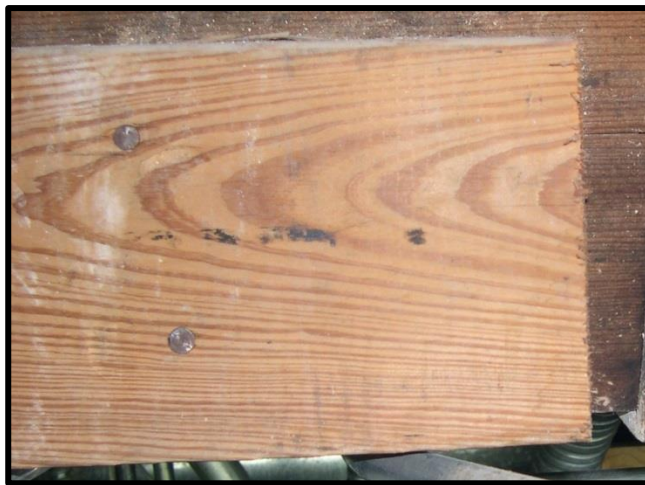
Figure 2.2. Flat-grained board with typical “U” shaped grain pattern.

Flat-grain lumber is wood that has been cut parallel to the tangential face of the log. This results in a pleasing characteristic “U” or “V” shaped grain pattern on the wide faces of boards and lumber (Figure 2.2). This cut is common because it maximizes the amount of useable material from the log. However, wood shrinks and swells the most in the tangential direction; therefore having large surface areas cut from the tangential faces of logs lead to boards and lumber that tends to cup, crown, bow, warp, and twist more than other cuts. This type of cut reduces the longevity of coatings due to greater shrinkage and swelling of the wood.

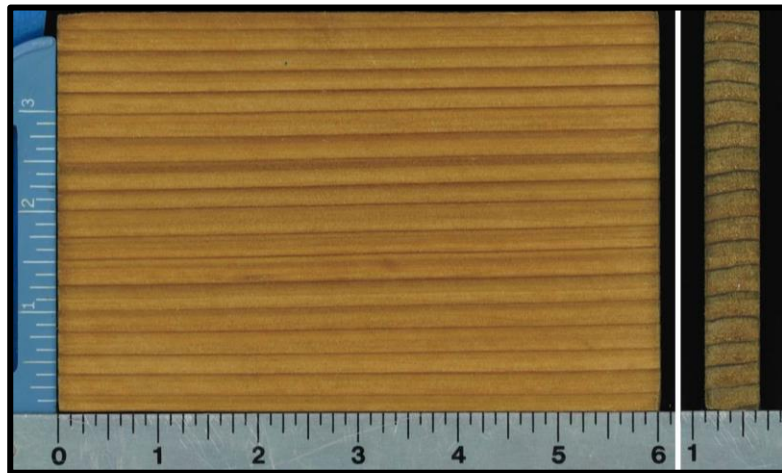
Figure 2.3. Vertical grain western red cedar showing the grain pattern on the wide (left) and narrow (right) faces.

Vertical grain lumber is cut to be as close as possible to the radial face of the log. This results in growth ring bands that are nearly perpendicular to the wide face of the wood and a minimization of tangential wood (Figures 2.3 and 2.4). Vertical grain wood exhibits the least movement in service, and, in some species with strong contrast between earlywood and latewood color, can have a strong, visually appealing striped effect caused by the alternating bands of earlywood and latewood on the wide face. Vertical grain lumber is the most expensive type of cut because it is the least efficient use of the log. Coatings can have difficulty adhering to the dense latewood when applied, particularly for woods such as southern yellow pine with a high ratio of latewood to earlywood. However, if properly maintained, the coating can have greater long-term stability because of the reduced shrinkage and swelling associated with this type of cut.

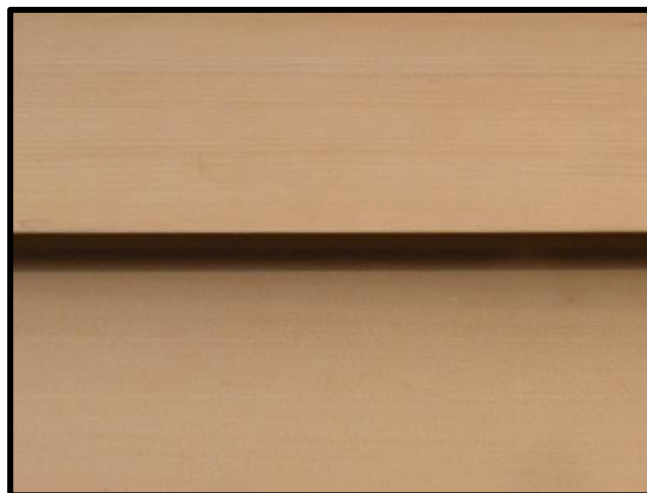
Figure 2.4. Tight vertical-grained Alaska yellow cedar siding with the wood fibers oriented parallel to the long axis of the boards.

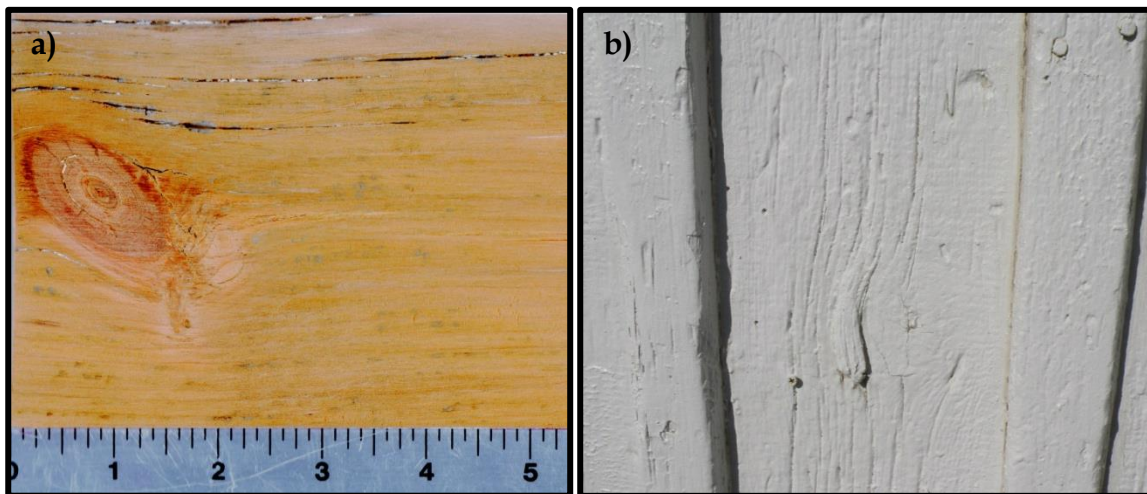
Figure 2.5a. An example of a knot on a sanded pine board.

Figure 2.5b. A knot that telegraphs through the paint on this board and batten siding.

Knots, which are the remnants of branches, form areas of irregular grain and wood cellular structure that may not absorb a coating in the same manner as the surrounding wood (Figure 2.5a and 2.5b). Additionally, knotwood does not shrink or swell at the same rate as the surrounding wood fibers, thus leading to loose knots, knot holes, or cracks or splits in the surrounding wood fibers. Bark inclusions can behave in a similar manner, and also present rough patches that may be difficult to coat effectively (Figure 2.6). Pitch pockets, which are, as the name implies, pockets of tree sap or pitch that can seep out after coating, can lead to blisters or peeling (Figure 2.7).

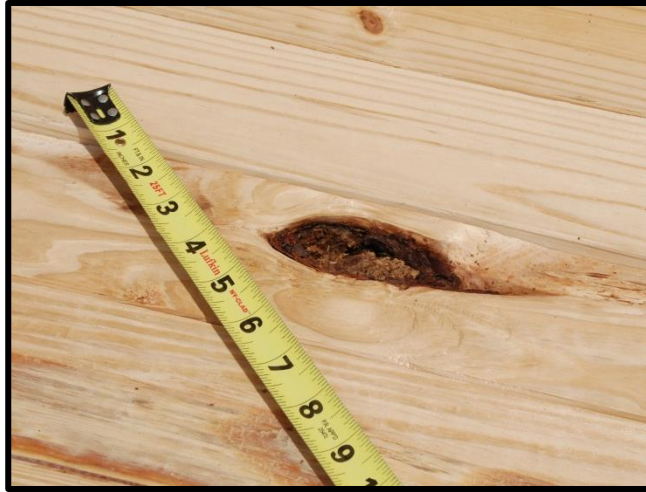
Figure 2.6. Bark Inclusions occur when a bark-covered branch or a separate stem becomes incorporated into the main trunk.

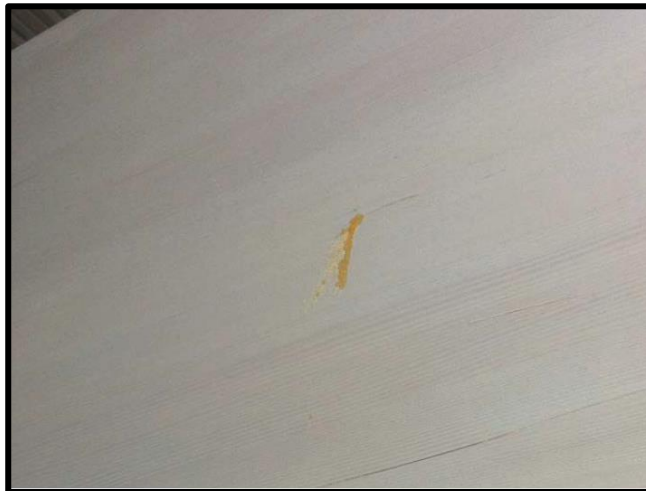
Figure 2.7. Although there is no visible evidence of a pitch pocket on the surface of the wood, the sap indicates the presence of one beneath the surface.

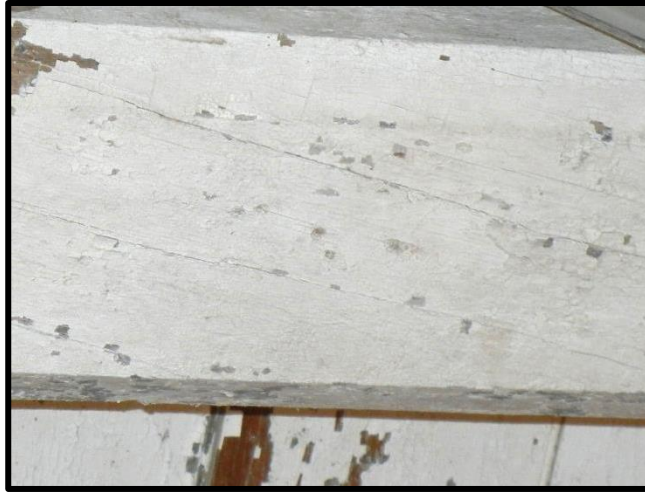
Figure 2.8. Slope of grain visible through the painted surface of a beam.

Slope of grain is the angle of the wood fibers relative to the long axis of the piece; wood with a high slope of grain tends to exhibit more checks, splits, and movement in service than wood where the grain runs parallel to the length of the piece. Checks and splits, which generally follow the slope of grain, usually develop as wood dries. Checks and splits make it difficult to seal the wood with the coating (Figure 2.8). Wood with splits and checks can allow for moisture intrusion, which in turn will increase movement in service and facilitate the development of additional and deeper checks and splits.

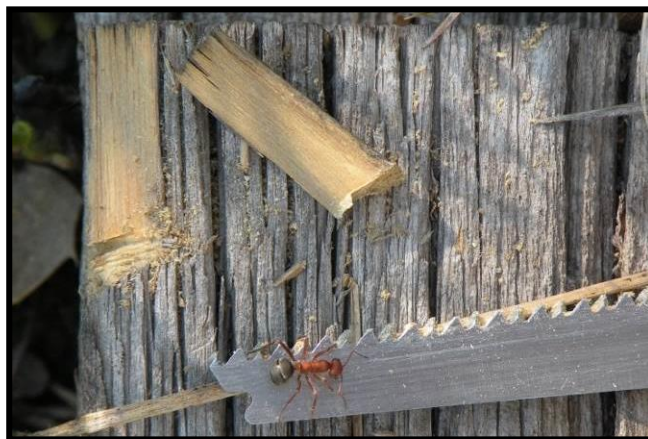
Figure 4.1. Example of a sample removed for species identification. Note that although the wood surface is weathered, the sample consists of sound wood.

Wood samples should be taken from sound wood (without decay) and should measure a minimum of ¼-inch wide x ¼-inch deep x ½-inch long. Larger samples are acceptable and may be preferable in situations where the wood is difficult to identify based on microscopic characteristics alone. The soundness of the wood sample can be determined by rolling it between the fingers; if the wood breaks apart, it should not be submitted and a new sample will need to be taken. To extract a sample, use a sharp knife, craft saw blade, and/or a chisel to make two cuts across the grain of the element (Figure 4.1). These two cuts should be a minimum of ¼-inch deep and ½-inch apart. A specimen can be split out by prying up at one of the incised points with a knife, or if a chisel is used, the edge of the chisel can be placed in one of the cuts and then angled down the grain towards the other cut. A sharp tap with a small hammer should provide enough force to remove a good specimen from the host element. Samples should be taken from an inconspicuous area on sound elements or from pieces that will need to be repaired or replaced. Each sample should be recorded, labeled and bagged separately prior to shipment for analysis.

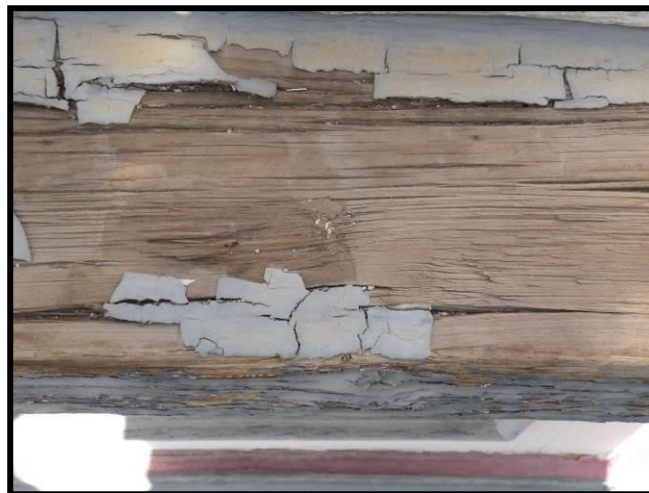
Figure 4.2. A window sill with failed paint and gray wood typical from UV exposure and weathering-caused cracks and checks that allow moisture penetration

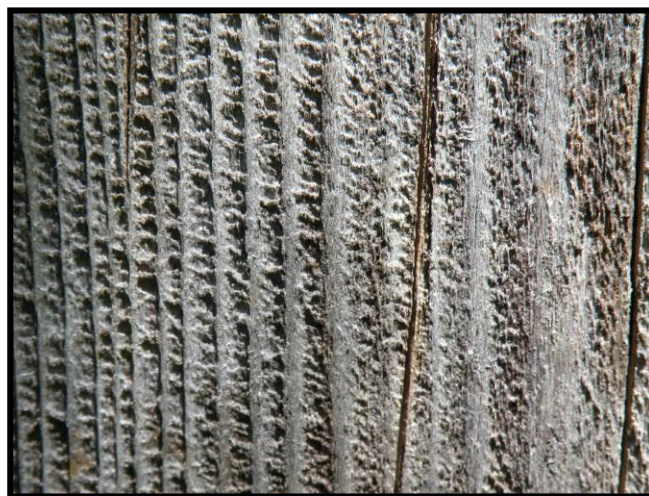
Figure 4.3. Detail of an uncoated wood substrate with erosion of the earlywood due to weathering.

In addition to the graying from UV exposure and swelling, shrinking, checking and splitting due to moisture intrusion, wind-blown debris erodes fibers on the exposed wood surface and collects in crevices, inhibiting drying and serving as a growth medium for wind-blown spores and seeds. For intact or partially intact coatings, UV exposure causes colors to fade and breaks down the surface layers of binder, leaving loose pigment particles on the surface, a condition known as chalking. As the weathering process continues, the coating erodes away. Areas of exposed wood experience differential weathering as the lighter-colored, less dense earlywood in the growth rings erodes faster than the darker, denser latewood bands, resulting in a rough surface texture (Figure 4.3).

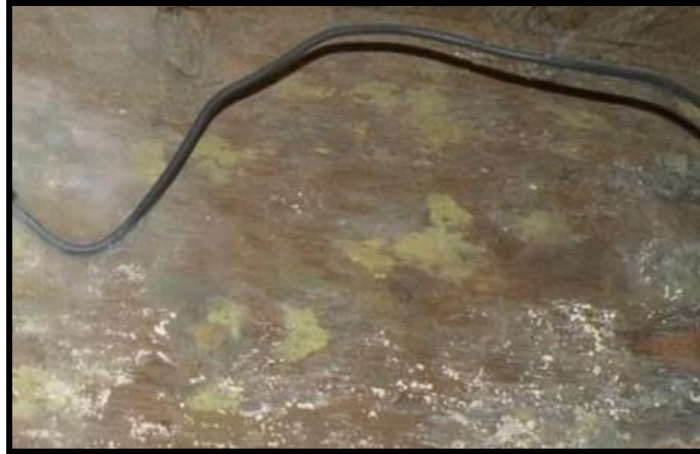
Figure 4.4. Yellow and white mold growth on an uncoated wood surface.

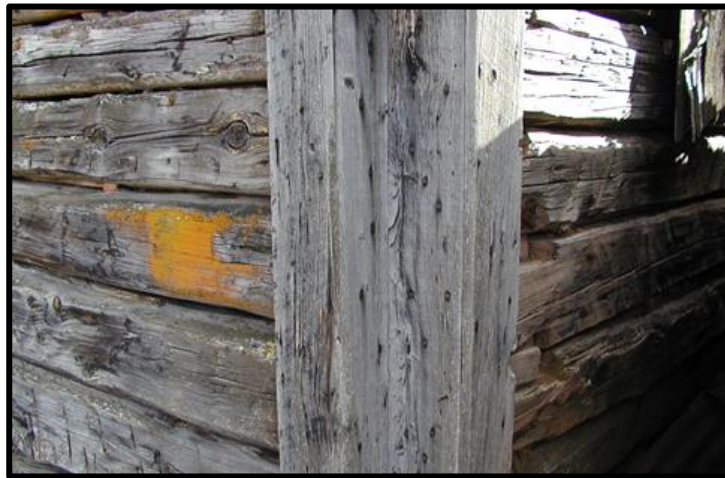
Figure 4.5. Lichens on the surface of a log structure.

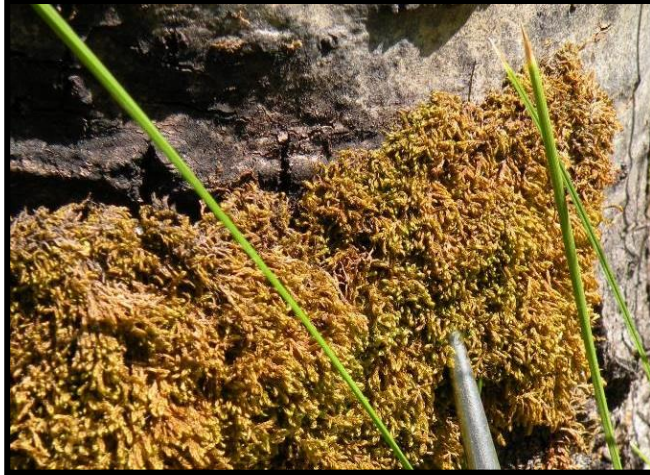
Figure 4.6. Moss growth on a wood substrate.

Mosses are non-vascular plants that can thrive on a variety of porous, moisture retentive surfaces (Figure 4.6). Mosses grow from spores and require near-constant high levels of moisture to survive. The presence of moss is an indication of a continuous high moisture environment, and the sponge-like composition of the moss traps moisture at the wood surface. If mosses are present on wood elements of a historic building, moisture levels are likely to be very high and decay fungi are probable. Moss can be easily removed with careful cleaning (Figure 4.7), but unless the favorable underlying conditions are altered, the moss will return. Mosses can be controlled by reducing the amount of available moisture and trimming trees and vegetation to increase sunlight exposure to enhance drying.

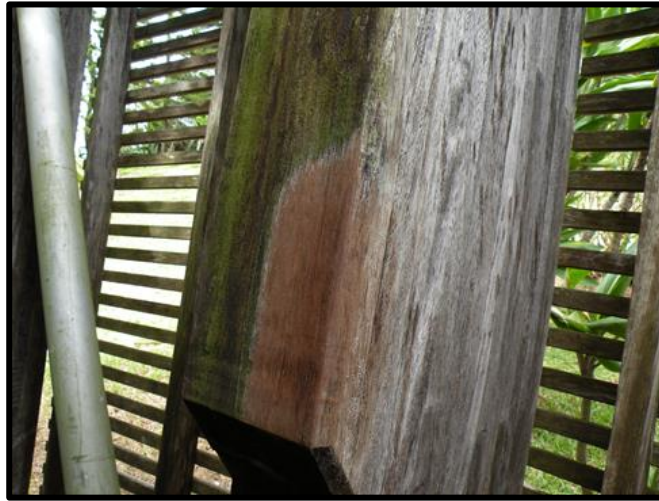
Figure 4.7. Biological growth and weathered patina, both of which can be removed through cleaning, as shown here.

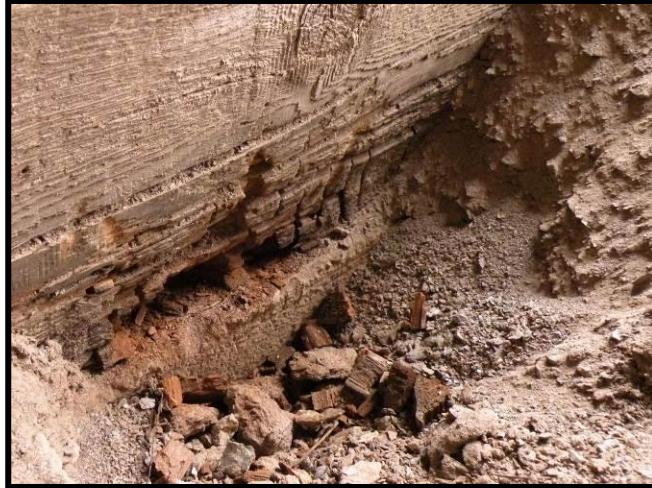
Figure 4.8. Deterioration of wood caused by wood-decay fungi.

All wood is subject to a variety of deterioration mechanisms, the most damaging throughout the U.S. of which is wood-decay fungi. Wood-decay fungi excrete enzymes that break down wood fibers, which can ultimately lead to a loss of integrity and the inability of the wood to perform its intended function. Most wood-decay fungi are only able to grow on wood with a moisture content greater than 20 percent (but require high moisture contents to initiate) and are unable to damage adjacent dry wood (Levy 1979). Evidence of typical decay of wood products can be identified by the dry, cubicle cracking that occurs in the wood substrate and/or by fungal fruiting bodies visible on the wood surface, although other patterns of deterioration can occur (Figures 4.8 and 4.9).

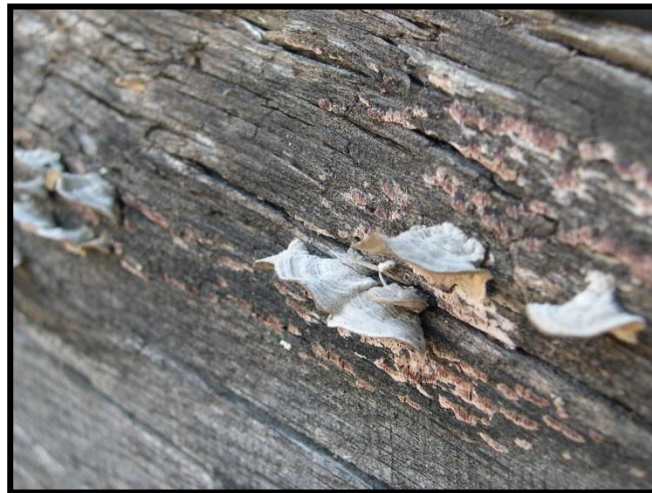
Figure 4.9. Fungal fruiting bodies growing out of a wood substrate.

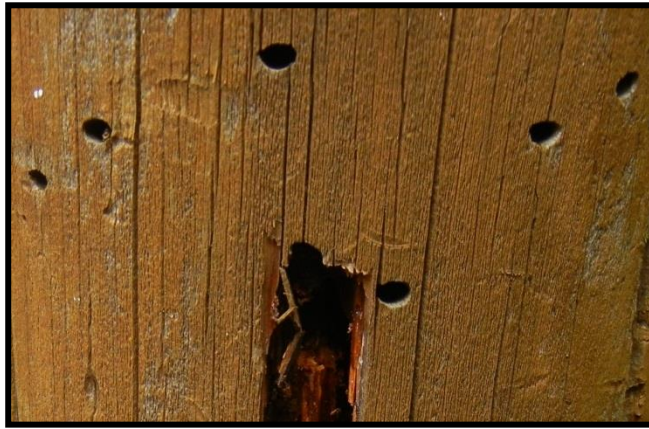
Figure 4.10. Bore holes in a stained column (also with deterioration by wood-decay fungi).

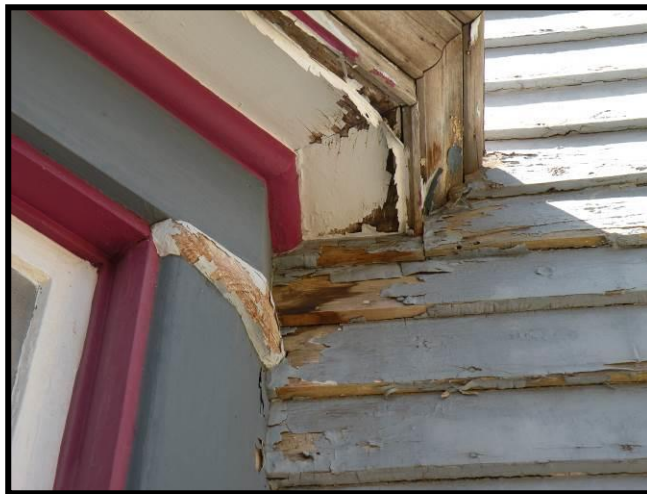
Figure 4.11. Coating failure near the end grain in an area where water flowed down the face of the exterior cladding, as evidenced by the moisture stains on the exposed wood.

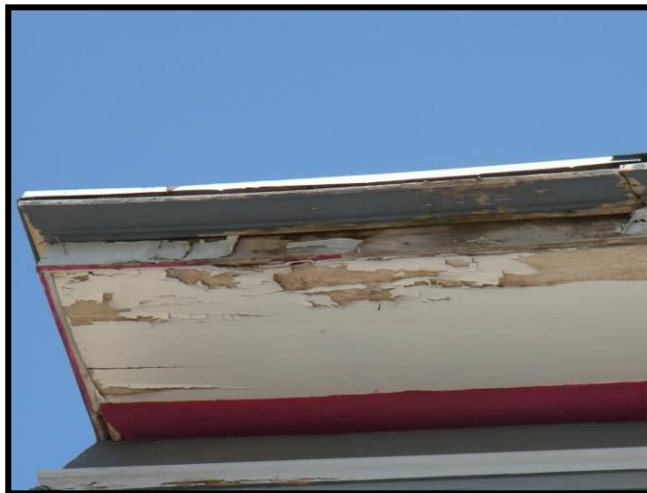
Figure 4.12. Fascia and soffit with failing paint due to moisture absorption.

gutters and downspouts, and any place where rain runoff may make contact with coated wood surfaces (Figure 4.12).

Peeling from excessive moisture generally includes all layers of paint on a wood substrate, as shown in Figures 4.12 and 4.13 above. Intercoat peeling, where one layer of paint separates from the layer or layers below, is not generally the result of moisture but of a weak bond between coatings (Figure 4.14). This type of peeling can be caused if paint has been applied over heavily soiled or chalky paint without proper cleaning or surface preparation, and may be common on historic structures that have had only sporadic exterior maintenance.

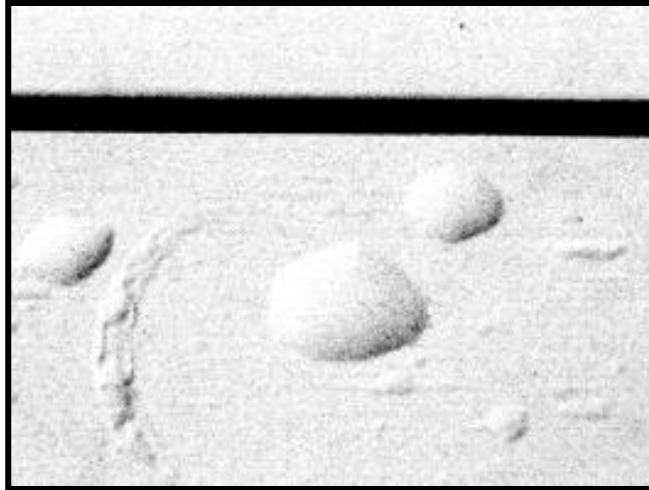
Figure 4.13. Moisture blisters in paint. Image from Cassens and Feist 1988.

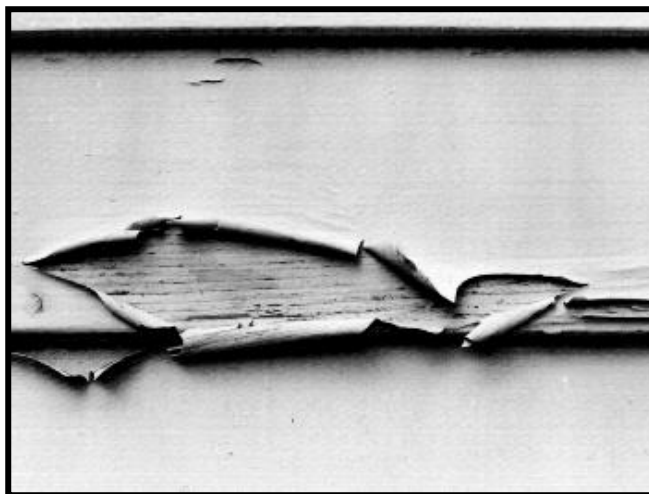
Figure 4.14. Intercoat peeling is indicated when older coatings remain adhered to the wood substrate. Image from Cassens and Feist 1988.

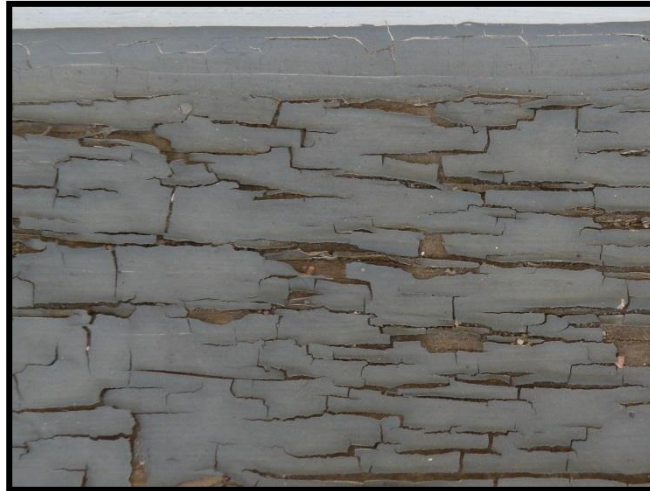
Figure 4.15. Cracking and cross-grain cracking (alligatoring) of the paint.

Cracking can occur for a number of reasons. Generally, cross-grain cracking, or alligatoring, occurs on historic structures because the paint layers become too thick and brittle and can't expand and contract with the movement of the wood substrate (Figure 4.15). Alligatoring can also occur if paint is applied too thickly in a single

coat, or if a second coat is applied before the first coat has thoroughly dried. Alligatoring is indicative of a failed bond between the wood substrate and the coating(s) and paint that exhibits this type of cracking must be entirely removed and a new coating applied.

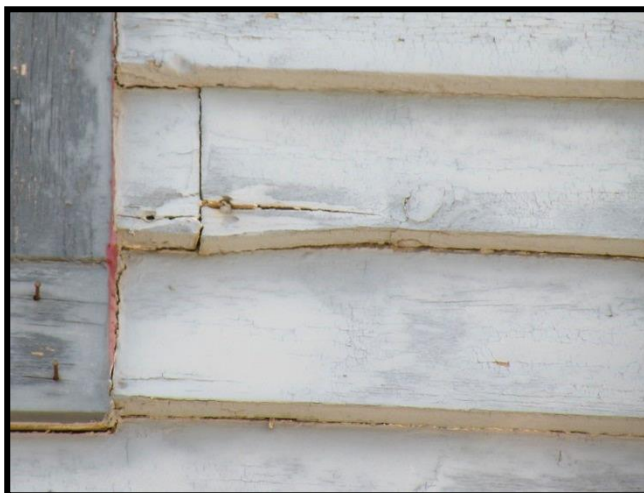
Figure 4.16. Wood siding and trim with areas of chalking. The splits in the wood are due to overdriven fasteners, not the performance of the coating.

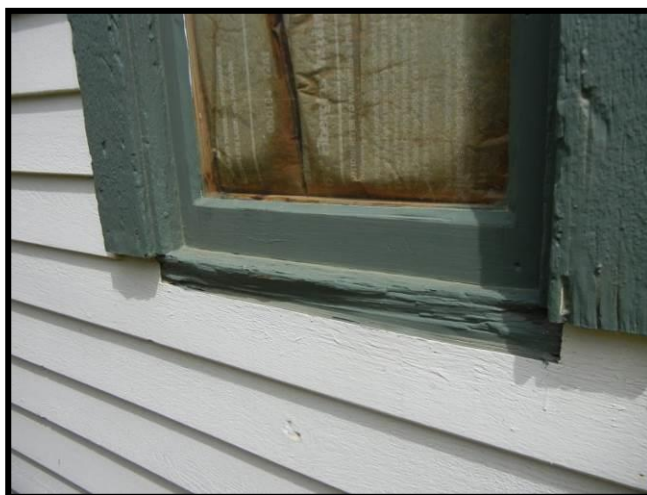
Figure 4.17. Missing window sill.

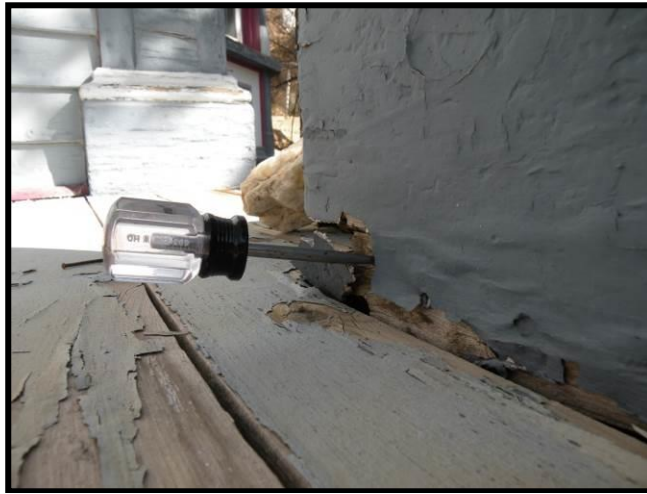
Figure 4.18. Probing at the base of a porch column with an awl reveals some deterioration.

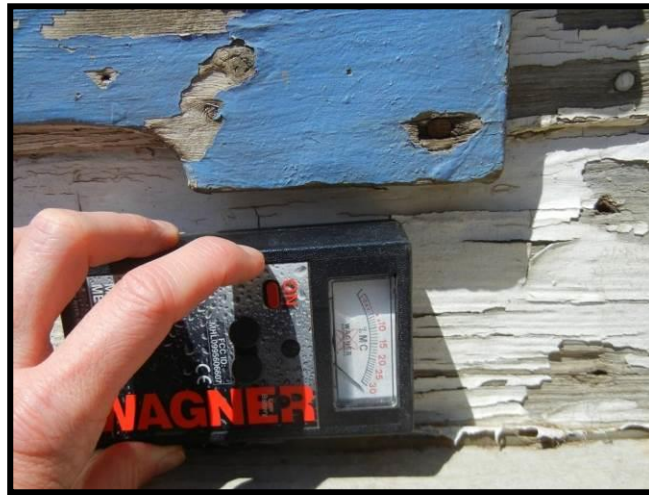
Figure 4.19. Use of a pinless (capacitance) moisture meter to determine the moisture content of siding.

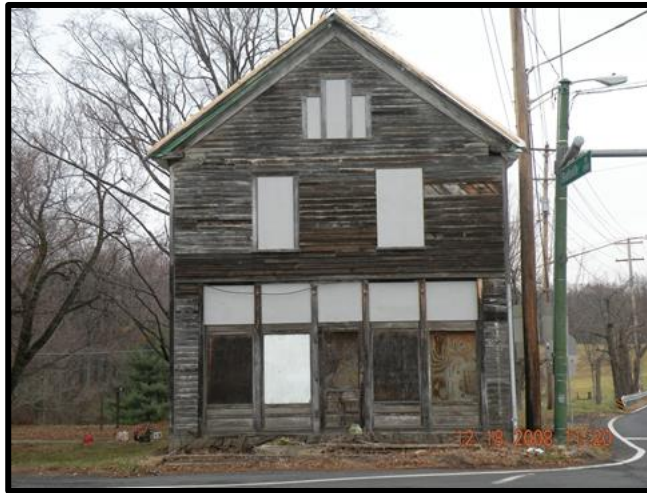
Figure 5.1 Weathered cladding from a naturally durable wood species that results in an appearance quite different than if it was painted.

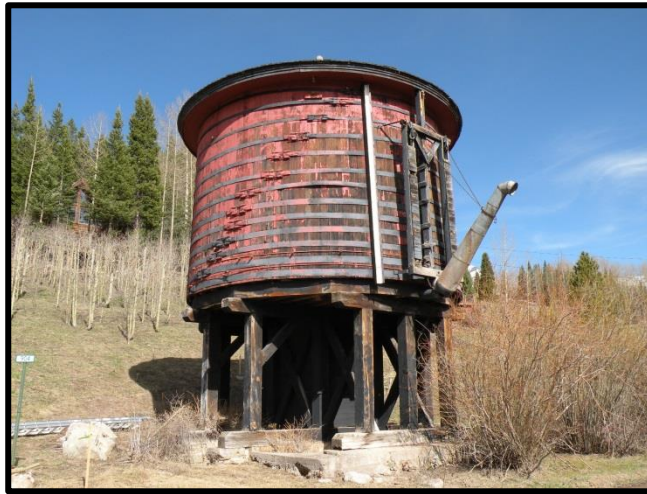
Figure 5.2. Deterioration of the staves of this water tank has resulted in friable wood surfaces that are delaminating. Given the fragile surface condition of many of the staves, repainting is not advised due to the potential damage that could result from removing the existing paint and properly preparing the surface for repainting; instead, replacement material can be painted to match the existing color, and the existing paint allowed to continue weathering.

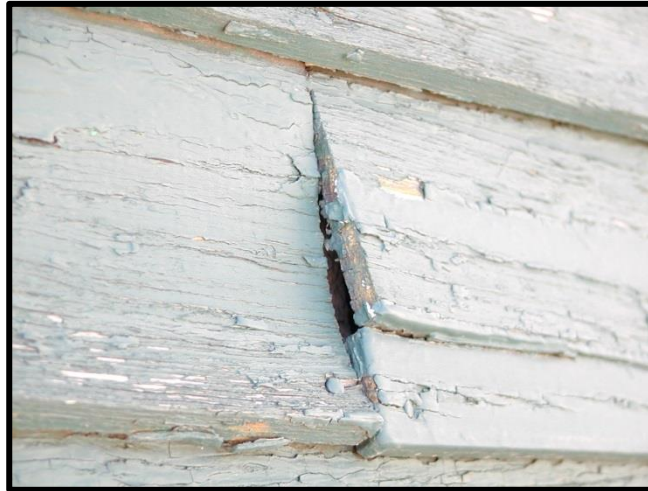
Figure 5.3. Cupping and splitting of boards on a historic theater building.

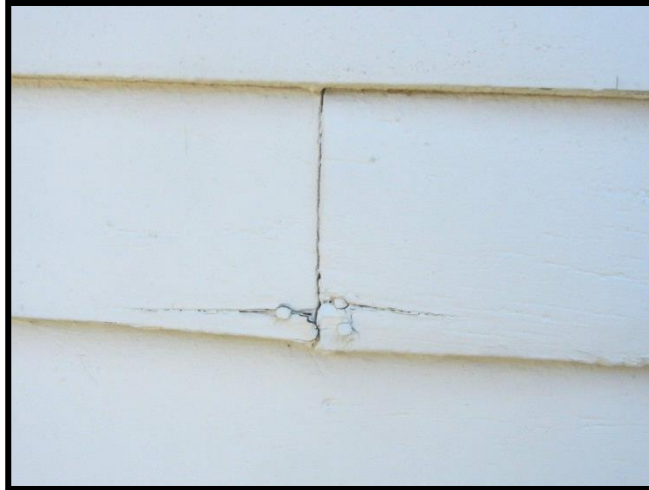
Figure 5.4. Horizontal siding with a butt joint. Note the siding has also been face-nailed in an attempt to prevent or minimize cupping. Face nailing tends to lead to board failure, as the wood is forced to move differentially, leading to splits, as shown here.

Typically scarf-joint or other types of wood joint repairs are preferable to butt-joints for both horizontal and vertical elements to increase the gluing surface area and holding power of the repair. Butt joints have square-cut end grain of two pieces of wood that are joined or “butted” up against one another (Figure 5.4). Scarf joints, in their most basic form, involve miter cuts across the end grain so that the two pieces of wood overlap, allowing for a greater cross section of wood to be used as the gluing surface and thus tending to form stronger joints than butt joints (Figure 5.5). However, scarf joints that are not tight will have more end grain exposed to potentially absorb moisture. Attention to the repair details is critical to prevent future problems associated with the repairs. Scarf joints on vertical elements should be angled up and towards the interior of the structure so that water will not be readily absorbed into the joint.

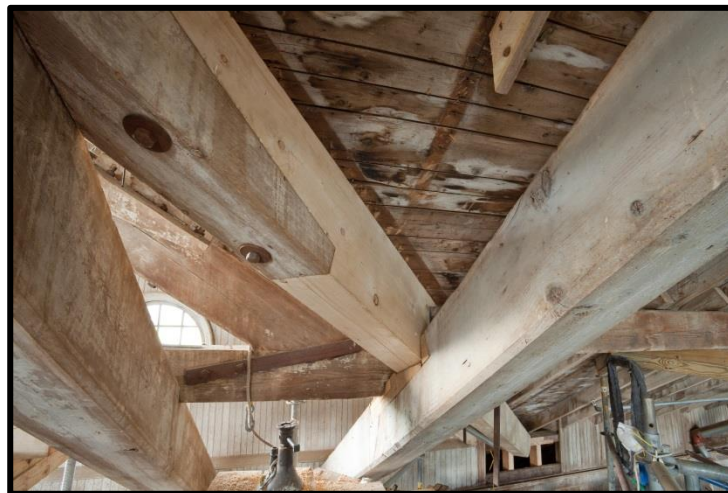
Figure 5.5. Example of a keyed scarf joint in an historic structural timber. Simple scarf joints can be used for architectural elements (courtesy of Douglas Porter, Conservation Associates).

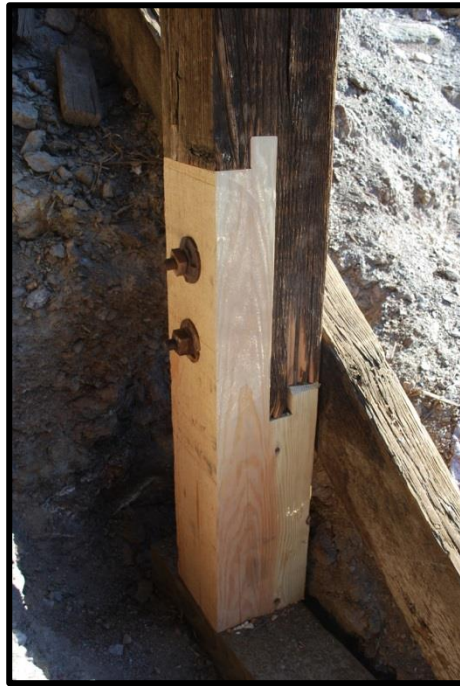
Figure 5.6. A Dutchman repair on an exterior column that had deteriorated in ground contact (courtesy of Douglas Porter, Conservation Associates).

For thicker or larger wood elements, repairs with in-kind replacement (new or reclaimed) material can be spliced to remaining sound wood using a variety of wood joints or a “Dutchman” repair. A Dutchman repair involves removing the deteriorated wood and using wood of the same species, cut, and moisture content to fill in the cut area (Figure 5.6). An epoxy resin or waterproof exterior glue can be used to ensure adhesion between the pieces; however, epoxies tend to inhibit moisture flow through the member and may cause the repair to fail at a much faster rate than if no adhesive is applied if a protective coating is not maintained. Therefore, if moisture issues are not addressed prior to repairs being implemented,
