CERTIFICATE OF APPROPRIATENESS APPLICATION FORM

1. HISTORIC NAME OF PROPERTY OR HISTORIC DISTRICT: (if known)
FORMER BILTRITE FURNITURE BLDG. / MITCHELL ST. HIST. DIST.

729-737 W. HISTORIC MITCHELL ST.

1. REPLACE MISSING PEDIMENT WITH NEW PIECE BUFF COLOR INDIVIDUAL LIMESTONE. PIN IN PLACE (STAINLESS STEEL), MORTAR AND APPLY SEALANT AT PERIMETER
2. PIN IN PLACE OTHER FRACTURED STONE PIECES AND ATTACH WITH MORTAR OR EPOXY. EPOXY SEAL THE PERIMETER BUT NOT AT BASE TO ALLOW MOISTURE TO ESCAPE.
3. THE BOTTOM FLANGE OF AN "I" BEAM SUPPORTING THE BRICK AND STONE AT THE HEAD LEVEL OF THE SECOND STORY MITCHELL STREET FACADE IS COMPLETELY RUSTED AWAY. REMOVE THE RUSTED STEEL AND INSTALL NEW STEEL ANGLES AS SHOWN ON THE PLAN. EVERY EFFORT WILL BE MADE TO MINIMIZE BRICK OR STONE REMOVAL. ANY REMOVED PIECES WILL BE RE-INSTALLED. ANY PIECES BEYOND REPAIR WILL BE REPLACED WITH NEW PIECES TO MATCH EXISTING TIE STONE & BRICK TO STRUCTURE.
4. STRAIGHTEN CENTER PICKSTONES AS MUCH AS POSSIBLE.
5. TUCK POINT ALL OPEN MORTAR JOINTS.

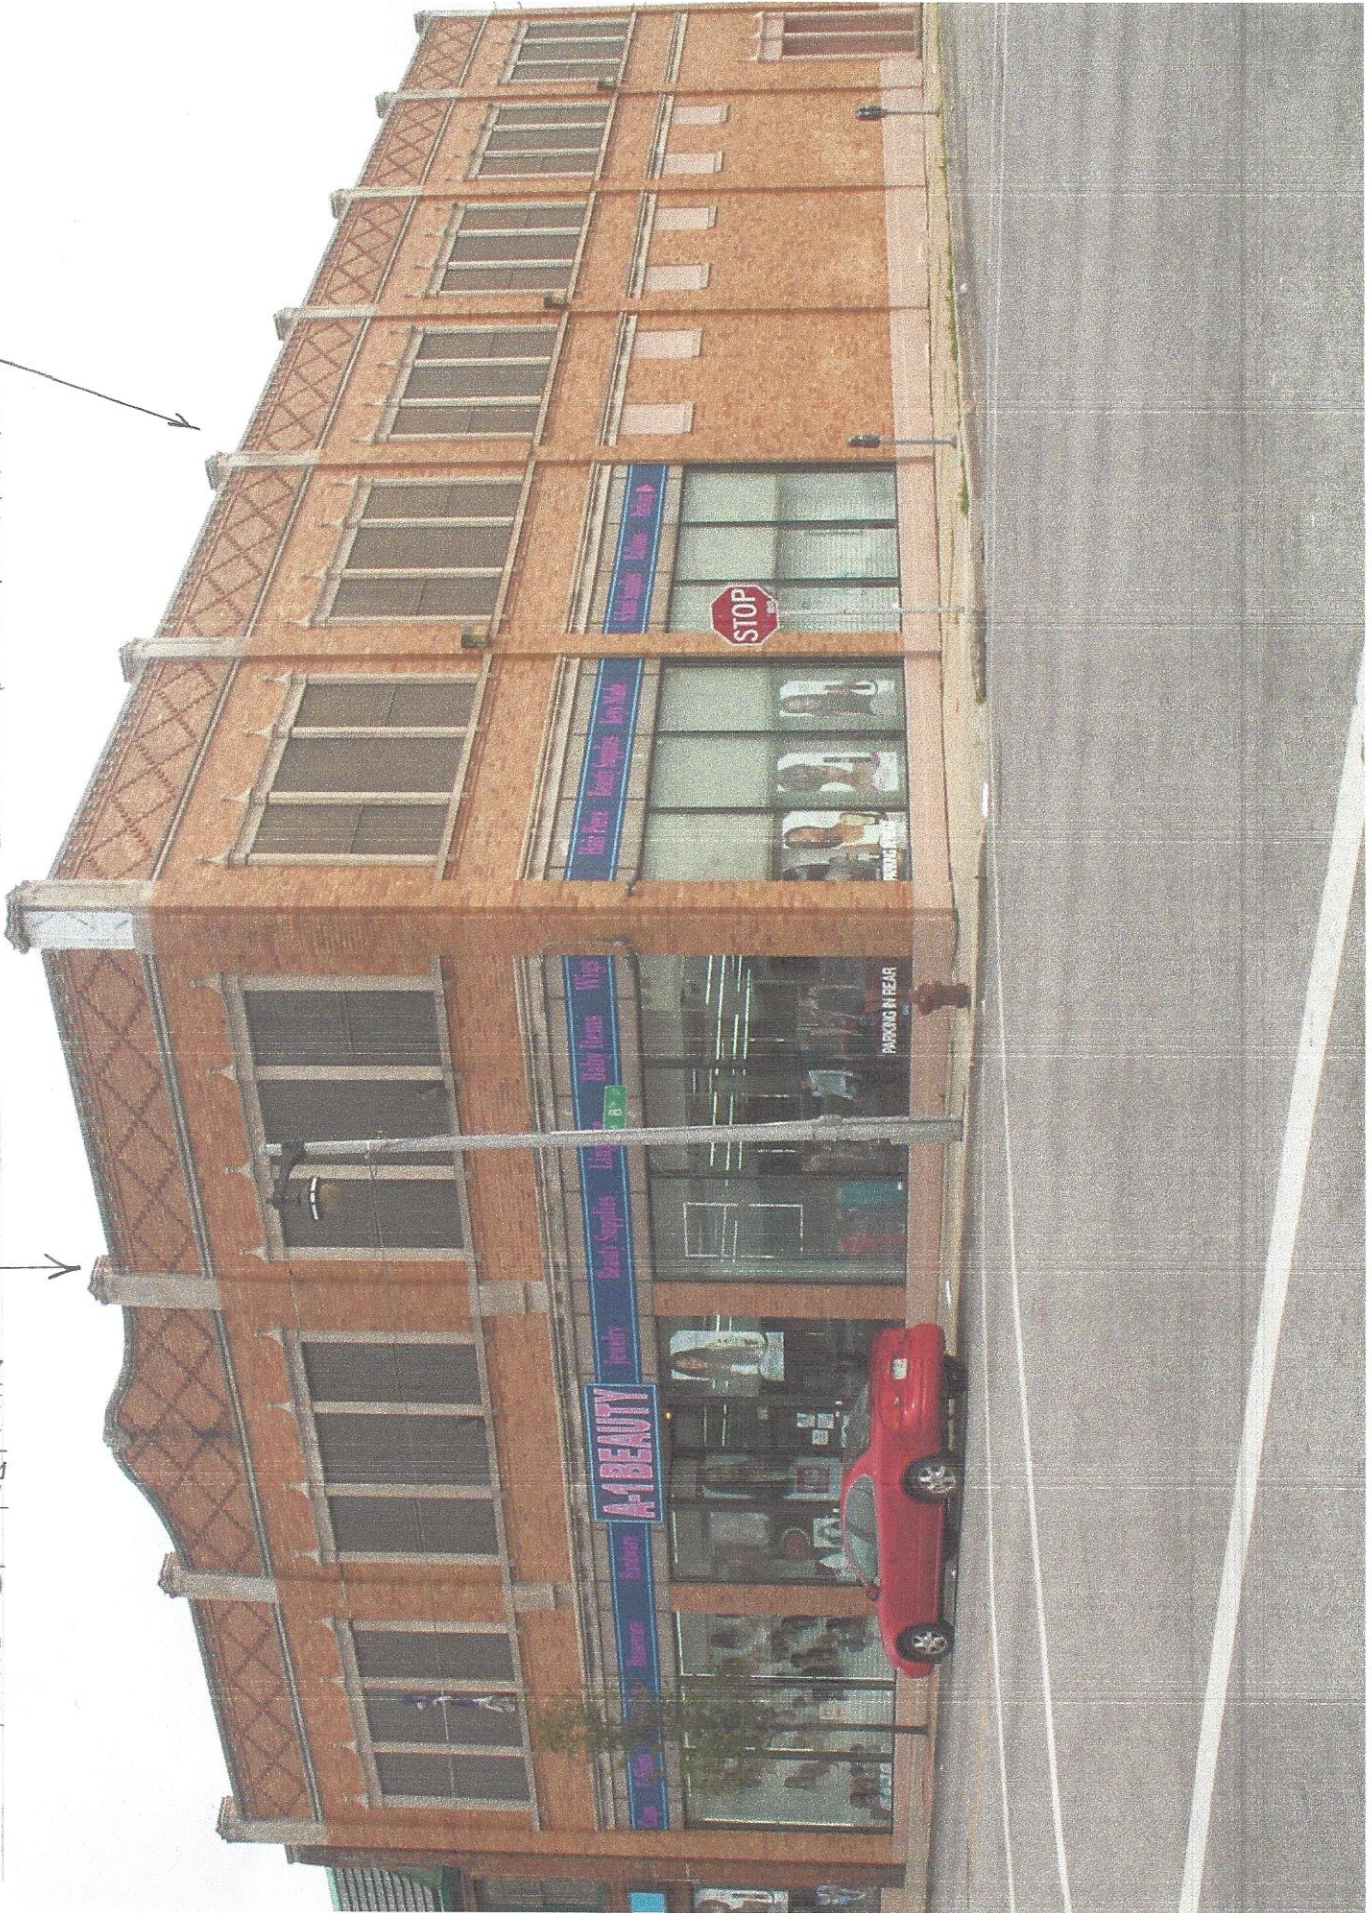
VIEW LOOKING SOUTHEAST
WEST (RIGHT) FACADE IS IN
GOOD CONDITION

NORTH (LEFT) FACADE IS IN
NEED OF REPAIR

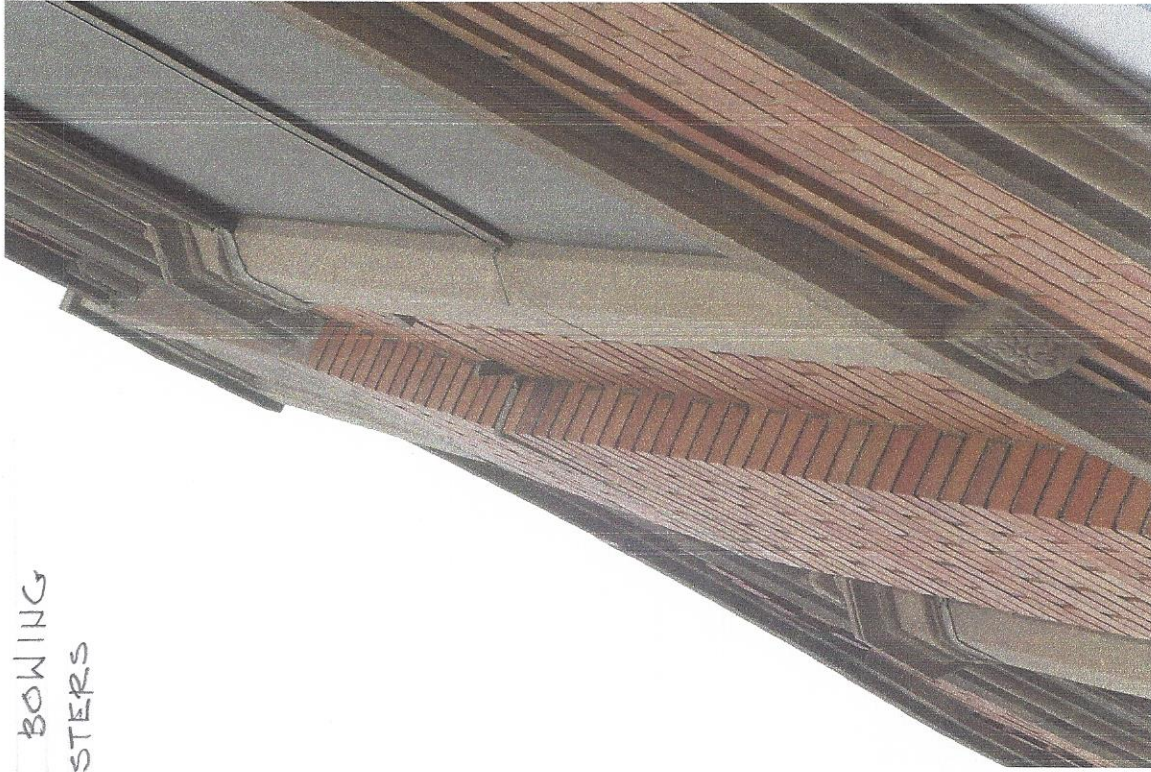
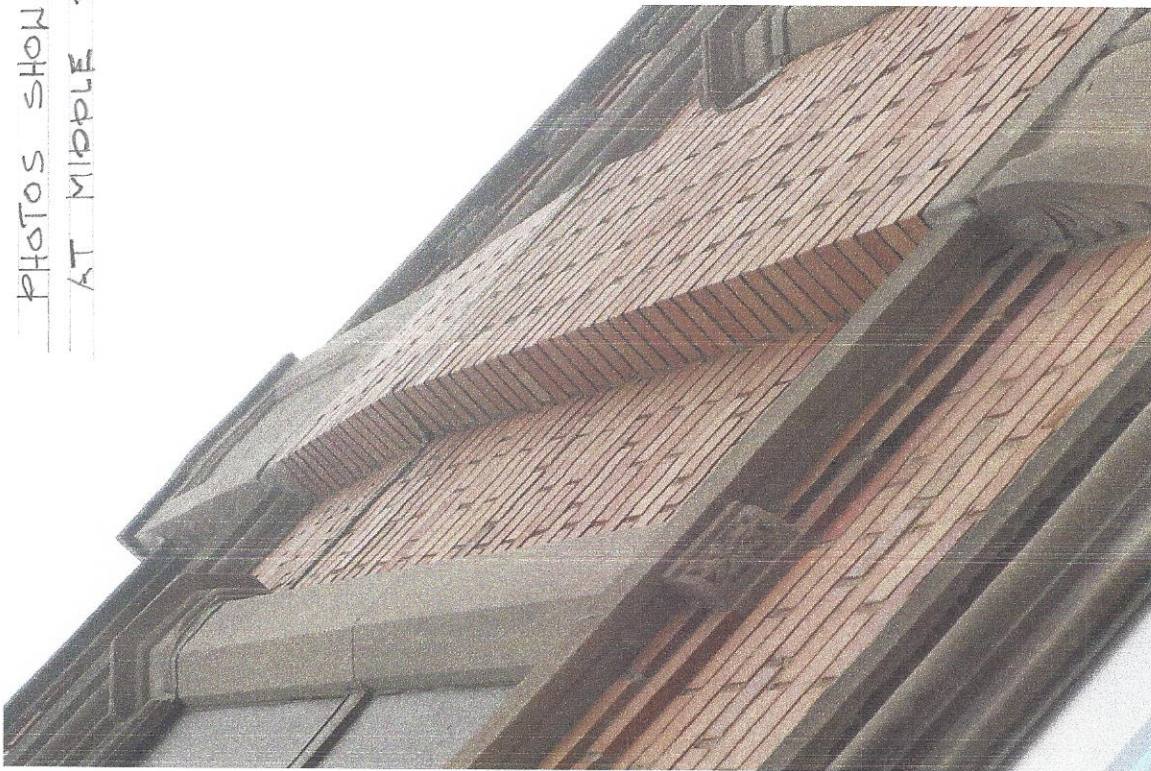
PHOTOS SHOWING BOWING
AT MIDDLE PILASTERS

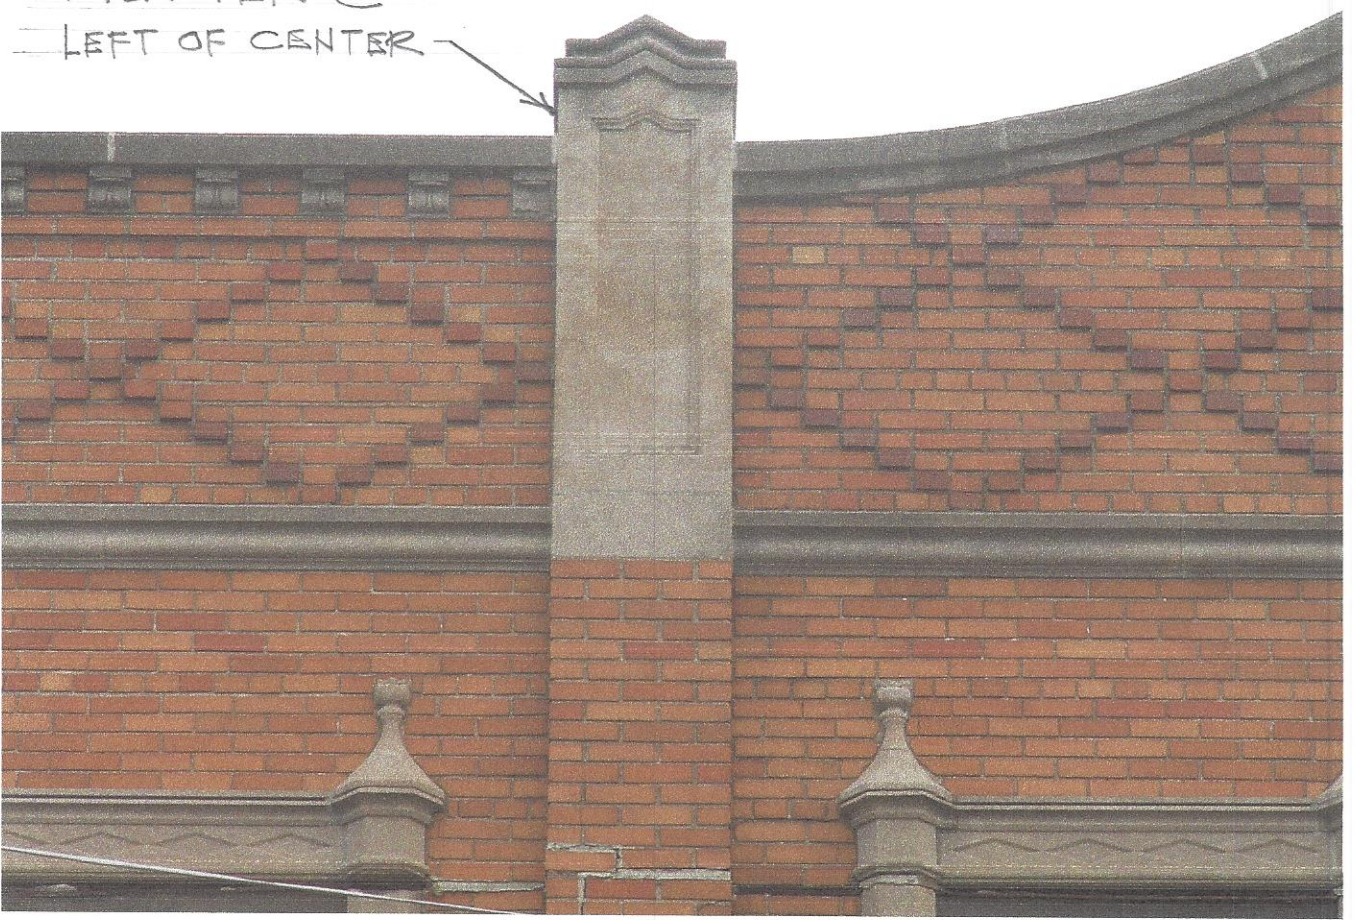
PILASTER @

LEFT OF CENTER
