# CAPITAL IMPROVEMENTS PLAN

## Department of Public Works

Capital Improvements Committee  
March 3, 2010

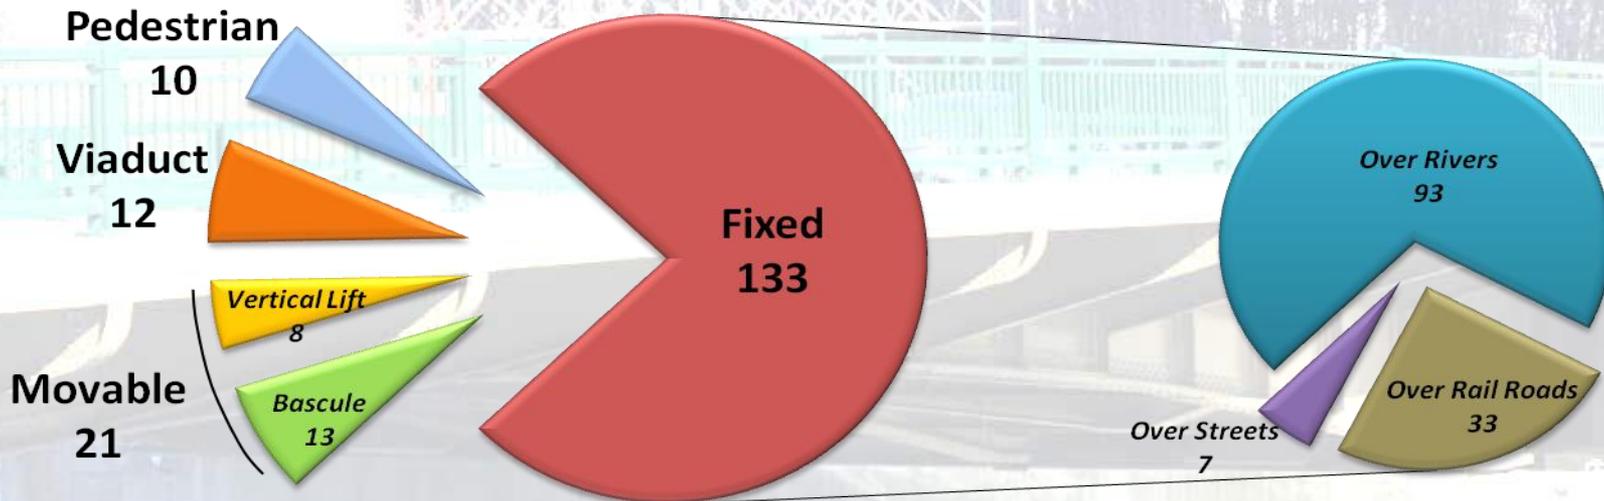
- 176 City-owned and maintained bridges
- Relative comparison of bridge types:

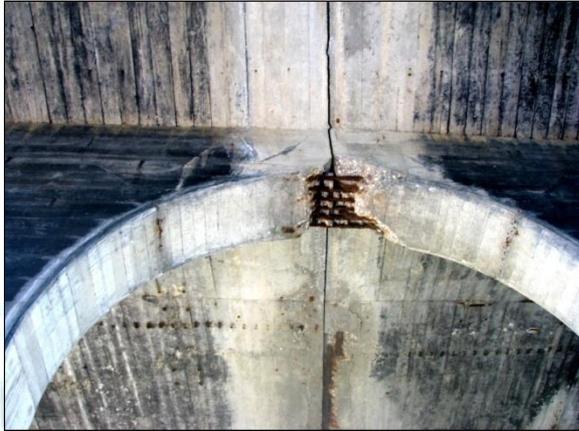
# Sufficiency Rating (SR)

Shanghai Road

Over the Main Bridge

Deficient

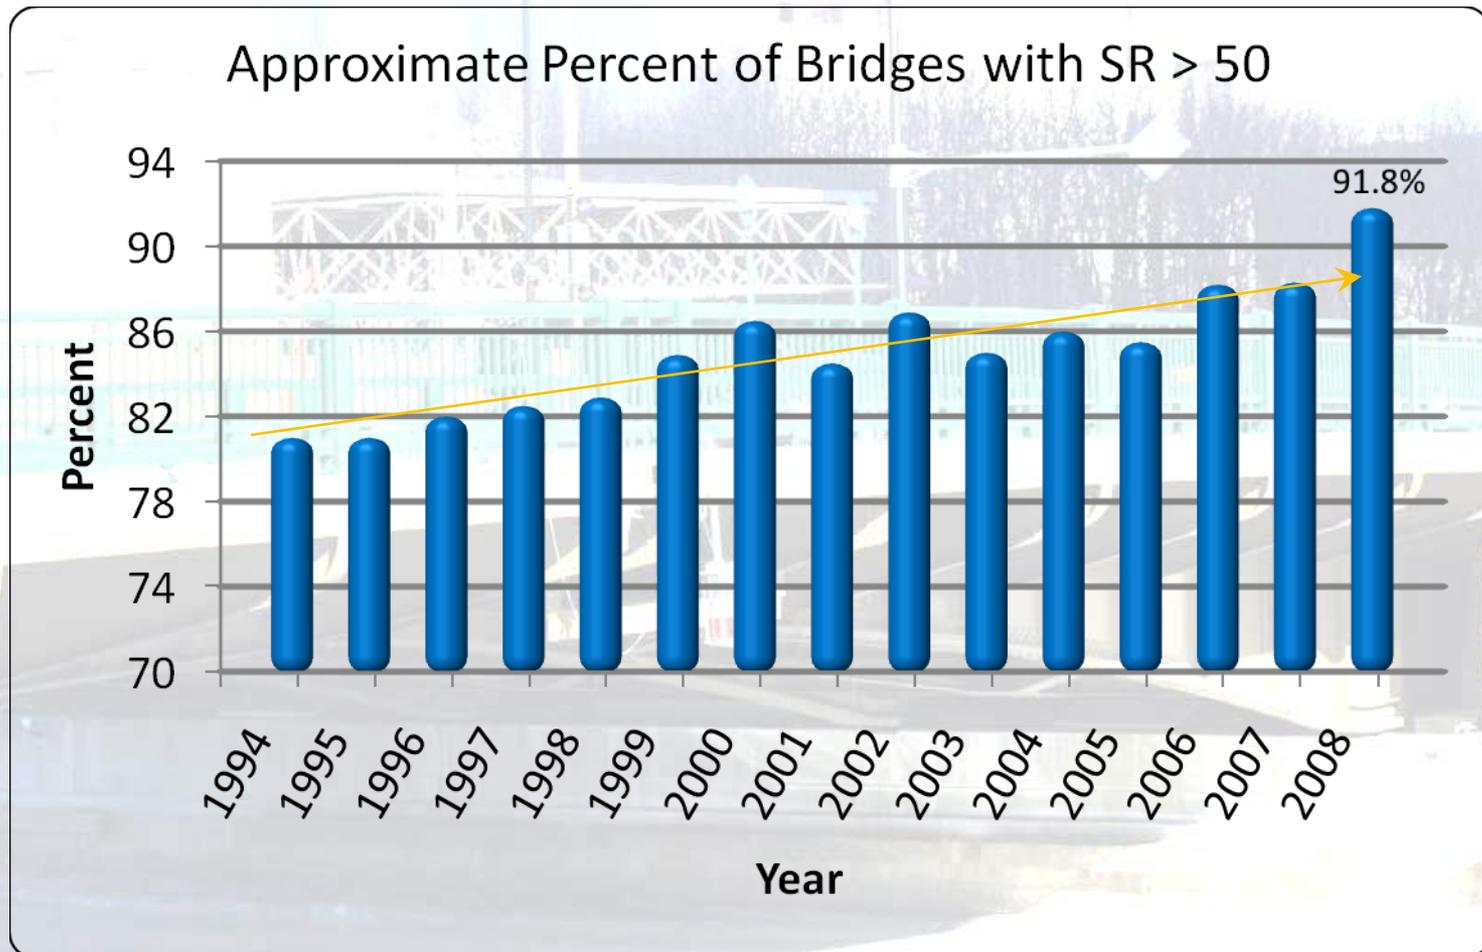
- SR of bridge inventory trending upwards

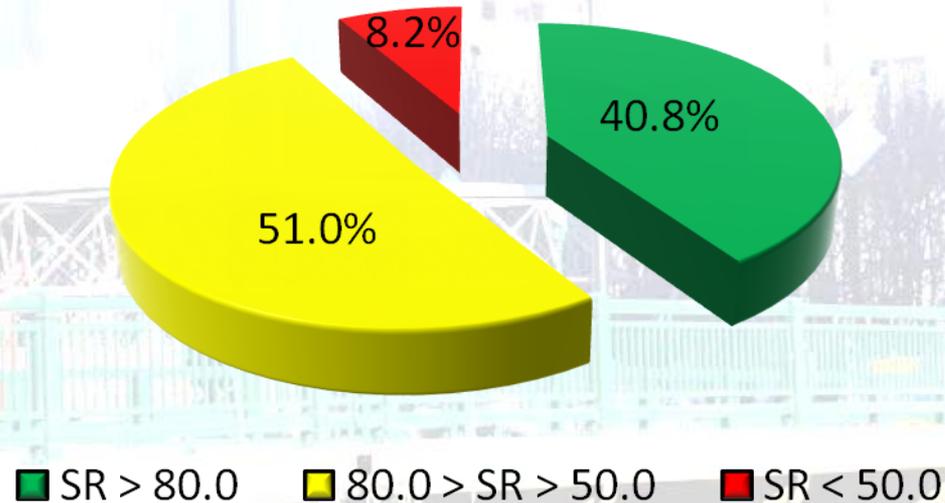
- Relative comparison of SR for city rated bridges, 2008

- SR < 80.0 : Bridge eligible for rehabilitation
- SR < 50.0 : Bridge eligible for rehabilitation or replacement

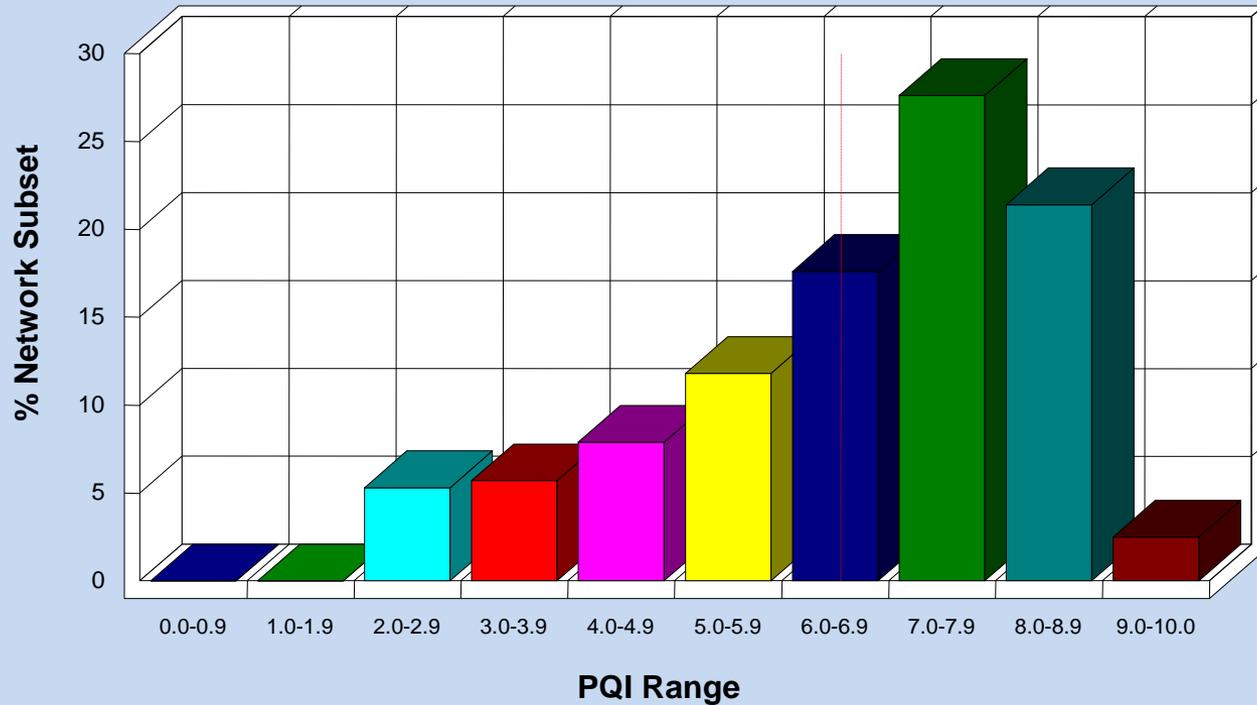
Data defined for analysis a : PQI by Lane-Miles

PQI Range:	0.0-0.9	1.0-1.9	2.0-2.9	3.0-3.9	4.0-4.9	5.0-5.9	6.0-6.9	7.0-7.9	8.0-8.9	9.0- 10	
Sections:	0	0	119	148	206	314	453	715	559	66	2580
%:	0.0	0.0	5.3	5.7	7.9	11.8	17.6	27.6	21.4	2.5	
Ln-mi x 10 :	0.0	0.0	2.6	2.8	3.8	5.7	8.5	13.2	10.3	1.2	48.0

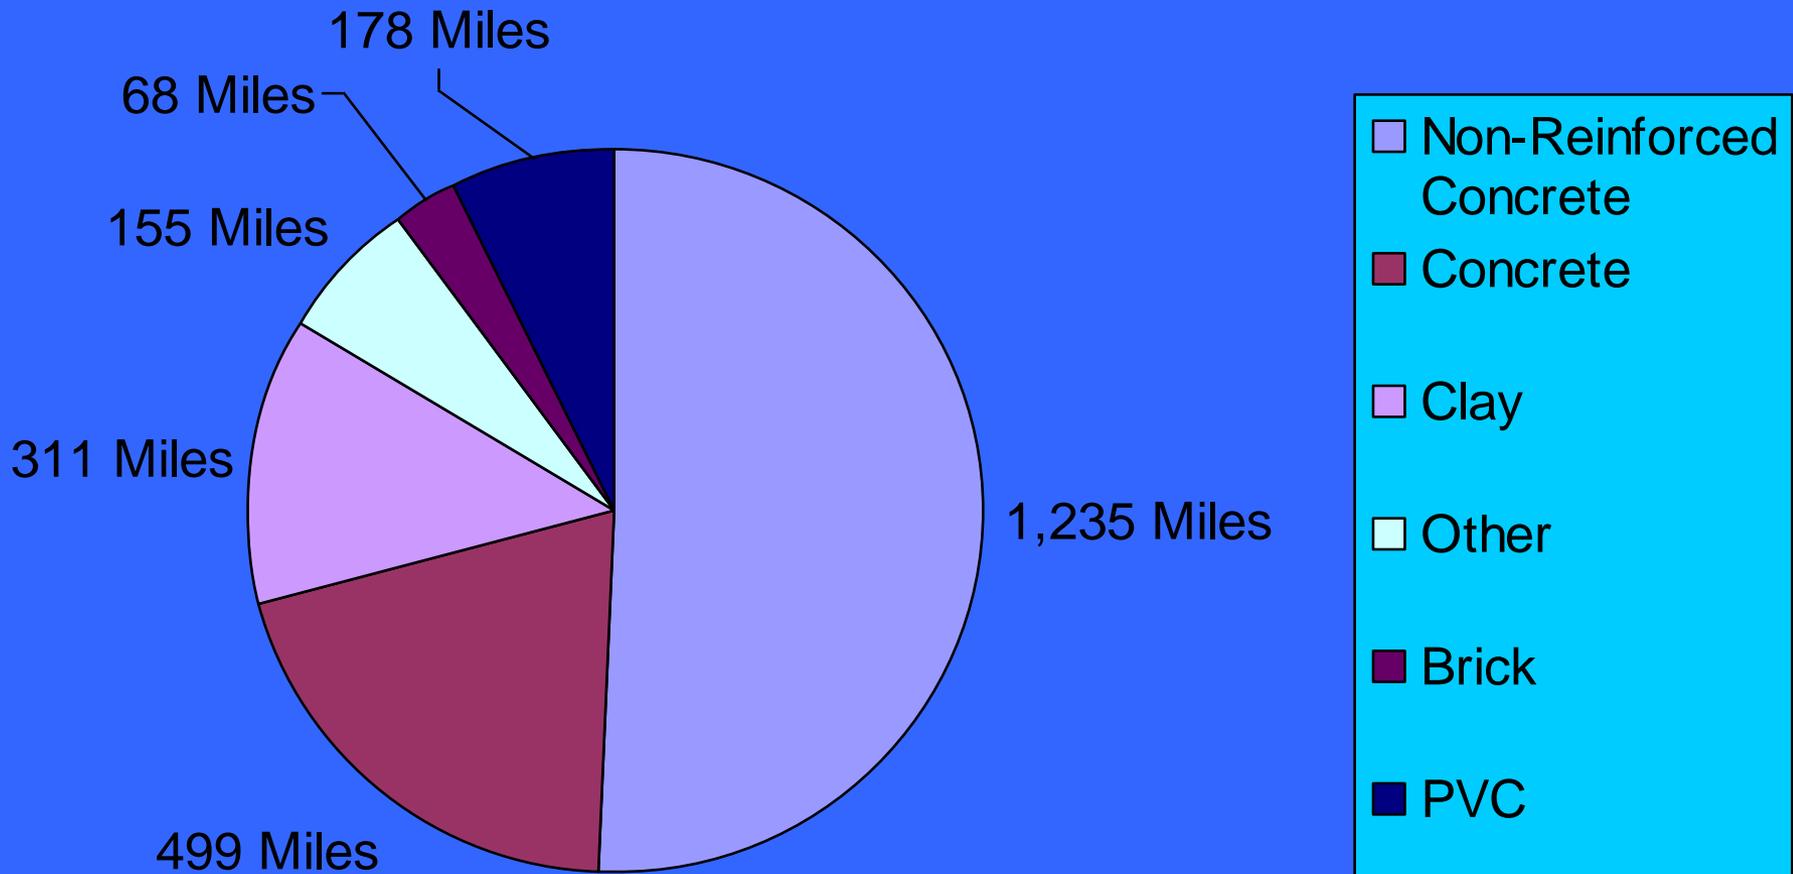
# Total lengths of sewer by material type

\* Non-Reinforced Concrete Pipe has shown to decay at a much faster rate than other materials

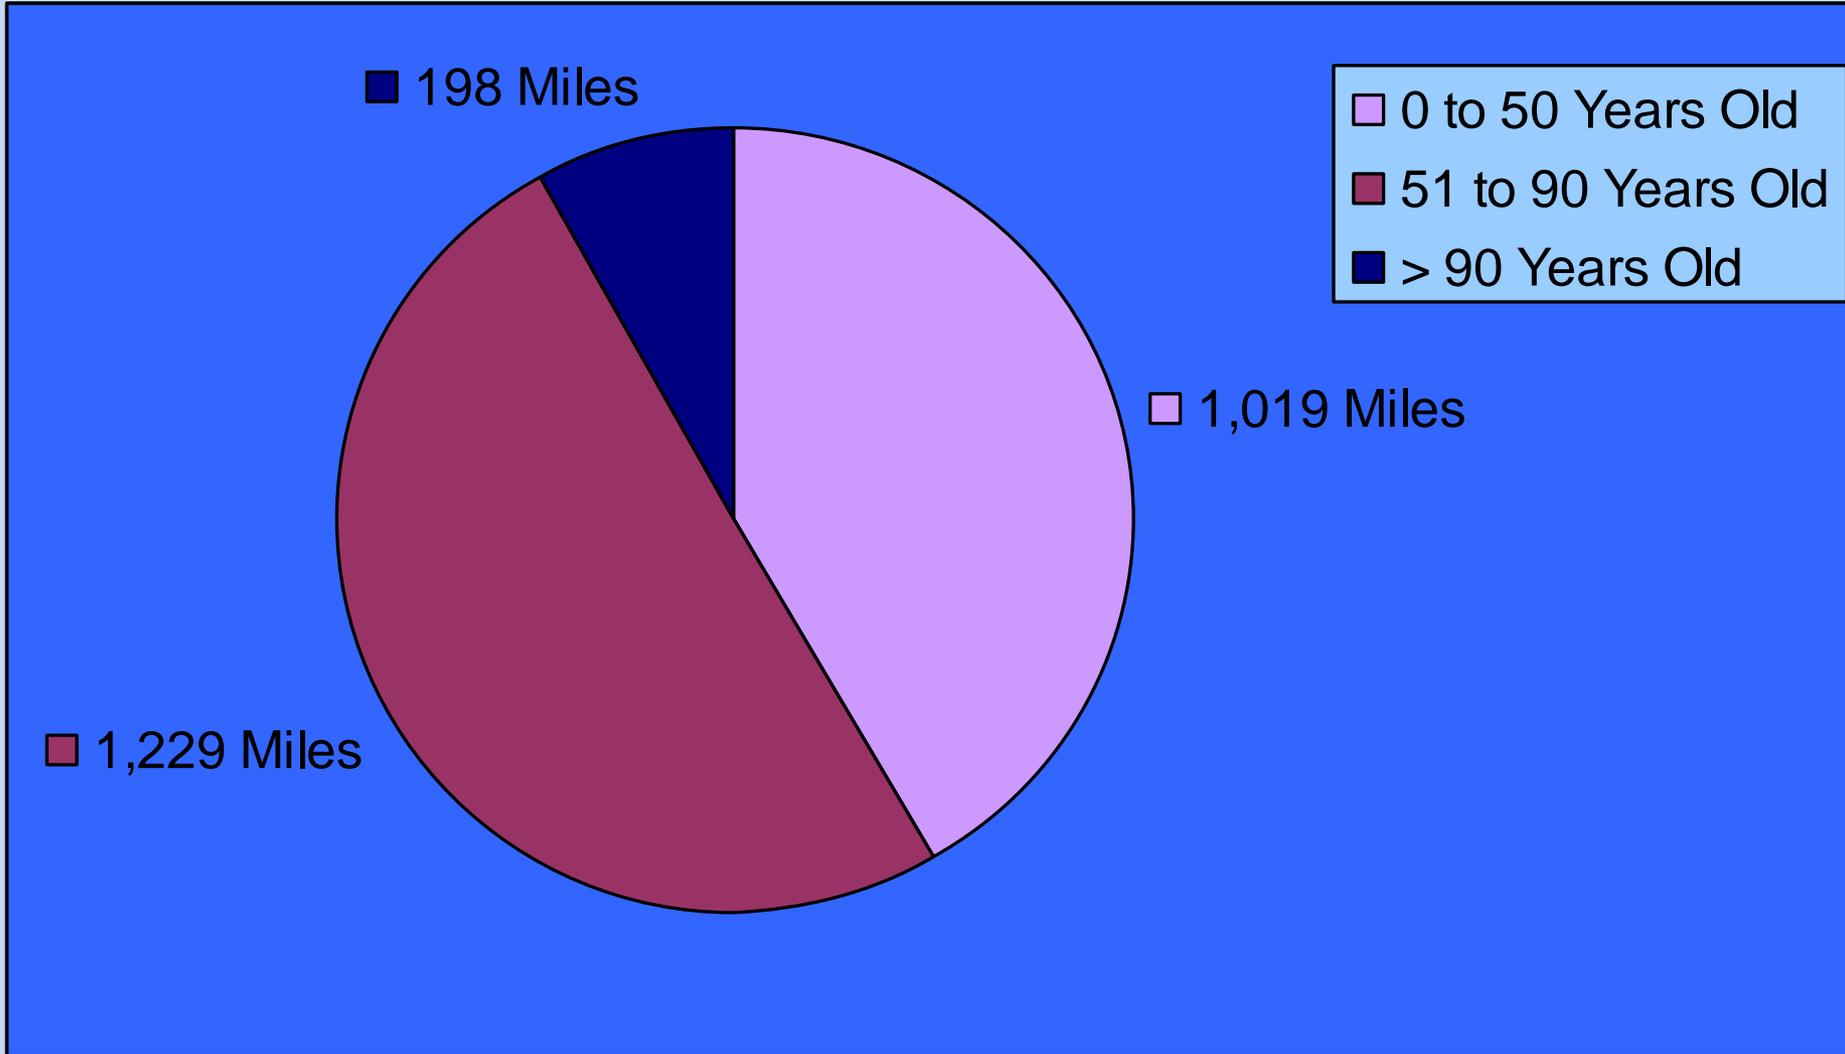
# City of Milwaukee sewers by age

- Currently there are 198 miles of City of Milwaukee sewers that are greater than 90-years old
- With 2,446 miles of sewer in the City and an annual replacement rate of 13.7 miles our current sewer replacement rate is once every 179 years
- With 2,446 miles of sewer in the City and a useful sewer life cycle of 90 years the replacement rate needed to meet the 90 year useful life cycle is 27 miles annually

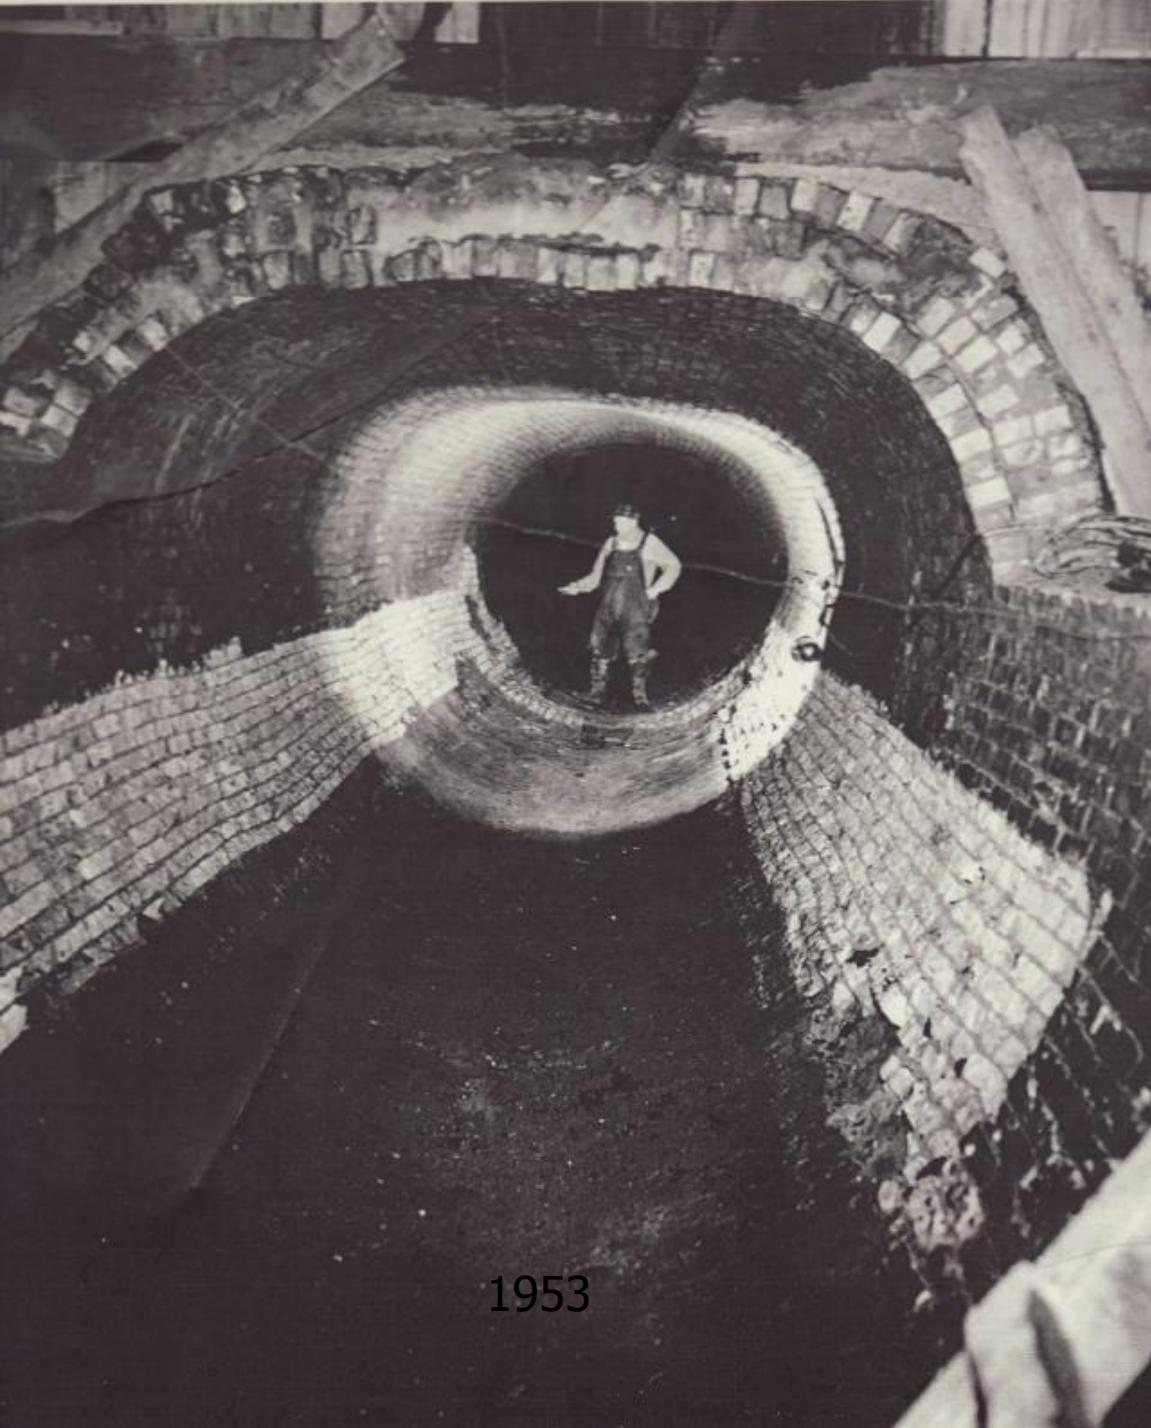
City of Milwaukee West  
Becher Street 89" and 86"  
Sewer. Asbestos Bonded  
Coated and Paved Pipe in  
a failing brick sewer. The  
pipe has flattening of its  
crown and cracks.

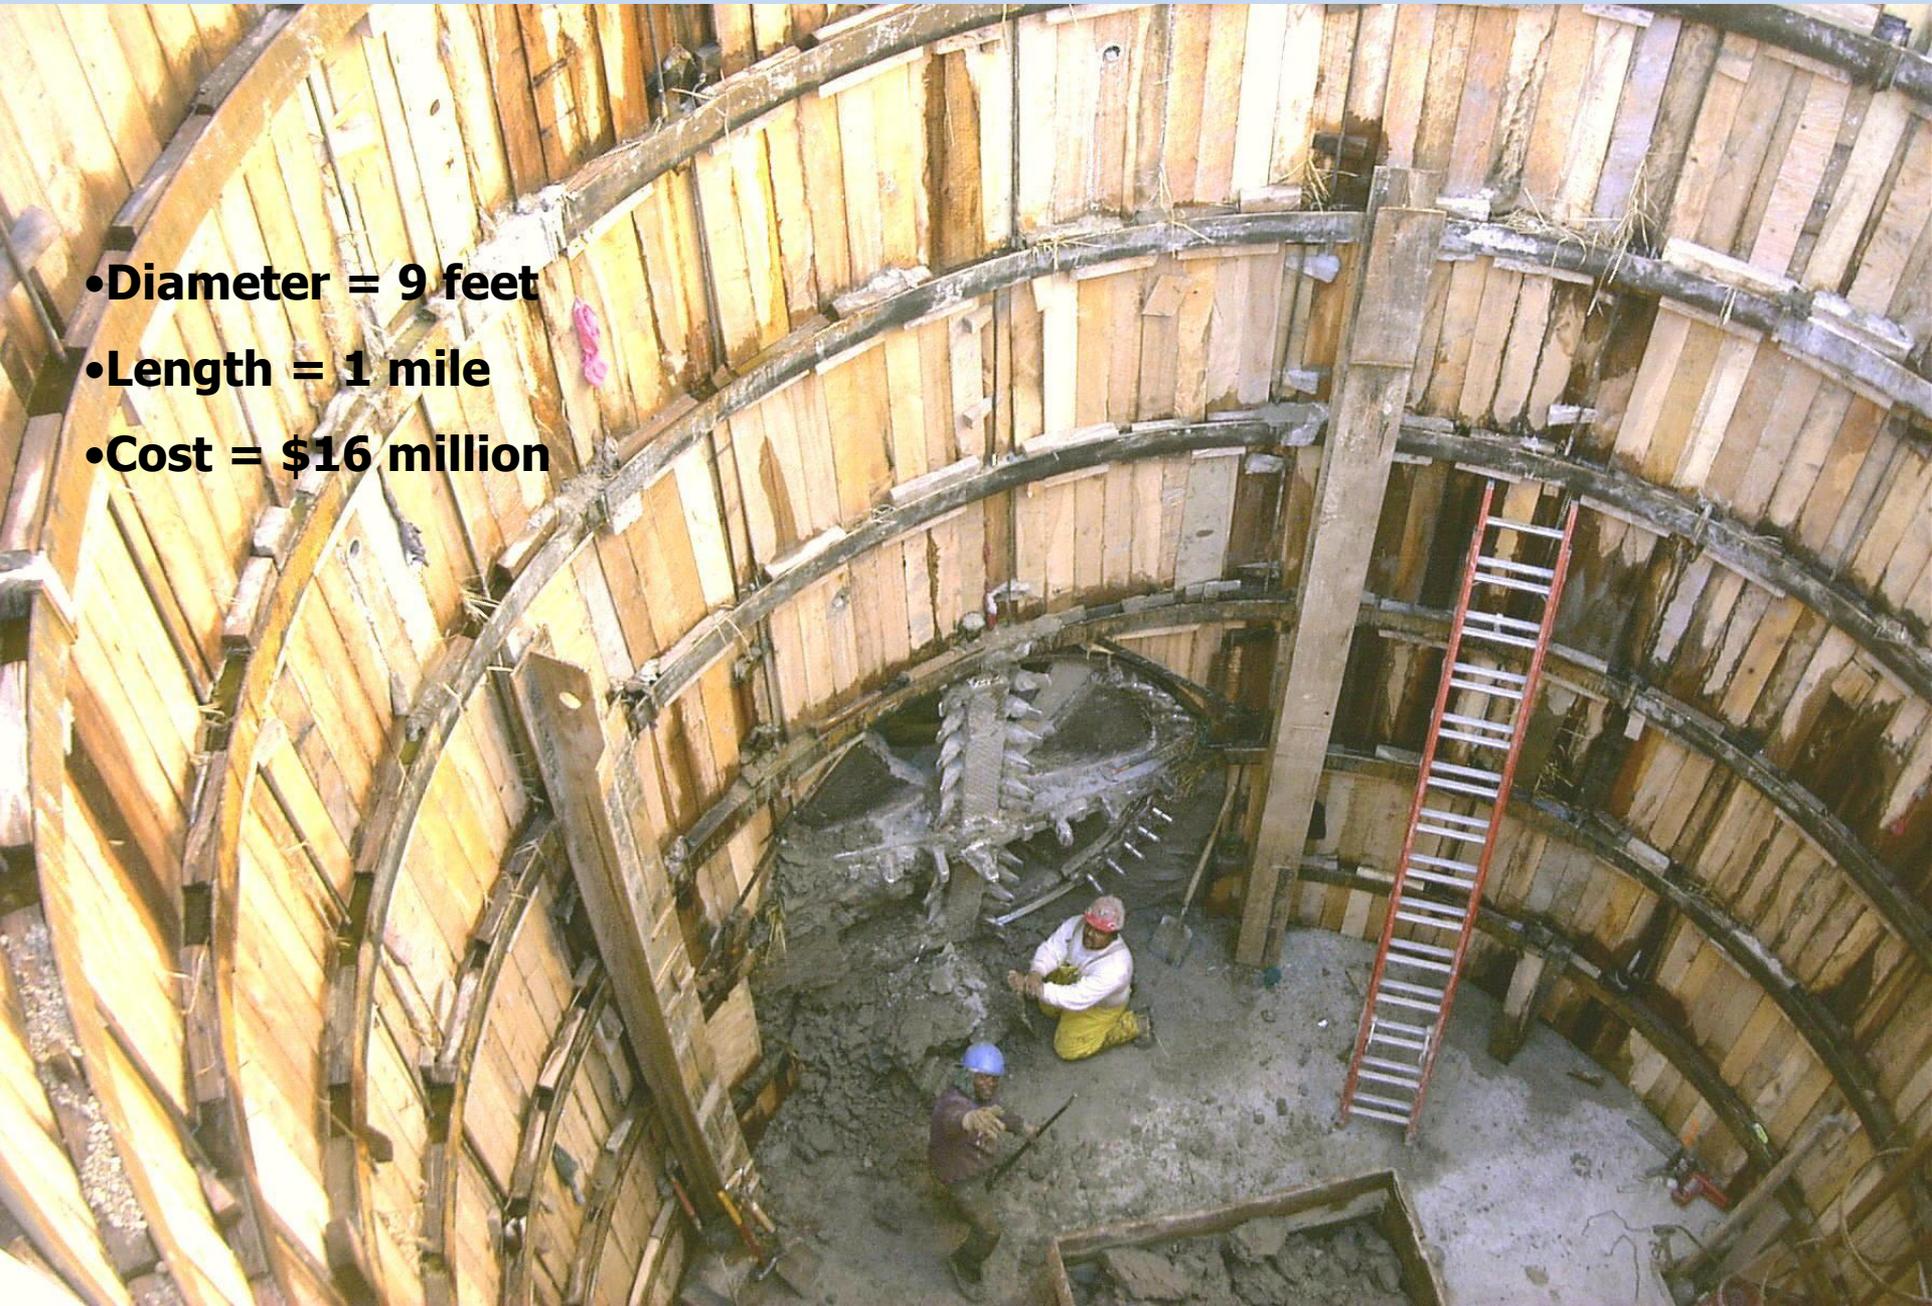
# Becher Street Sewer Tunneling

- **Diameter = 9 feet**
- **Length = 1 mile**
- **Cost = \$16 million**

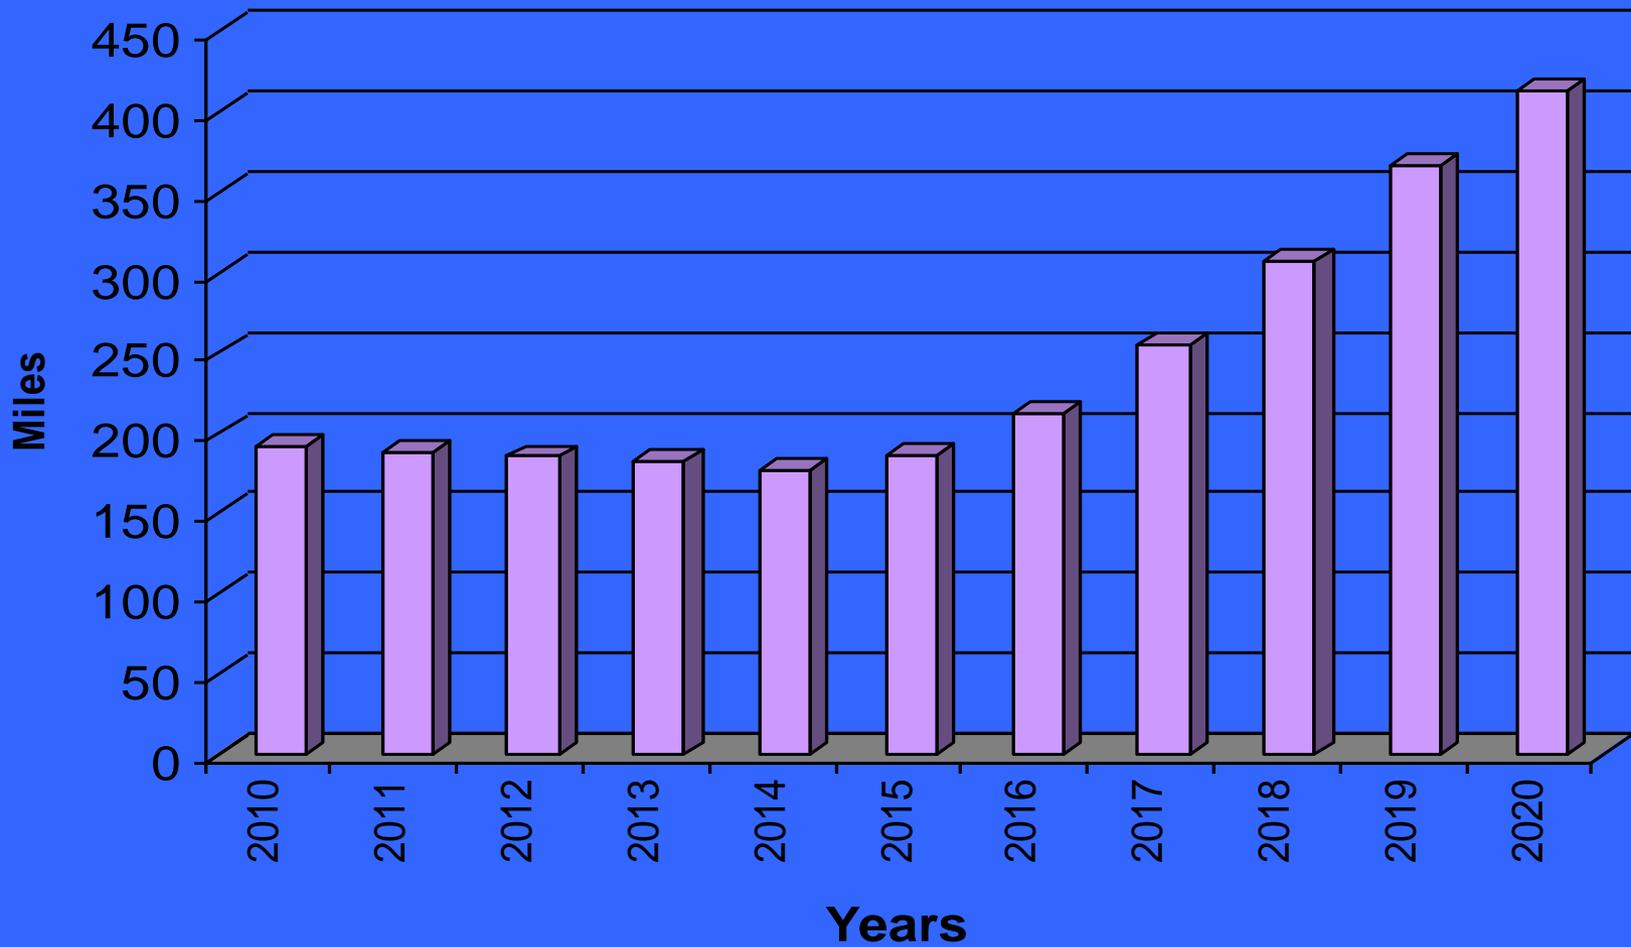
# Future Sewer Lengths needed to be rehabilitated that are greater than 90- Years Old 2010-2020 (assuming an average replacement rate of 13.7 miles per year)

- The average cost of replacement per foot of sewer is estimated to be \$225
- At \$225 per foot, the annual cost to replace 27 miles of City of Milwaukee sewers to meet the 90-year expected life is \$32 Million (2010 dollars)

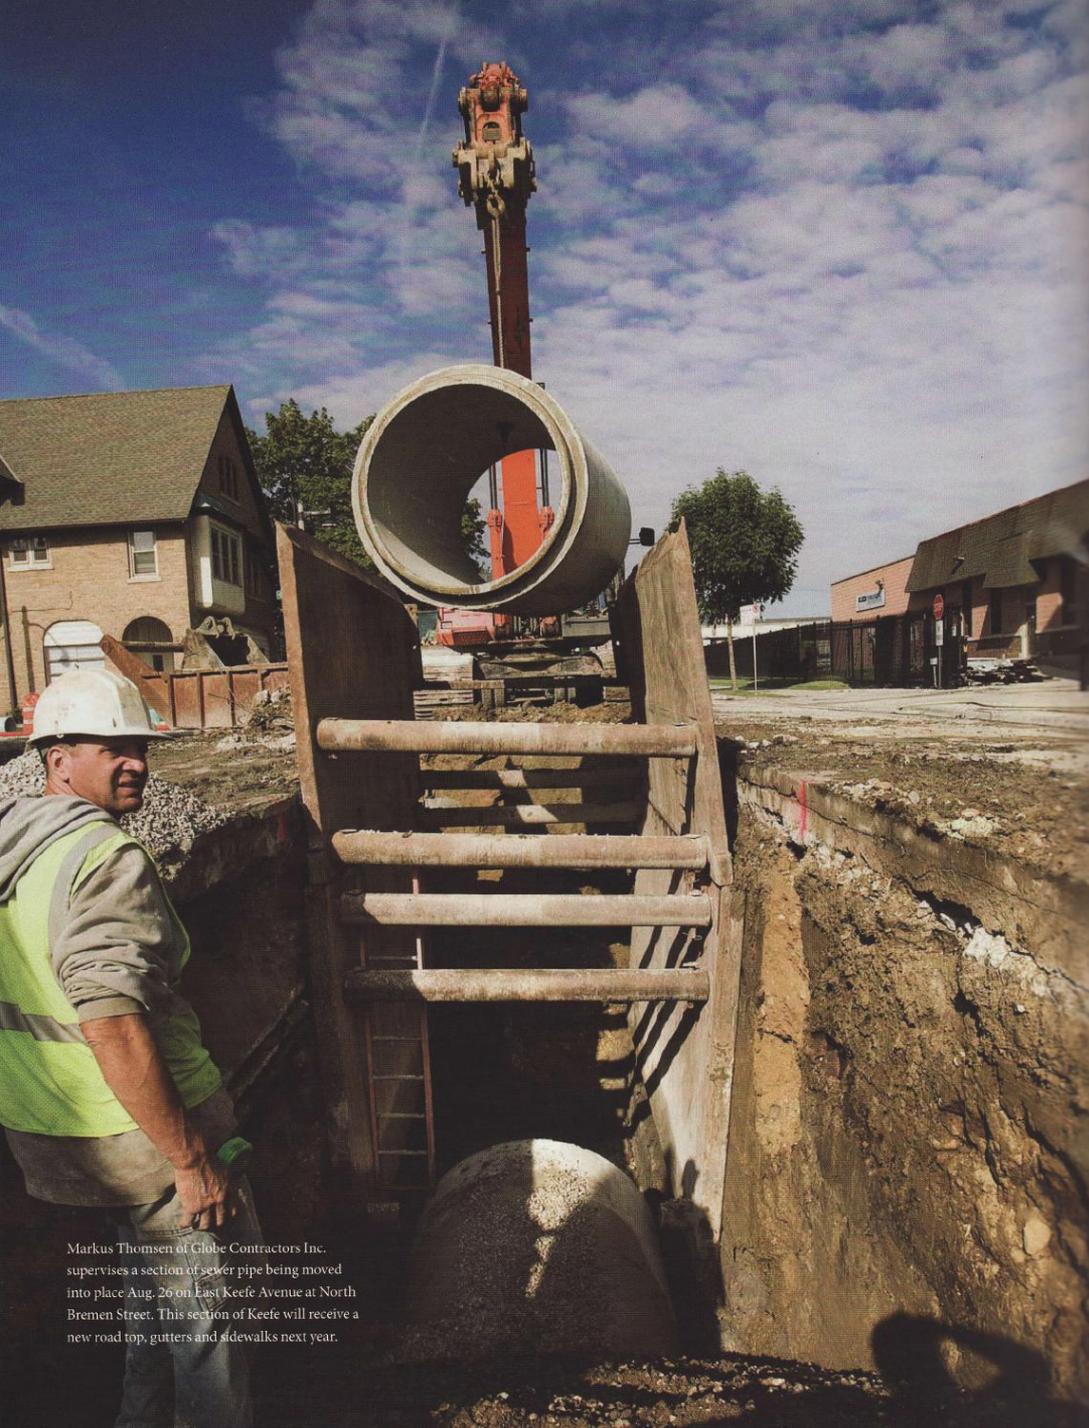
Markus Thomsen of Globe Contractors Inc. supervises a section of sewer pipe being moved into place Aug. 26 on East Keefe Avenue at North Bremen Street. This section of Keefe will receive a new road top, gutters and sidewalks next year.

- 2009 Keefe Avenue Relay Project
- Diameter = 5 feet
- Length = 1.2 miles
- Cost = \$5.5 million

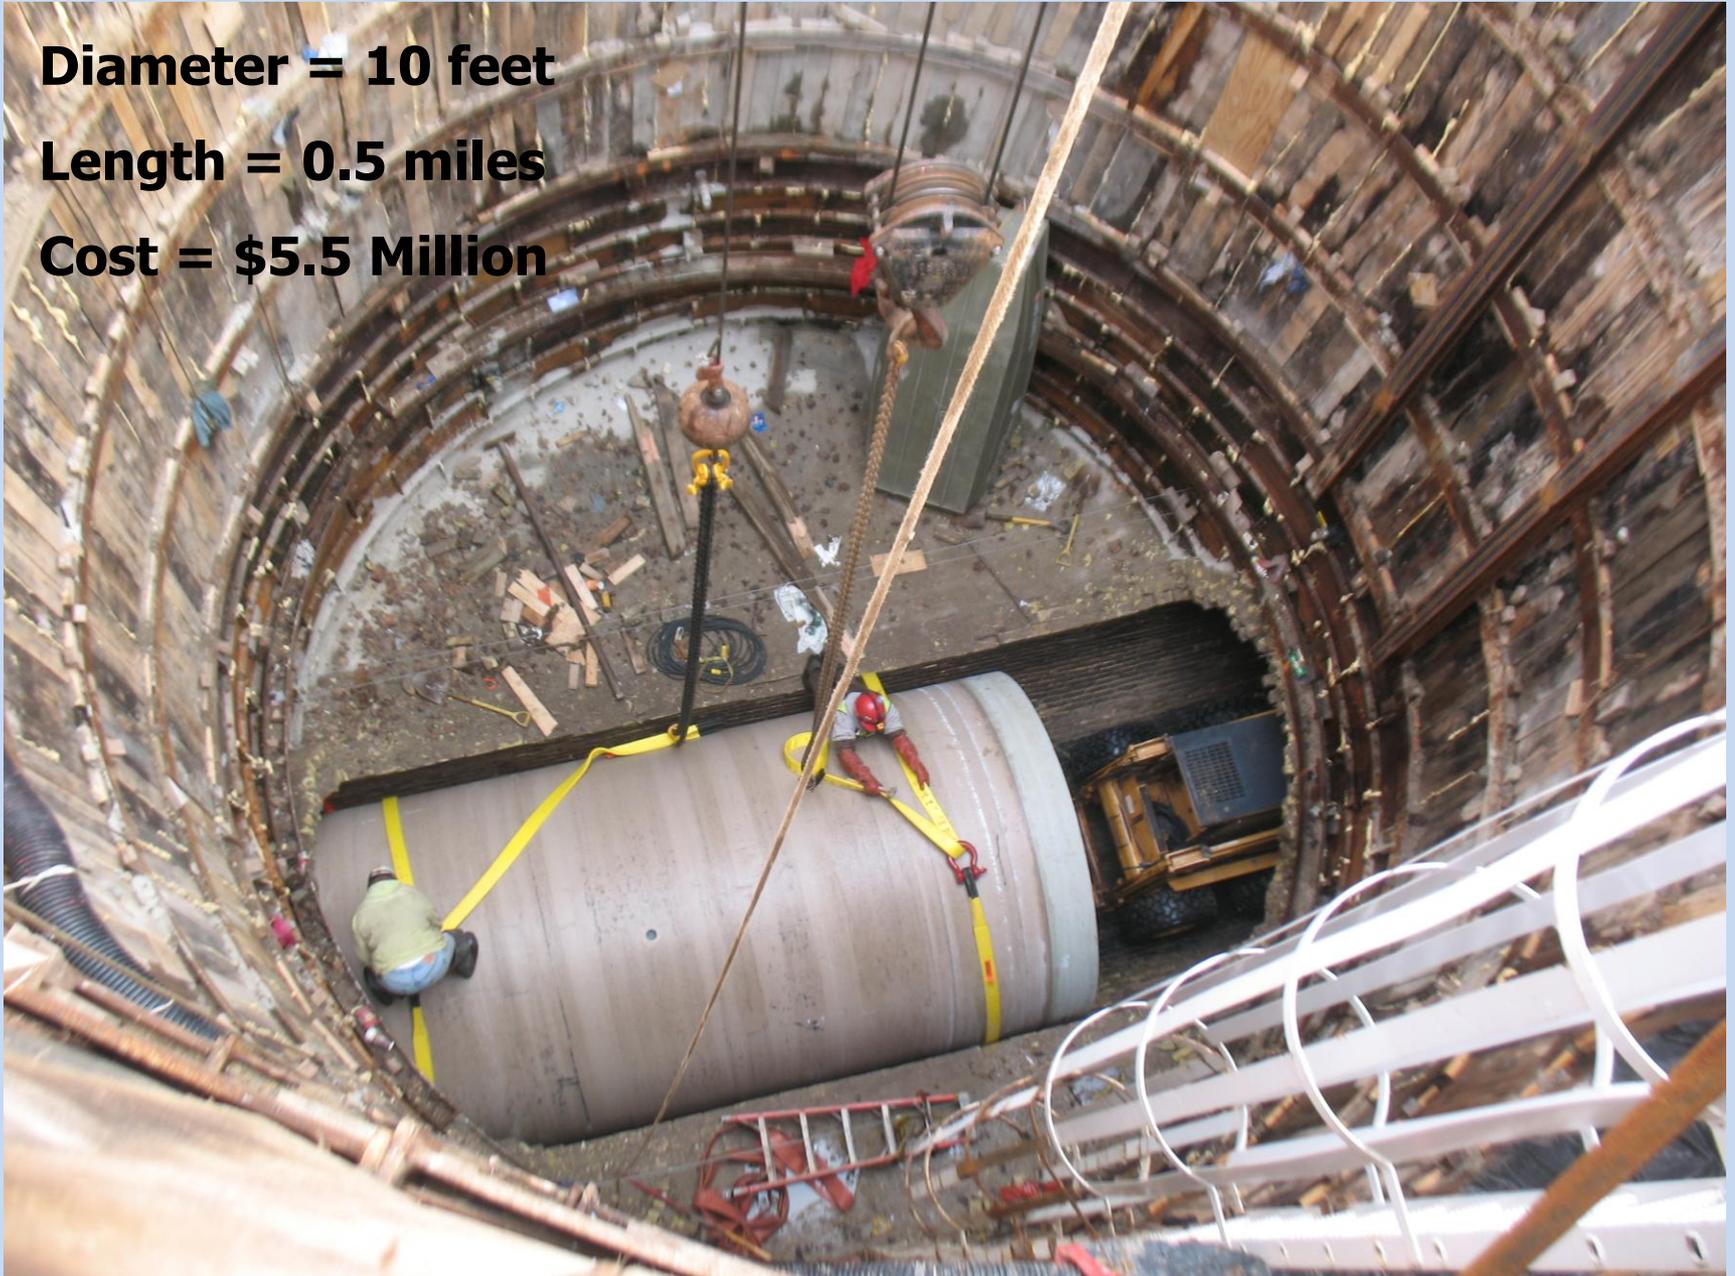
# McKinley Ave Sewer Construction

**Diameter = 10 feet**

**Length = 0.5 miles**

**Cost = \$5.5 Million**

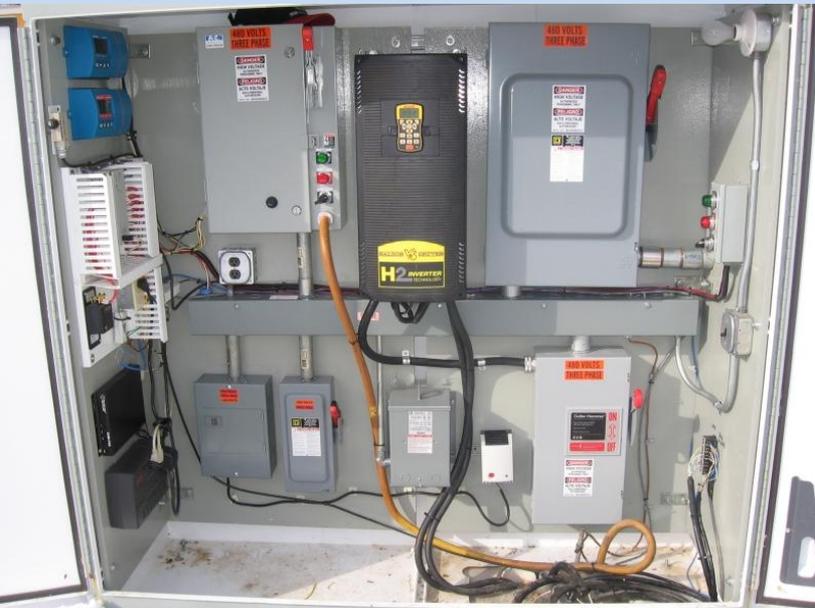
Sanitary Bypass Pump Controls

- 83 Bypass Pumps
- 6 Lift Stations

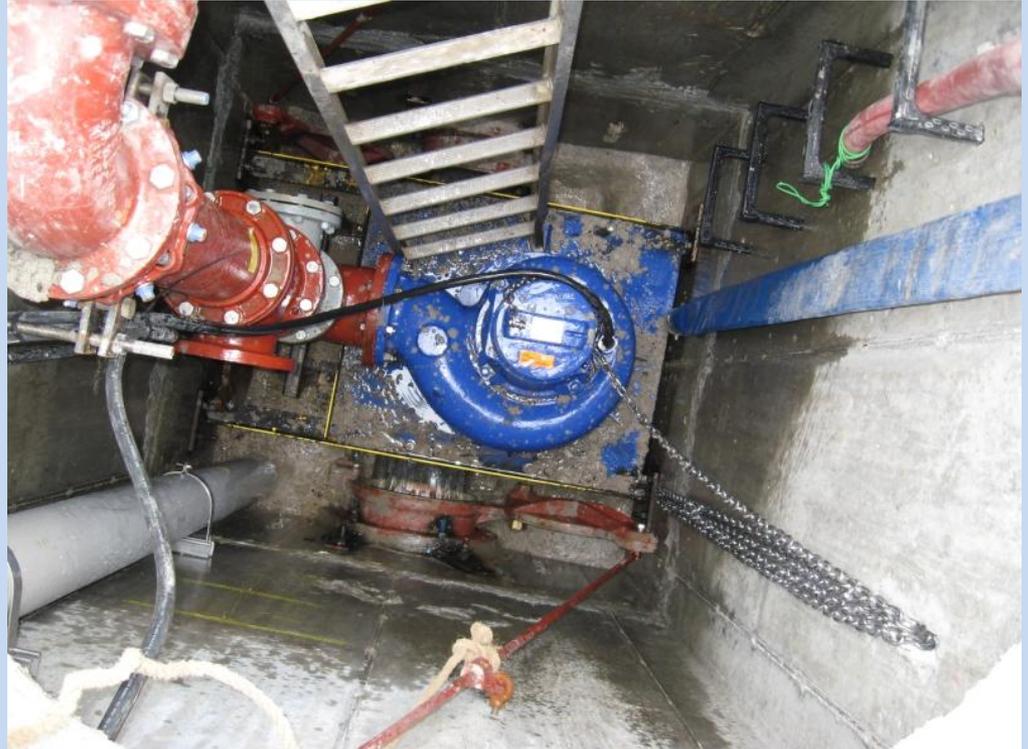
Sanitary Bypass Pump

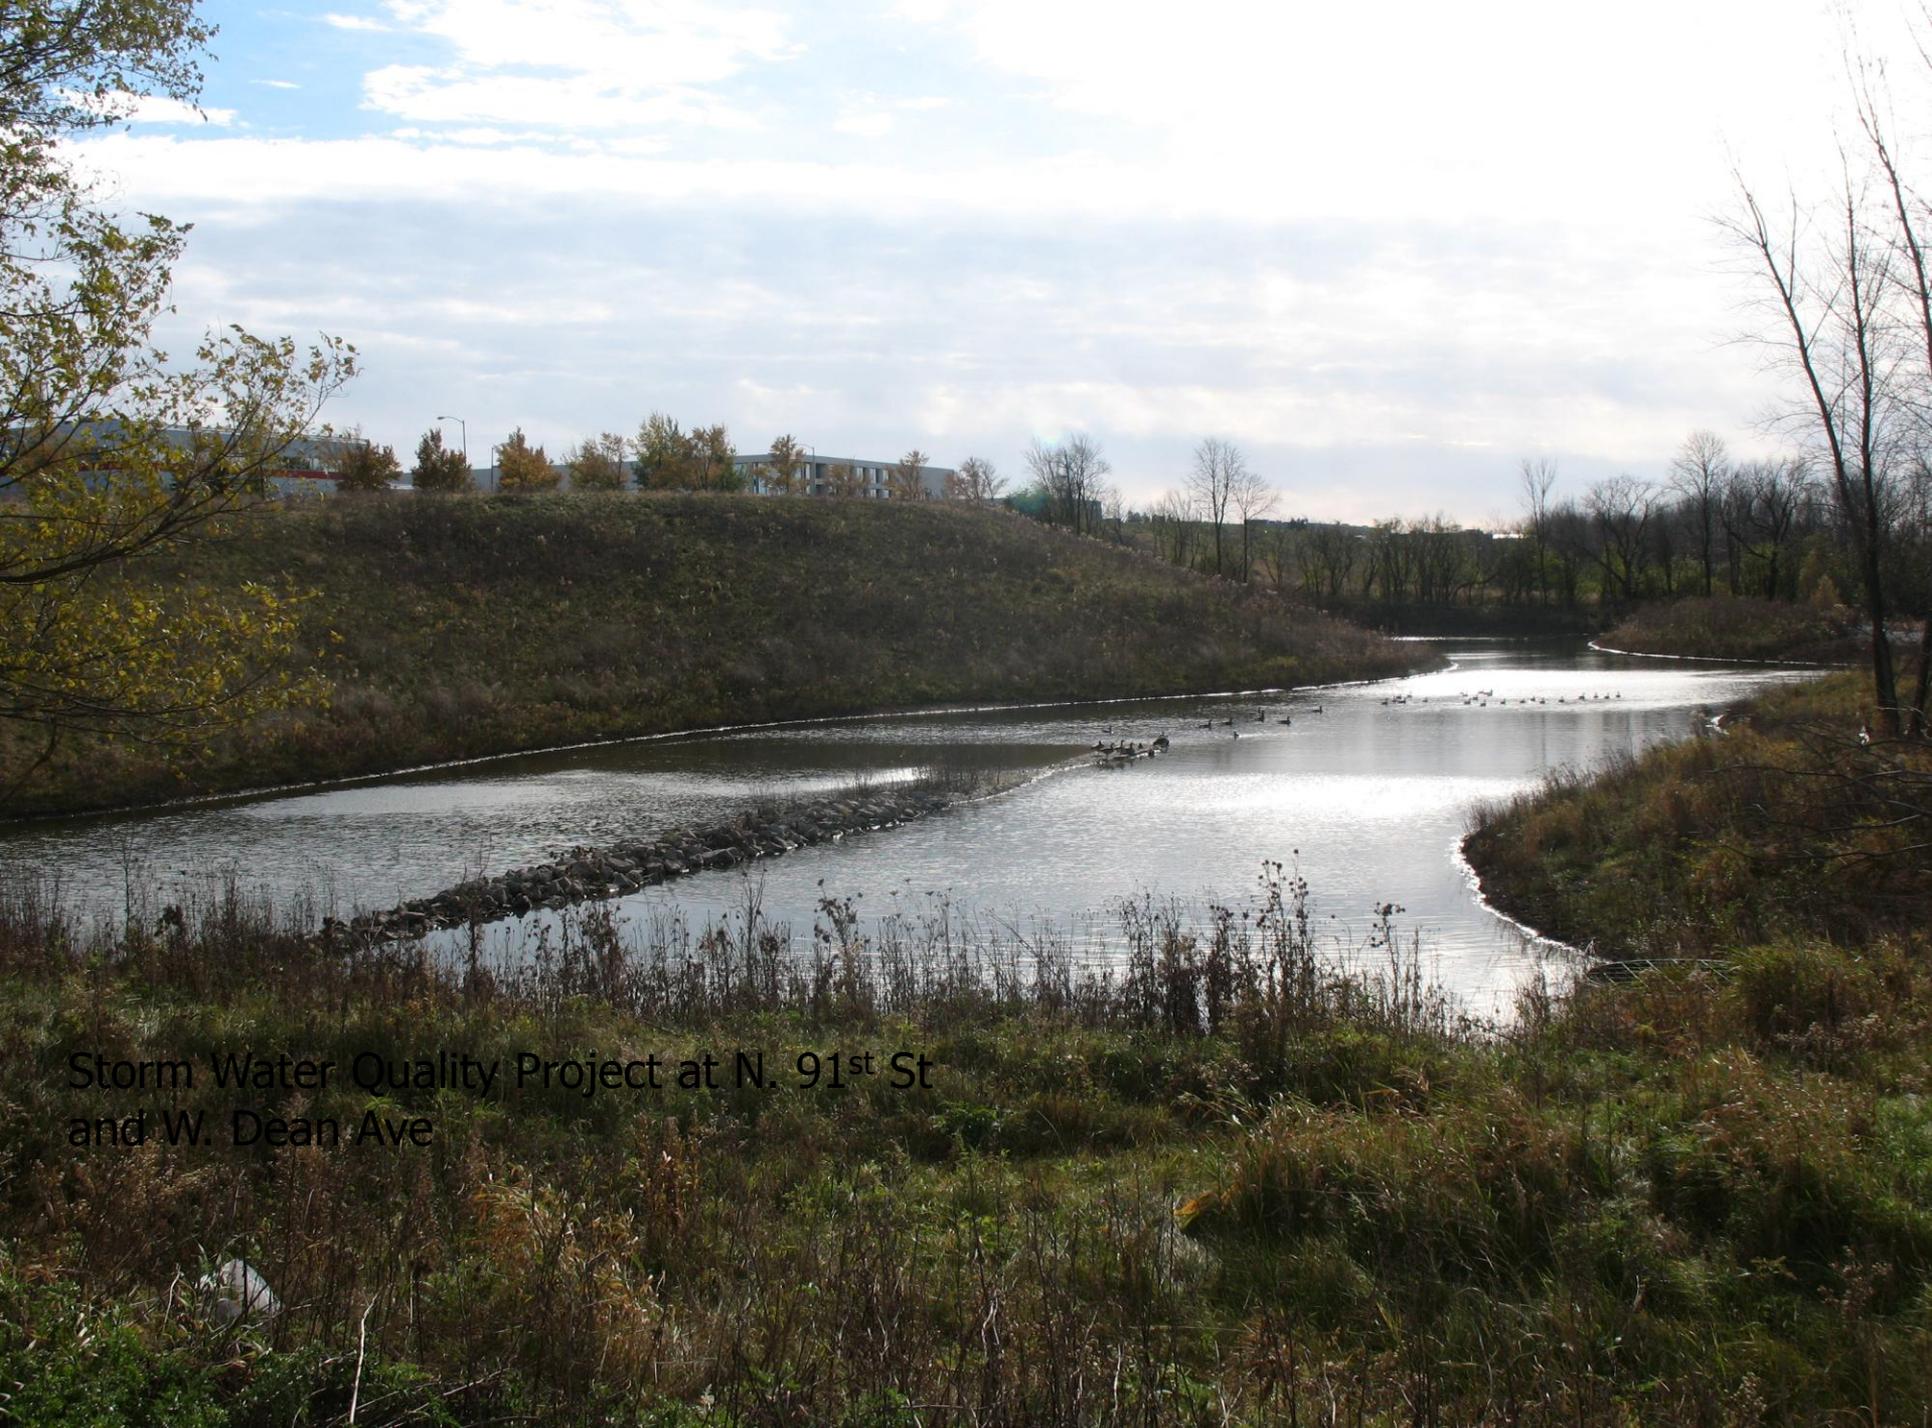
Storm Water Quality Project at N. 91<sup>st</sup> St  
and W. Dean Ave

- Storm Water Quality Projects include: Detention Ponds, Bio-retention Facilities, Green Streets, and Storm Water Treatment Devices
- Reduces the total suspended solids (TSS) as required by DNR regulations
- The TSS in Milwaukee must be reduced by 40 % by the end of 2013

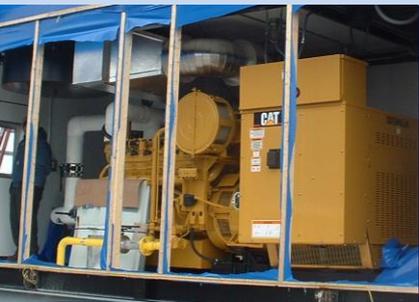
### **Zeidler Municipal Building**

Natural Gas Generator  
700 KWH on Request  
\$4,000 Savings/Month Possible

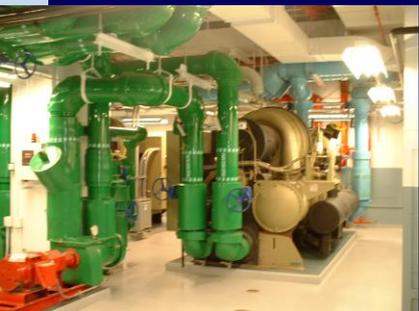
### **CHC Chiller Plant**

Cost \$3.5 Million  
Annual Energy Savings of \$39,500

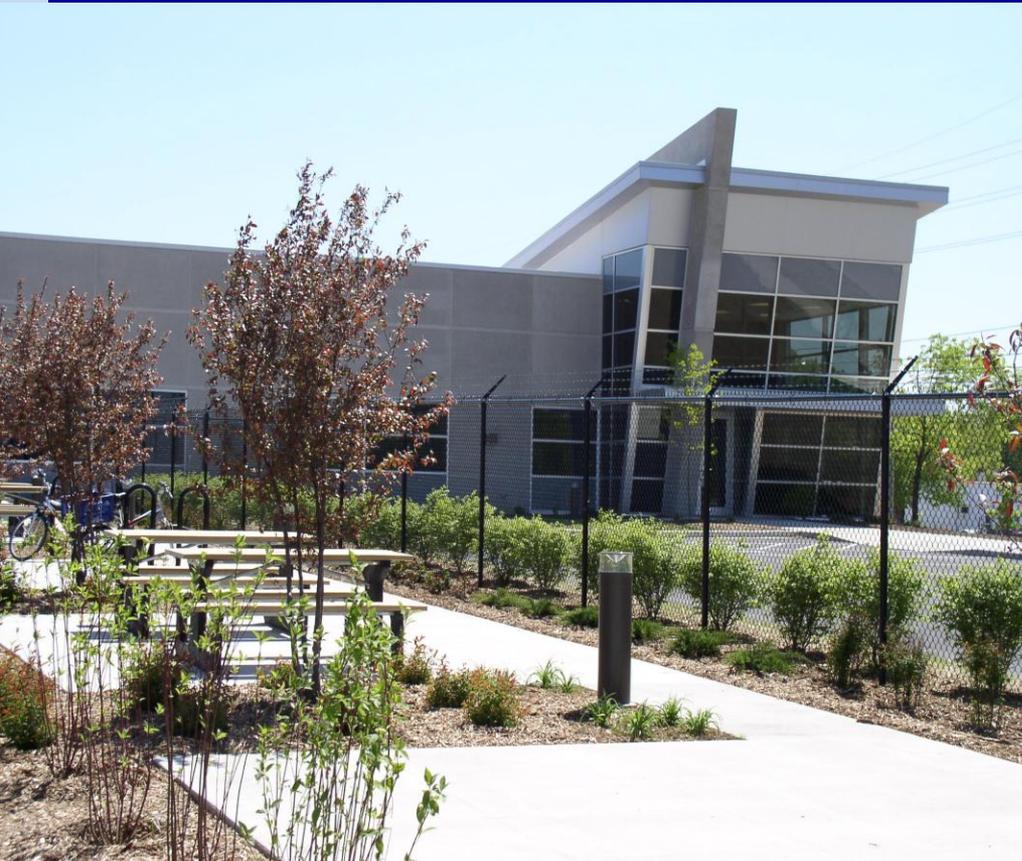
# New DPW Field Headquarters North 35<sup>TH</sup> Street and West Capital Drive

## Improved Efficiencies With Consolidation of 7 Sites

First Year
<b>Deferred Maintenance Savings</b>	<b>\$8,900,000</b>
<b>Operations Savings (Staffing and Energy)</b>	<b>\$1,330,000</b>
