# CAPITAL IMPROVEMENTS PLAN

## Department of Public Works

Capital Improvements Committee  
March 3, 2010

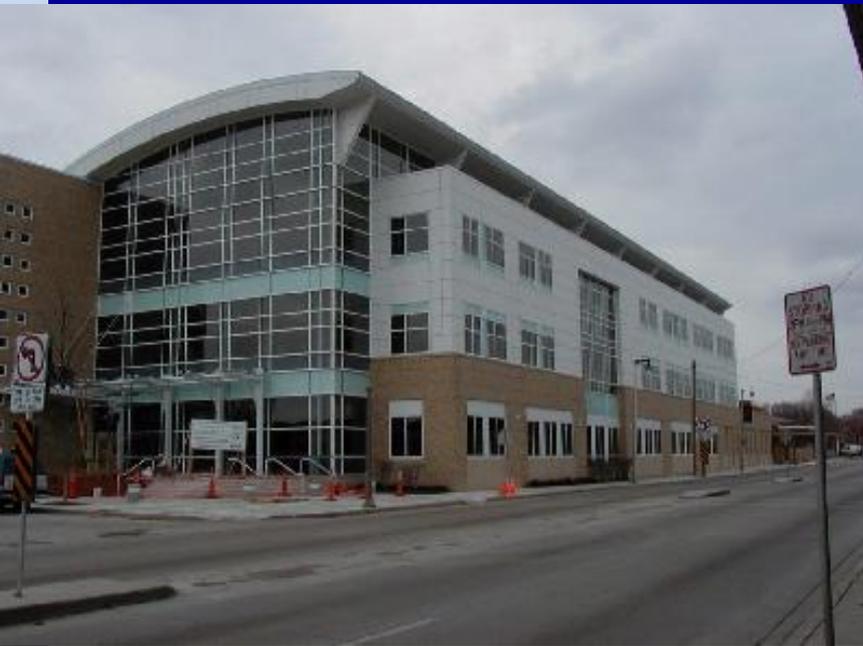
# New 3<sup>RD</sup> District Police Station

**Improved Efficiencies With Facilities Consolidation**

**Oversaw Project Design and Construction**

- \$26 Million / 2001
- 201,370 Square Foot Facility
- Consolidation of District Station and Data Communication Center
  - Replaced Antiquated Facilities
  - Improved Police Operation Efficiencies
  - Provided Needed Space in the PAB
  - Provided Police Presence in Community

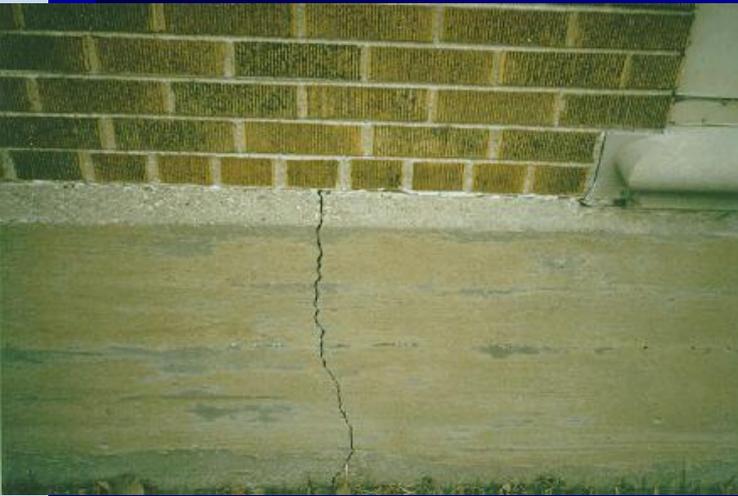
# Facilities Condition Information System

**Maintenance Backlog Examples**

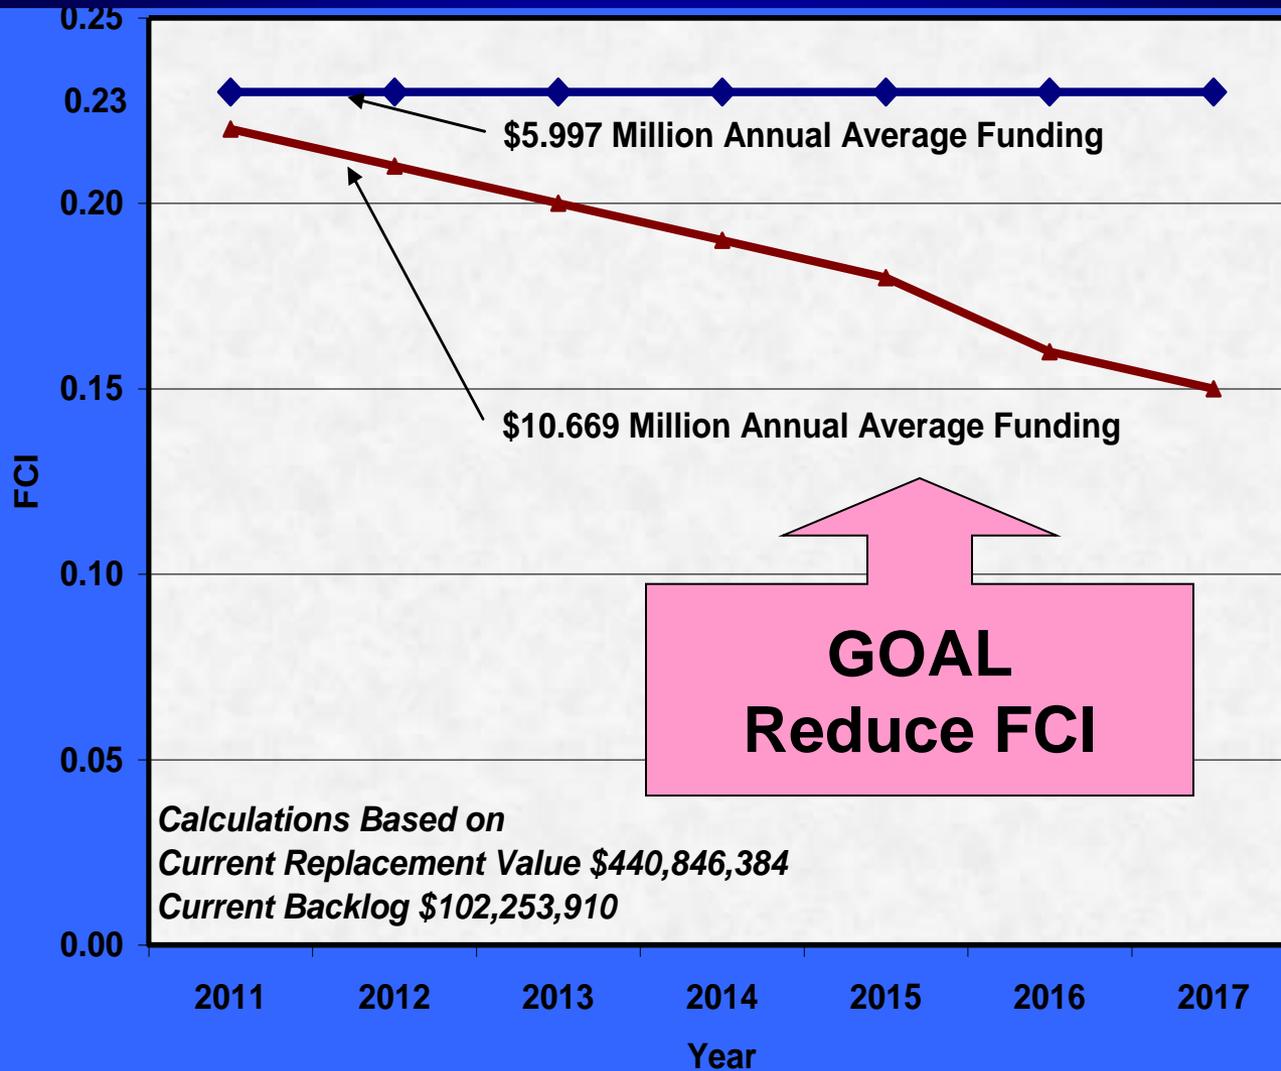
# Six Year Facilities Condition Indexes (For DPW Facilities Only)

$$FCI = \frac{\text{Backlog of Maintenance and Repair}}{\text{Current Replacement Value}}$$

<i>FCI Range</i>	<i>Condition Rating</i>
Under 0.05 (5%)	Good
Between 0.05 (5%) - 0.10 (10%)	Fair
Over 0.10 (10%)	Poor

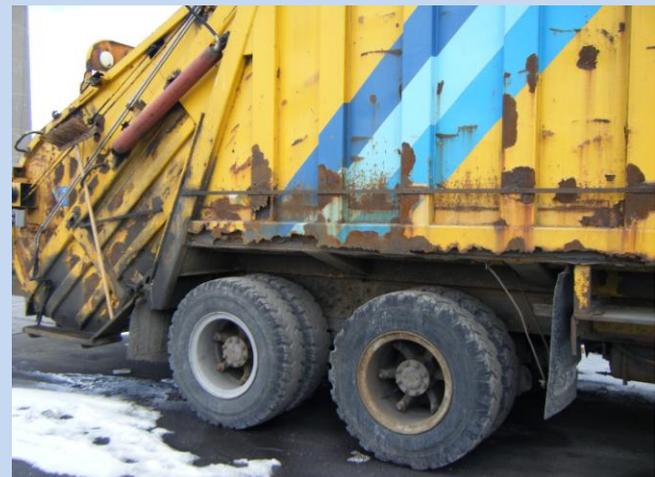
117 Refuse (Cart) Trucks in the Fleet

1990 truck #32985 (right) is one of 38 refuse packers beyond its reasonable expected life

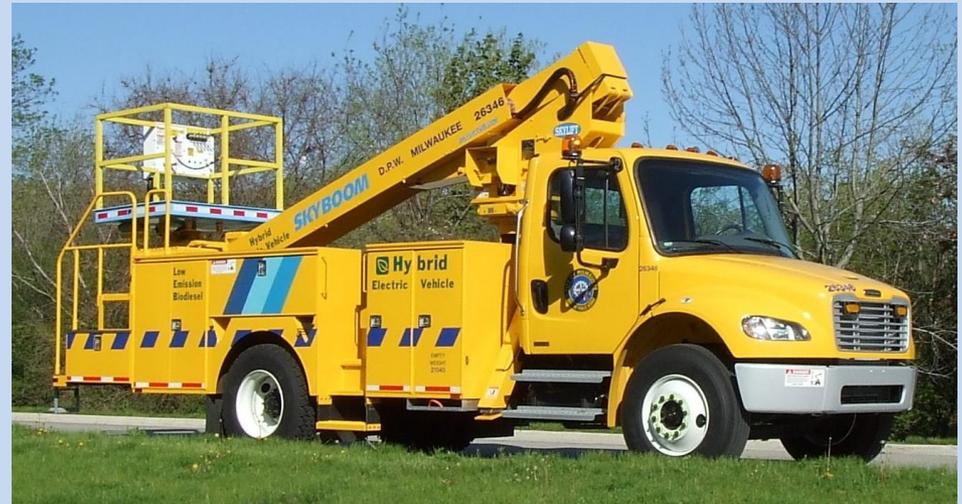
- Hybrid Aerial Trucks: 2

- Smaller diesel engine
- 330 volt Li-Ion battery, used to power boom and assist to propel truck
- Quieter neighborhood operation
- 11% improvement in mileage

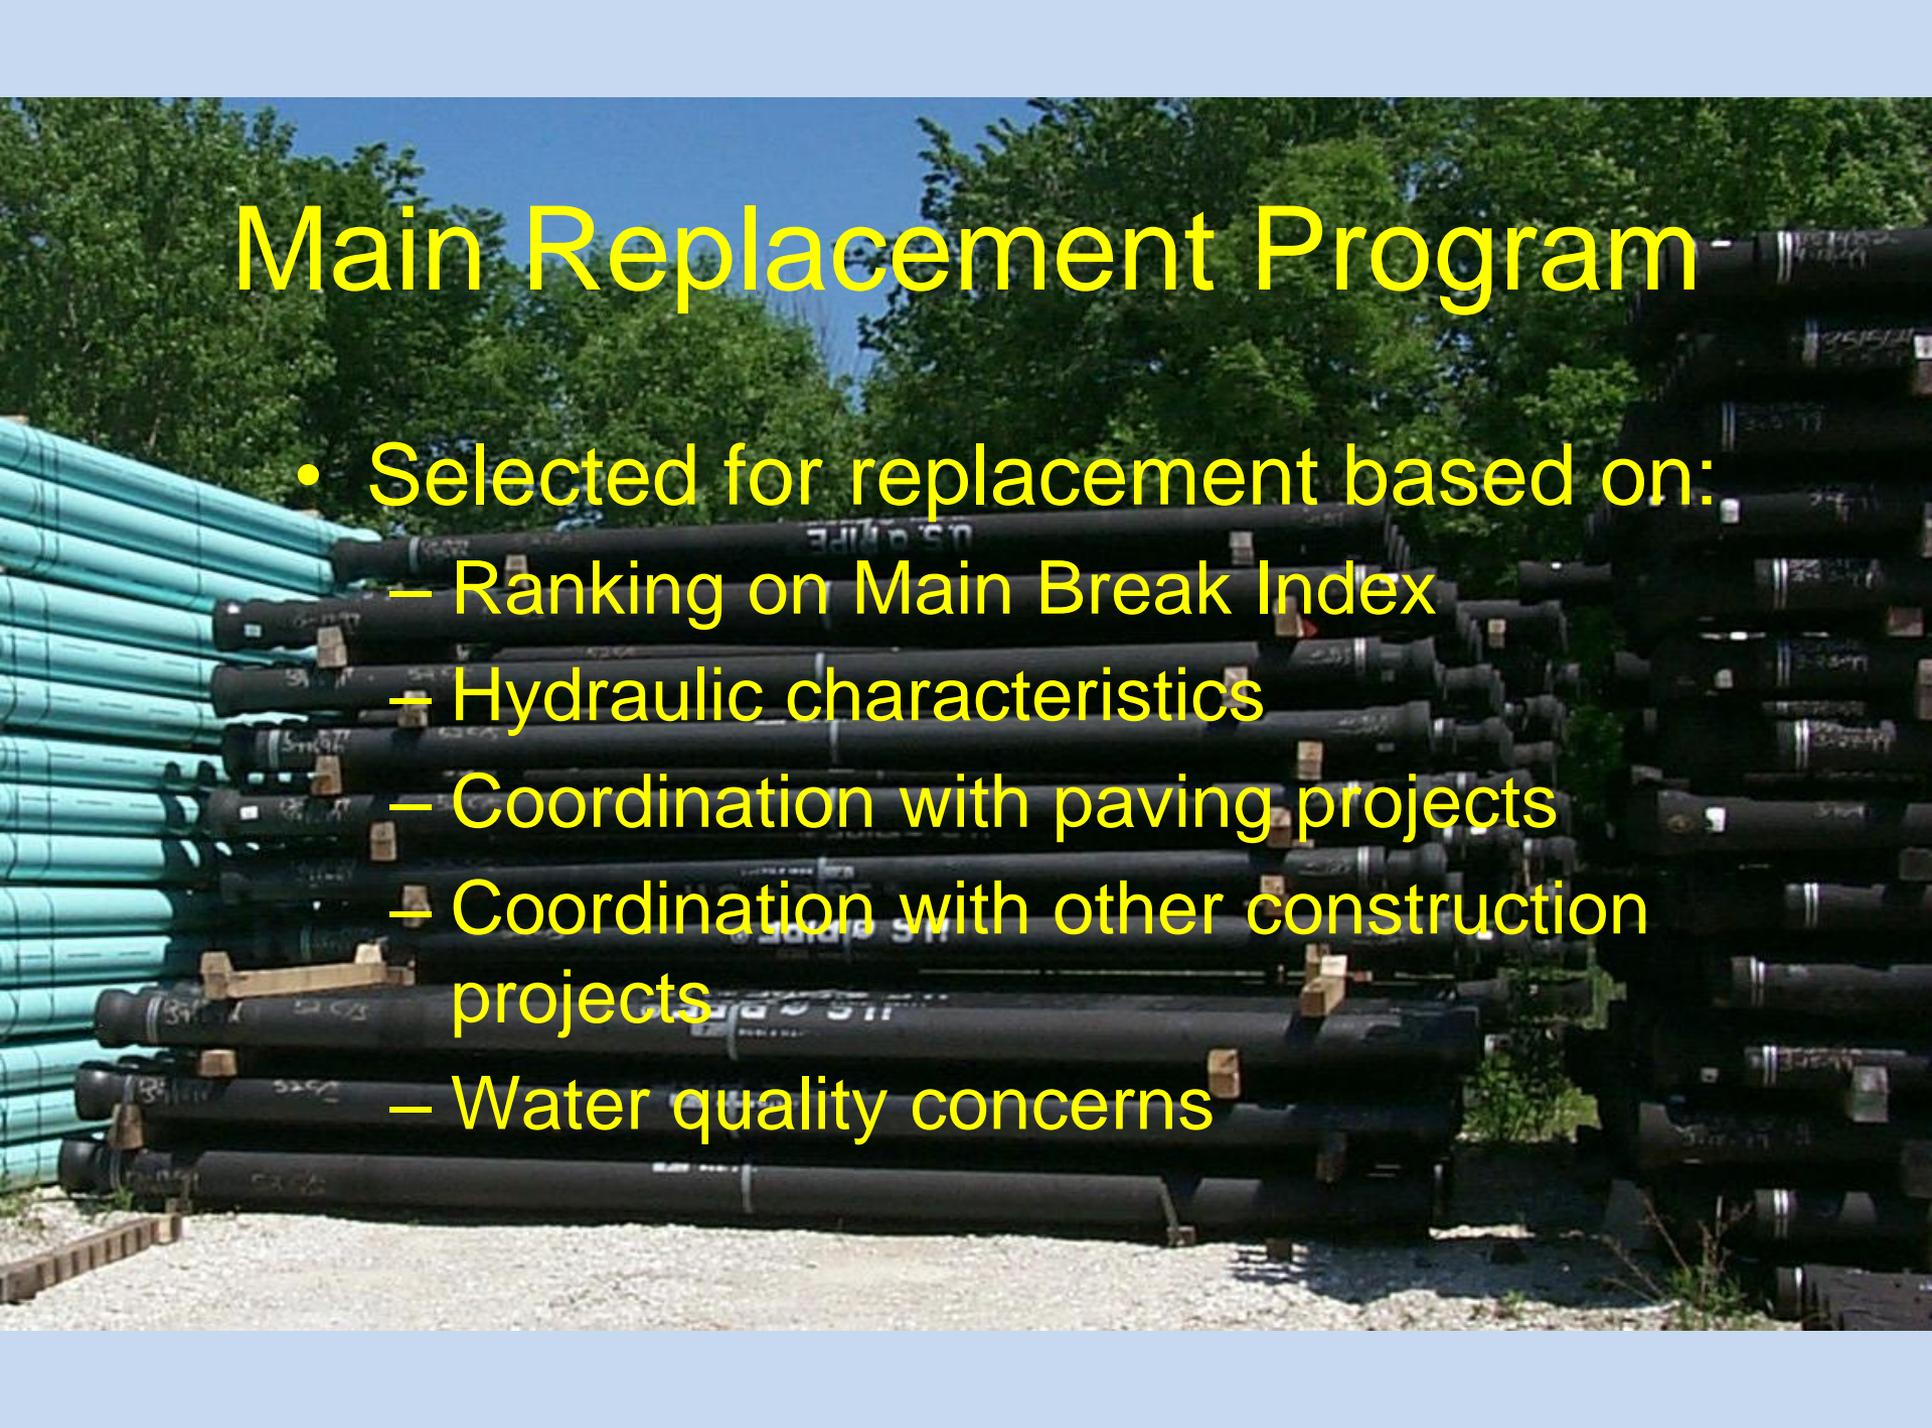
# Main Replacement Program

A large stack of black and blue pipes is visible in the background, suggesting a construction or replacement project. The pipes are stacked in neat rows, with some blue pipes on the left and black pipes on the right. The scene is set outdoors with green trees and a clear blue sky in the background.

- Selected for replacement based on:
  - Ranking on Main Break Index
  - Hydraulic characteristics
  - Coordination with paving projects
  - Coordination with other construction projects
  - Water quality concerns
