Certificate of Appropriateness

2015 N. PALMER ST. BREWERS HILL HD

PTS ID 115265 COA: MASONRY & WINDOWS

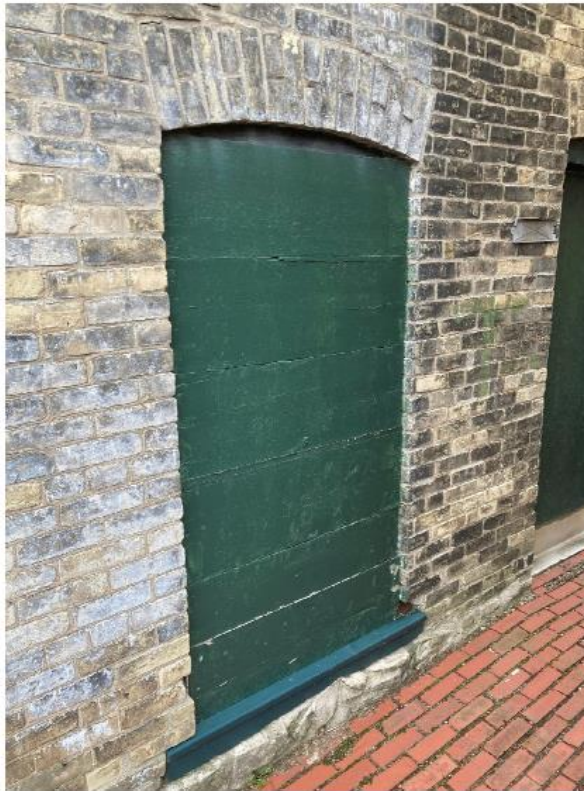
Lower Level Window to be opened up (North Face)

Opening of Lower Level Side Window and Side door that are boarded up.

Due to security issues with large, at grade window. We are looking to install non-operable window, that is made to resemble double hung 2-over-2 style of rest of house. Because this window is at grade and exposed to water run off and snow buildup from adjacent walkway, we would like permission for this to be an aluminum clad, Marvin Ultimate window. Color forest green to match other paintwork.

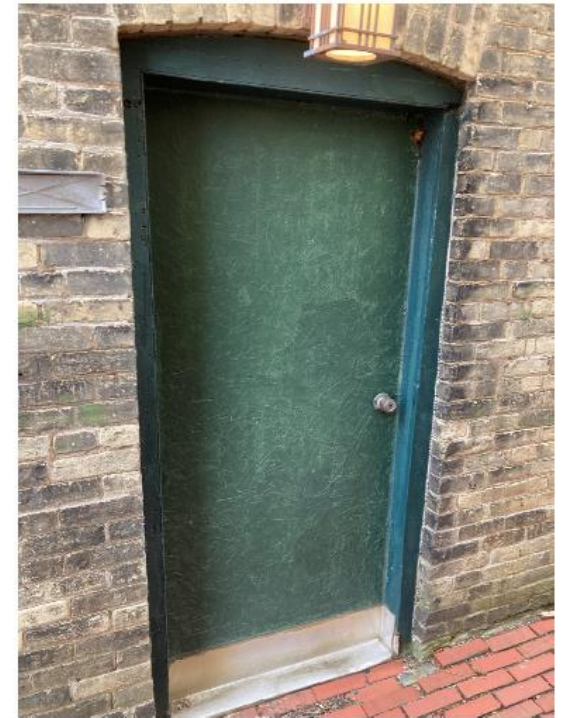
Lower level Side door to be opened up. (North Face)

Door to be replaced with solid wood 4x panel exterior door. Custom made for short height of existing opening.

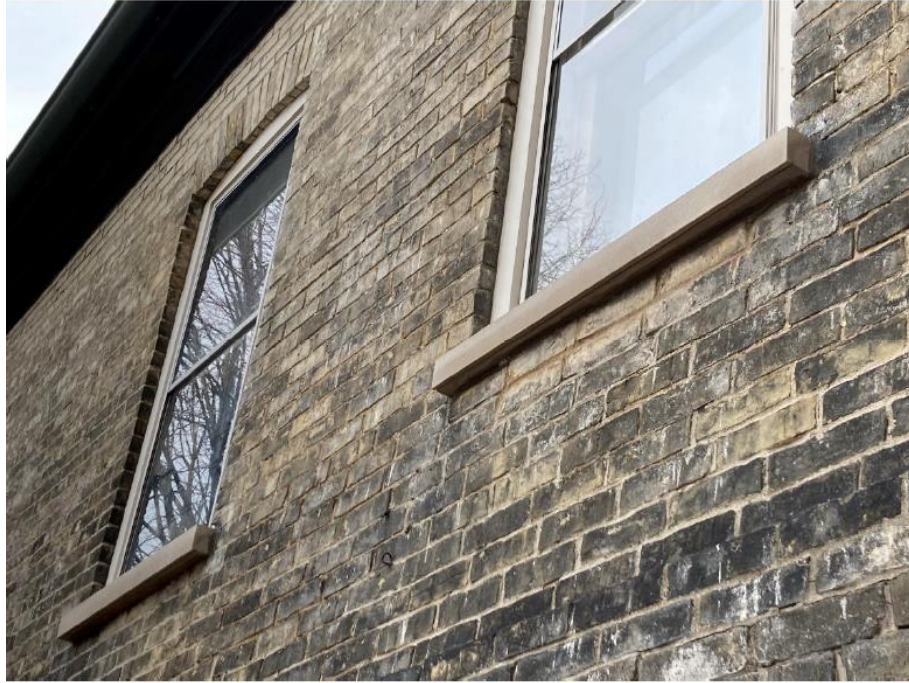
Example of Existing Stone Sills, (North Face)
Windows to be replaced

Replacement of 3x additional existing (not historic) windows on north side with same as above.

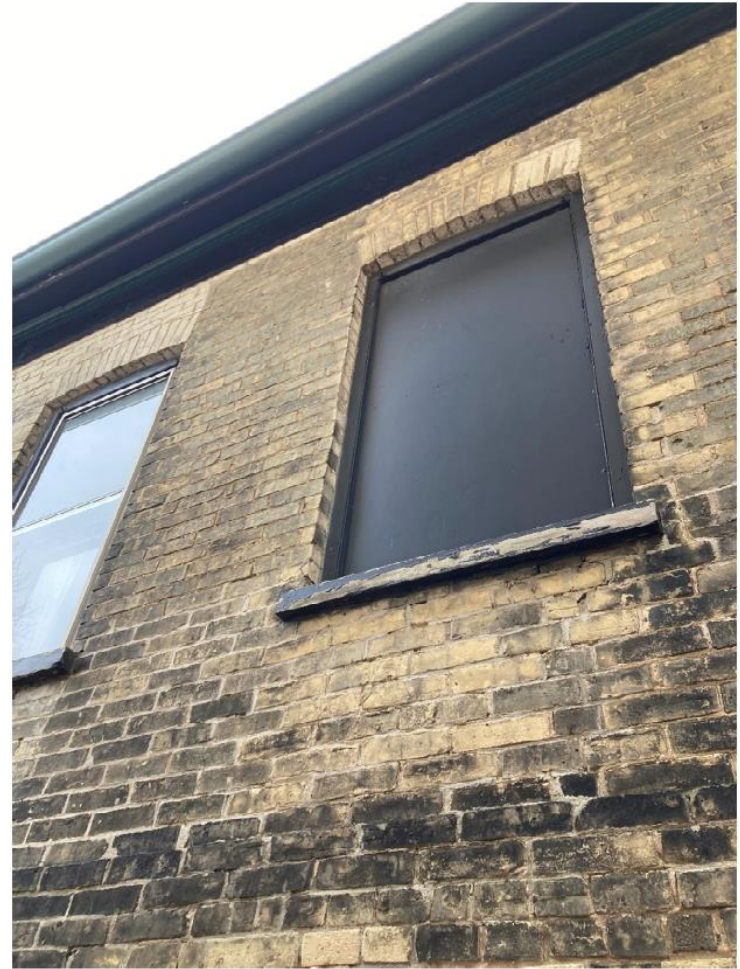
Wooden Sills to be replaced with Stone. Closed Window to be opened. New window to be installed. (North Face)

Opening of second floor boarded up window. New Marvin Ultimate Wood insert to be installed to match existing opening. 2 over 2, simulated divided light with spacer bar. Non-LowE double layered. Matching replacements as previously approved for 3 front upper and rear kitchen window replacements.

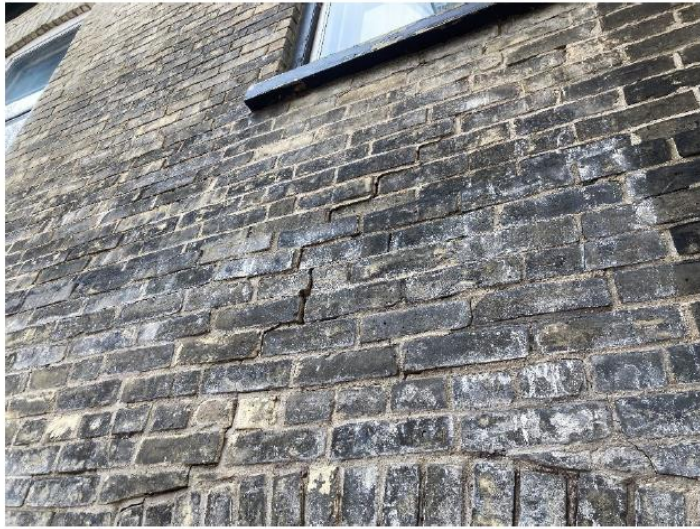
Examples of deterioration to brick to be repaired.

Section above shows signs of delamination.
Portion of wall to be disassembled and rebuilt.

Restoration of damaged brickwork. Disassembly and rebuilding of section of north wall that appears to be delaminating. Repair of cracks in brick on North Wall. Replacement of eroded bricks on exterior ledge. Application of mortar wash to ledge to prevent water ingress and future erosion. Replacement of 4x wooden sills on north face with stone sills (2x second floor window, 1x first floor door, 1x first floor window). Sections of Mortar that had previously been repaired with caulk to be properly restored with mortar. Tuckpointing and mortar repair in brick and foundation as needed.

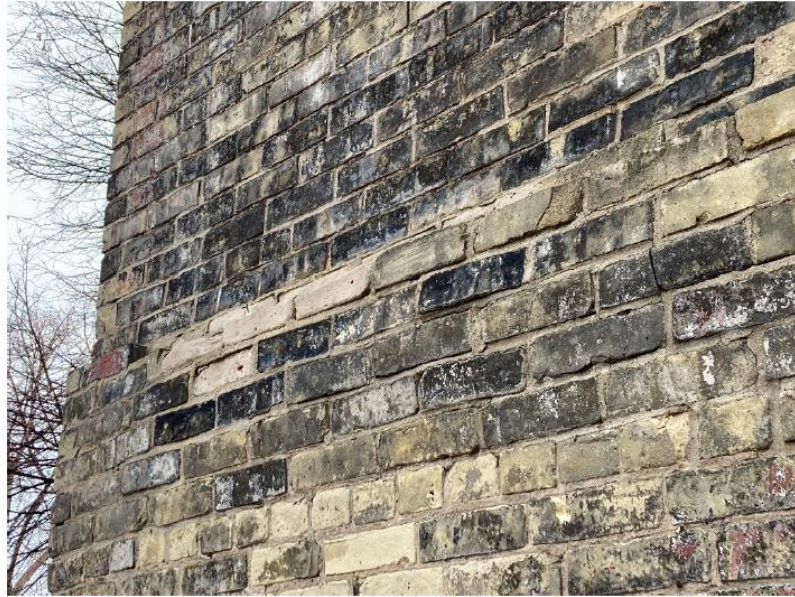
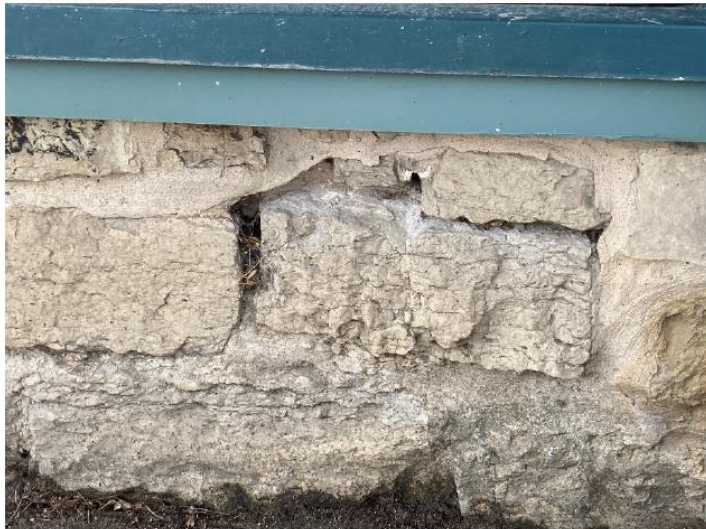
Typical damage
