# Certificate of Appropriateness Concordia Historic District

831 N. 33RD ST.

PTS ID 115305 COA new roof shingles

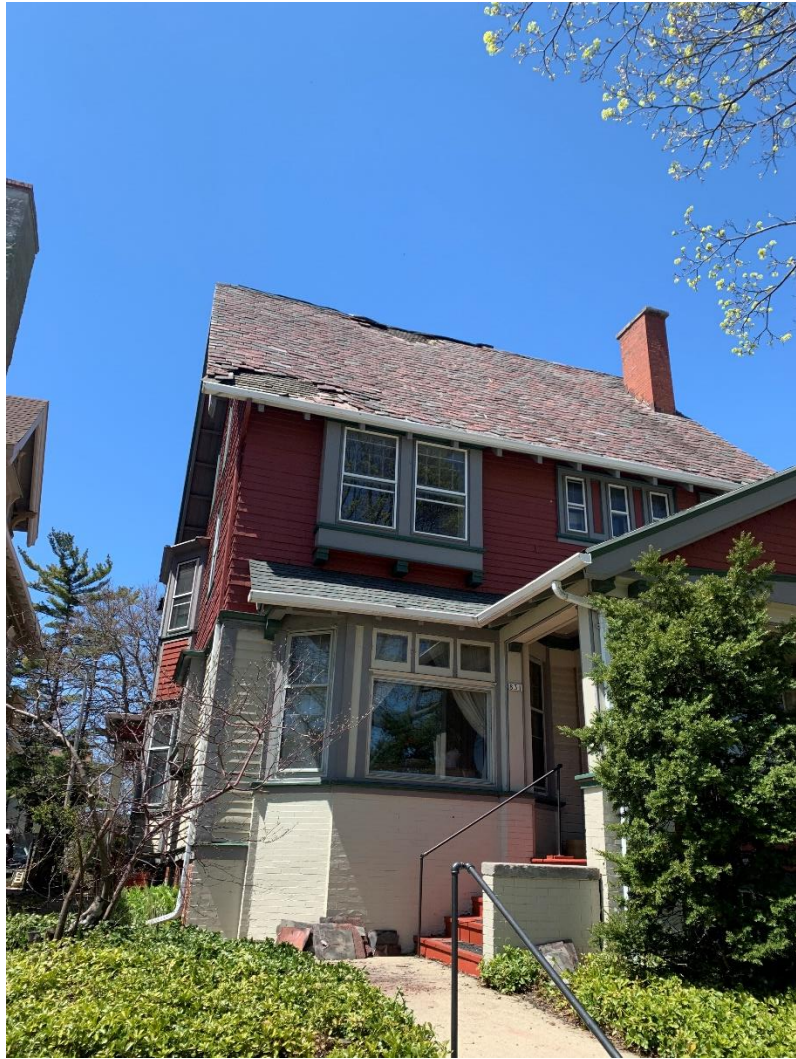
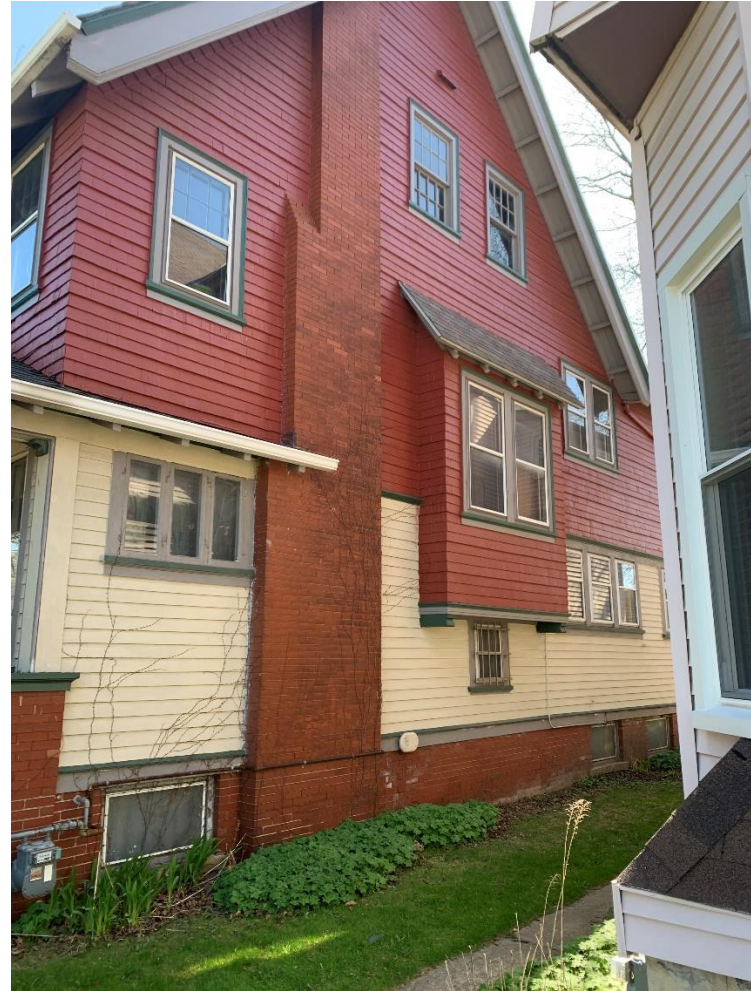
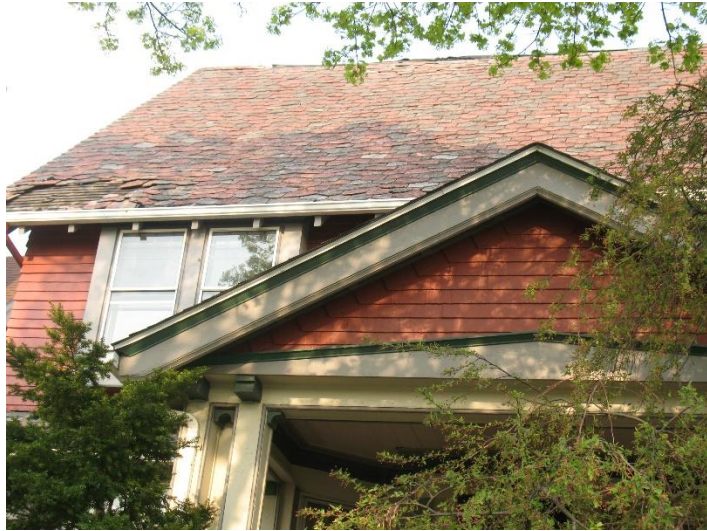
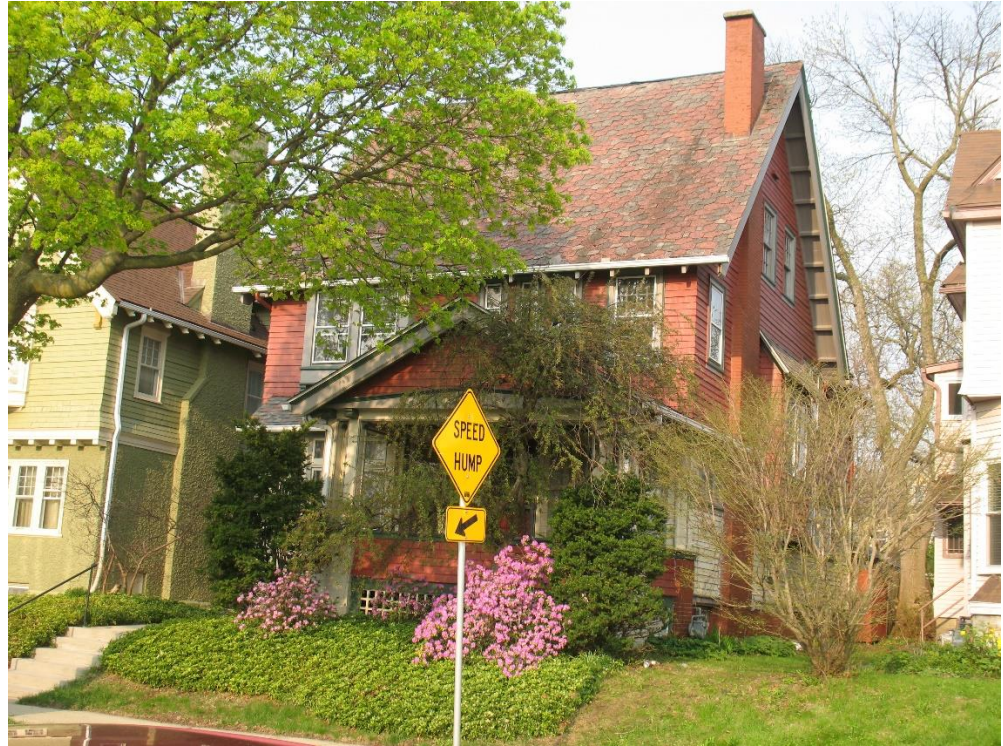
See Images attached. Step flashing is required around chimney for the roof’s longevity. Straight flashing will fail and leak.

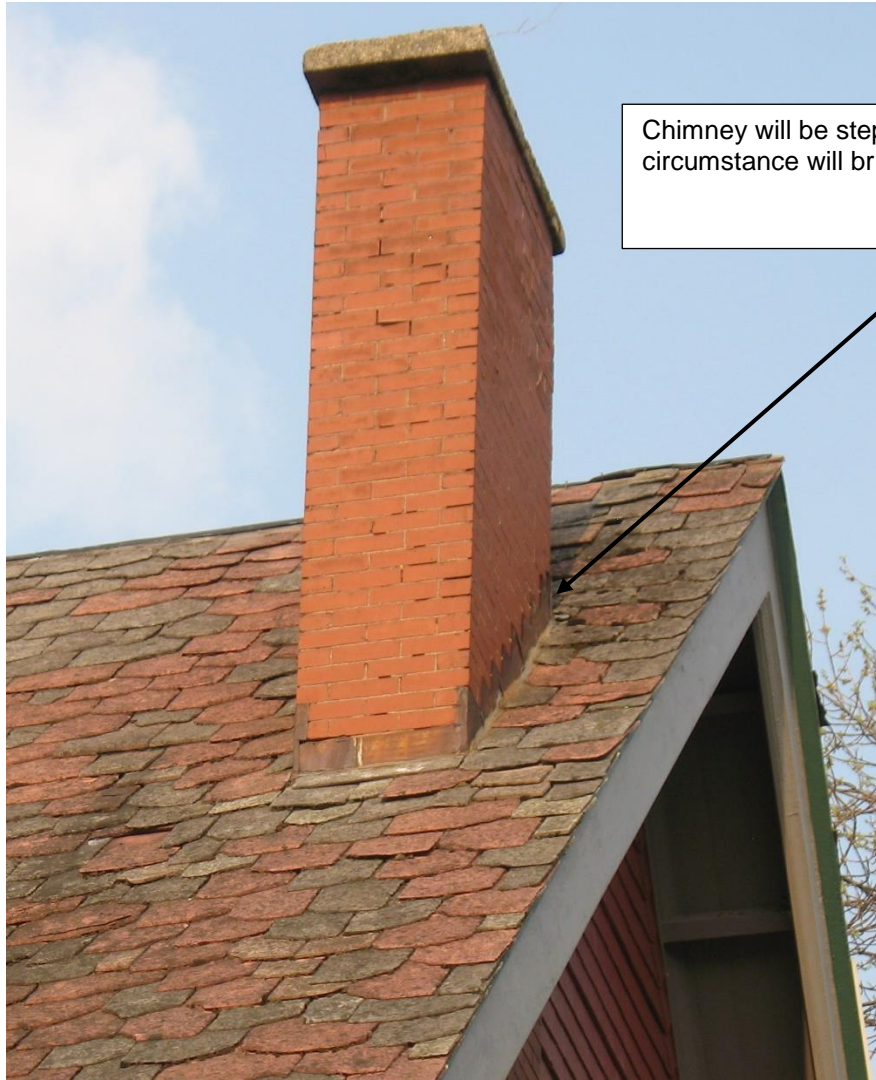
Chimney will be step flashed as shown here. Under no circumstance will brick be cut to install flashing.

EERE » BTO » Building America » Solution Center Home » Image Gallery » Right - Step flashing along a chimney is integrated in a layered manner with asphalt shingle roofing and topped with counterflashing that is embedded into brick mortar joint above

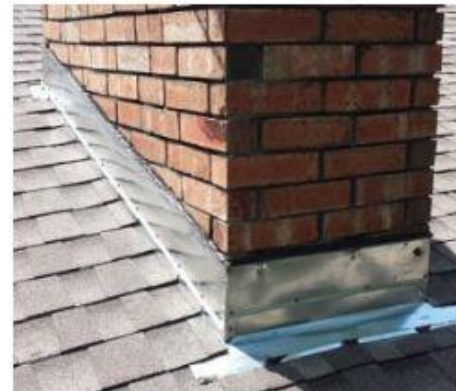
## Straight Flashing is a Short-Cut

The common mistake among general contractors is installing the wrong type of flashing. Straight flashing also called L-flashing is a shortcut around chimneys. Step flashing creates a better more lasting seal than L-flashing. L-flashing is faster to install and allows contractors to cut corners and cost. Straight flashing wraps around the base then shingle are installed over top.
