# **TURNER HALL ANNEX REPAIR**

## Turner Hall Annex

The Annex is the Northern two story section of Turner Hall adjacent to the parking lot. The Annex was added to the building in 1902, twenty years after the original structure was built.

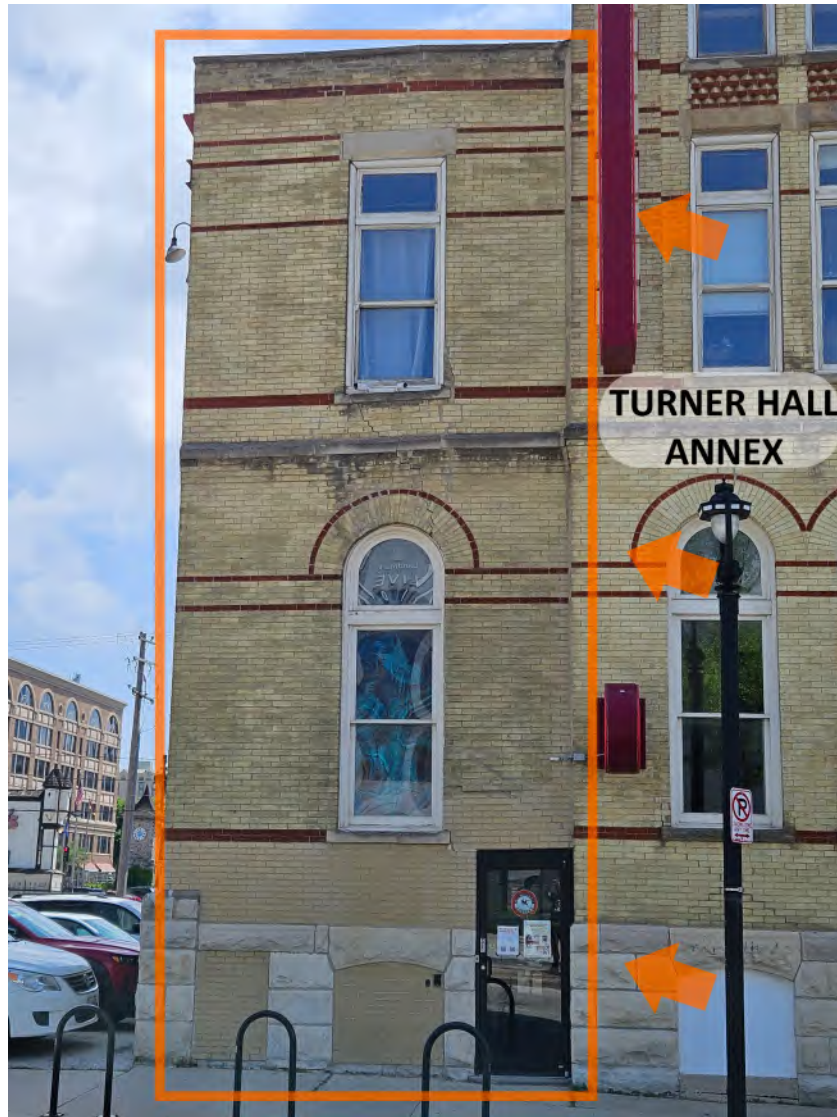
The Annex was damaged by the Deep Tunnel Project and the demolition of the Bradley Center.

-West facade pictured here

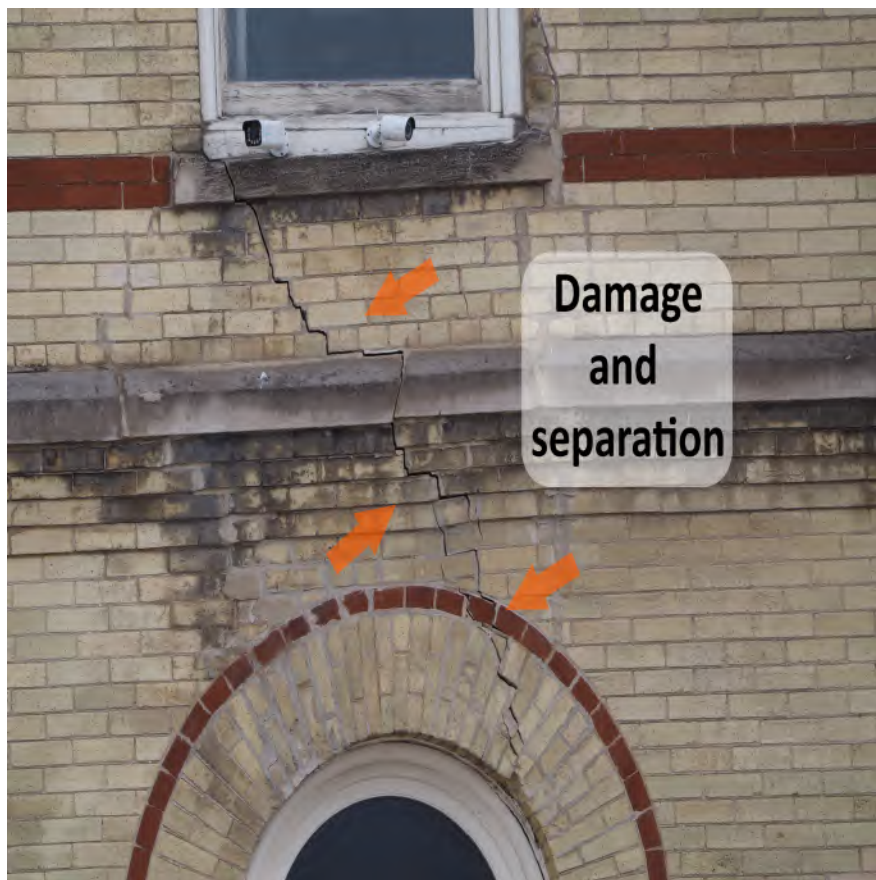
-West facade below second floor window

Damage to the masonry is causing separation of the facade just above and below the second floor window.

Observations of the Annex performed by Beane Engineering found that the facade is separating and needs to be stabilized. The following drawings were proved as a proposal to stabilize the Annex West facade.

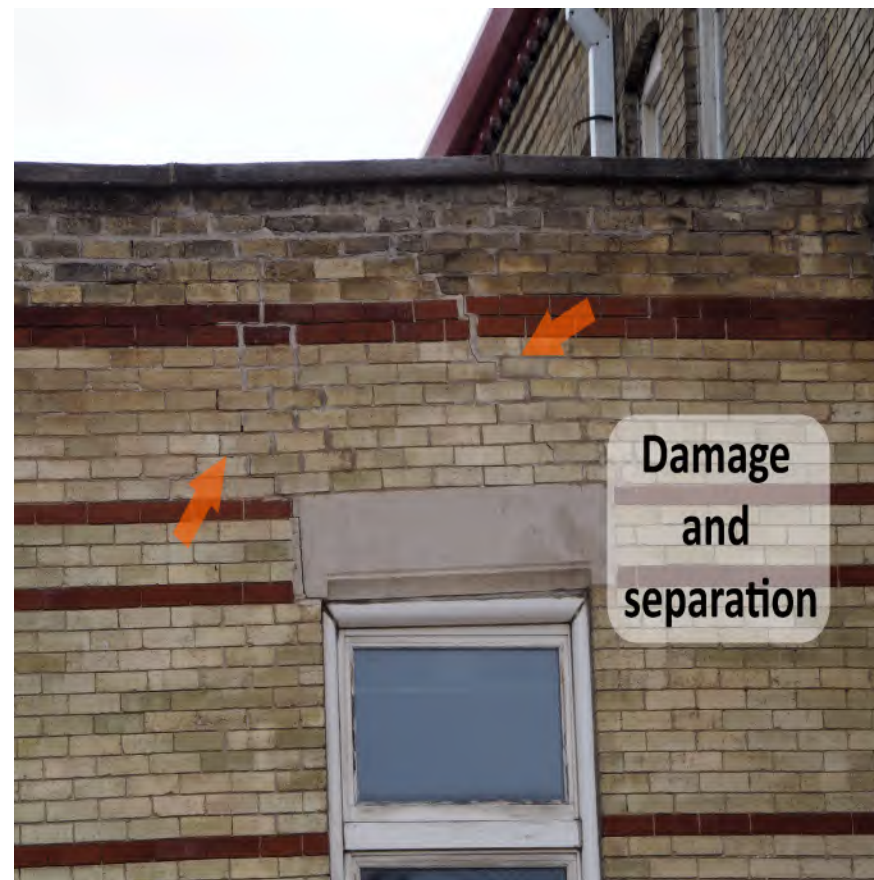
-West facade above second floor window

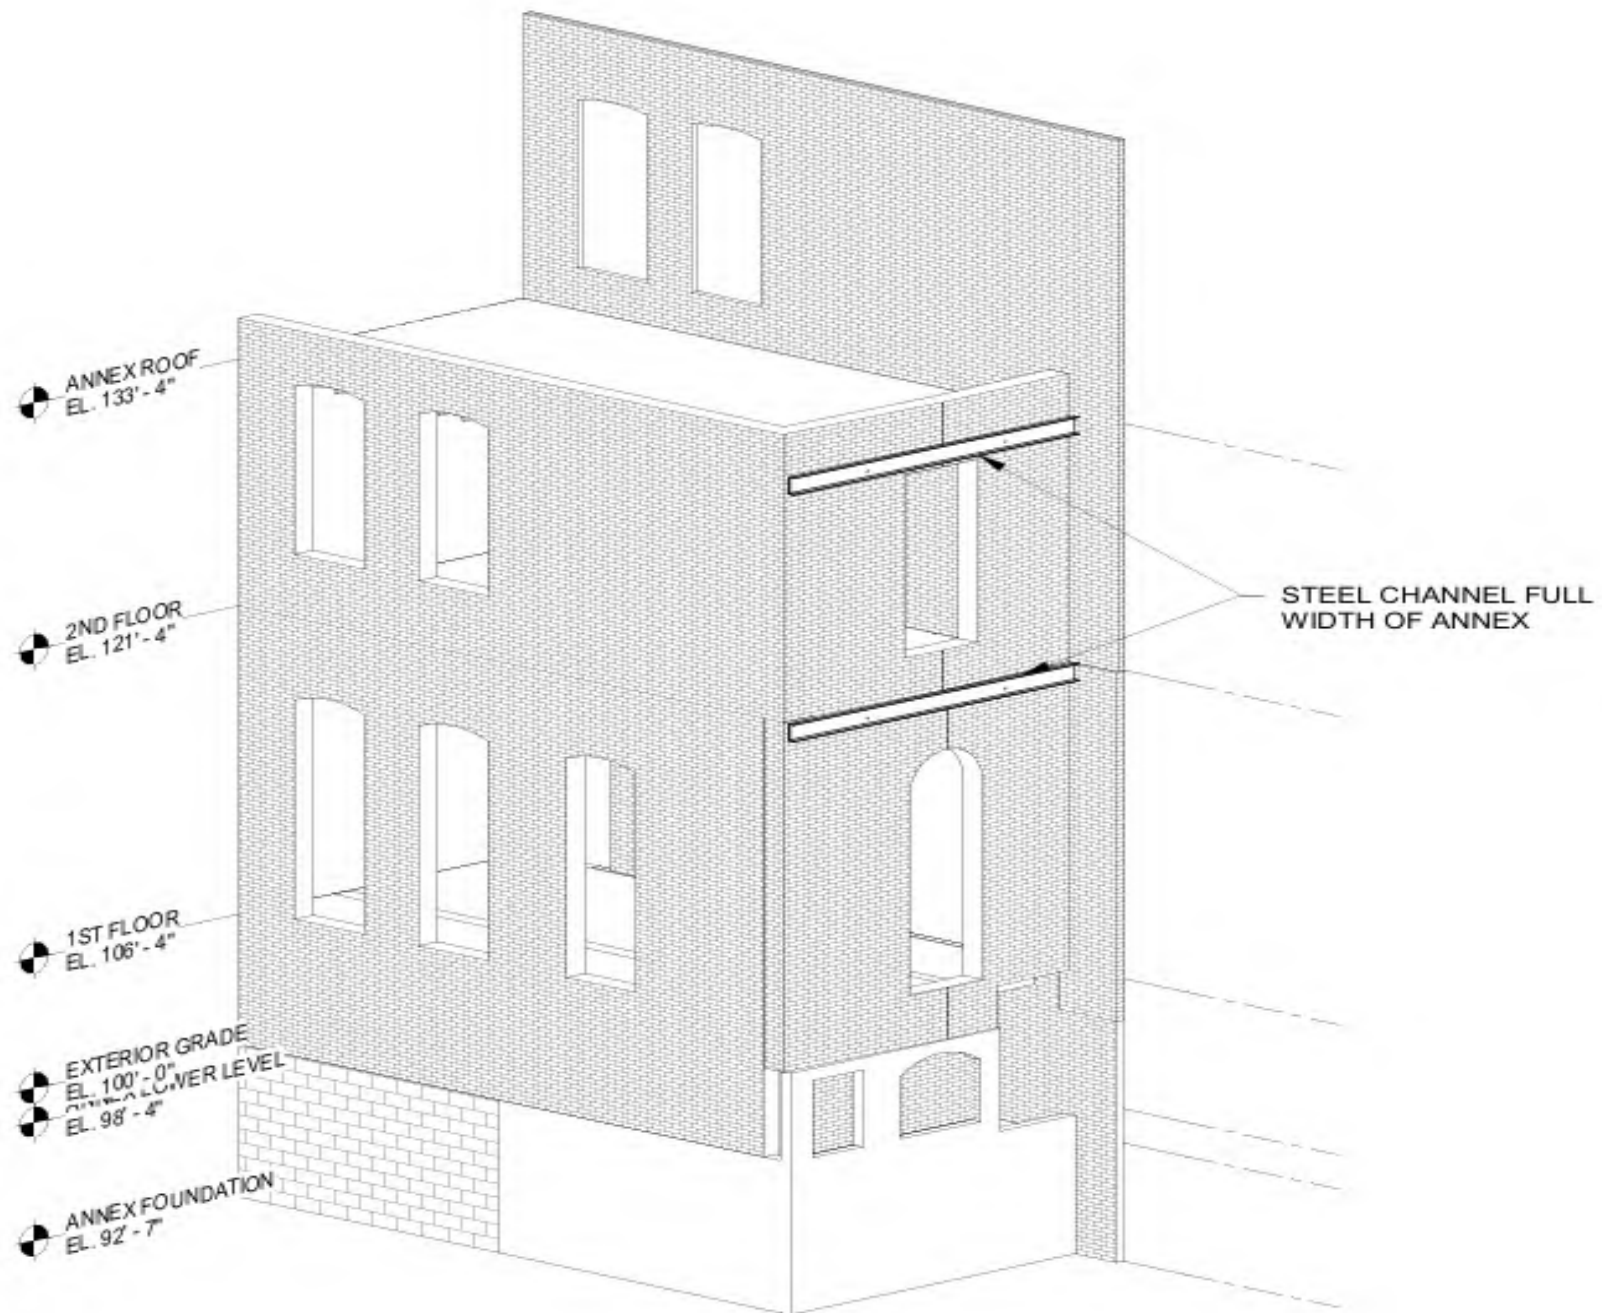
ANNEX ROOF  
EL. 133' - 4"

2ND FLOOR  
EL. 121' - 4"

STEEL ROD AND WOOD  
BLOCKING IN FLOOR/ ROOF  
SYSTEM (REQUIRES  
OPENING UP FLOOR/ ROOF  
OR CEILING FOR  
INSTALLATION)

1ST FLOOR  
EL. 106' - 4"

EXTERIOR GRADE  
EL. 100' - 0"  
BASEMENT LOWER LEVEL  
EL. 98' - 4"

ANNEX FOUNDATION  
EL. 92' - 7"

The steel channels would be mounted to the facade with steel rods running approximately 8' back into the building with blocking along the joists/rafters.
