Lead Service Line Program Semi-Annual Update

Steering and Rules Committee

July 19, 2018

**Milwaukee
Water Works**

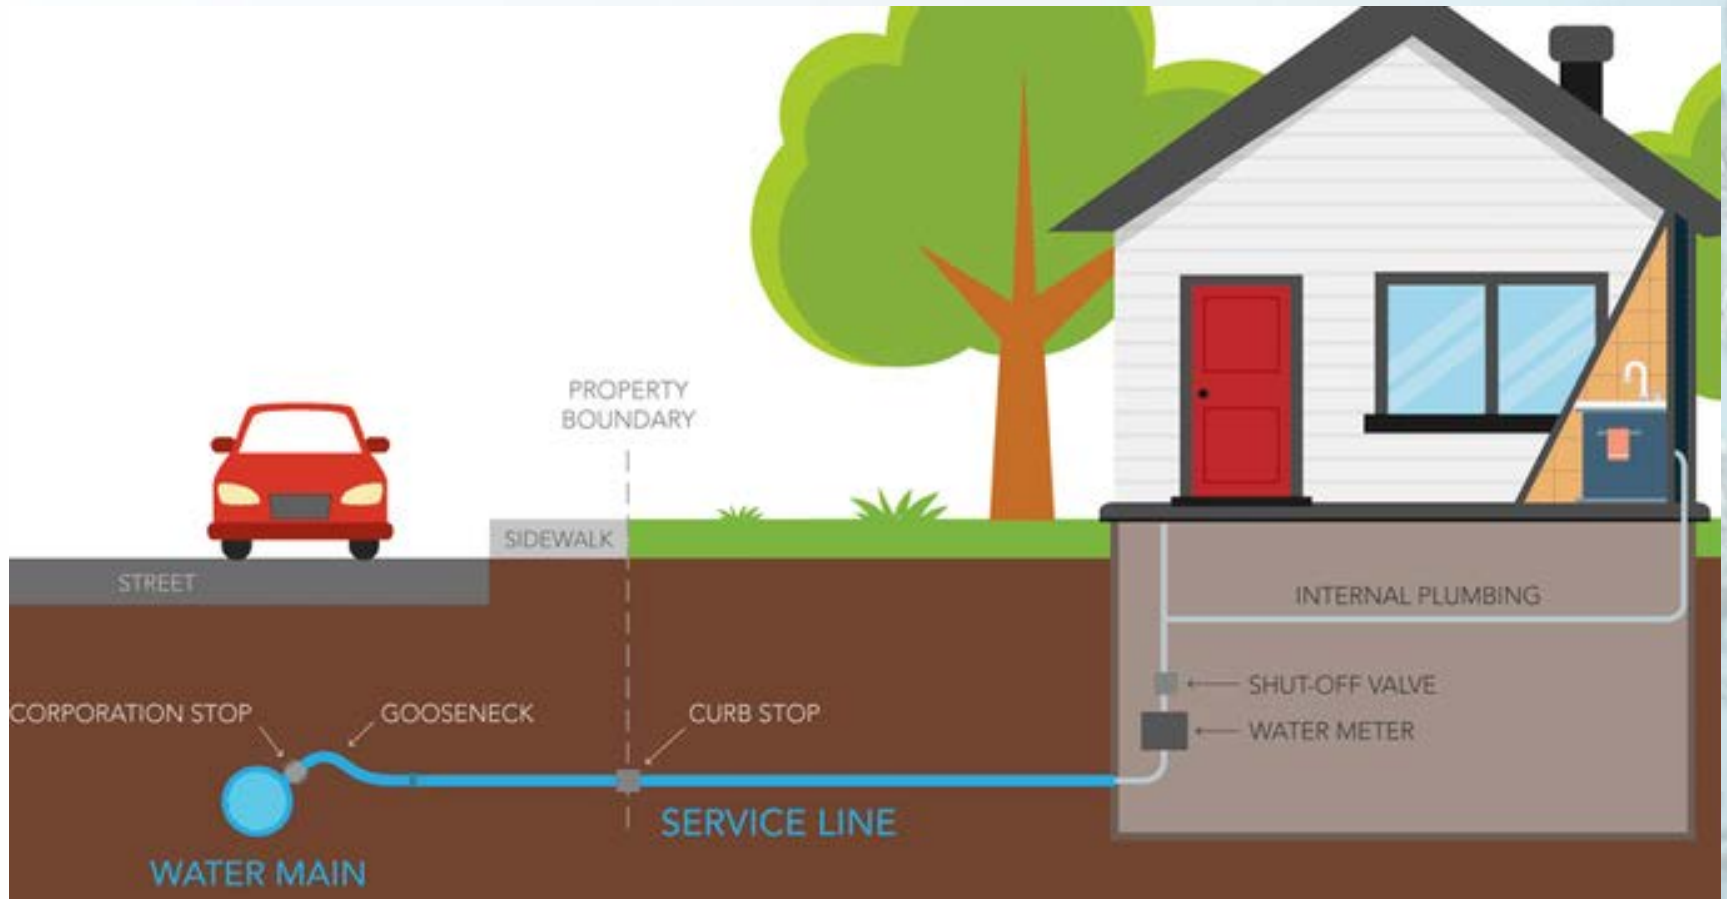
What is a Service Line?

- The water service line is co-owned by the utility and the property owner
- Milwaukee Water Works (MWW) started phasing out the use of lead for the public side of water service lines in 1947
- City enacted an ordinance in 1962 requiring copper service line installation on the private side
- MWW has used orthophosphate for corrosion control since 1996
- MWW is compliant with the Lead and Copper Rule, and is on a reduced monitoring status because our corrosion control is considered to be optimized

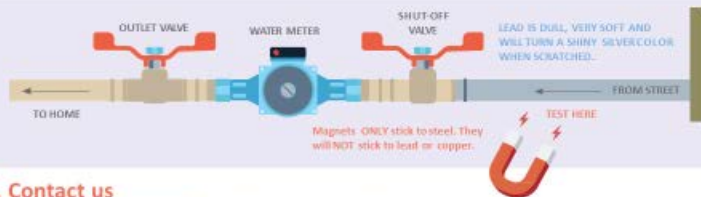
- Find the water meter. This is typically in the basement but it could be on the first floor. From the meter, work your way to where the service line enters the building in the wall or in the floor.
- Find an area to test on the pipe between the wall or floor and the shut-off valve. (See diagram)
- The pipe may be wrapped in insulation. Pull this back to reveal the pipe.
- Use the magnet from this letter to see if it sticks to the pipe. If it sticks, the pipe is made of galvanized steel.
- If the magnet does not stick, use a key or a coin to scrape the pipe. If the scratch is copper-colored like a penny, the pipe is copper.
- If the scraped area is shiny and silver, the service line is made of lead.
- After touching a lead service line, wash your hands with soap and water. Safely clean up any debris from the scraped pipe with a disposable wet cloth.

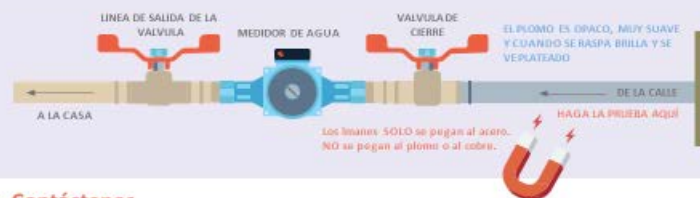
- Busque un área para hacer la prueba en la tubería, entre la pared o el piso y la válvula de cerrar. (Ver el diagrama). La tubería podría estar envuelta en material aislante. Quitarlo para ver la tubería.

- Use el imán que va con esta carta para ver si se pega a la tubería. Si se pega, la tubería está hecha de acero galvanizado.
- Si el imán no se pega, use una llave o una moneda para raspar la tubería. Si la raspadura es del color del cobre, como un centavo, la tubería es de cobre.

- Si el área raspada es brillante y plateada, la línea de servicio es de plomo.
- Después de tocar una línea de servicio de plomo, lávese las manos con agua y jabón. Con cuidado limpie cualquier basura del tubo raspado con una toalla mojada desechable.

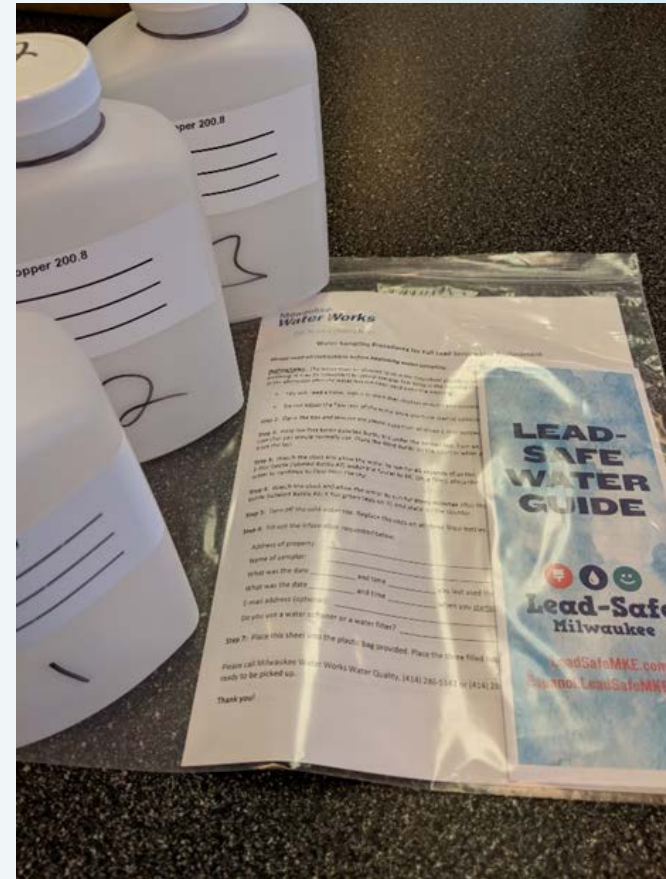
- LSLR project entered into Water Distribution database, filter provided
- Project leader checks if resident is interested in lead sampling
- Call resident, explain process, answer questions, set up appointment
- Deliver 3-bottle kit, instructions, lead safe guide, flushing instructions, contact information
- Resident calls, pick up kit, preserve samples, chain of custody form, UPS to certified laboratory
- Contact resident, mail results, follow-up

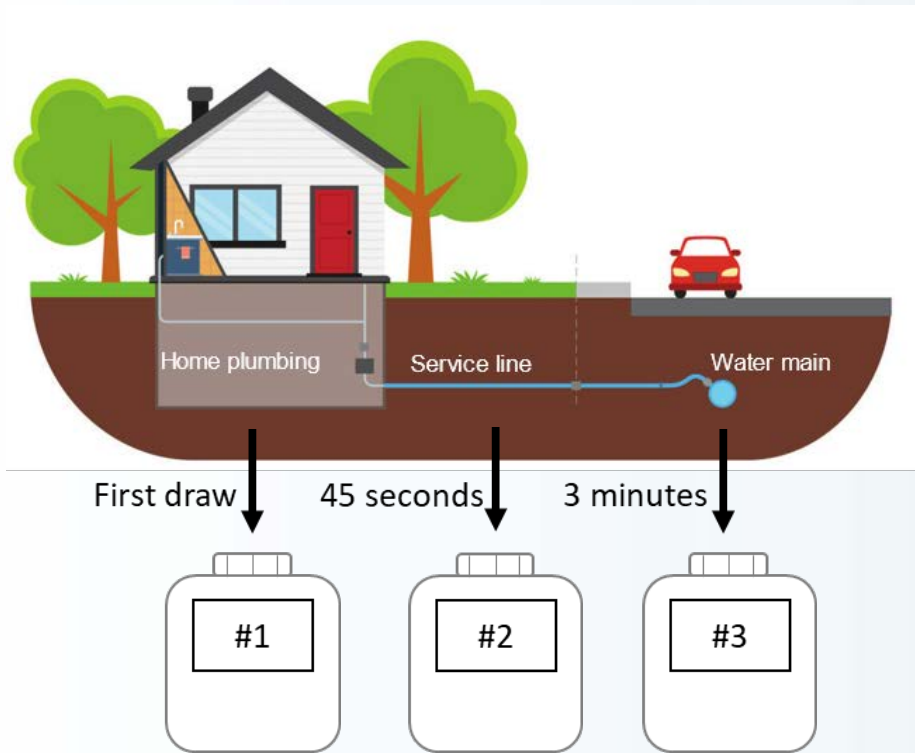
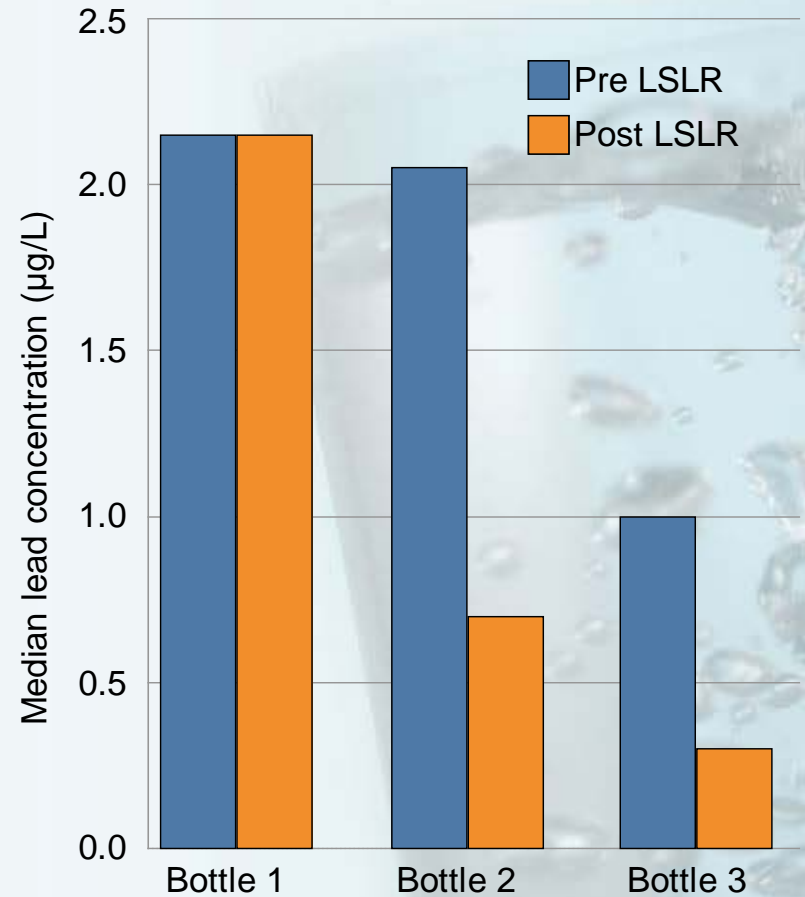
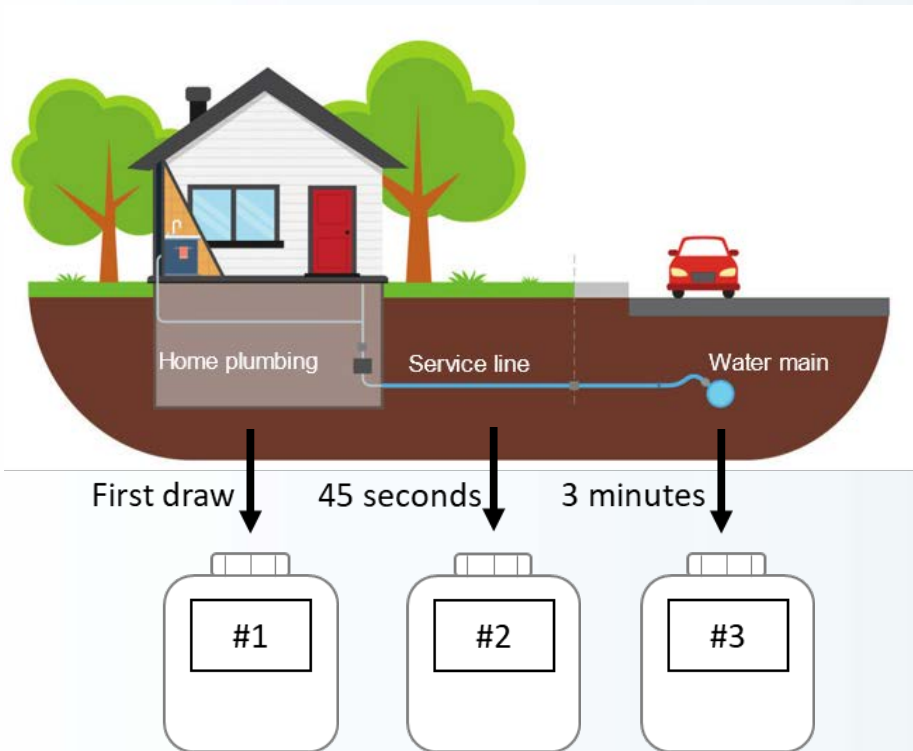
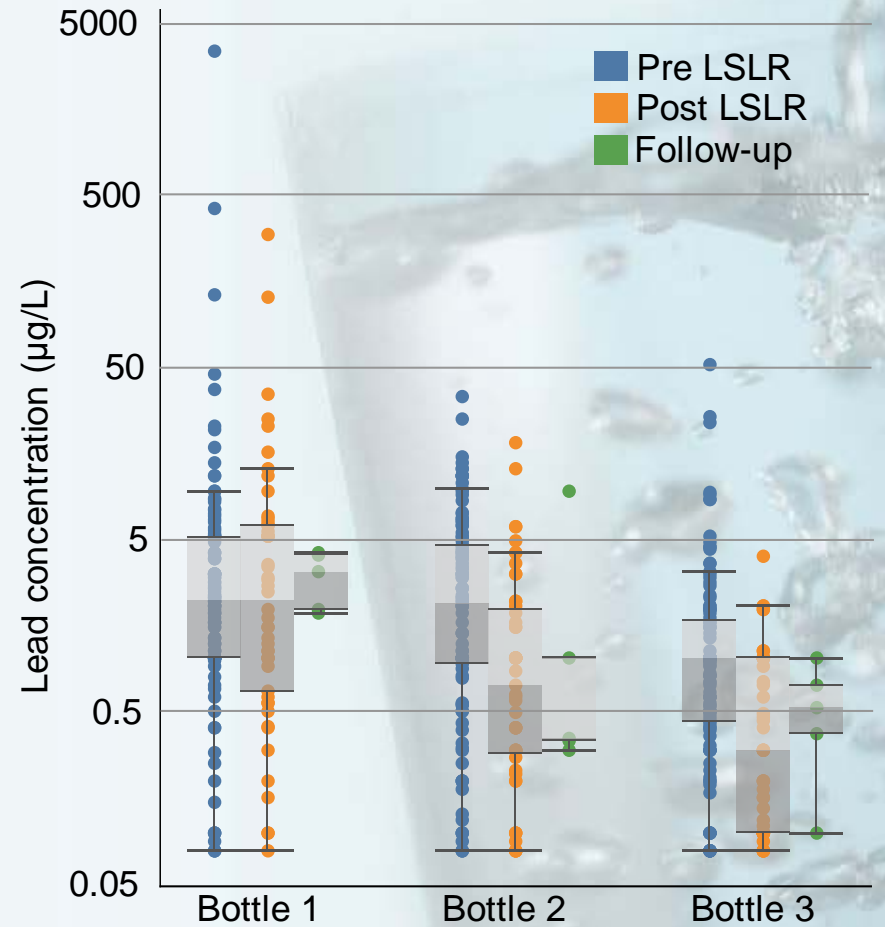
Lead Service Line Replacement Results

- Vast majority of samples had lead levels $< 5 \mu\text{g/L}$
- Highest lead levels are often from first draw sample (home plumbing)
- No significant reduction in first draw lead levels after LSLR
- However, significant reduction in lead levels seen after 45 second flush following LSLR
- Most lead levels $> 15 \mu\text{g/L}$ explained by sampling mistakes or insufficient flushing following LSLR
- All follow-up samples were below $10 \mu\text{g/L}$
- Corrosion control has been effective at reducing lead and copper in water but does not eliminate it

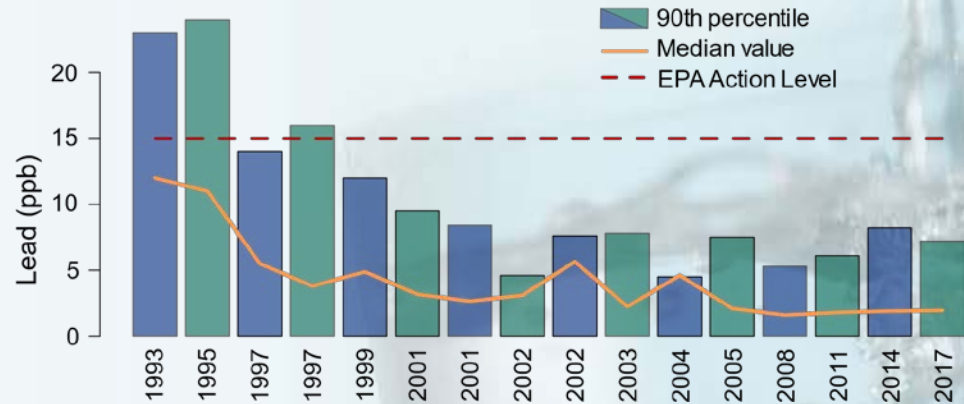
- 1988 MWW proactive study on lead reduction
- 1991 Lead and Copper Rule promulgation
- CH2M study at MWW to reduce lead, recommendations to DNR by 1994
- 1994 phosphate pilot study in Wauwatosa
- 1995-1996 MWW design, construction, training, startup, 2 rounds of sampling
- Full-scale implementation January 1997
- Addition of orthophosphate at 3 mg/L for 6 months (passivation process)
- Recommended dose reduction to ~1.2 mg/L orthophosphate, but continued 2.0 mg/L per DNR
- 2002 DNR issues letter stating MWW optimization and reduced sampling status for LCR compliance
- After 2002, MWW continues to dose at ~1.9-2.0 mg/L orthophosphate at a cost of \$350,000 per year
- 2016 EPA publishes OCCT technical evaluation and recommendations (MWW optimized by EPA standards)
- 2018 MWW working with Comptroller to evaluate lead and copper corrosion control optimization

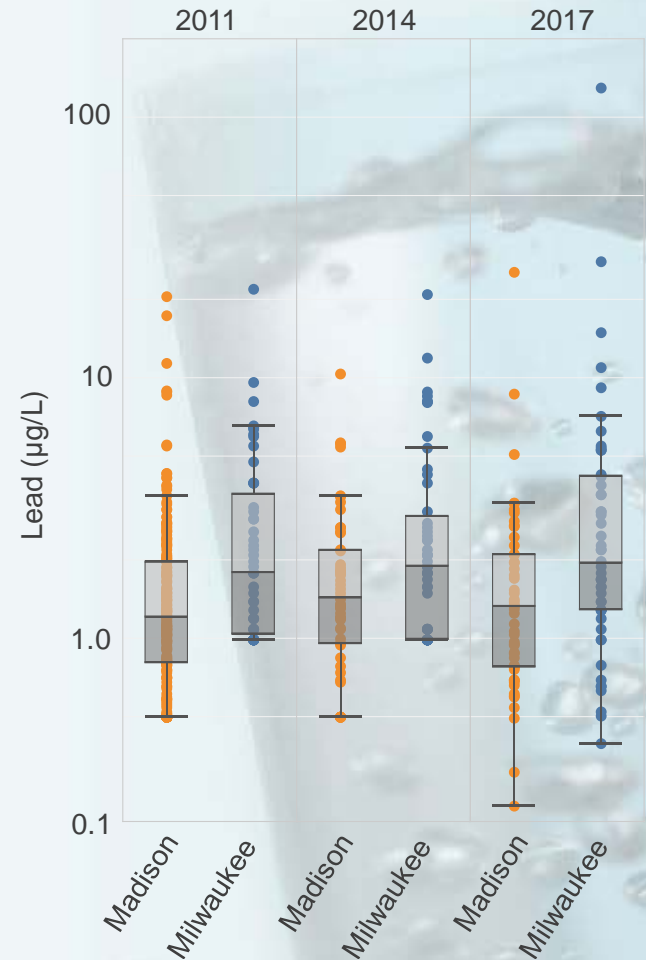
Madison and Milwaukee LCR Results from 2011-2017

- No lead service lines
- Tier 1 = single family homes copper service lines with lead solder
- Ground water
- None, minimal corrosion control
- Median lead = 1.33 $\mu\text{g/L}$

- ~73,000 lead service lines
- Tier 1 = single family homes with lead service line
- Surface water
- Orthophosphate for corrosion control
- Median lead = 1.88 $\mu\text{g/L}$

Both had > 25% of samples below detection limit

Neither exceeded EPA action level
