## PRESERVATION BRIEFS

# 15

## Preservation of Historic Concrete

Paul Gaudette and Deborah Slaton

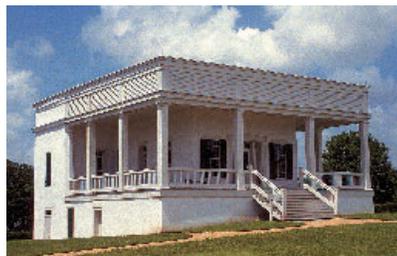
**Figure 1.** The Sebastopol House in Seguin, Texas, is an 1856 Greek Revival-style house constructed of lime concrete. Lime concrete or "limecrete" was a popular construction material, as it could be made inexpensively from local materials. By 1900, the town had approximately ninety limecrete structures, twenty of which remain. Photo: Texas Parks and Wildlife Department.

The Erie Canal in New York is an example of the early use of concrete in transportation in the United States. The natural hydraulic cement used in the canal construction was processed from a deposit of limestone found in 1818 near Chittenango, southeast of Syracuse. The use of concrete in residential construction was publicized in the second edition of Orson S. Fowler's *A Home for All* (1853) which described the advantages of "gravel wall" construction to a wide audience. The town of Seguin, Texas, thirty-five miles east of San Antonio, already had a number of concrete buildings by the 1850s and came to be called "The Mother of Concrete Cities," with approximately ninety concrete buildings made from local "lime water" and gravel (Figure 1).

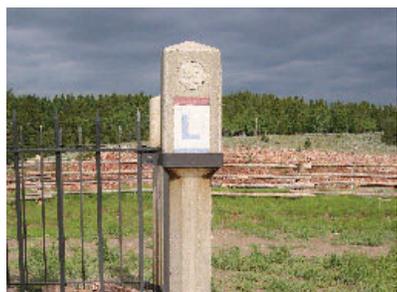
**Figure 3.** The Lincoln Highway Association promoted construction of a high quality continuous hard surface roadway across the country. The Boys Scouts of America installed concrete road markers along the Lincoln Highway in 1928.

The Lincoln Highway Association, incorporated in 1913, promoted the use of concrete in construction of a coast-to-coast roadway system. The goal of the Lincoln Highway Association and highway advocate Henry B. Joy was to educate the country in the need for good roads made of concrete, with an improved Lincoln Highway as an example. Concrete "seedling miles" were constructed in remote areas to emphasize the superiority of concrete over unimproved dirt. The Association believed that as people learned about concrete, they would press the government to construct good roads throughout their states. Americans' enthusiasm for good roads led to the involvement of the federal government in road-building and the creation of numbered U.S. routes in the 1920s (Figure 3).

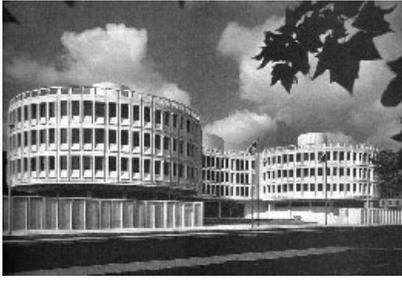
**Figure 5.** Following World War II, architects and engineers took advantage of improvements in concrete production, quality control, and advances in precast concrete to design structures such as the Police Headquarters building in Philadelphia, Pennsylvania, constructed in 1961. Photo: Courtesy of the Philadelphia Police Department.

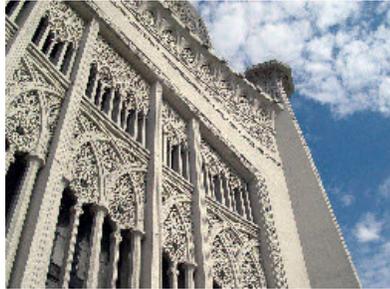
**Figure 4.** The highly ornamental concrete panels on the exterior facade of the Baha'i House of Worship in Wilmette, Illinois, illustrate the work of fabricator John J. Earley, known as "the man who made concrete beautiful."

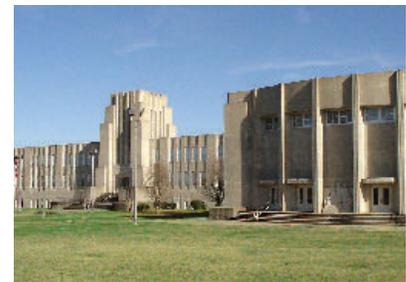
**Figure 6.** The Bailey Magnet School in Jackson, Mississippi, was designed as the Jackson Junior High School by the firm of N. W. Overstreet & Town in 1936. The streamlined building exemplifies the applicability of concrete to creating a modern architectural aesthetic. Photo: Bill Burris, Burris/Wagnon Architects, P.A

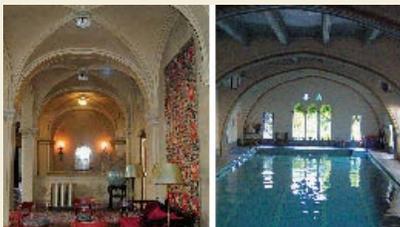
**Figure 10.** The Berkeley City Club has significant interior spaces and features of concrete construction, including the lobby and pool. Photos: Una Gilmartin (left) and Brian Kehoe (right), Wiss, Janney, Elstner Associates, Inc.

The expanded use of concrete provided new opportunities to create dramatic spaces and ornate architectural detail on the interiors of buildings, at a significant cost savings over traditional construction practices. The architectural design of the Berkeley City Club in Berkeley, California, expressed Moorish and Gothic elements in concrete on the interior of the building (Figure 10). Used as a woman's social club, the building was designed by noted California architect Julia Morgan and constructed in 1929. The vaulted ceilings, columns, and ornamental capitals of the lobby and the ornamental arches and beamed ceiling of the "plunge" are all constructed of concrete.

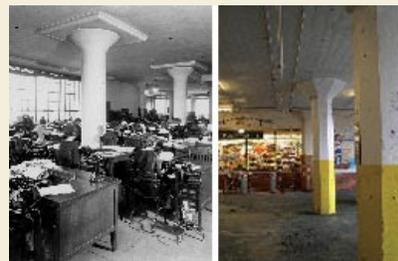
**Figure 11.** Whether in a circa 1925 office (left) or in a parking garage and retail facility (right), exposed concrete structures help characterize these building interiors. Photo: Minnesota Historical Society (left).

The historic character of a building's interior can also be conveyed in a more utilitarian manner in terms of concrete features and finishes (Figure

11). The exposed concrete structure— columns, capitals, and drop panels — is an integral part of the character of this old commercial building in Minneapolis. In concrete warehouse and factory buildings of the early twentieth century, exposed concrete columns and formboard finish concrete slab ceilings are common features as seen in this warehouse, now converted for use as a parking garage and shops.

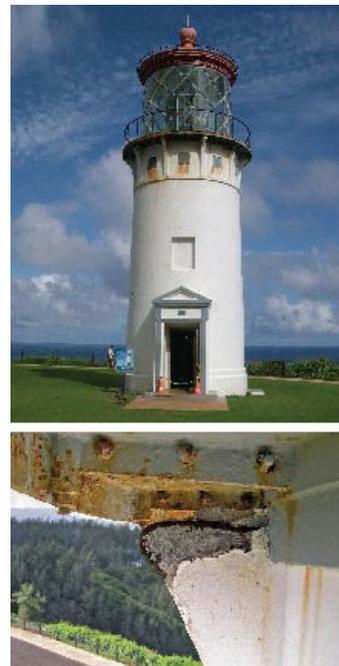
**Figure 12.** The concrete lighthouse at the Kilauea Point Light Station, Kilauea, Kauai, Hawaii, was constructed circa 1913. The concrete, which was a good quality, high strength mix for its day, is in good condition after almost one hundred years in service. Deterioration in the form of spalling related to corrosion of embedded reinforcing steel has occurred primarily in areas of higher ornamentation such as projecting bands and brackets (see close-up photo).

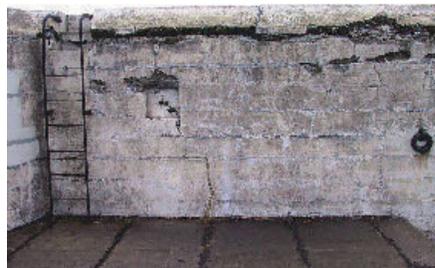
**Figure 13.** Fort Casey on Admiralty Head, Fort Casey, Washington, was constructed in 1898. The lift lines from placement of concrete are clearly visible on the exterior walls and characterize the finished appearance.

In concrete structures built prior to the First World War, concrete was often placed into forms in relatively short vertical lifts due to limitations in lifting and pouring techniques available at the time. Joints between different concrete placements (often termed cold joints or lift lines) may sometimes be considered an important part of the character of a concrete element (Figure 13). However, wide joints may permit water to infiltrate the concrete, resulting in more rapid paste erosion or freeze-thaw deterioration of adjacent concrete in cold climates.

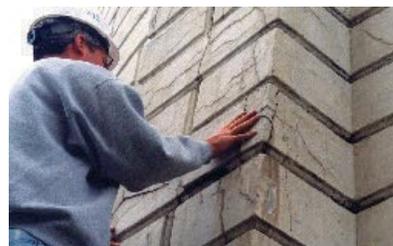
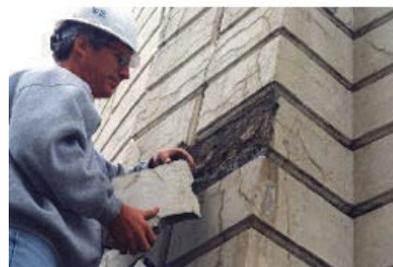
**Figures 14.** Layers of architectural concrete that have debonded (spalled) from the surface were removed from a historic water tank during the investigation performed to assess existing conditions. Photos: Anita Washko, Wiss, Janney, Elstner Associates, Inc.

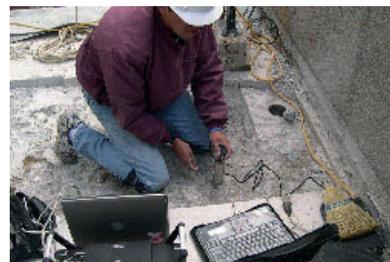
**Figure 16.** Impact echo testing is performed on a concrete structural slab to help determine depth of deterioration. In this method, a short pulse of energy is introduced into the structure and a transducer mounted on the impacted surface of the structure receives the reflected input waves or echoes. These waves are analyzed to help identify flaws and deterioration within the concrete.

A number of nondestructive testing methods can be used in the field to evaluate concealed conditions. Basic techniques include sounding with a hand-held hammer (or for horizontal surfaces, a chain) to help identify areas of delamination. More sophisticated techniques include impact-echo testing (Figure 16), ground penetrating radar, pulse velocity, and other methods that characterize concrete thickness and locate voids or delaminations. Magnetic detection instruments are used to locate embedded reinforcing steel and can be calibrated to identify the size and depth of reinforcement. Corrosion measurements can be taken using copper-copper sulfate half-cell tests or linear polarization techniques to determine the probability or rate of active corrosion of the reinforcing steel.

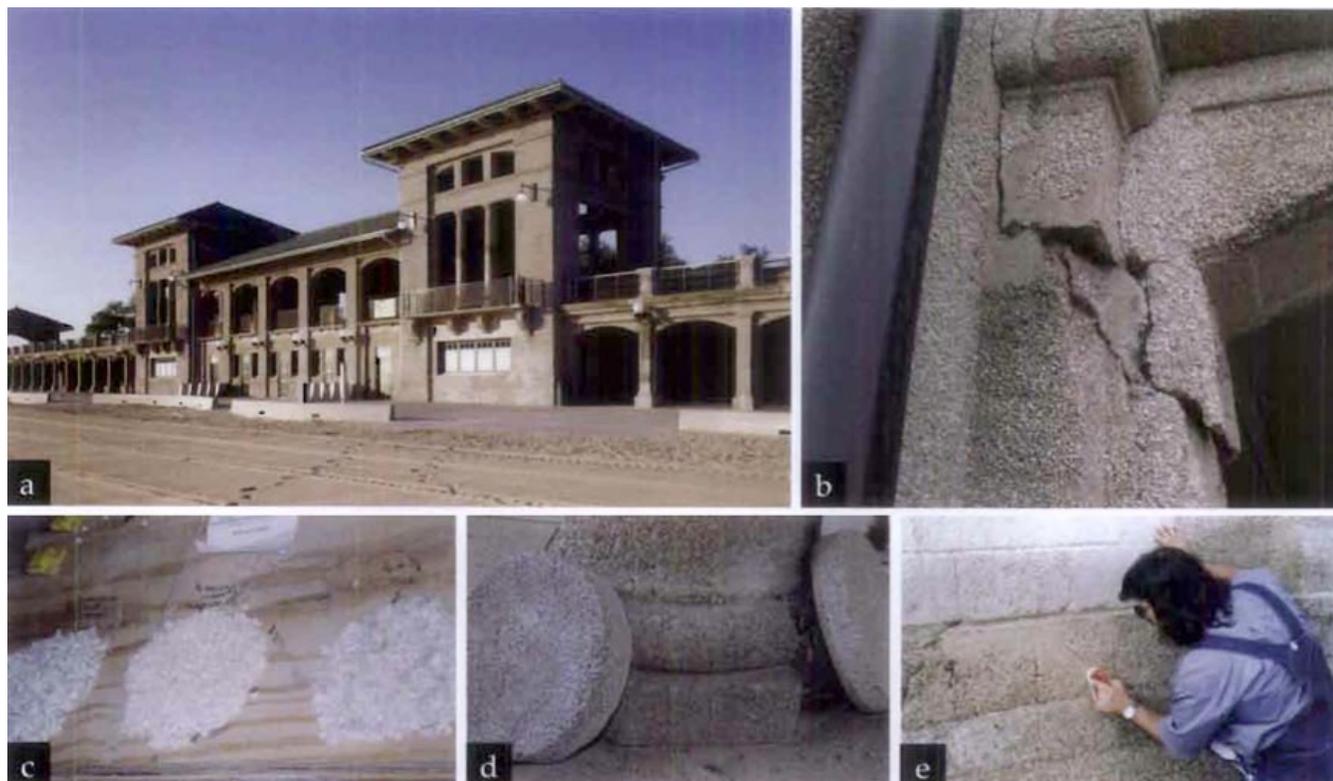
**Figure 17.** (a) The 63rd Street Beach House was constructed on the shoreline of Chicago in 1919. The highly exposed aggregate concrete of the exterior walls of the beach house was used for many buildings in the Chicago parks as an alternative to more expensive stone construction. Photo: Leslie Schwartz Photography. (b) Concrete deterioration included cracking, spalling, and delamination caused by corrosion of embedded reinforcing steel and concrete damage due to cyclic freezing and thawing. (c) Various sizes and types of aggregates were reviewed for matching to the original concrete materials. (d) Mock-ups of the concrete repair mix were prepared for comparison to the original concrete. Considerations included aggregate type and size, cement color, proportions, aggregate exposure, and surface finish. (e) The craftsman finished the surface to replicate the original appearance in a mock-up on the structure. Here, he used a nylon bristle brush to remove loose paste and expose the aggregate, creating a variable surface to match the adjacent original concrete.

durability, information gathered through trial repairs and mock-ups is invaluable in refining the construction documents prior to the start of the overall repair project (Figure 17).

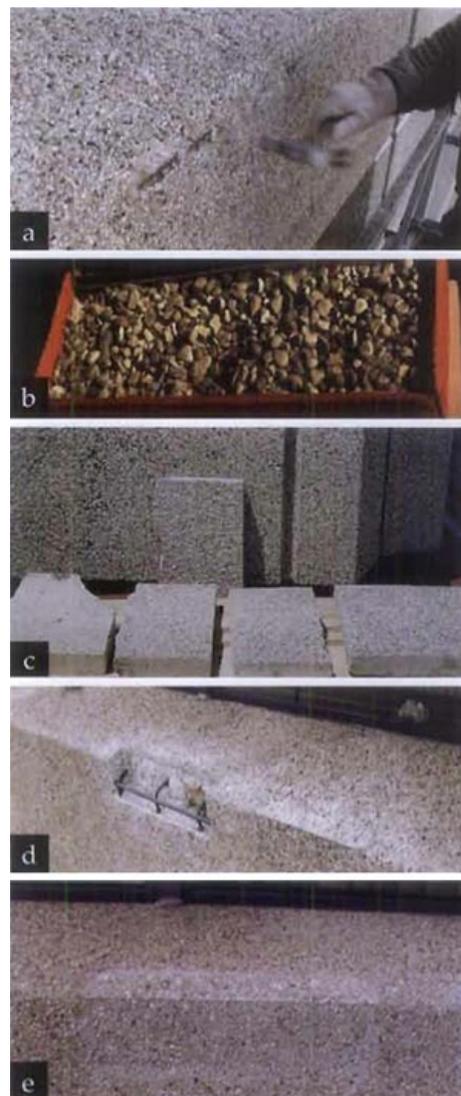
**Figure 18.** (a) Exposed aggregate precast concrete is sounded with a hammer to detect areas of deterioration. Corrosion of the exposed reinforcing steel bar has led to spalling of the adjacent concrete. (b) Samples of aggregate considered for use in repair concrete are compared to the original concrete materials in terms of size, color, texture, and reflectance. (c) Various sample panels are made using the selected concrete repair mix design for comparison to the original concrete on the building, and the mix design is adjusted based on review of the samples. (d) After removal of the spall, the concrete surface is prepared for installation of a formed patch. (e) Prior to placement of the concrete, a retarding agent is brush-applied to the inside face of the formwork to slow curing at the surface. After the concrete is partially cured, the forms are removed and the surface of the concrete is rubbed to remove some of the paste and expose the aggregate to match the original concrete.

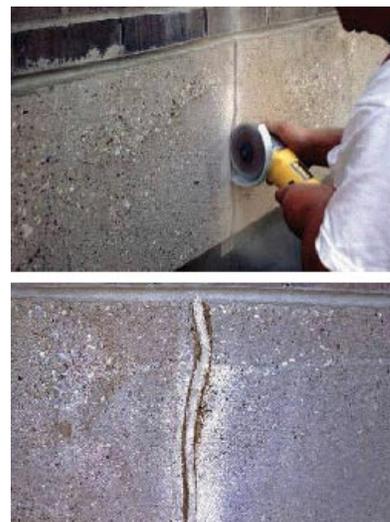
**Figure 19.** A high-speed grinder is used to widen a crack in preparation for installation of a sealant. This process is called "routing." After the crack is prepared, the sealant is installed to prevent moisture infiltration through the crack. Although sealant repairs can provide a durable, watertight repair for moving cracks, they tend to be very visible.

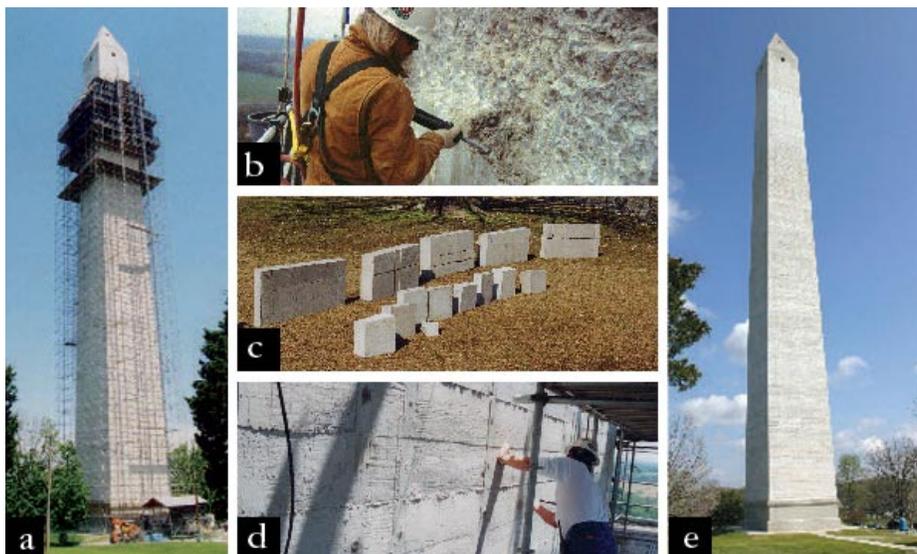
**Figure 20.** (a) The Jefferson Davis Memorial in Fairview, Kentucky, constructed from 1917-1924, is 351 feet tall and constructed of unreinforced concrete. The walls of the memorial are 8 feet thick at the base and 2 feet thick at the top of the wall. Access to the monument for investigation was provided by rappelling techniques, while ground supported and suspended scaffolding was used to access the exterior during repairs. (b) The concrete was severely deteriorated at isolated locations, with spalling and damage from cyclic freezing and thawing of entrapped water. In addition, previous repairs were at the end of their service life and removal of deteriorated concrete and failed previous repairs was required. Light duty chipping hammers were used to avoid damage to adjacent material when removing deteriorated concrete to the level of sound concrete. (c) Field samples were performed to match the color, finish, and texture of the original concrete. A challenge in matching of historic concrete is achieving variability of appearance. (d) The completed surface after repairs exhibits intentional variability of the concrete surface to match the appearance of the original concrete. Some formwork imperfections that would normally be removed by finishing were intentionally left in place, to replicate the highly variable finish of the original concrete. (e) The Jefferson Davis Memorial after completion of repairs in 2004. Photo e: Joseph Lenzi, Senler, Campbell & Associates, Inc.
