Certificate of Appropriateness

1145 W. WISCONSIN AV.

Gesu Church

PTS ID 114420 COA: gutters and downspouts

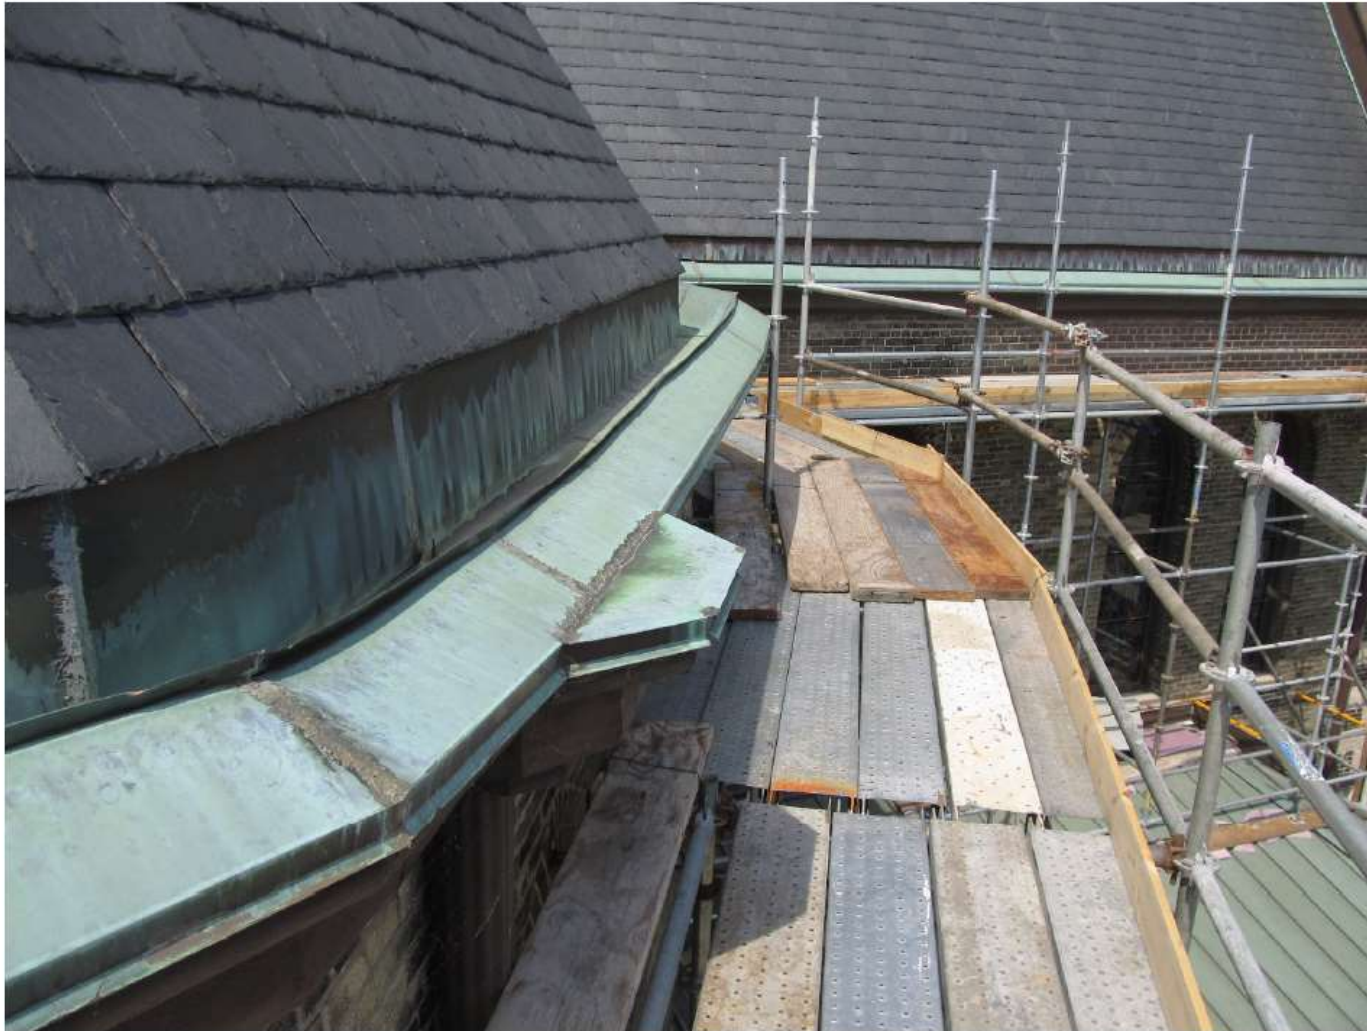
Photo 1 shows the 1972 copper gutter liner – which was leaking at holes, tears and split seams.

- Removal of 1972 20-ounce copper gutter liners and later asphalt membrane liners and liner substrates.
- Repair wood gutter bed where needed.
- Install waterproofing underlayments.
- Install new 20-ounce copper gutter liners to match historic gutter liners.
- Install snow fence to match existing.
- Repair 3 small sections of cornice to match existing.
- Replace sections of split copper downspouts with matching copper downspouts.

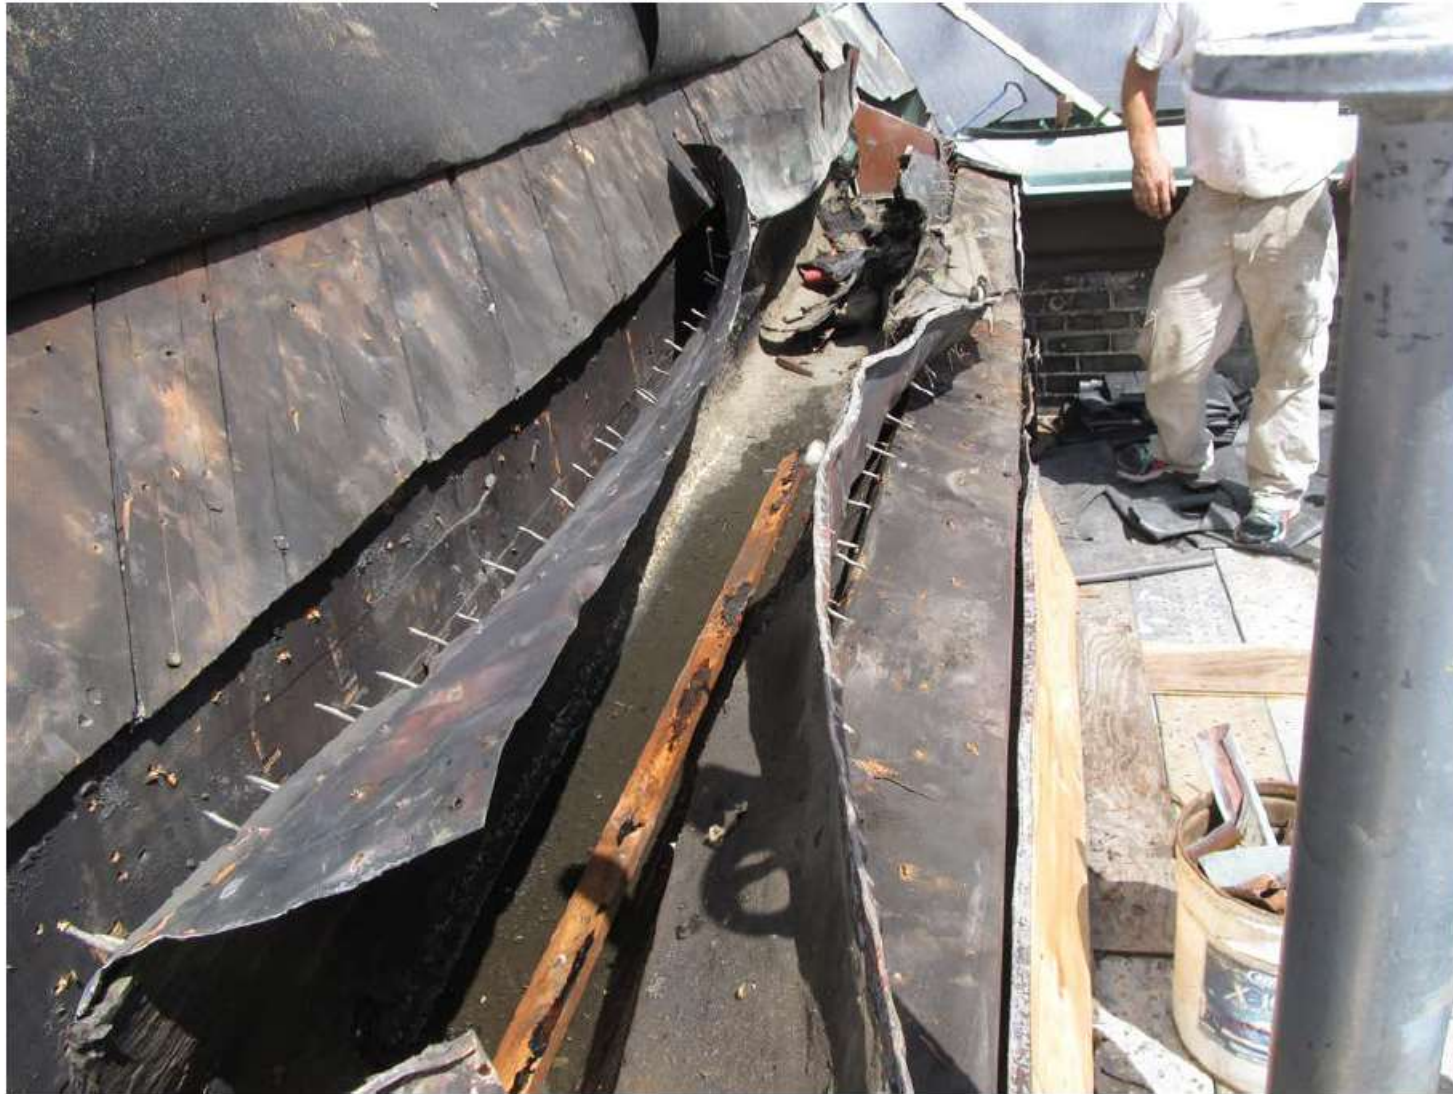
Photo 2 shows removal of the 1972 gutter liner and the later membrane liner, and then exposing the original wood gutter liner bed and top of the original cornice which were left in place.

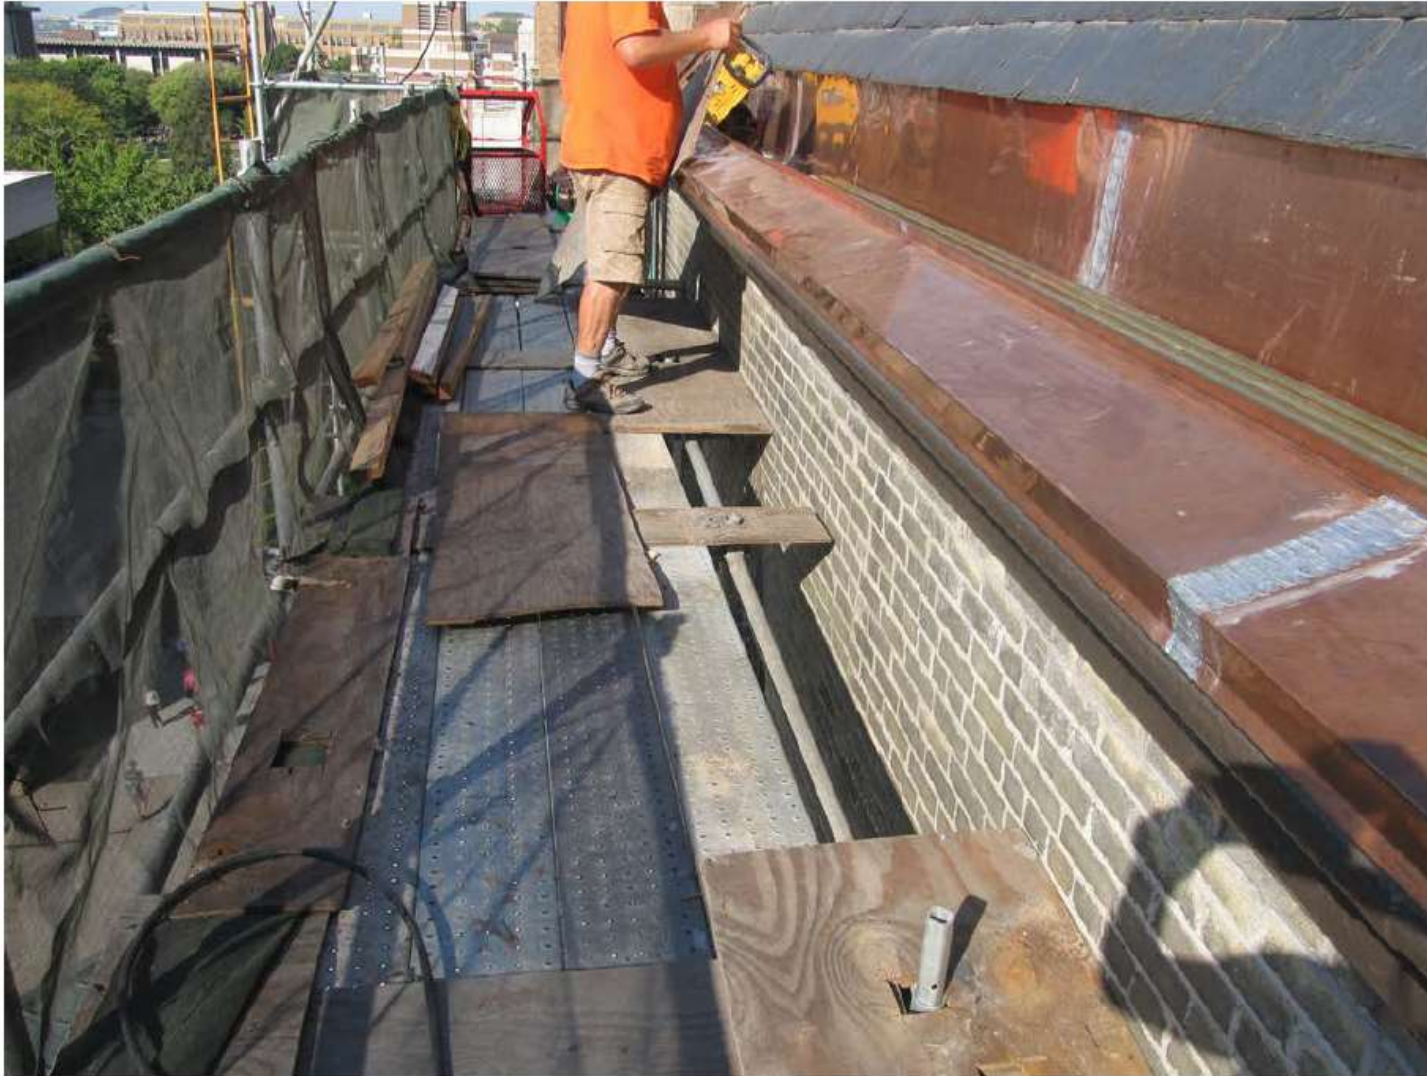
Photo 3 shows the new 20 ounce copper gutter liner set to the original cornice and the slate roof.

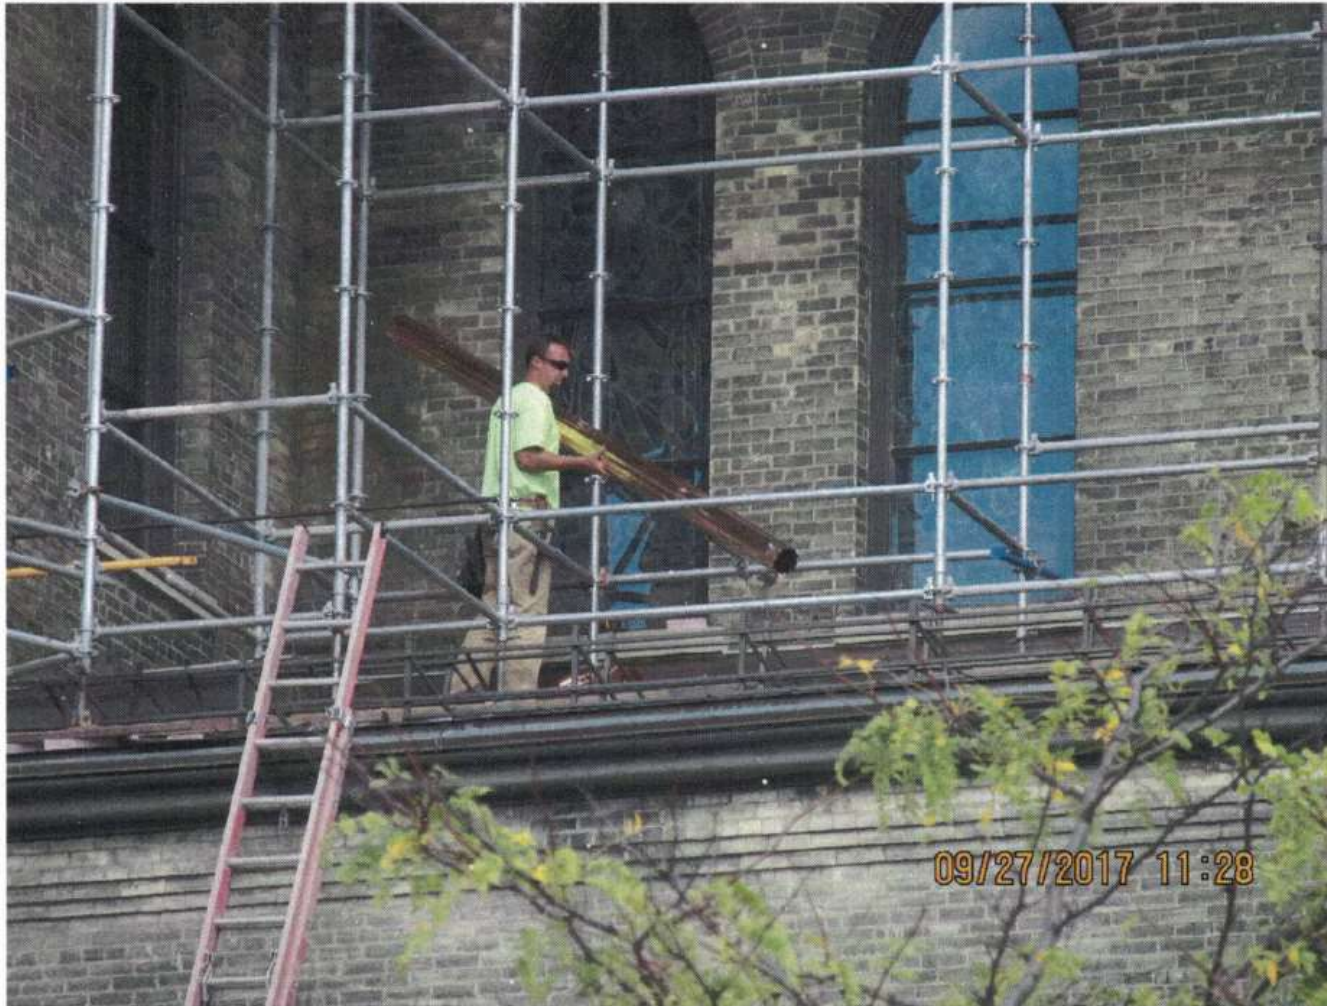
Photo 4 shows on of the replaced in kind copper downspouts that match the still remaining originals and earlier replacements. Much of the exterior of the building remains original and the policy of the owner is to carefully follow The Secretary of the Interior's Standards for Rehabilitation of Historic Buildings.
