Contribution of Service Line and Plumbing Fixtures to Lead and Copper Rule Compliance Issues

Anne Sandvig, Pierre Kwan, and Gregory Kirmeyer

HDR Engineering

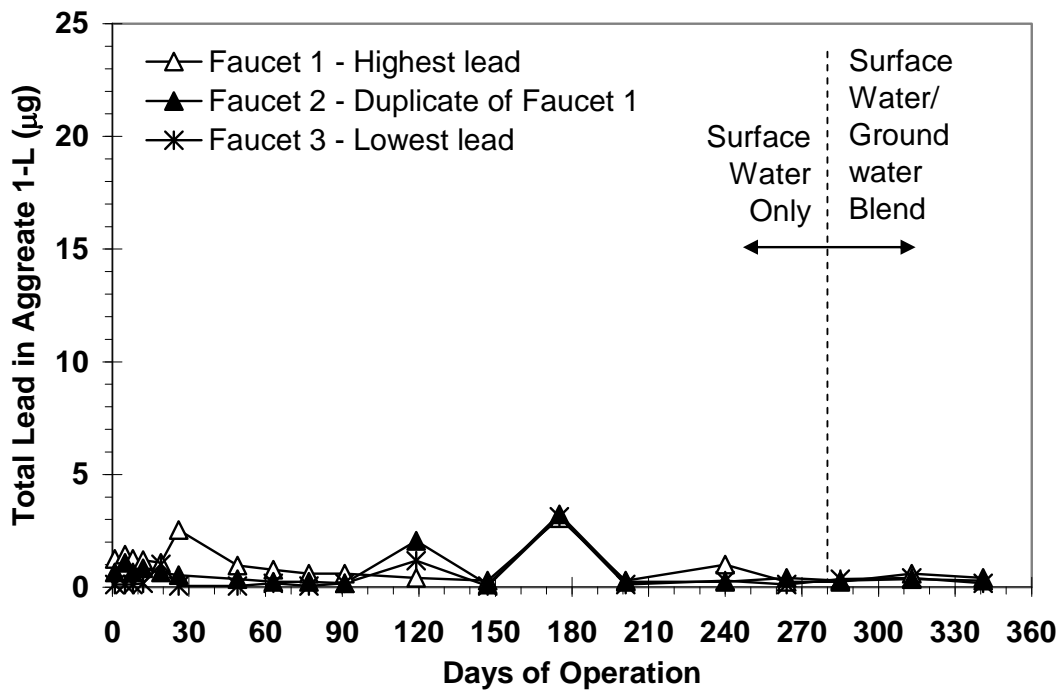
Figure C.13 Total lead mass in aggregate 1-L samples for Faucets 1, 2, and 3 over time.

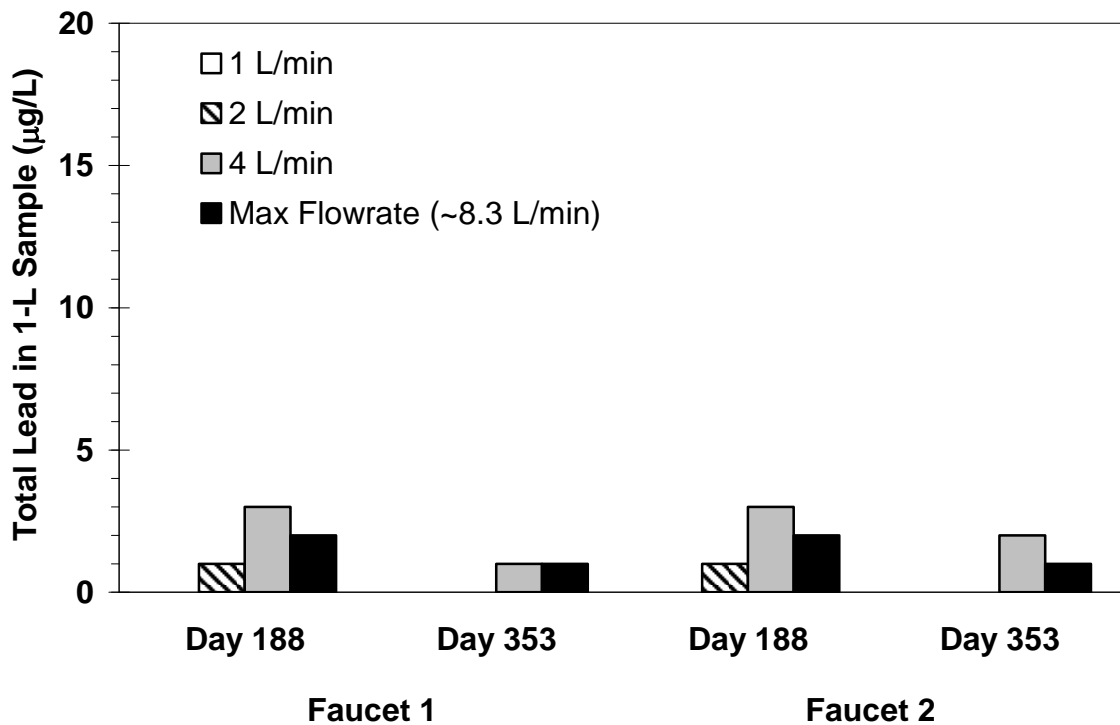
Figure C.15 Total lead in 1-L samples for Faucets 1 and 2 as function of sampling flow rate.

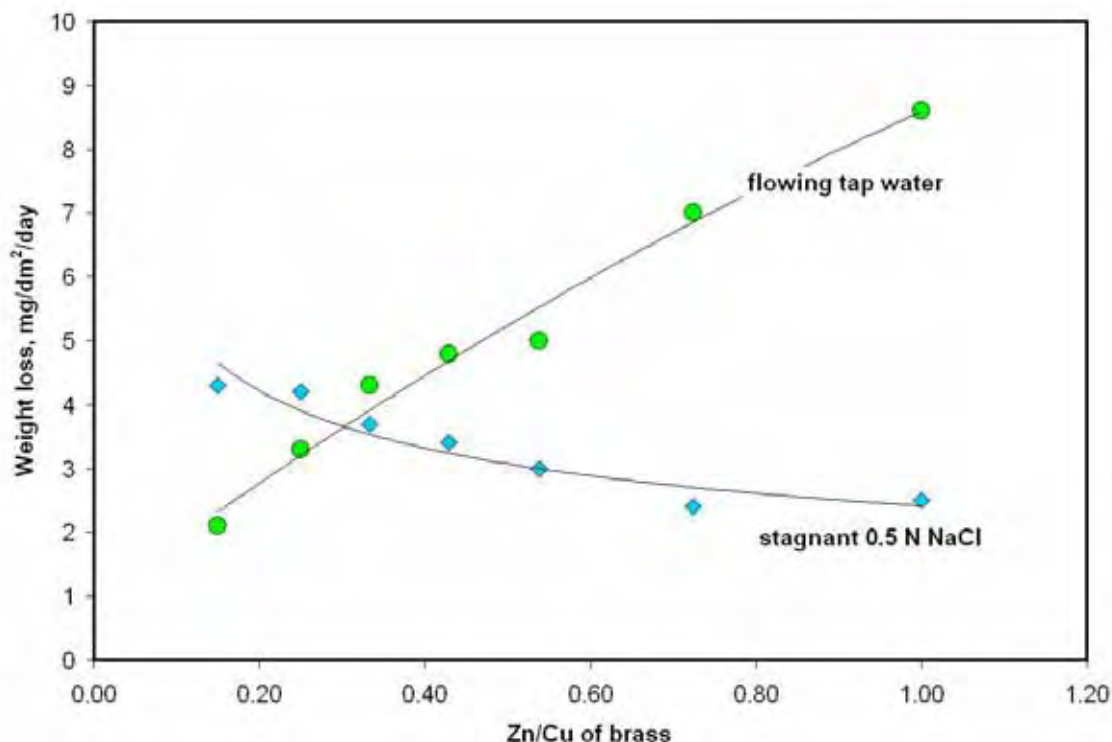
Figure C.34 Corrosion rates for brass coupons a function of Zn/Cu content of the brass. The r^2 values for the two functions are 0.982 and 0.985. Flowing 0.5 N NaCl produces similar results to the flowing tap water, but with rates about 2X higher.

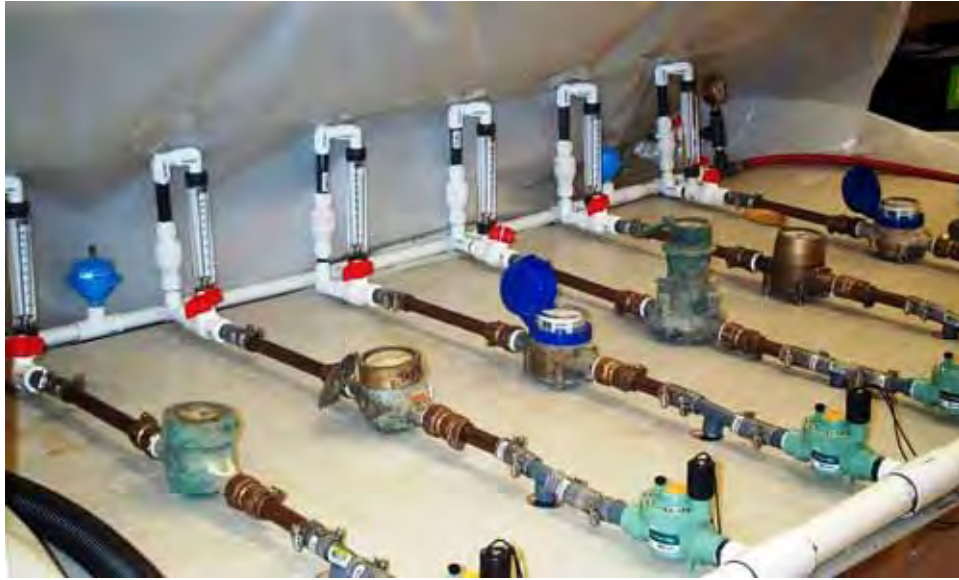
Figure C.35 Water meter test rig. Meters are numbered from left to right, with Meter 1 being the leftmost one and Meter 6 the rightmost.

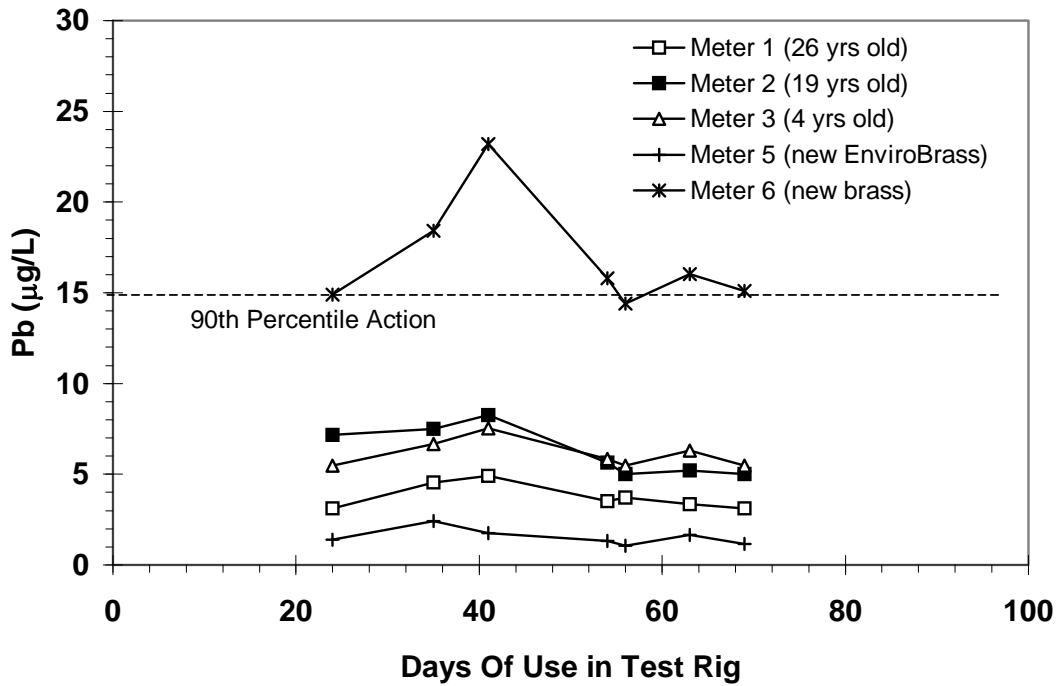
Figure C.36 Total Pb detected in 250-mL 6-hour stagnation samples from stabilization period for Meters 1, 2, 3, 5, and 6. Stabilization period ends on Day 101.

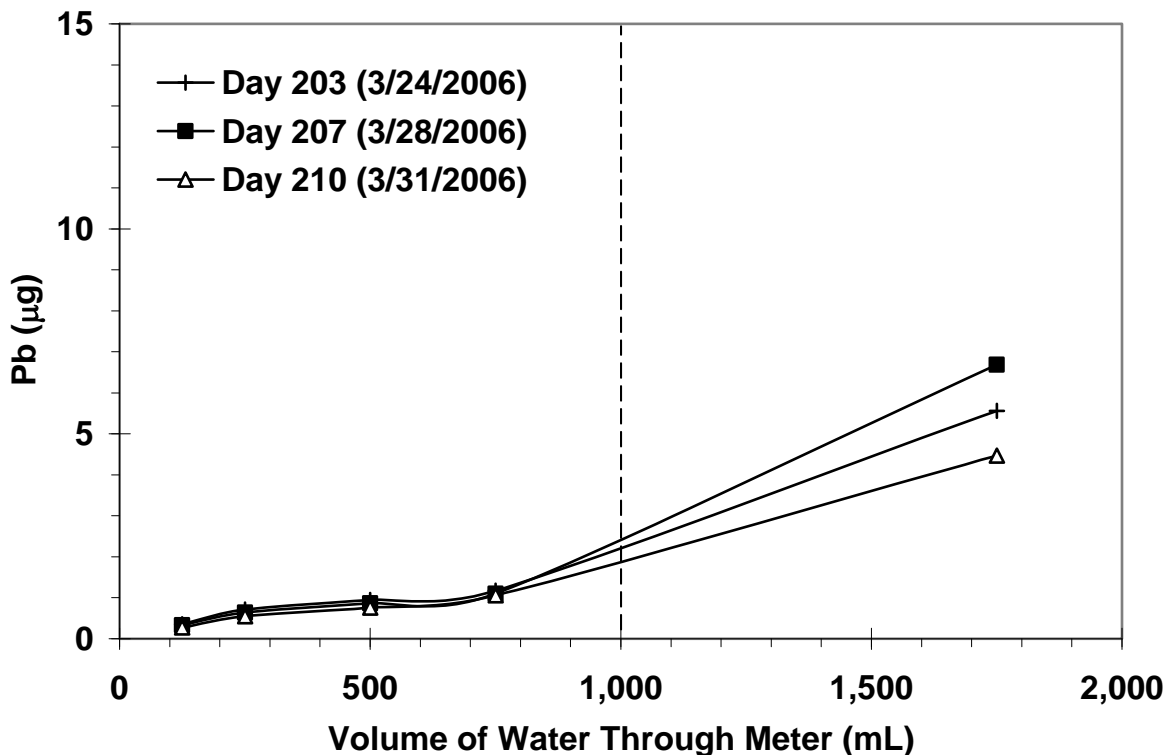
Figure C.54 Cumulative total Pb mass in Meter 1 – 26 years old (6-hour stagnation samples from simulated use at 4 L/min).

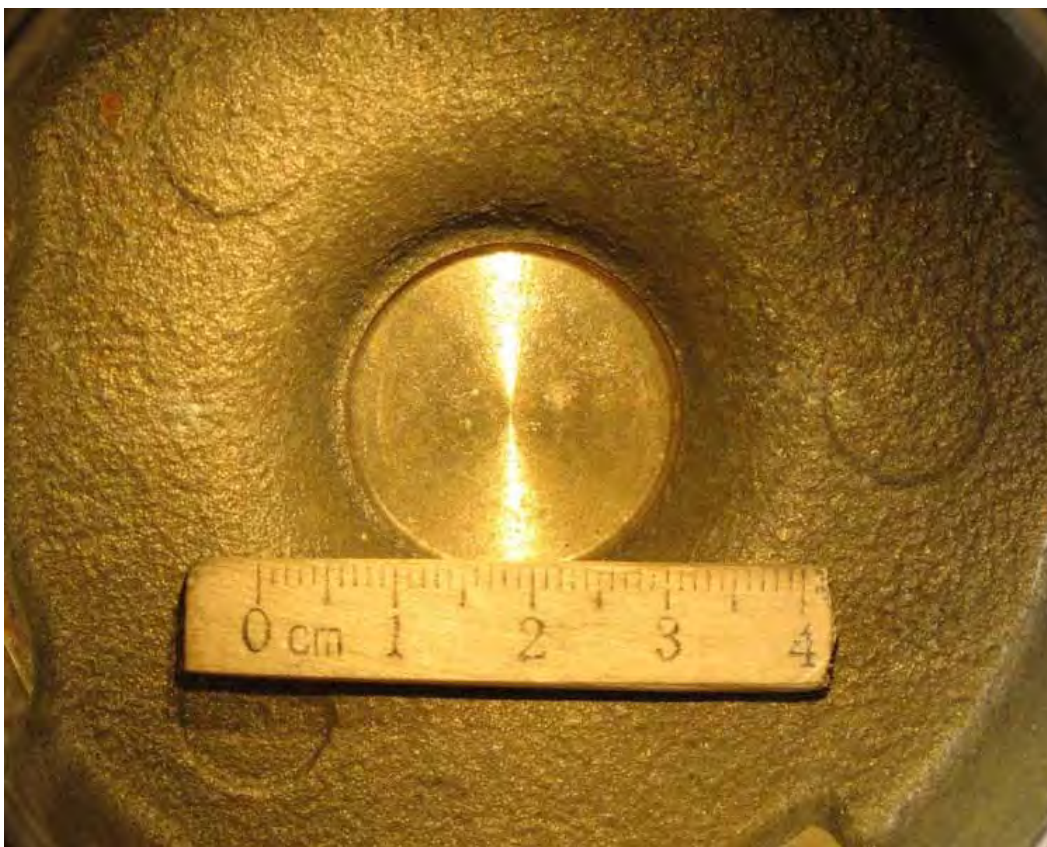
Figure C.78 Photograph of the bottom of meter 5.

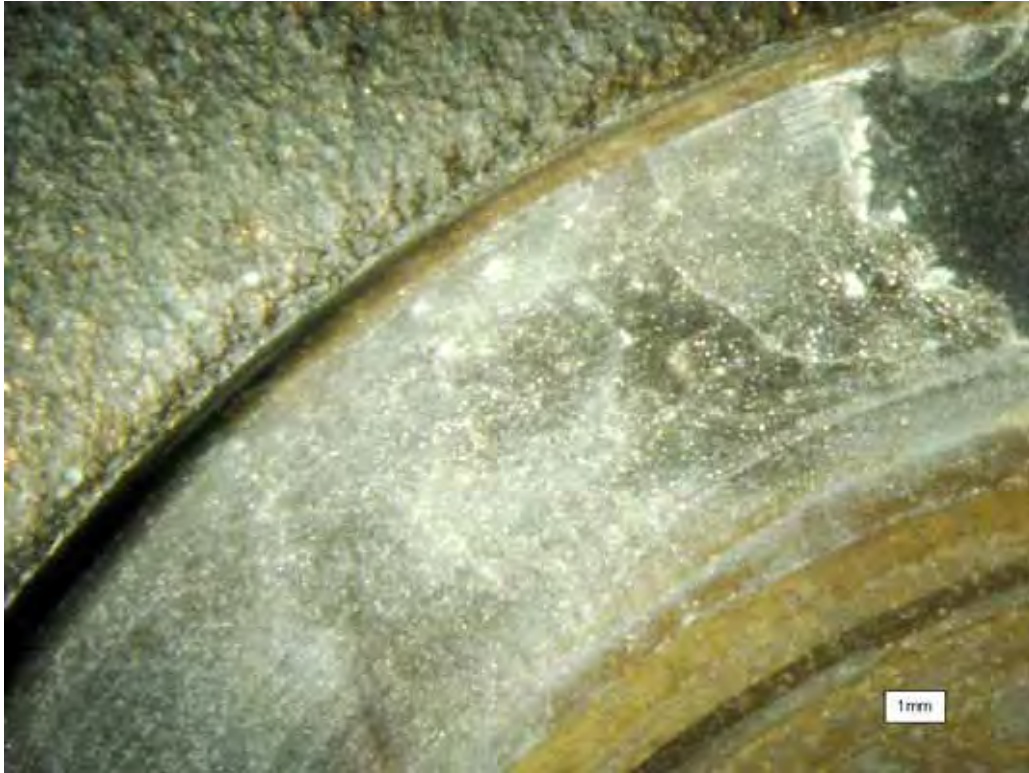
Figure C.80 Photograph of the bottom of meter 6.

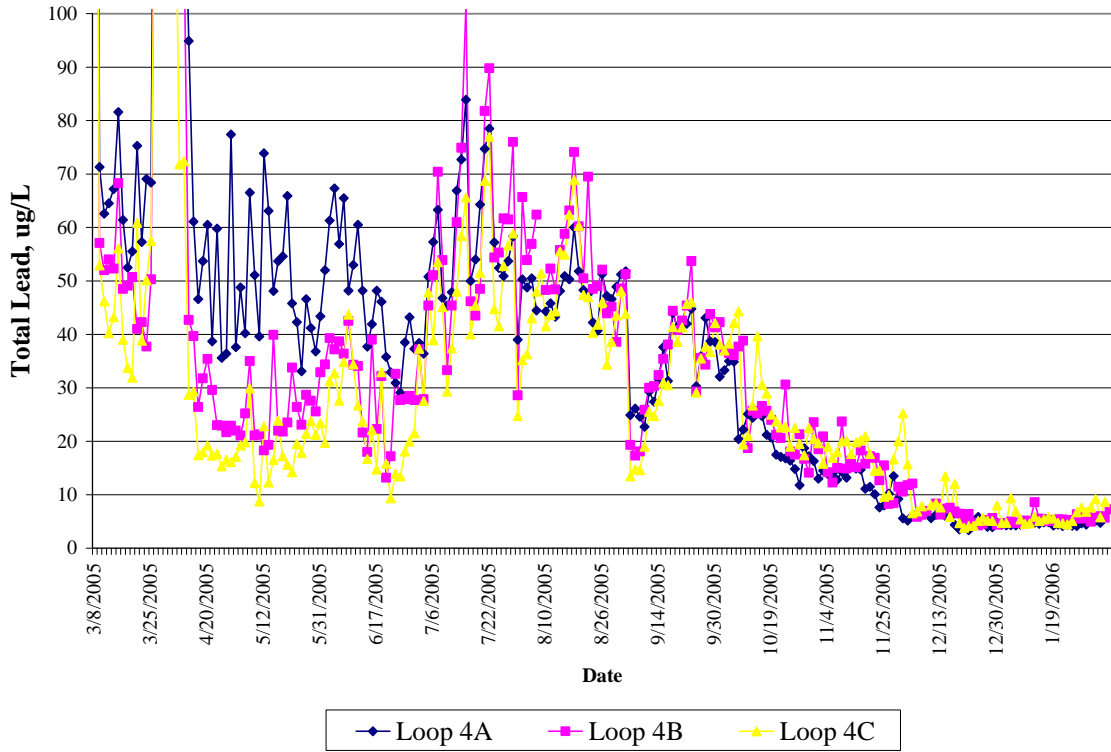
Figure C.91 Rack 4. High chloramines, no corrosion inhibitor

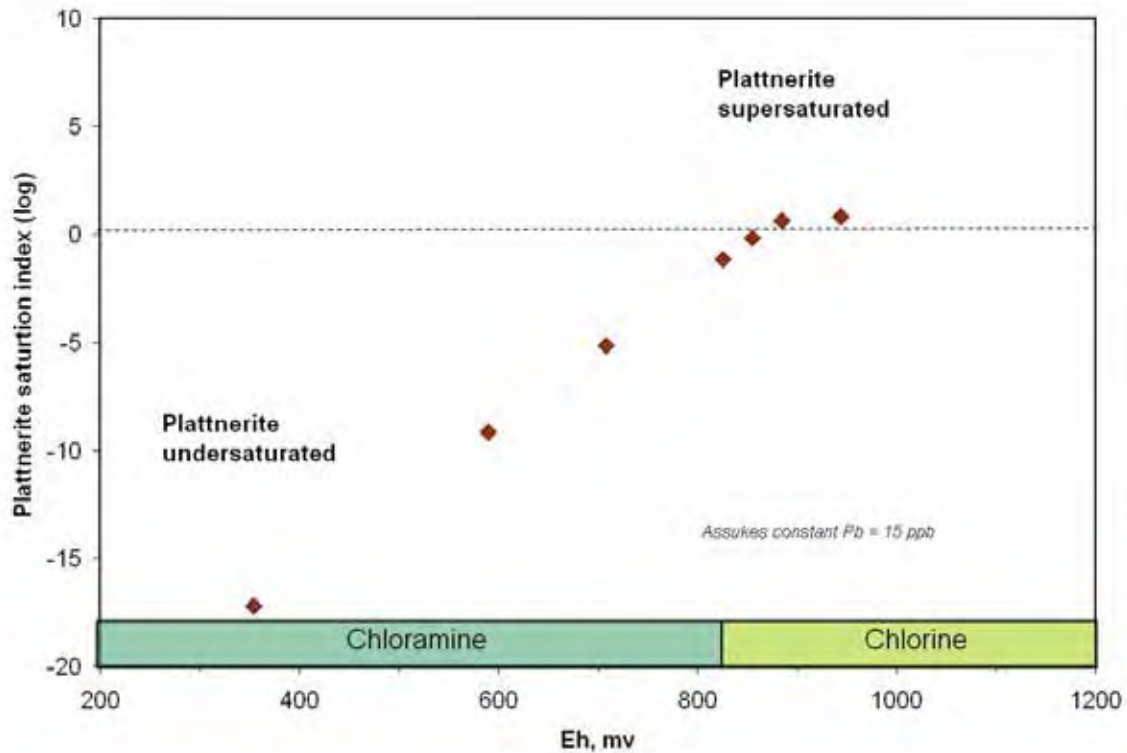
Figure C.103 Relationship of plattnerite solubility to oxidation state of the water for Washington Aqueduct finished water with 15 ppb Pb. Plattnerite is unstable in the presence of chloramine.

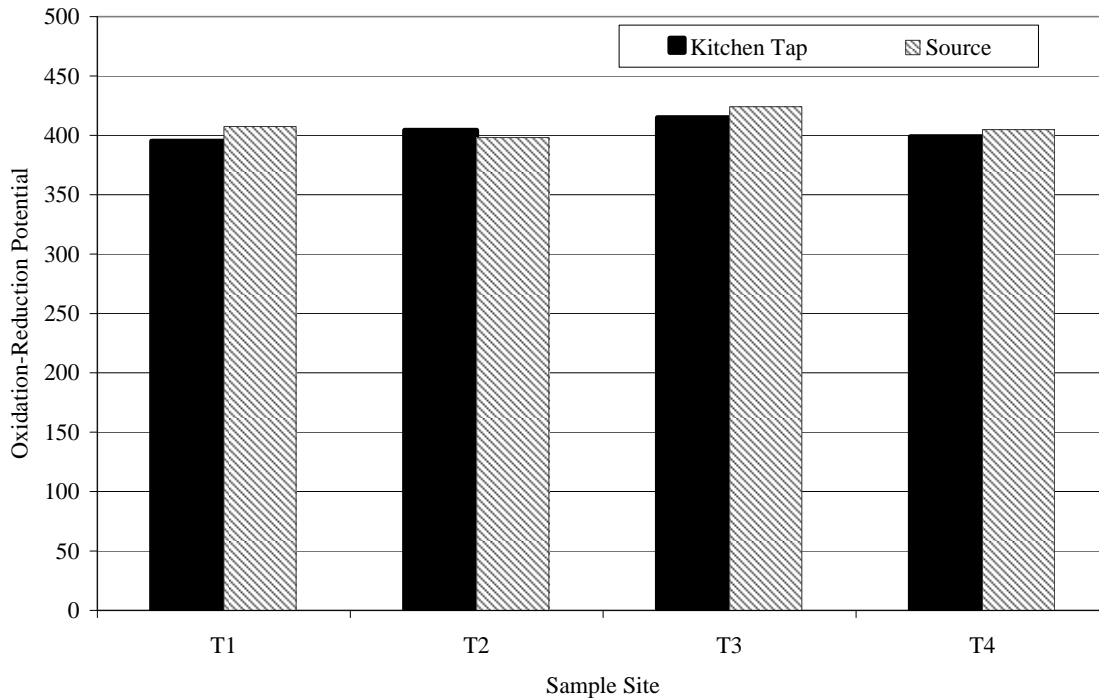
Figure F.49 Oxidation/Reduction Potential for Toronto LSLR Sites

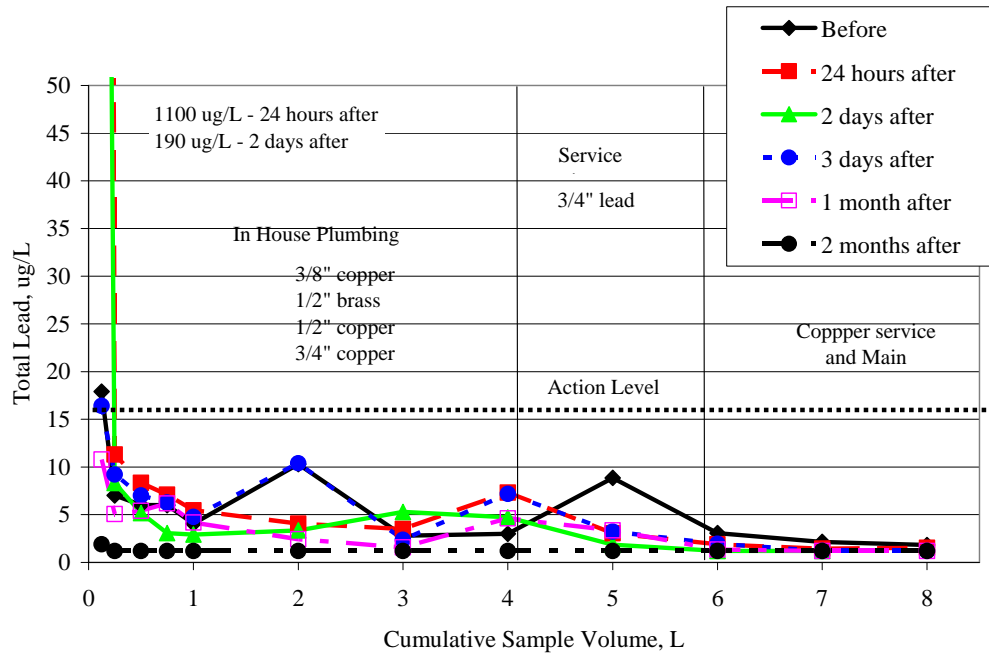
Figure F.85 Site B-1 Total Lead Level Concentration Profiles (stagnation)
