LAMERS BLOCK

830-832(A) S. 5th Street

HISTORIC DESIGNATION REPORT

MAY 2023

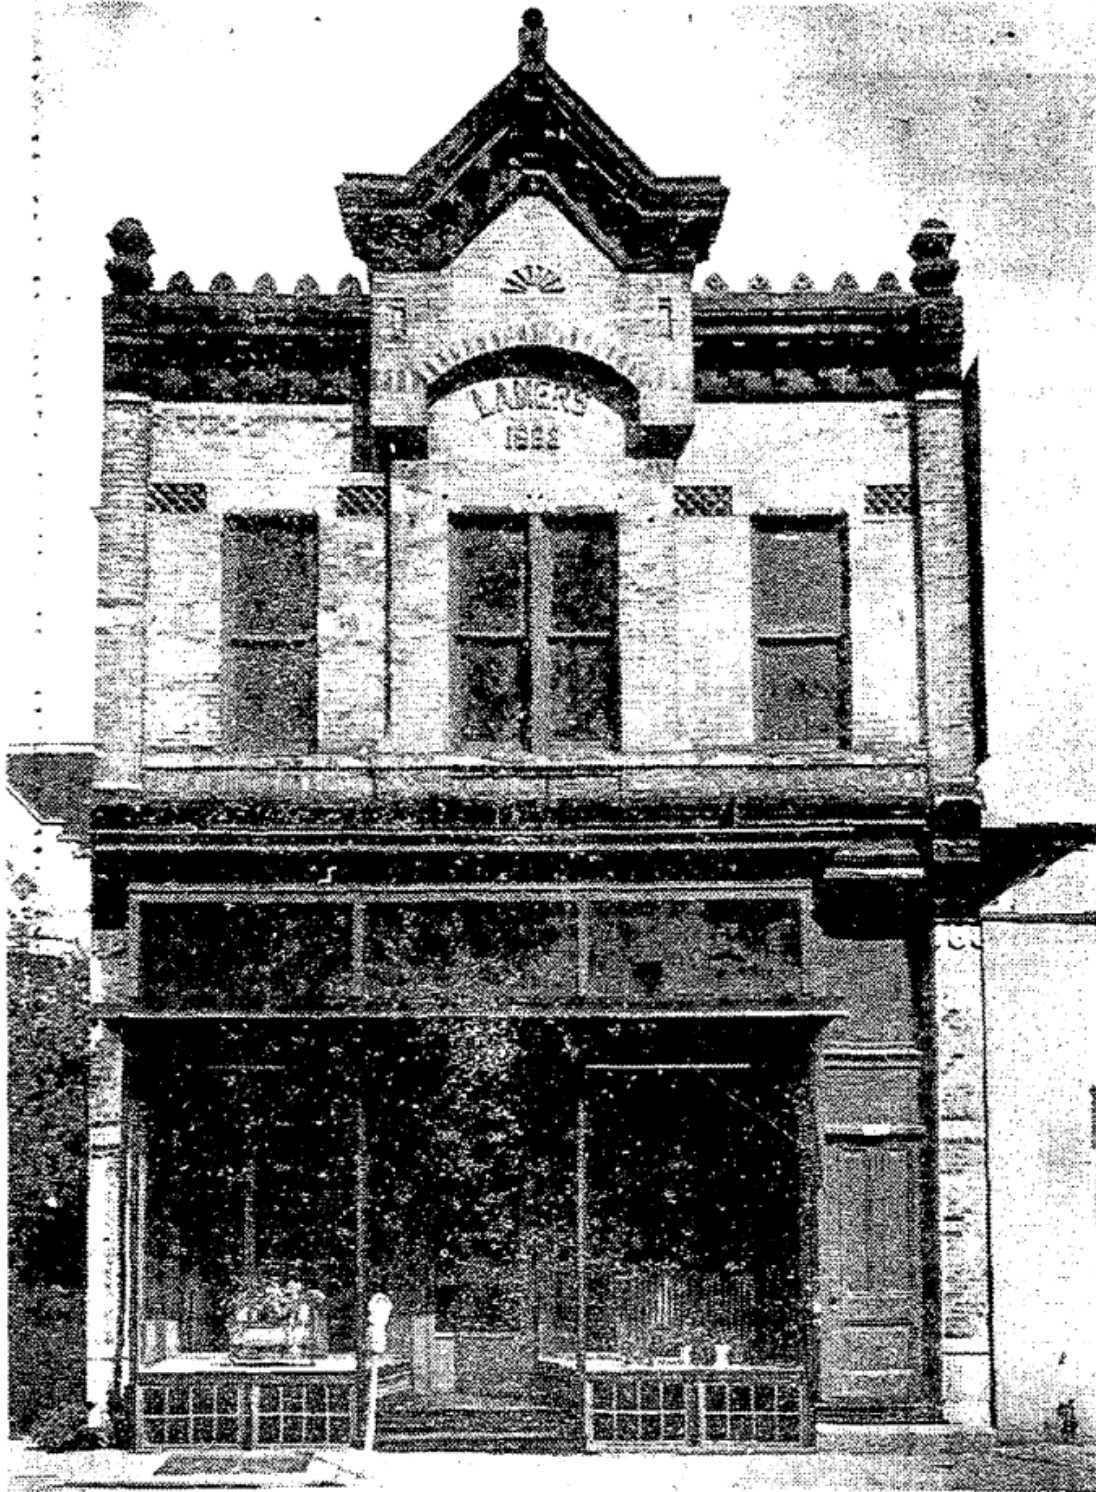
Figure 9. *Milwaukee Journal*, September 25, 1977.

Green paint was stripped from the first floor facade of the Lamers building at 830 S. 5th St., and the metal was painted black, the wood caramel. The owner, sculptor Celine Farrell, did most of the work herself.
