Contribution of Service Line and Plumbing Fixtures to Lead and Copper Rule Compliance Issues

Subject Area:
Infrastructure Reliability

Anne Sandvig, Pierre Kwan, and Gregory Kirmeyer

HDR Engineering

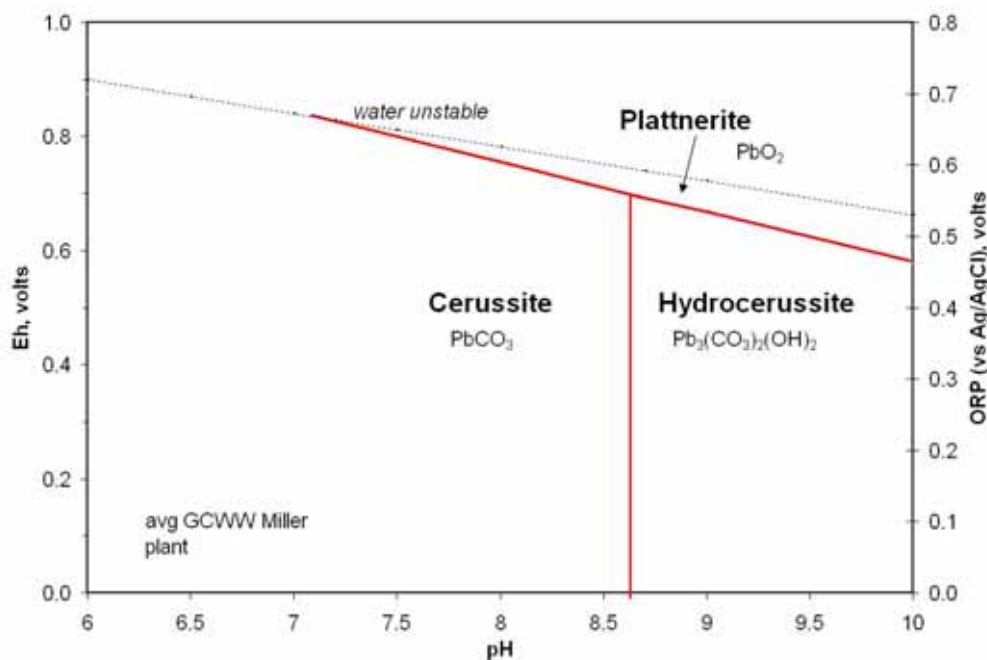
Figure 2.5 Eh-pH diagram for the Pb carbonates and the oxide plattnerite under alkaline conditions

The importance of plattnerite is that it can revert to more soluble lead minerals if the Eh subsequently drops (Figure 2.5). Lytle and Schock (2005) presented experimental evidence for ready reversibility of the plattnerite-cerussite transition. A possible explanation for increases in lead in systems that change from chlorine to chloramine disinfection, may be that the Eh is reduced below the stability level of plattnerite, allowing litharge to temporarily control lead levels (Edwards and Dudi 2004; Schock and Giani 2004).

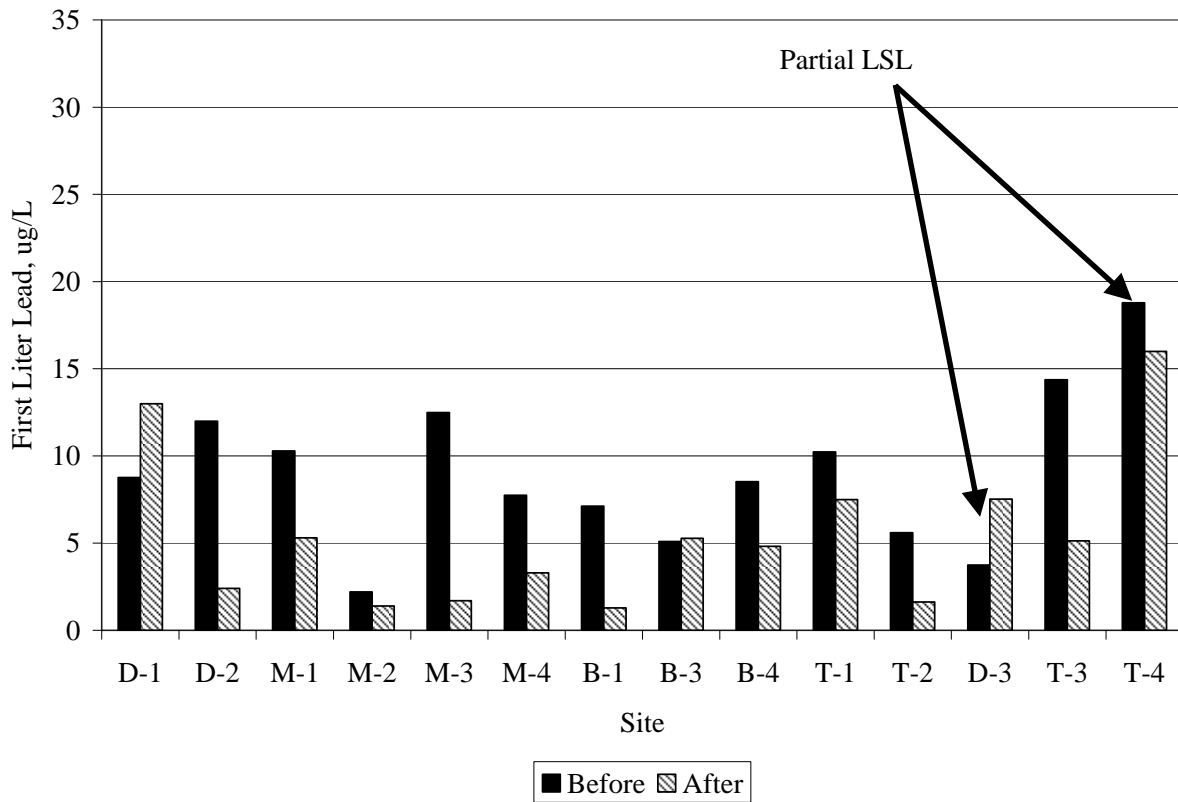
Figure 3.5 First-liter lead levels before and one or two months after LSL replacement

For the remaining sites where the entire lead service line was replaced, first-liter lead levels were generally lower within 1 to 2 months after replacement, or the same after replacement at sites where the first-liter lead levels was already low before the replacement (i.e., $\leq 5 \mu\text{g/L}$). One site (D-1) exhibited a reduction in total mass measured at the tap during sequential sampling, but the first-liter lead level was higher after full lead service line replacement ($8.8 \mu\text{g/L}$ before and $13.0 \mu\text{g/L}$ after). At this site, the third sample volume collected at the tap (third 125-mL sample) before replacement had a lead level of $20 \mu\text{g/L}$, indicating that there was a source of lead in the premise piping, just beyond the faucet. This may have been due to a brass fitting or flexible connector. Full lead service line replacement at this site did not improve the first-liter lead level; however, additional sampling would be needed to verify if there would be improvement over time. Figures 3.4 and 3.5 display the total lead mass measured from sequential samples and the first-liter lead levels measured before and after replacement at field study sites.

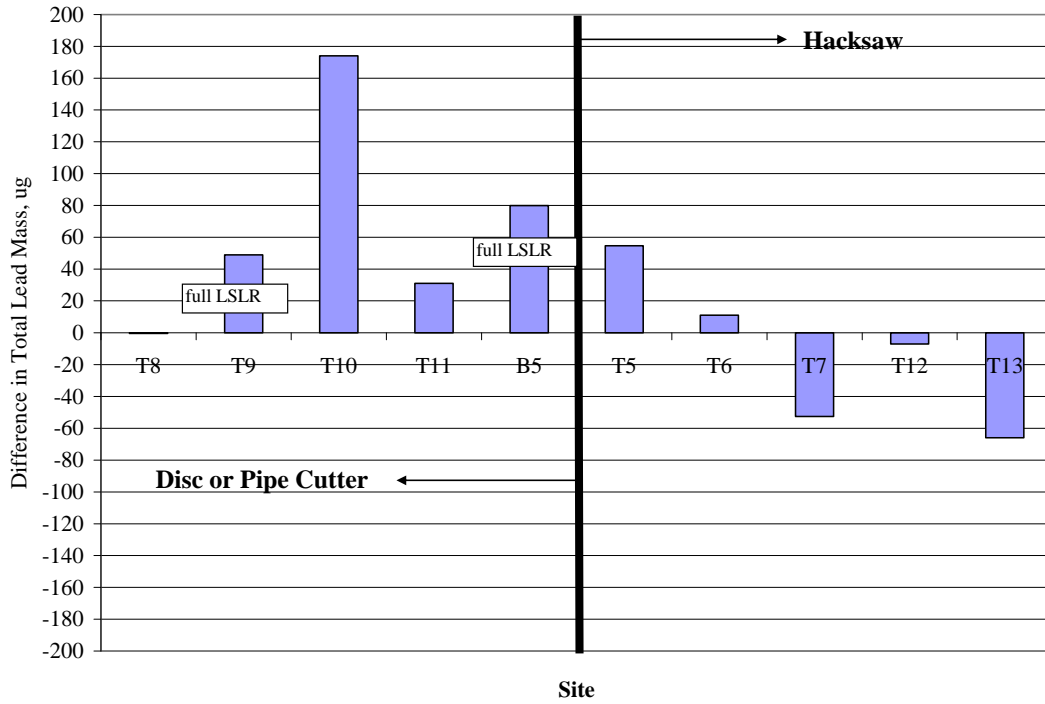
Figure 3.8 Difference in total lead mass measured at the tap at pipe cutting evaluation sites

Site	Type of Replacement	Type of Cutting	1 st Liter Before Replacement, µg/L	1 st Liter 3 Days After Replacement, µg/L	Difference in Total Mass at Tap after 3 days, ug
T5	Partial	Hacksaw	45.8	35.0	54.7
T6	Partial	Hacksaw	11.0	11.0	11.0
T7	Partial	Hacksaw	4.0	5.5	-52.7
T12	Partial	Hacksaw	15.0	10.0	-7.0
T13	partial	Hacksaw	11.0	32.0	-66.0
T8	Partial	Disc cutter	4.9	5.4	-0.4
B5	Full	Pipe cutter	29.4	33.1	79.9
T9	Full	Disc cutter	38.0	48.0	49.0
T10	Partial	Disc cutter	7.0	6.0	174.0
T11	Partial	Disc cutter	17.0	18.0	31.0

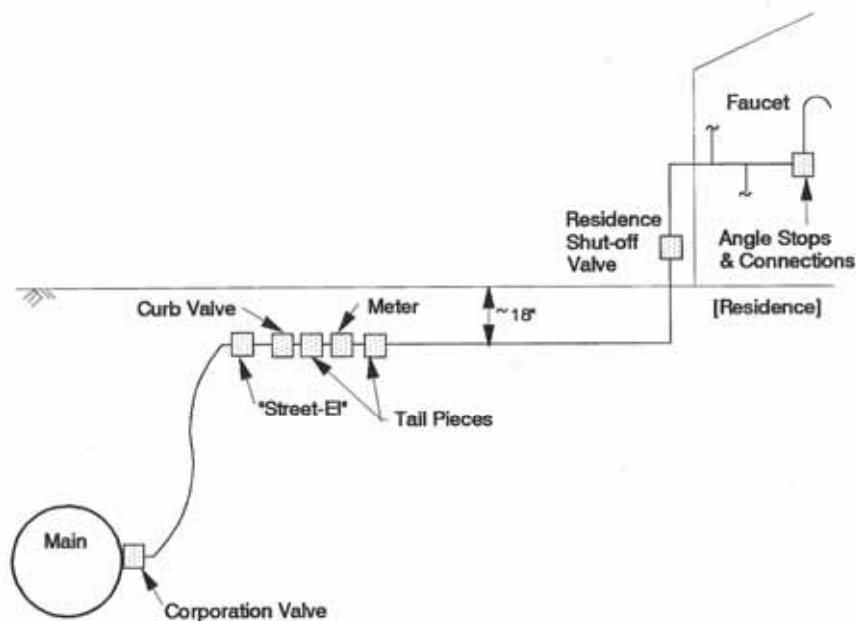
Figure B.4.1. Diagram of Typical Warm Climate Residential Service (Provided by Heumann 2005)

The LADWP system has one type of customer service, the Western or warm-climate service as illustrated in [Figure B.4.1](#).

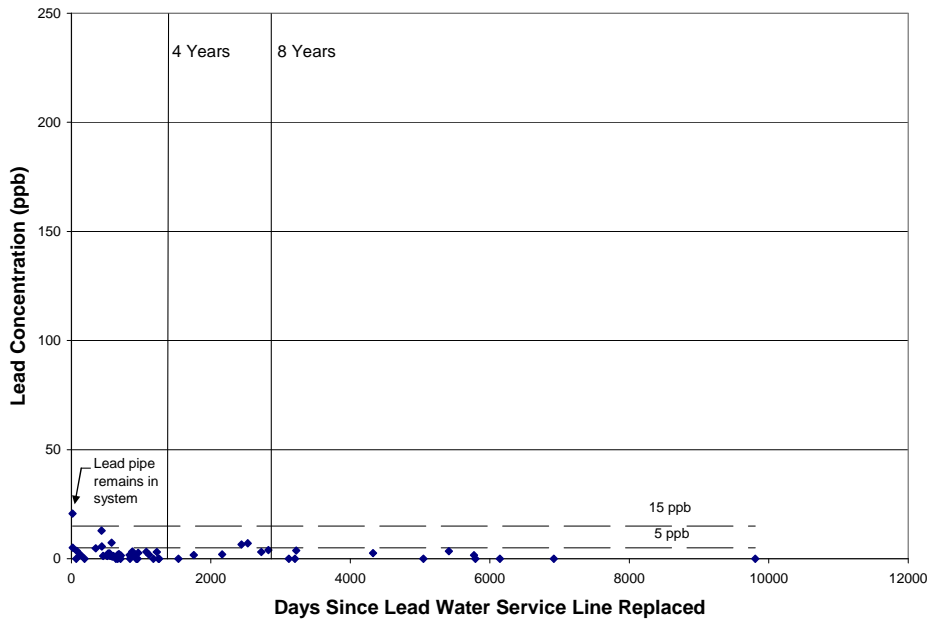
Figure B.6.3 Dissolved Lead Concentration vs. Time Since Full Lead Service Line Replacement

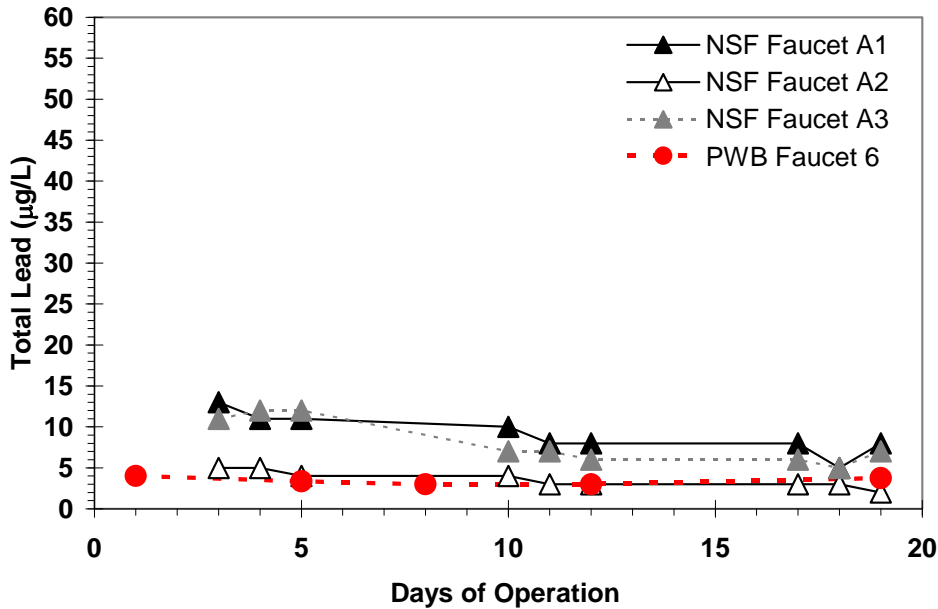
Figure C.22 ANSI/NSF Standard 61, Section 9 results for California Proposition 65 faucet (PWB Faucet 6).

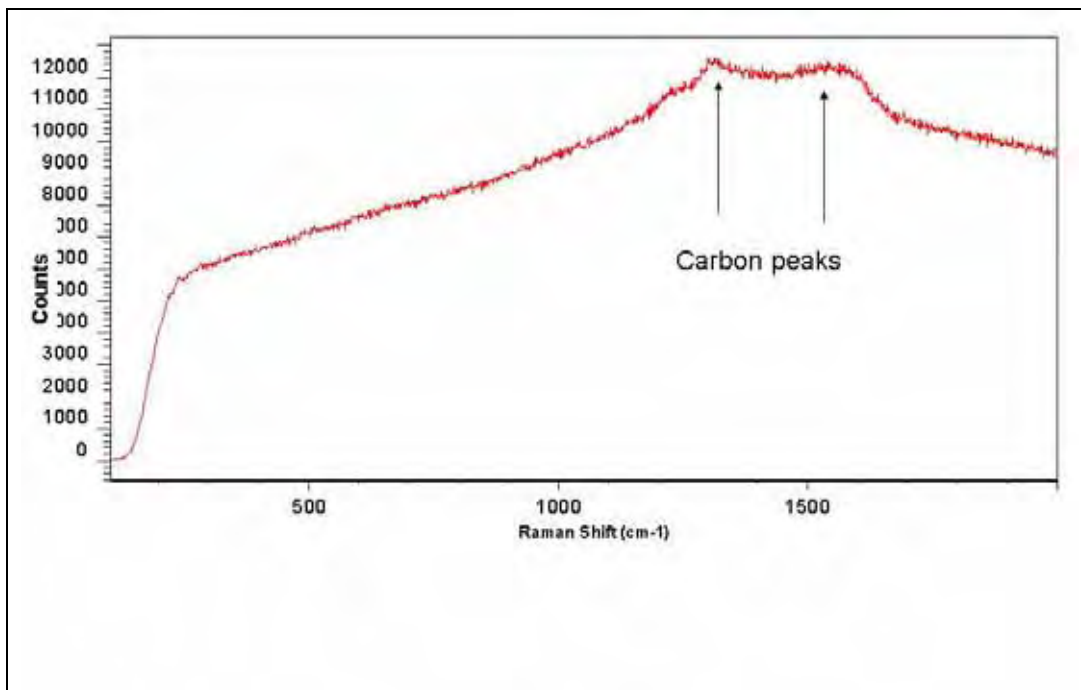
Figure C.29 Raman spectrum of ridges on spout interior surface. These ridges or mounds cover tension cracks; the Raman signal confirms that these are organic in origin.

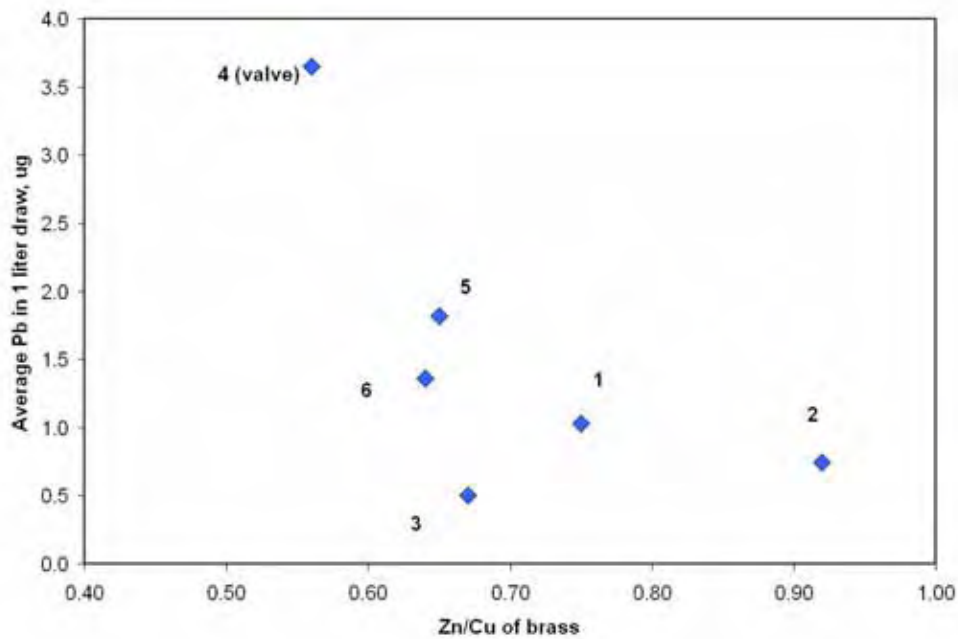
Figure C.33 Rate of Pb release as a function of Zn/Cu content of brass. The inverse relationship with Zn content is unexpected, but is shown dramatically by faucets 1 and 2, which are identical in all other aspects.

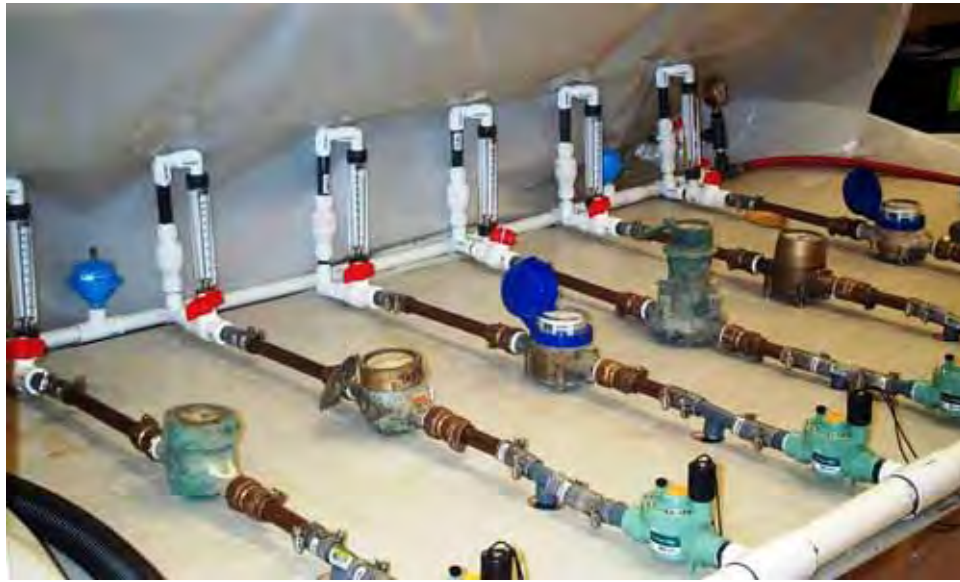
Figure C.35 Water meter test rig. Meters are numbered from left to right, with Meter 1 being the leftmost one and Meter 6 the rightmost.

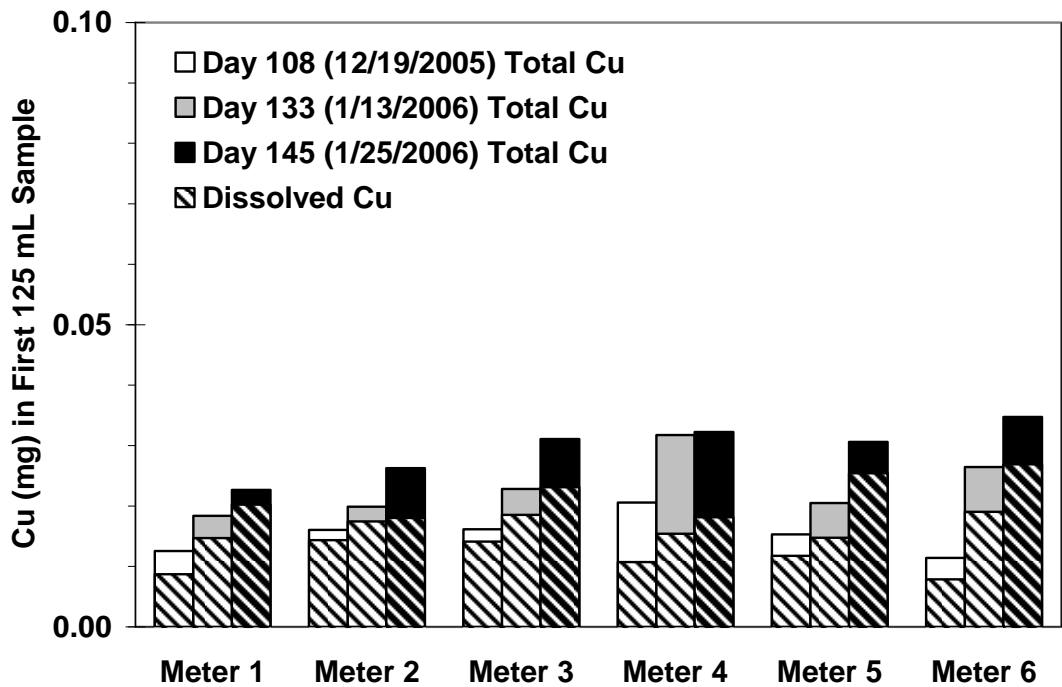
Figure C.50 Comparison of total and dissolved Cu in first 125 mL sample from each meter (6-hour stagnation samples from simulated use at 1 L/min).

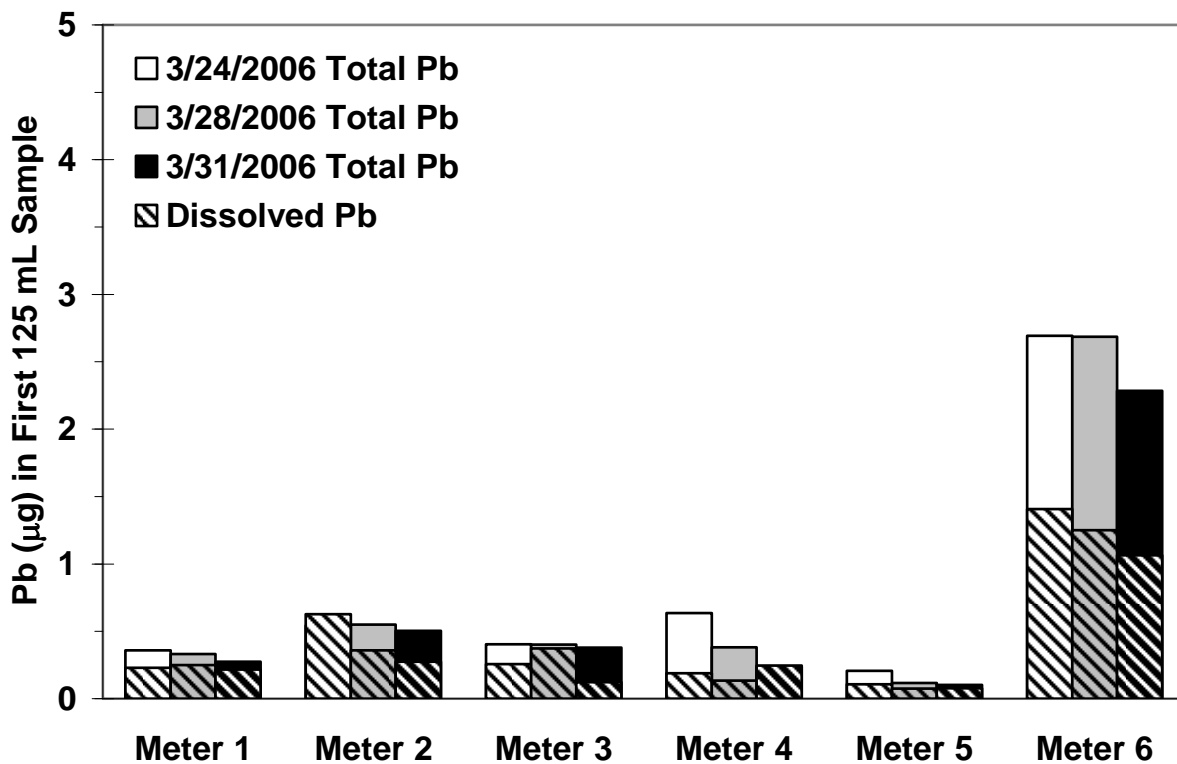
Figure C.61 Comparison of total and dissolved Pb in first 125 mL sample from each meter (6-hour stagnation samples from simulated use at 4 L/min).

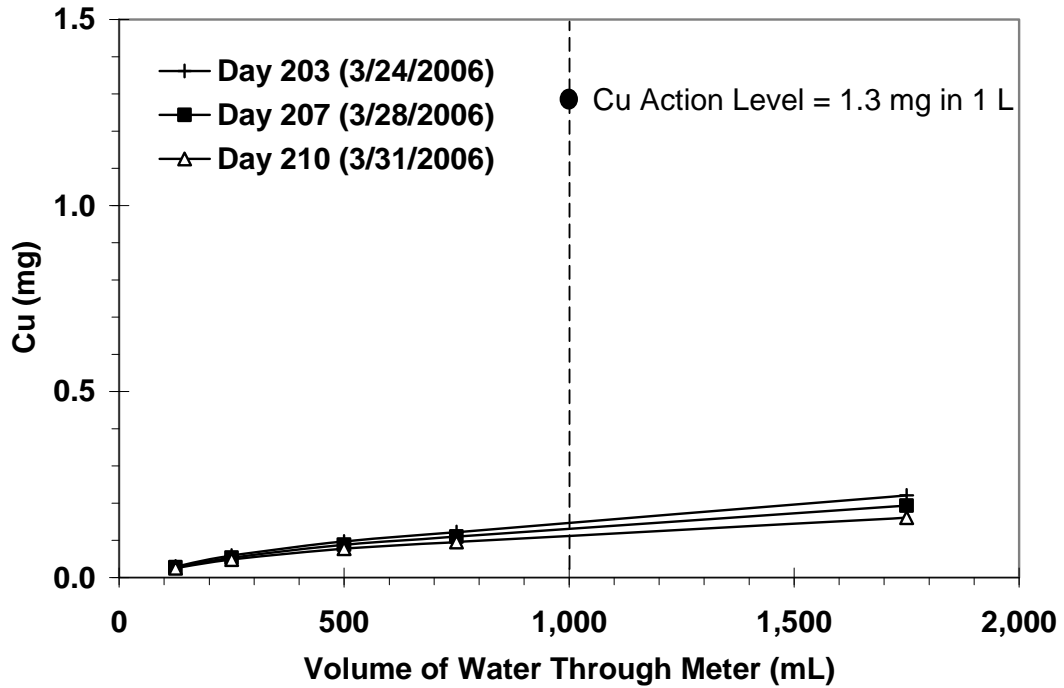
Figure C.62 Cumulative total Cu mass in Meter 6 – new leaded brass (6-hour stagnation samples from simulated use at 4 L/min).

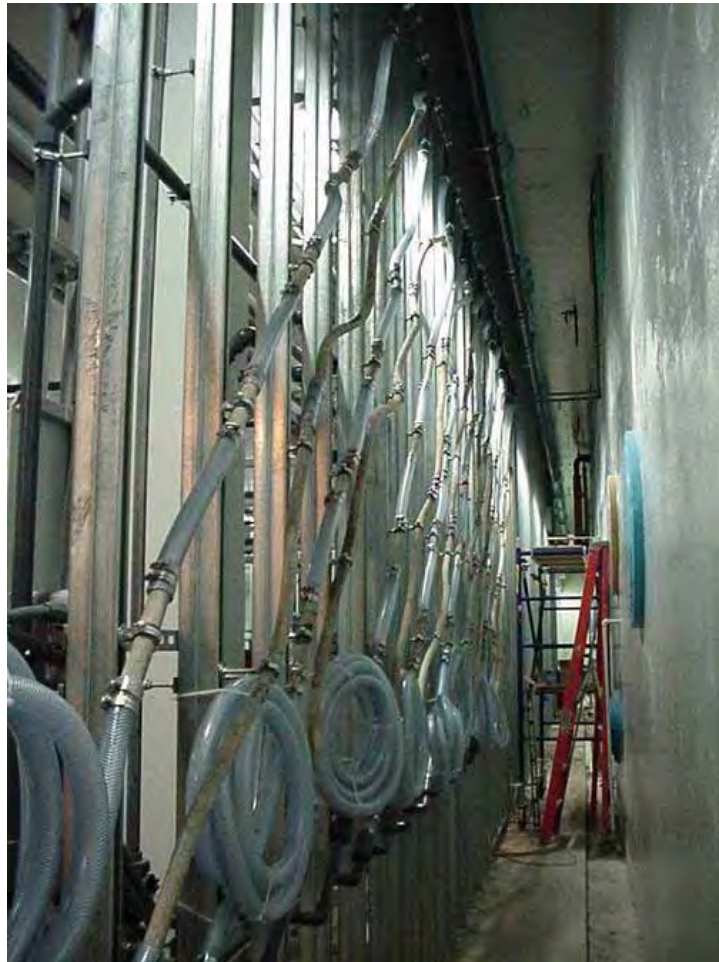
Figure C.87 Photograph of Washington Aqueduct Pipe Rack

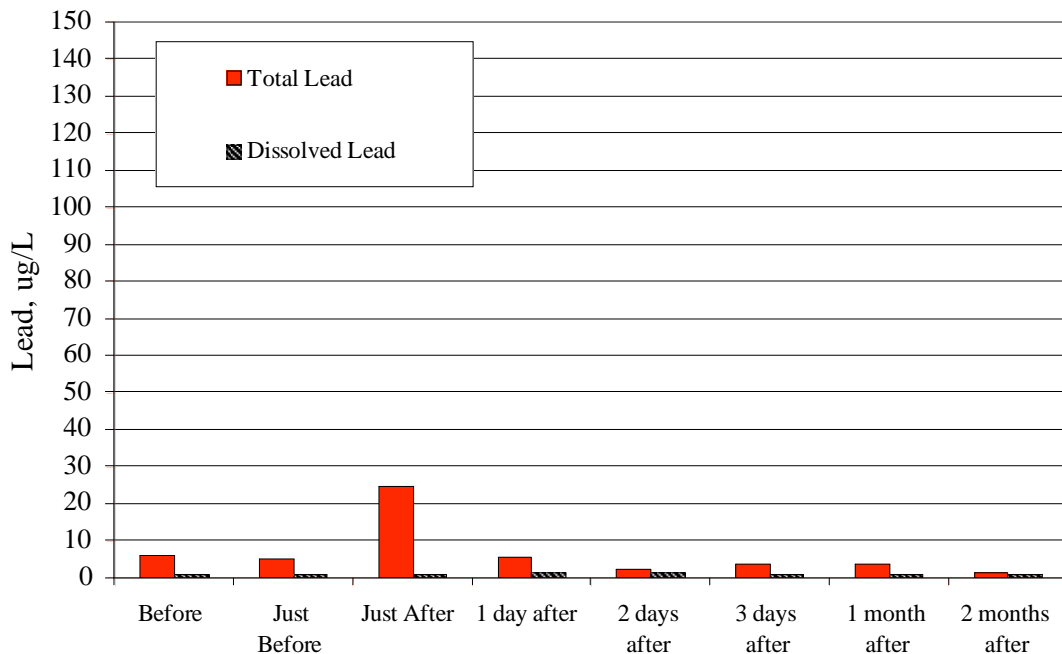
Figure F.10 M-1 Lead in Flowing Water

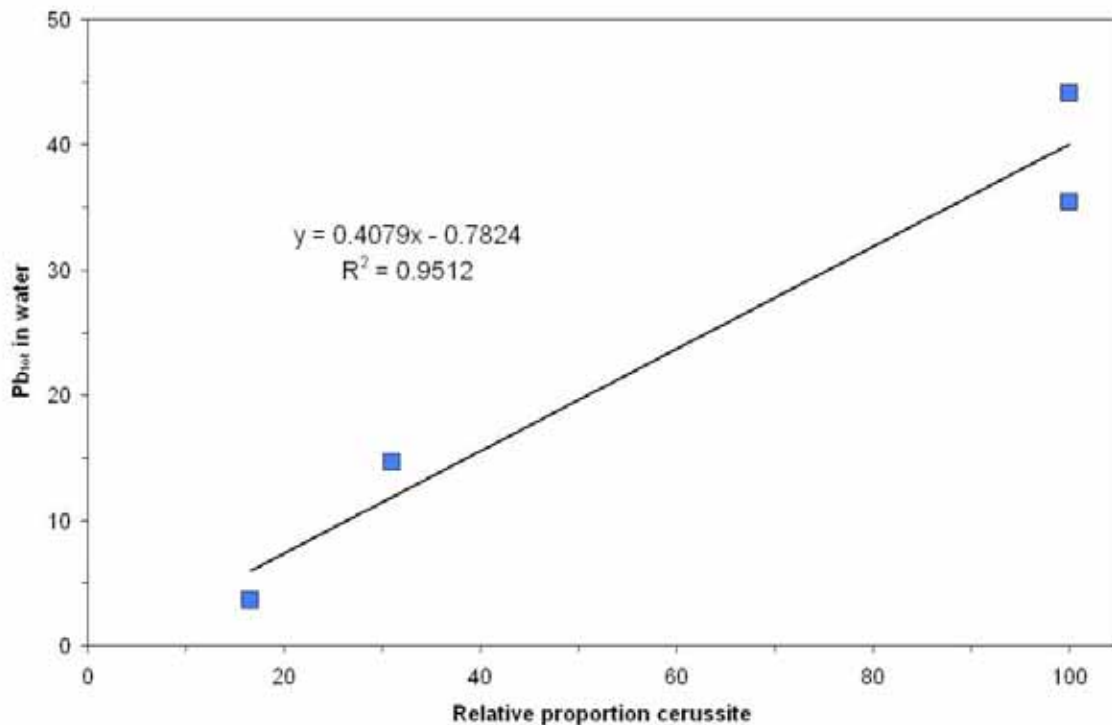
Figure F.18 Relationship of Average Total Lead Measured in Sequential Samples to the Relative Proportion of Cerussite Among the Scale Minerals (the dominant mineral is assigned a value of 100 percent and the other minerals scaled accordingly by peak intensity)

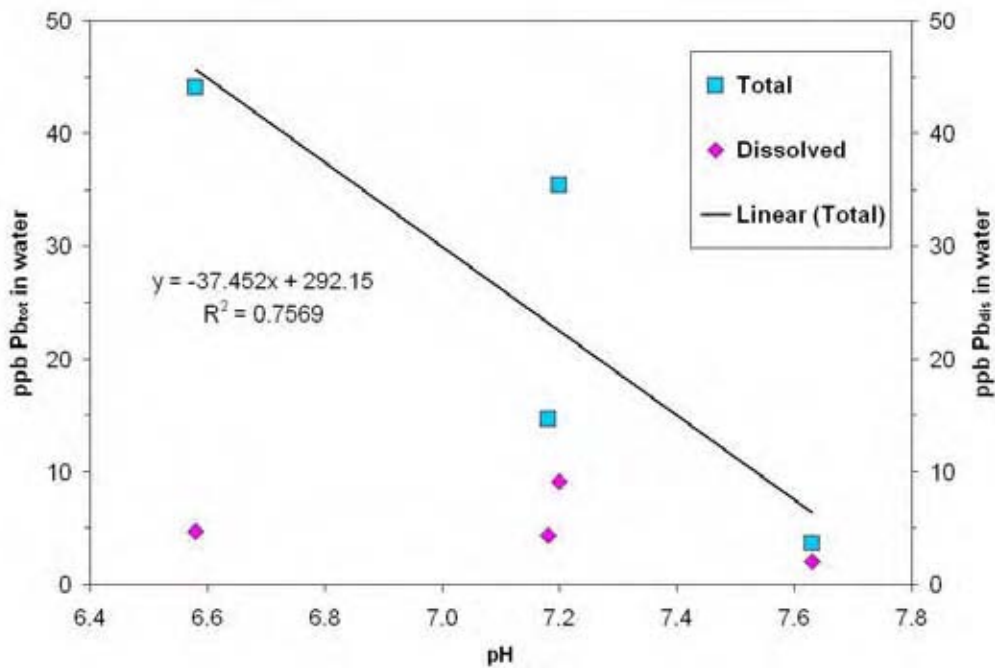
Figure F.19 Relationship of Total Pb to pH at Madison

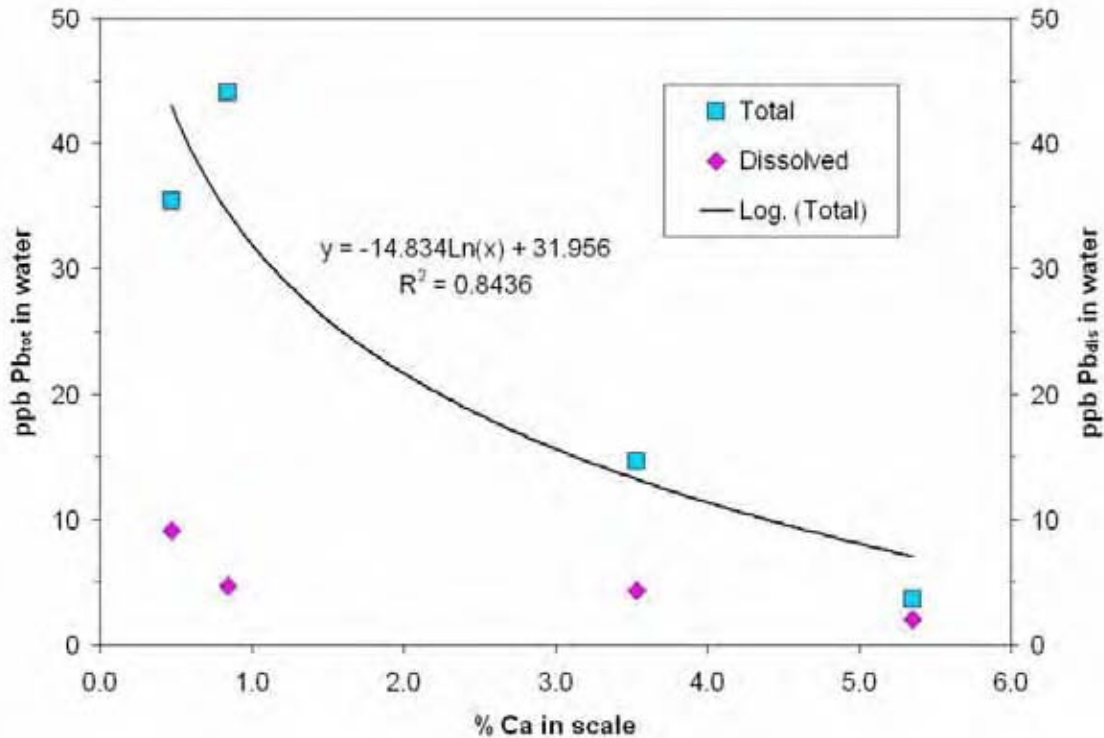
Figure F.20 Relationship of total Pb to % Ca in the scale

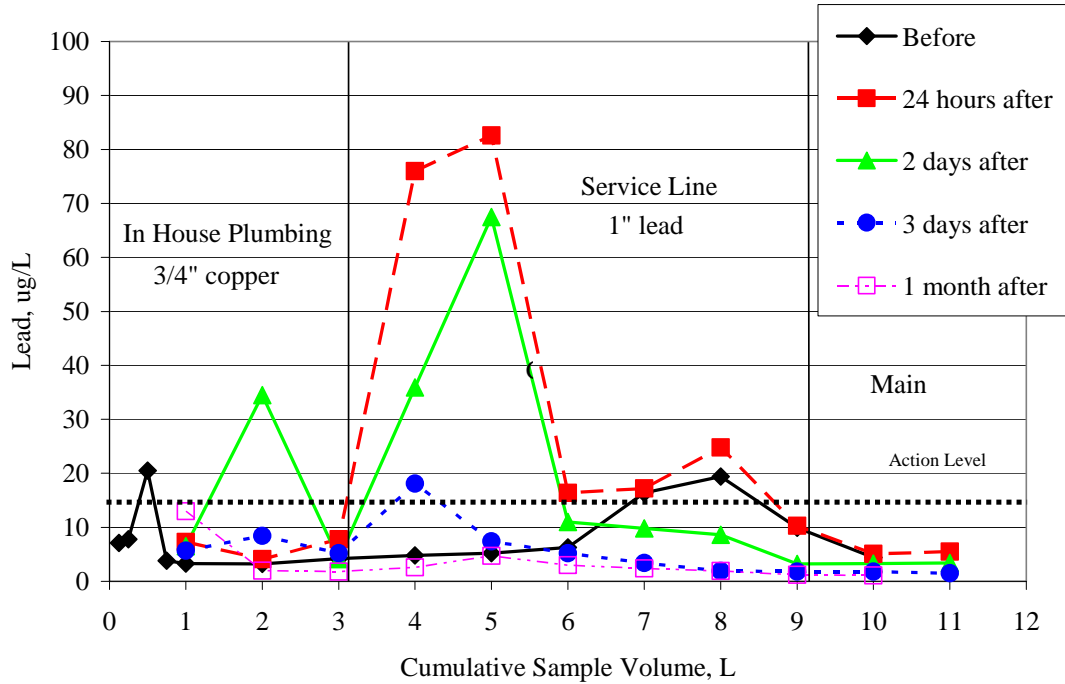
Figure F.22 Site D-1 Total Lead Concentration Profiles (stagnation)

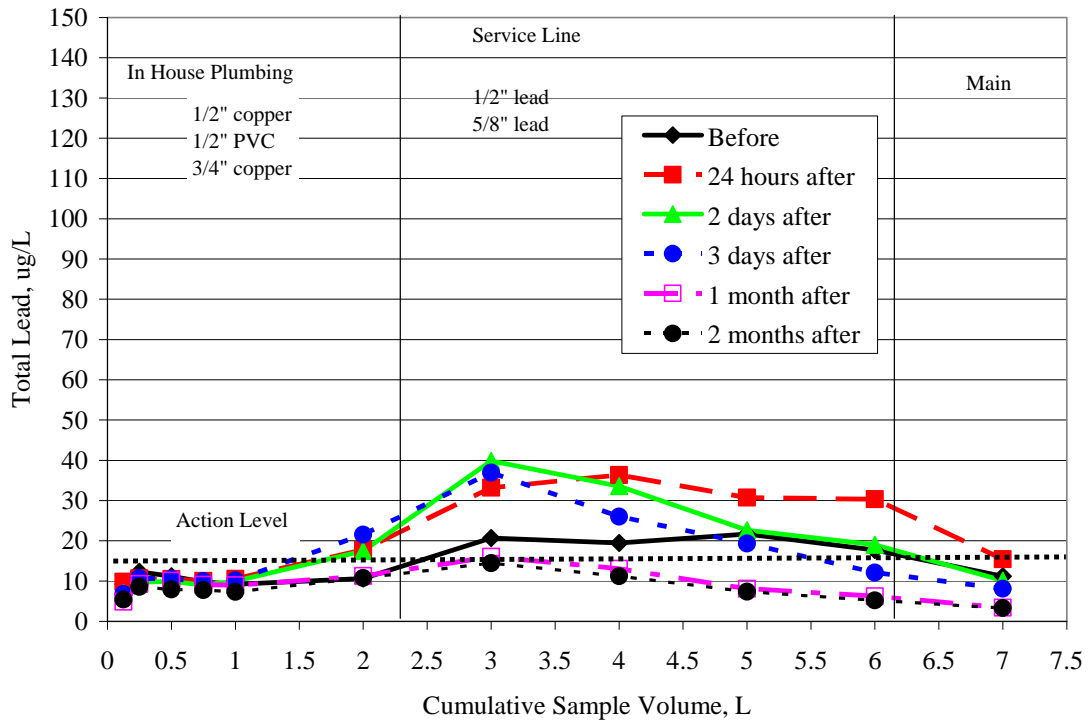
Figure F.54 Site T-1 Total Lead Concentration Profiles (stagnation)

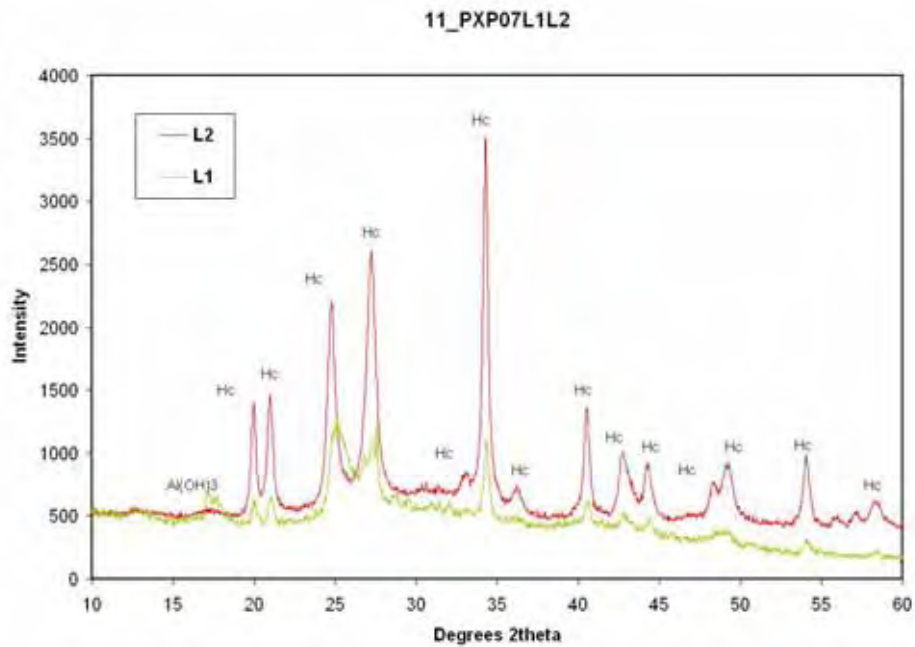
Figure F.73 Representative x-ray Diffraction Pattern from Toronto Pipe Scales

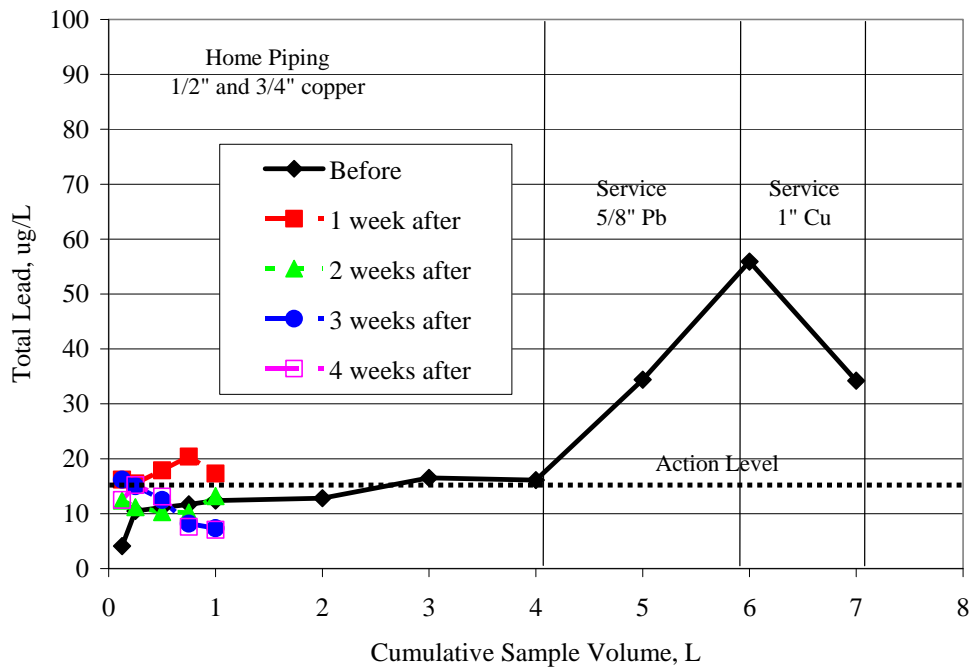
Figure F.110 Site F.1 Total Lead Concentration Profiles (stagnation)

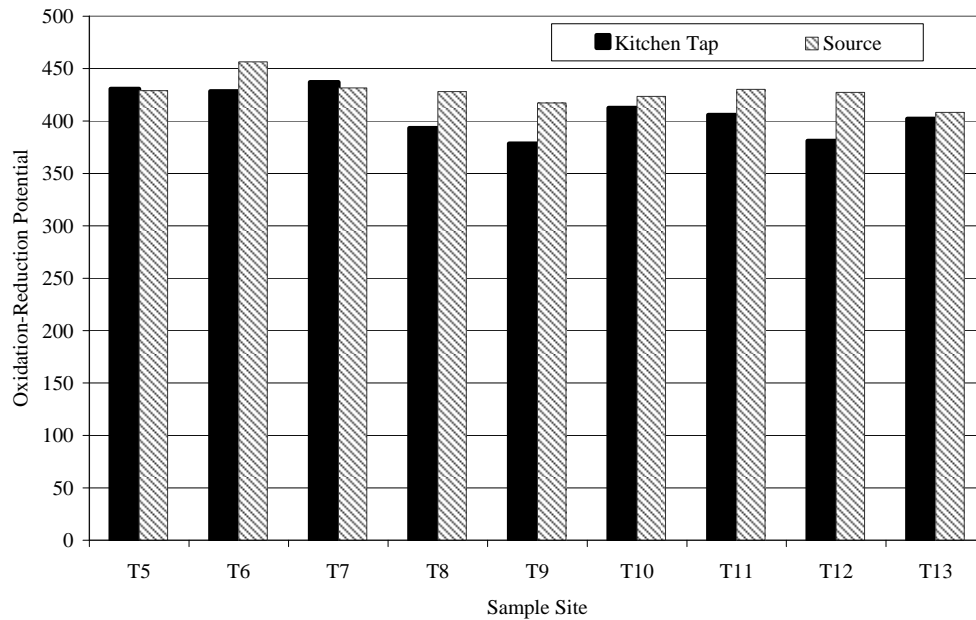
Figure F.134 ORP measurements for Sites T-5 through T-13
