Title WEST ELEVATION STAINED GLASS WINDOWS PROPOSED TO BE REMOVED
 Project Scottish Rite Masonic Center
 Project Number 21-102
 Date 3 FEB 2021
 Drawn by RAMLOW / STEIN

Title NORTH ELEVATION STAINED GLASS WINDOWS PROPOSED TO BE REMOVED
 Project Scottish Rite Masonic Center
 Project Number 21-102
 Date 3 FEB 2021
 Drawn by RAMLOW / STEIN

Title EAST ELEVATION WINDOWS PROPOSED TO BE ADDED
 Project Scottish Rite Masonic Center
 Project Number 21-102
 Date 3 FEB 2021
 Drawn by RAMLOW/STEIN

Description: **H600 CUT DETAILS**

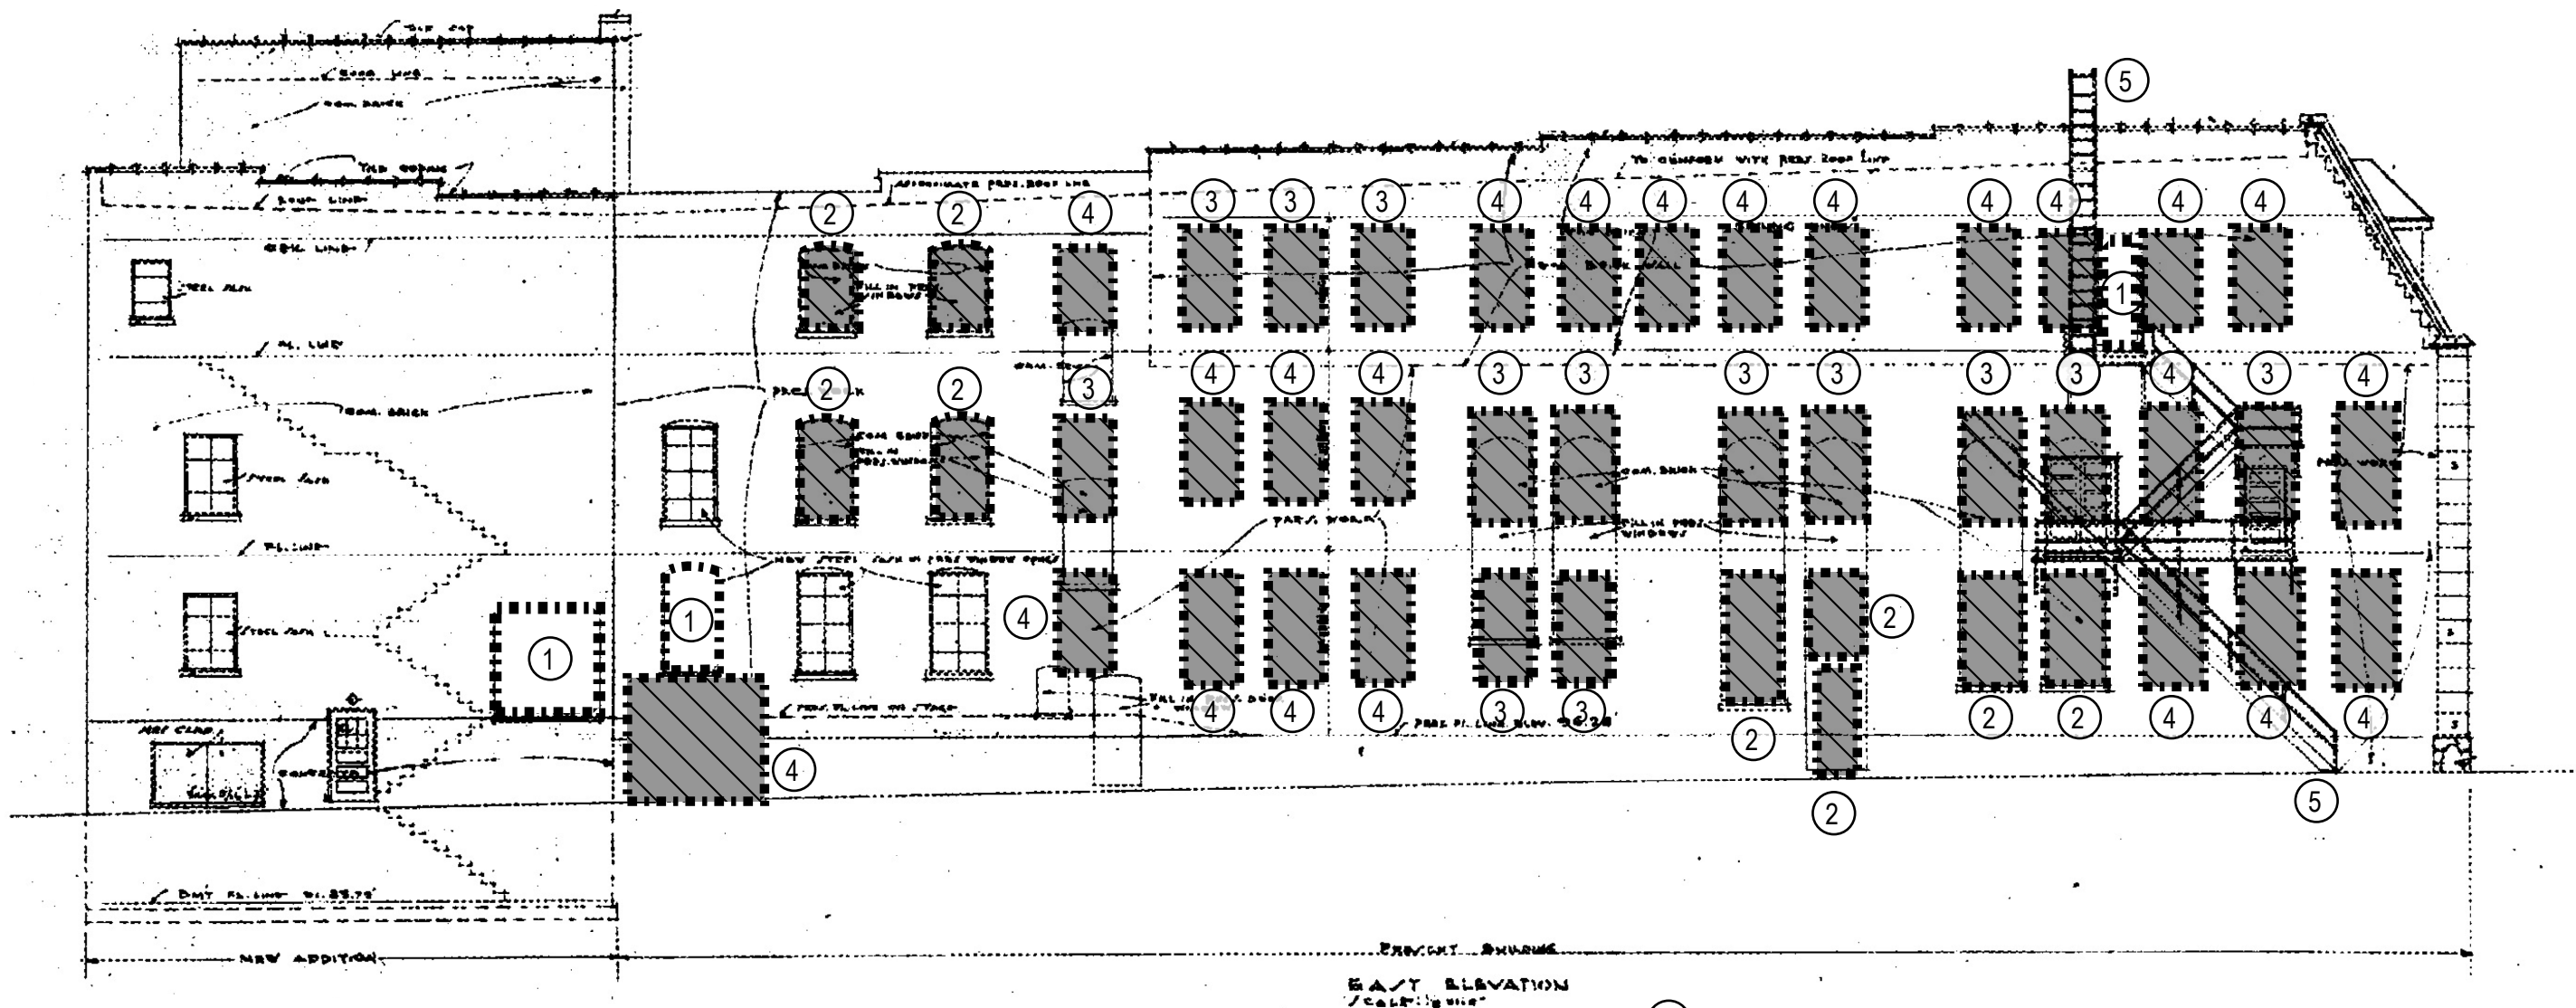
Scale: NA
 Drawing No. **A212**

4 EAST ELEVATION
SCALE: 1/8"=1'-0"

- ① INFILL EXISTING OPENING
- ② NEW WINDOW/ DOOR AT EXISTING OPENING
- ③ NEW WINDOW AT ENLARGED EXISTING OPENING
- ④ NEW OPENING
- ⑤ REMOVE EXTERIOR FIRE STAIR

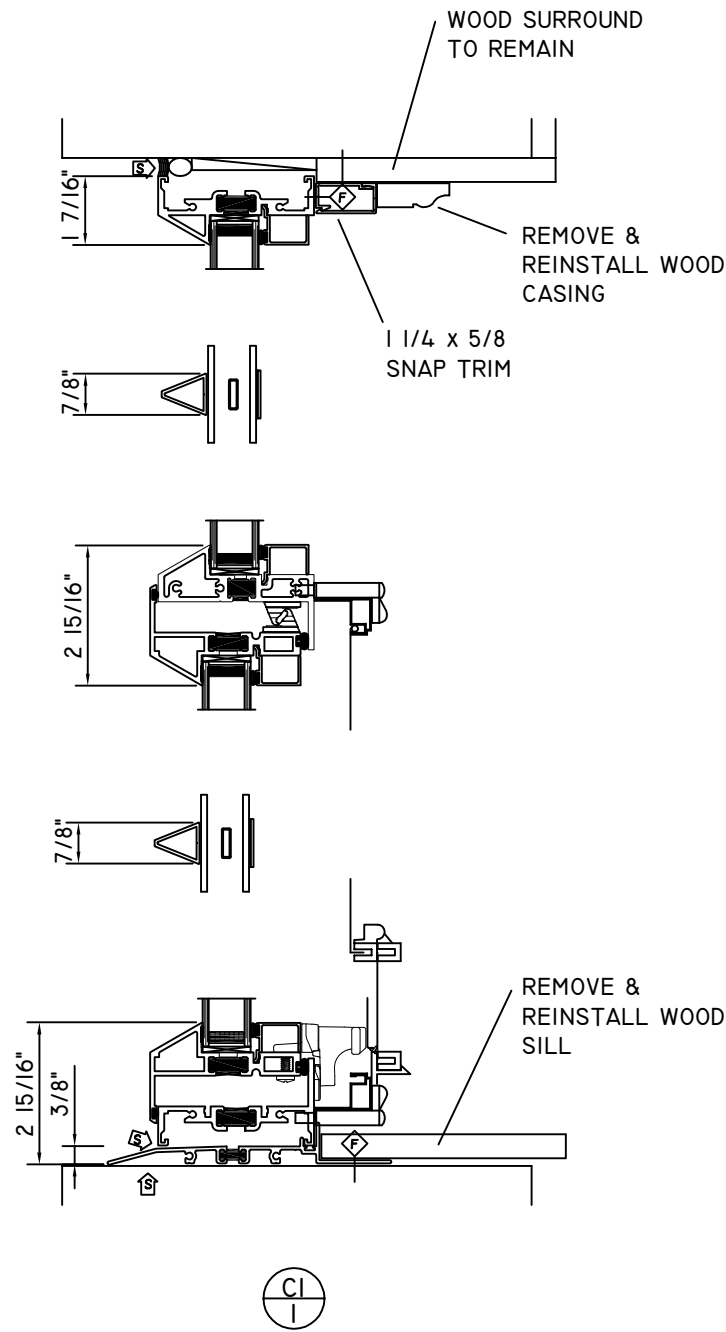
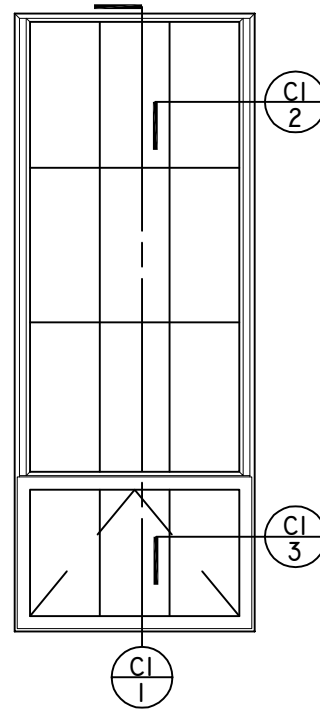
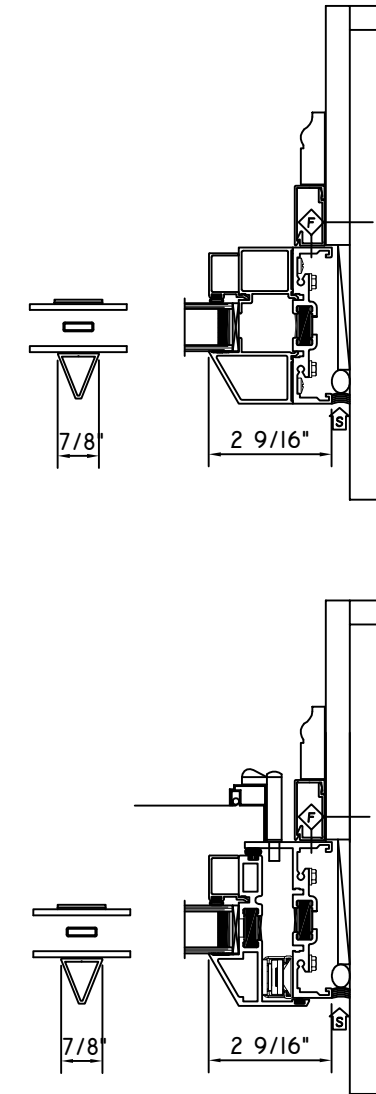
Scale: NONE
 Sheet #: C.1

VERIFY INSTALLATION
 VERIFY WALL DETAILS

ALL PANNING SHALL BE FIELD FIT & TRIMMED BY THE INSTALLER

ALL PANNING TO BE SEALED IN THE FIELD BY OTHERS

SEALANT MUST MEET OR EXCEED ASTM C920-11 SPECIFICATION

PROVIDE ADEQUATE BLOCKING TO SUPPORT THE SILL OF THE WINDOW

PACK INSULATION AROUND WINDOW FRAME. DO NOT USE EXPANDING OR SPRAY-IN TYPE FOAMS.
