**National Register of Historic Places
Registration Form**

historic name Underwriters Exchange Building
other names/site number

street & number	828 North Broadway	N/A	not for publication
city or town	Milwaukee	N/A	vicinity
state Wisconsin	code WI	county Milwaukee	code 079
			zip code 53202

Underwriters Exchange Building
Milwaukee, Milwaukee County, Wisconsin

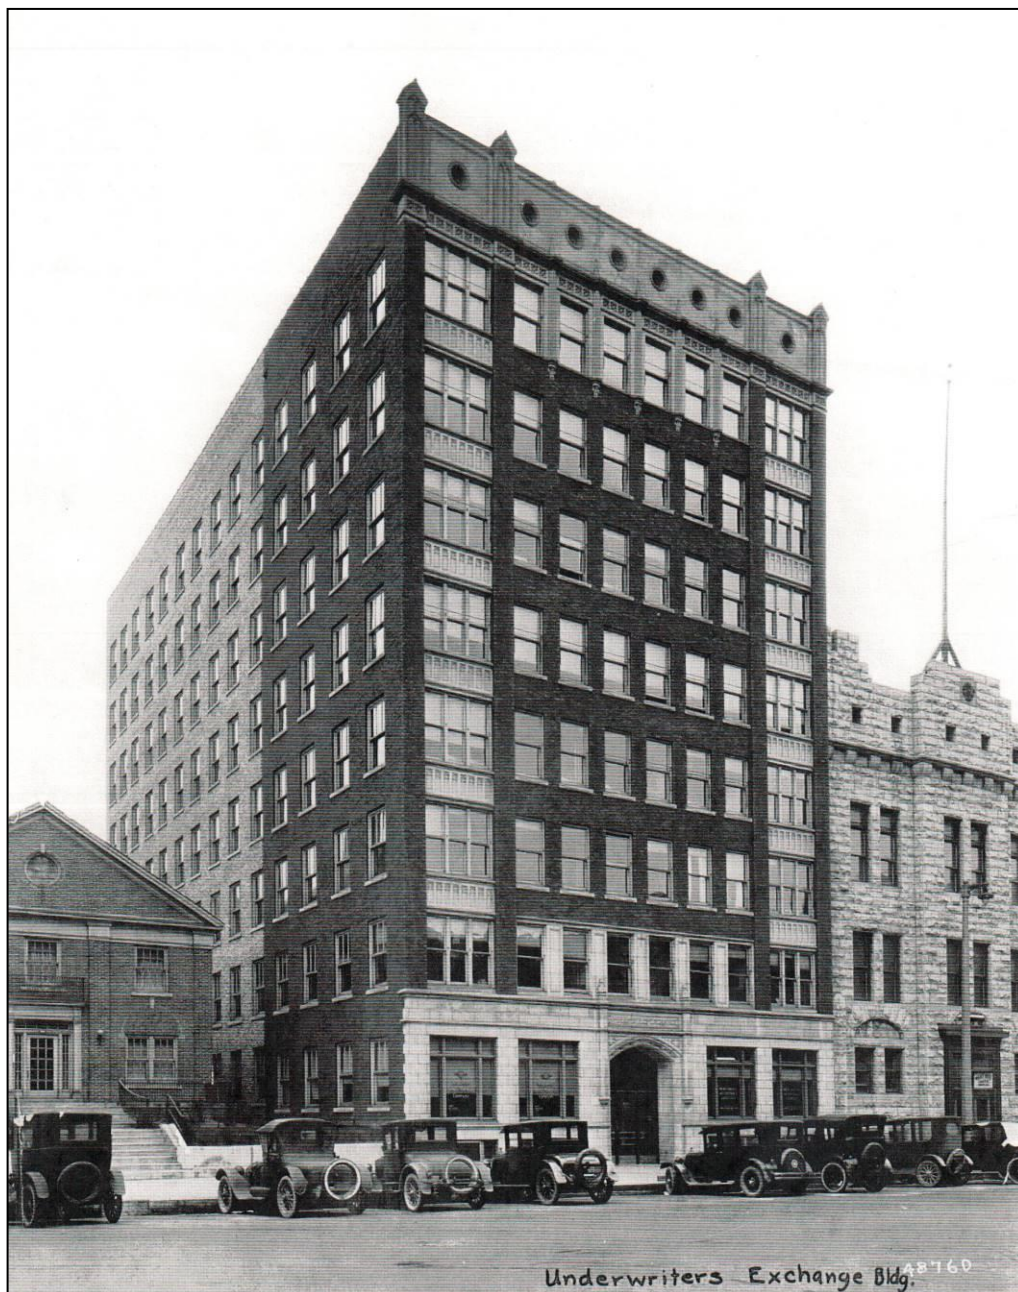
Figure 2: Underwriters Exchange Building, exterior

Undated photograph (taken shortly following 1924 construction) (Milwaukee Public Library photograph collection)

historically. These photographs reveal that alterations are primarily confined to the building entrance; specifically, the original doors and transom have been replaced and limestone ornament above the entrance, including the “UNDERWRITERS EXCHANGE” raised lettering, has been removed. Fenestration on the seventh floor has been replaced with modern aluminum windows.

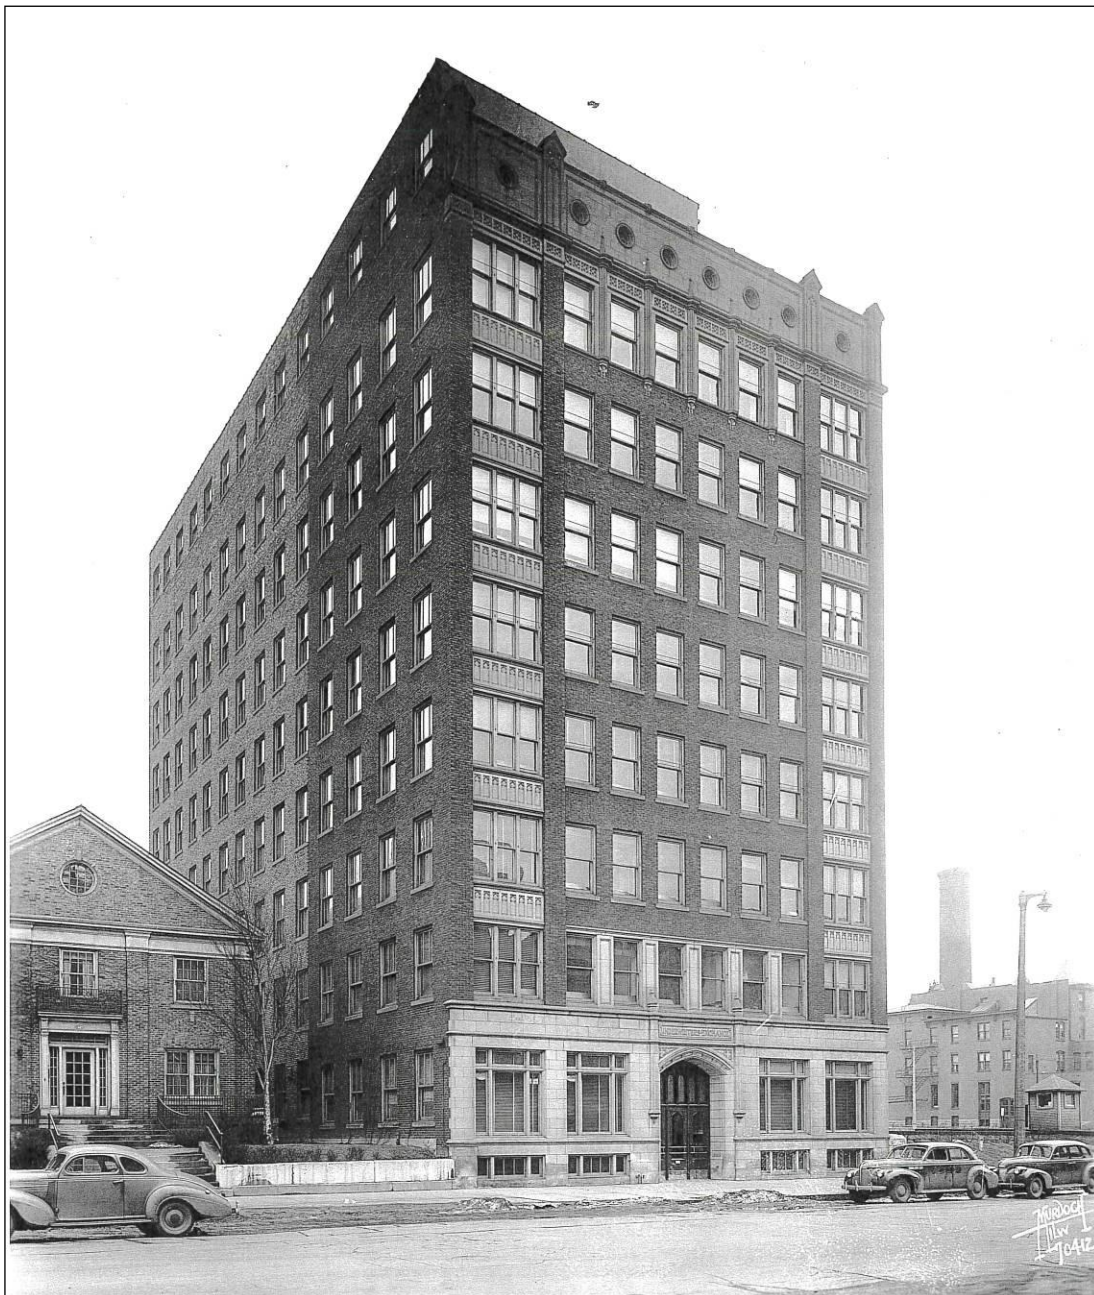
Figure 3: Underwriters Exchange Building, exterior

1945 photograph (Milwaukee County Historical Society photograph collection)

Historic photographs of the Underwriters Exchange Building found during the course of research are included with this nomination. The partial ninth floor, constructed in 1926 during the period of significance, is evident in the 1945 photograph. These historic photographs reveal that exterior alterations are primarily confined to the building entrance. The original entrance doors and transom have been replaced with the existing modern, aluminum-and-glass, double-doors with transom and sidelights configuration. This entrance is situated forward within the entrance opening compared to the historic entry doors. Additionally, limestone ornamentation above the entrance, including the original "UNDERWRITERS EXCHANGE" raised lettering signage, has been removed. Otherwise, the Underwriters Exchange Building possesses a high degree of exterior integrity; neither building permit records, nor historic fire insurance map images, reveal further exterior alterations.
