ORD-19-03984  
CCF 191341

# Certificate of Appropriateness

**Property** 931 N. 31ST ST. Concordia Historic District  
**Description of work** Replace 3-pane slider window with new wood window to match original in west front gable end. Dimensions and design are attached. Repair siding as needed with new wood shingles.  
**Date issued** 12/19/2019 PTS ID 114725 COA: replace slider window to match original

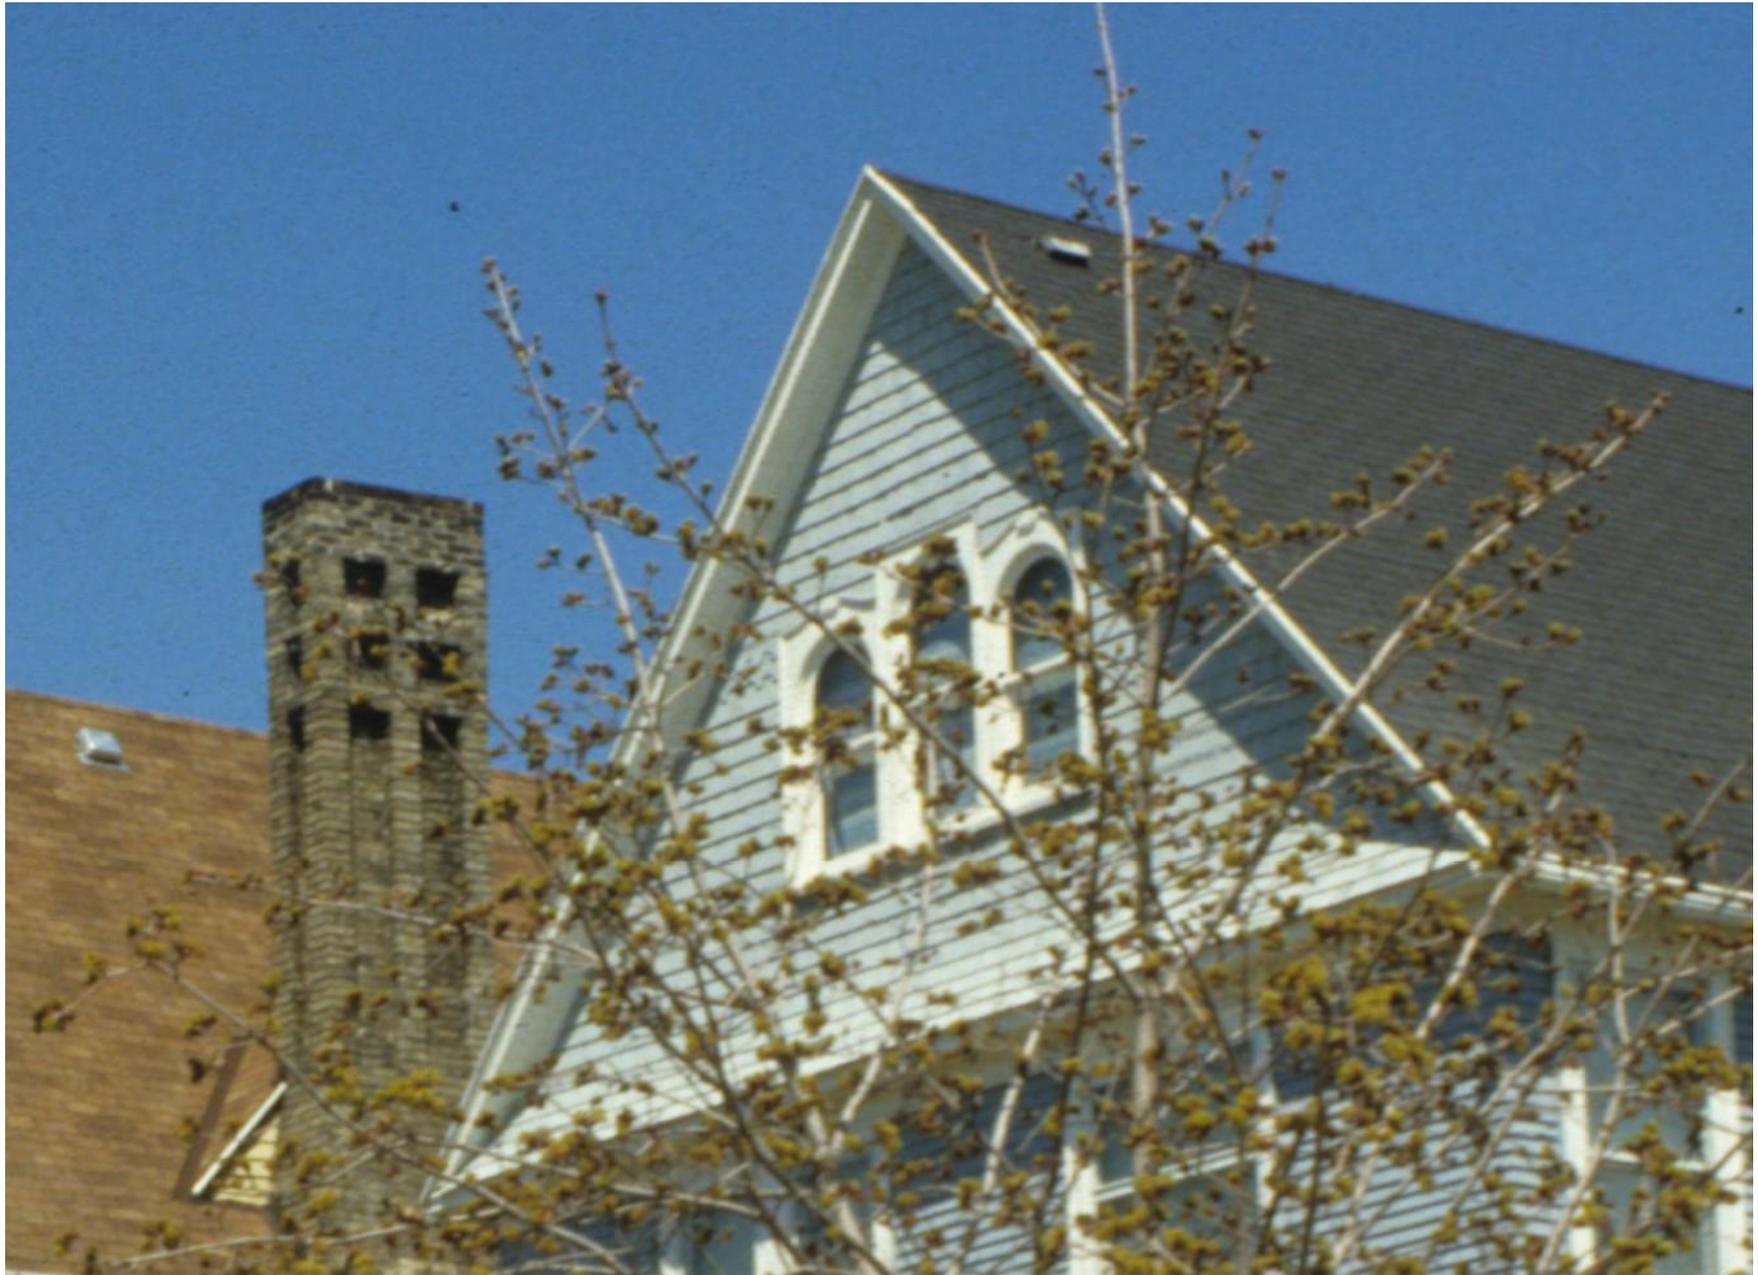
Original three-part window in c. 1990 photo

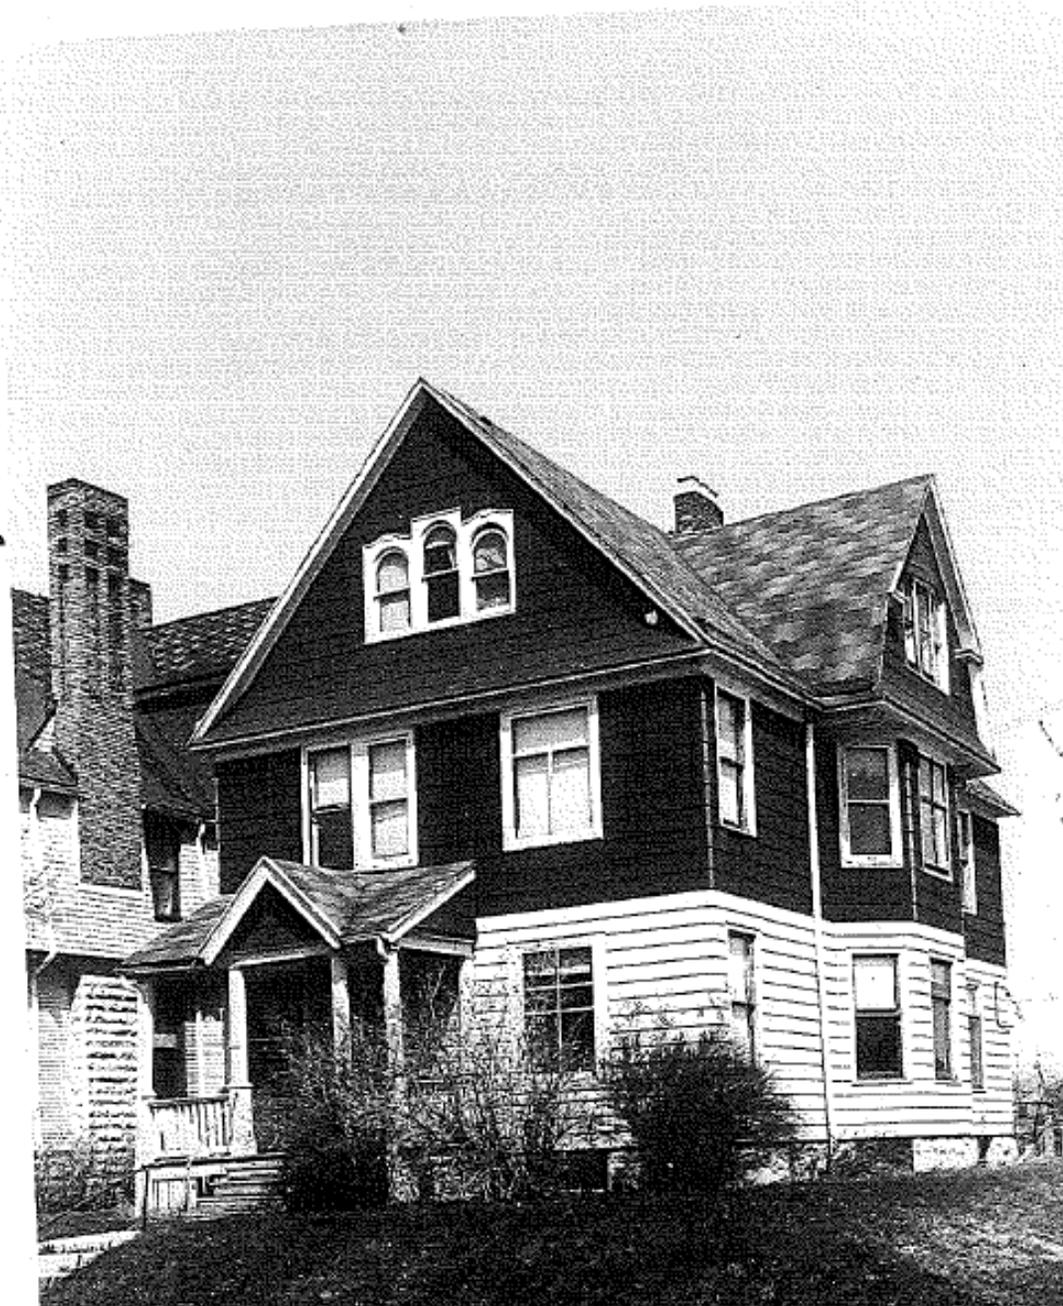
Front view of house in 1984 with original window

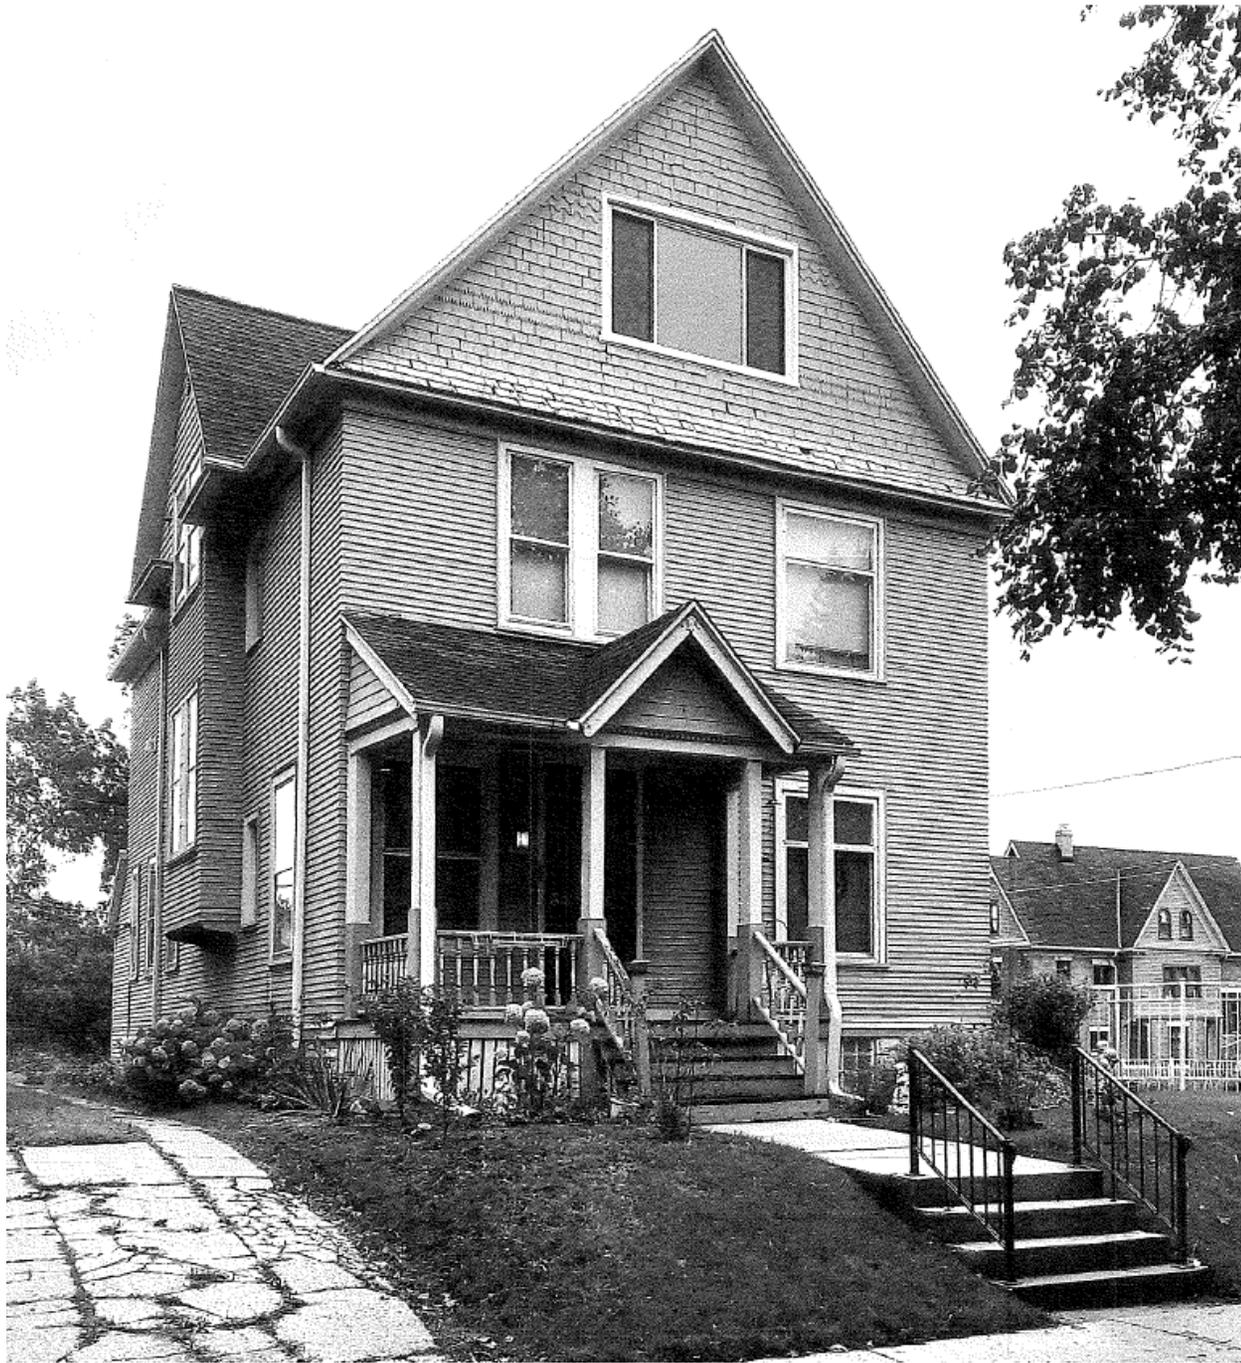
Front view of house as it appears in 2019
