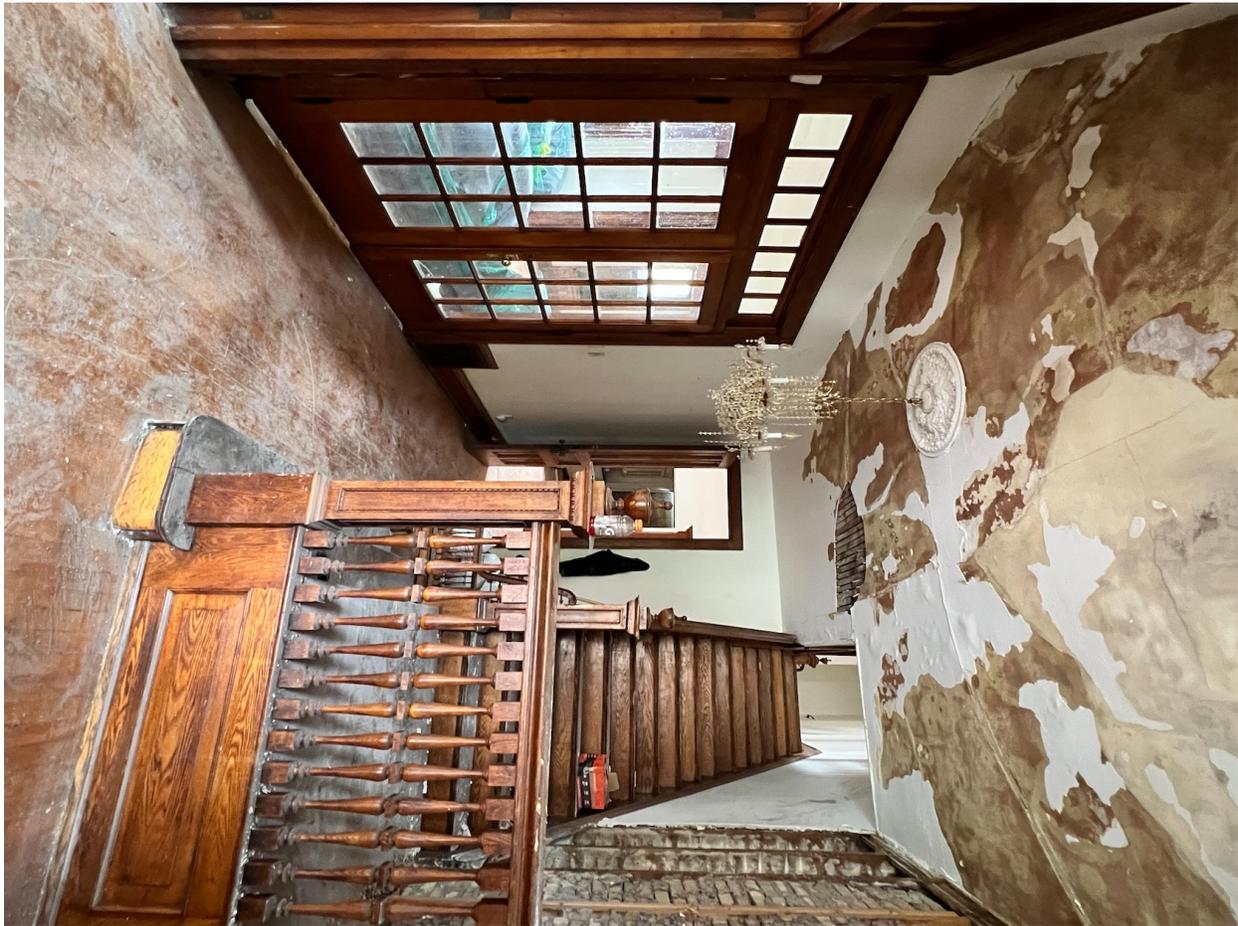
S1 - 2904 W State St Main Entrance, facing north - showing Grand Staircase. The Foyer has suffered from water damage and ceiling drywall/plaster is missing or damaged. The wood floors are damaged, there are missing stair banisters.

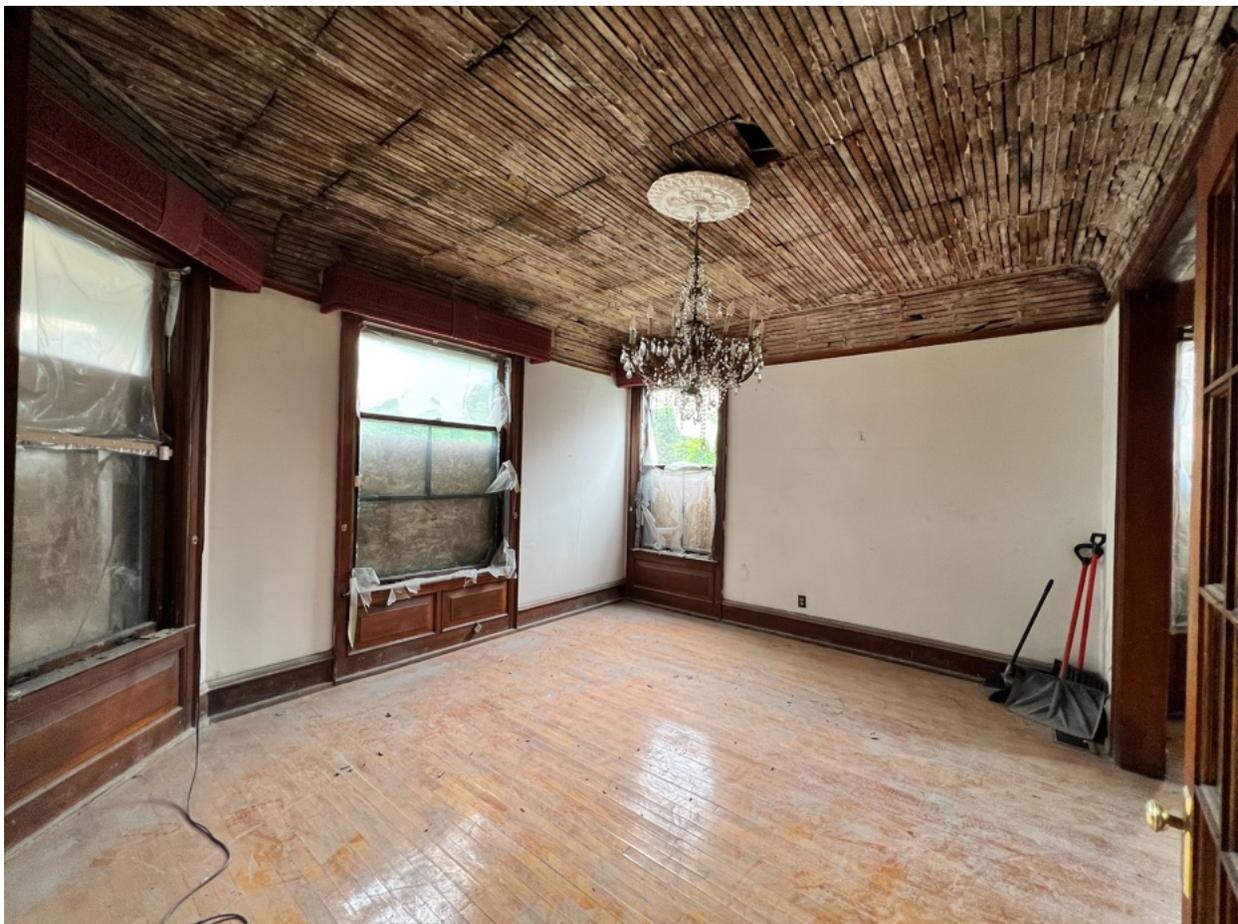
S2 - 2904 W State St Family Room, facing southwest. Majority of the ceiling and wall plaster/drywall is missing/damaged due to water penetration. Hardwood floors are scratched, windows are missing storm windows and have broken window panes and deteriorated/rotting wood frames. Chandelier is broken.

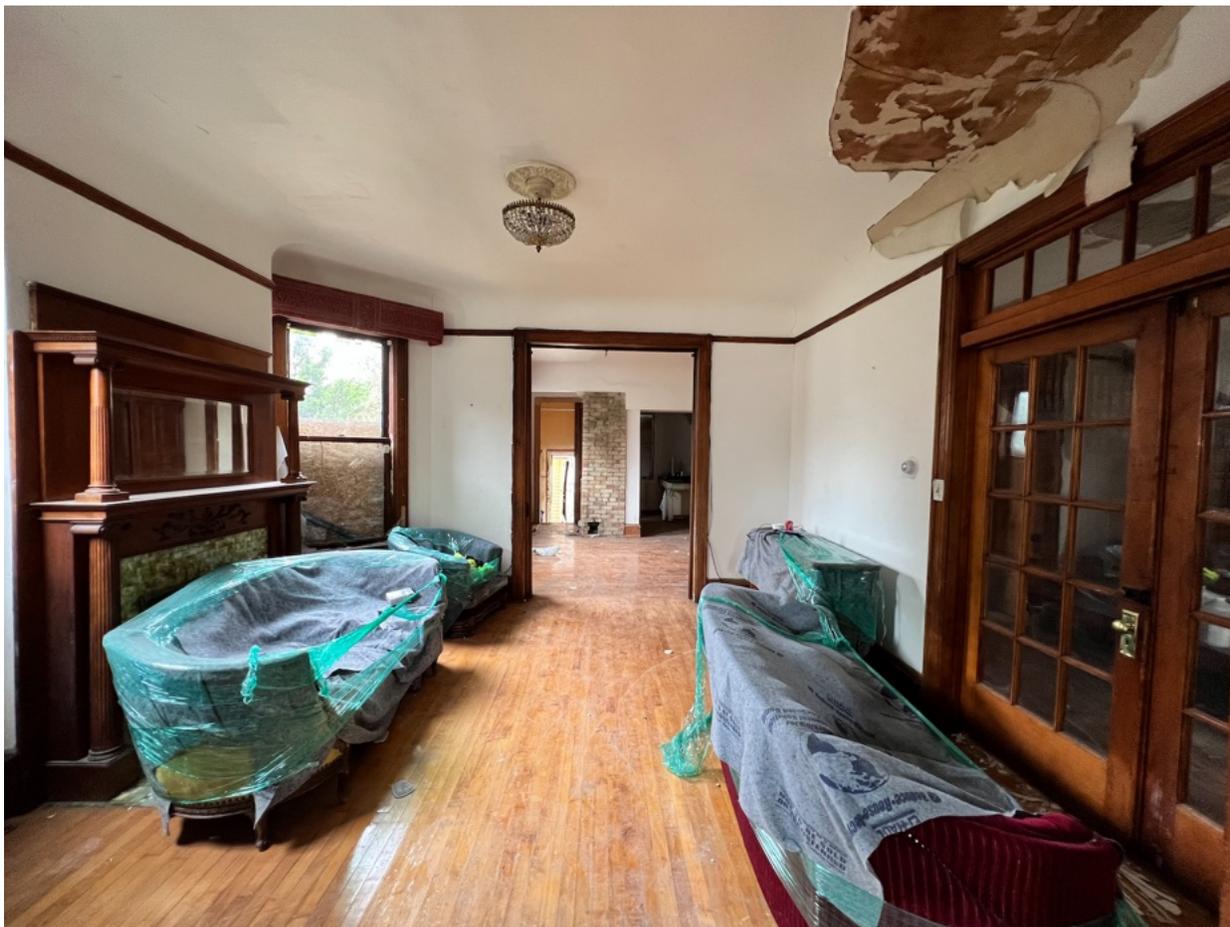
S3 - 2904 W State St Living Room, facing north. A large chunk of ceiling plaster/drywall is missing due to water damage. Wood floors are scratched. Fireplace mantel is intact but some tile is missing.

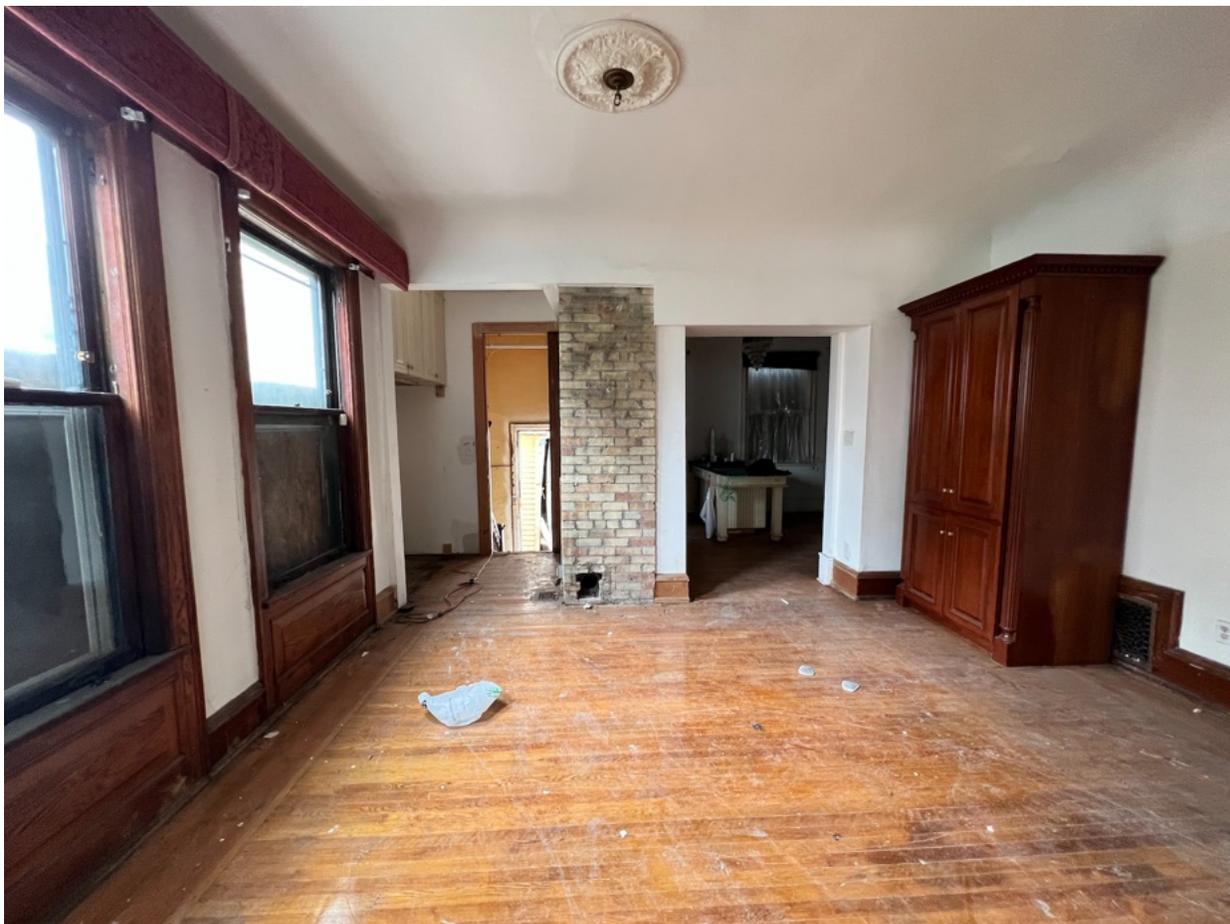
S4 - 2904 W State St Dining Room, facing north. Plaster/drywall is mostly intact, wood floors are scratched, chimney brick is exposed, two windows are missing storms. Windows are missing glazing and have some deteriorated wood. No light fixture.

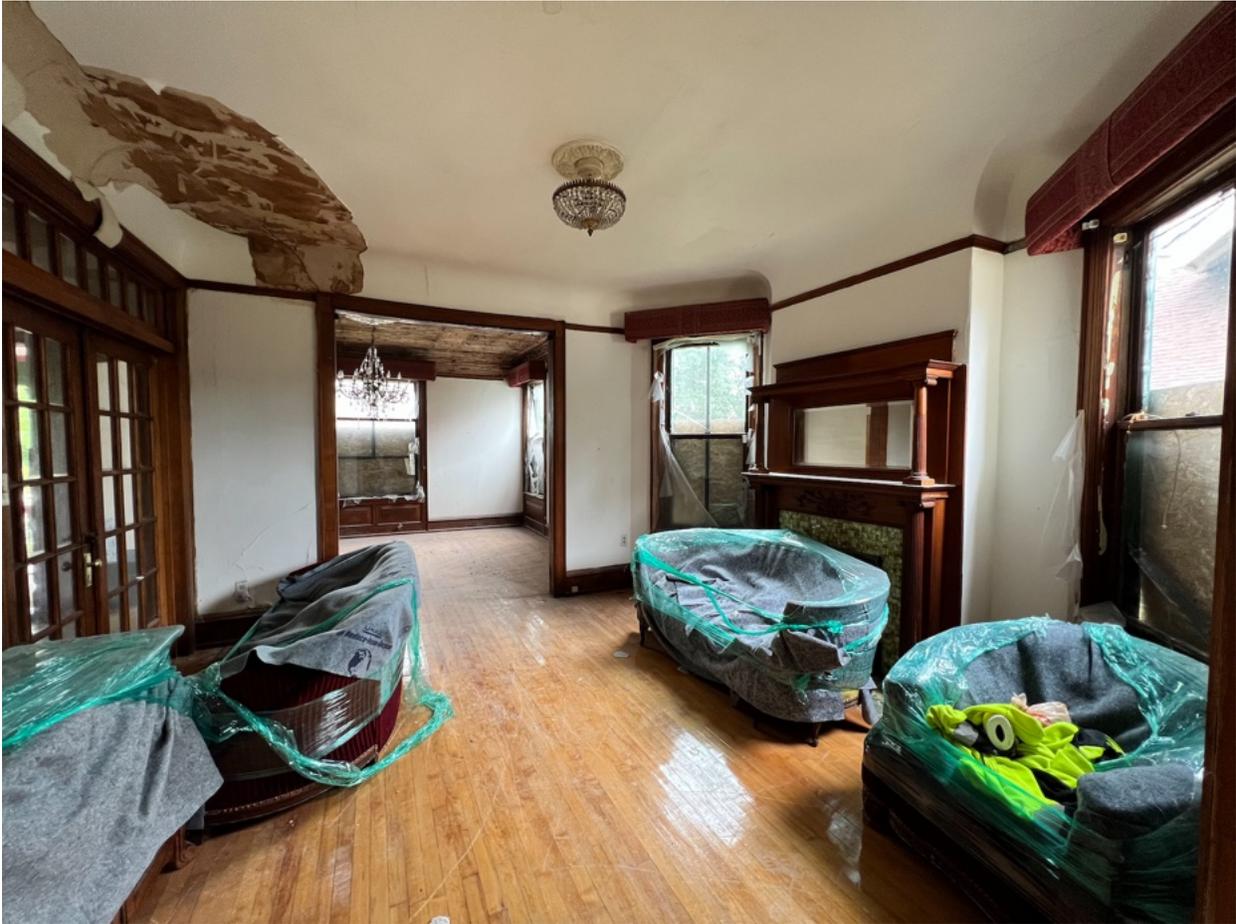
S5 - 2904 W State St Living room facing towards Family Room, facing south. Windows are missing storms and have deteriorated wood frames.

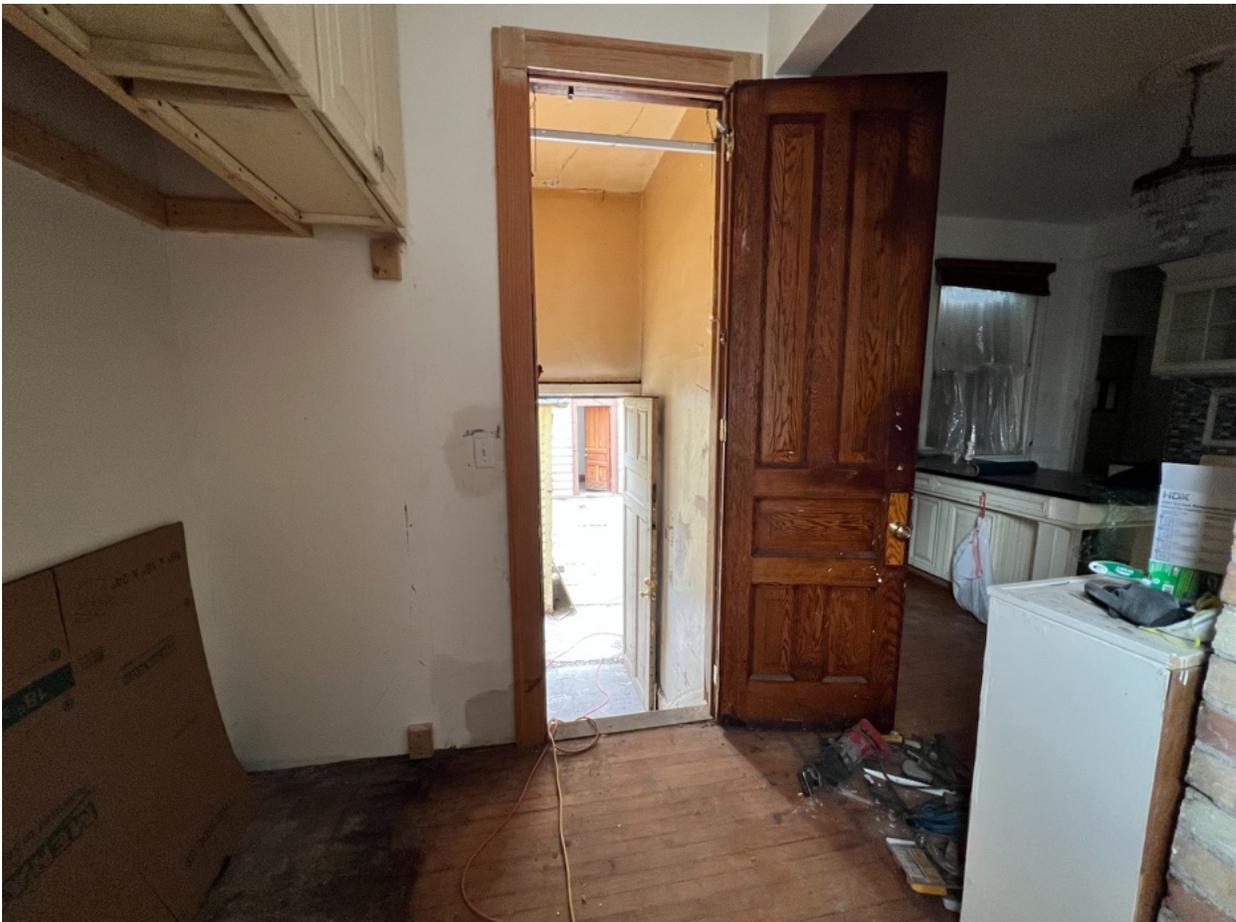
S6 - 2904 W State St Dining Room, facing north - showing back egress and basement entrance. Plaster/drywall mostly intact, wood floors are scratched.

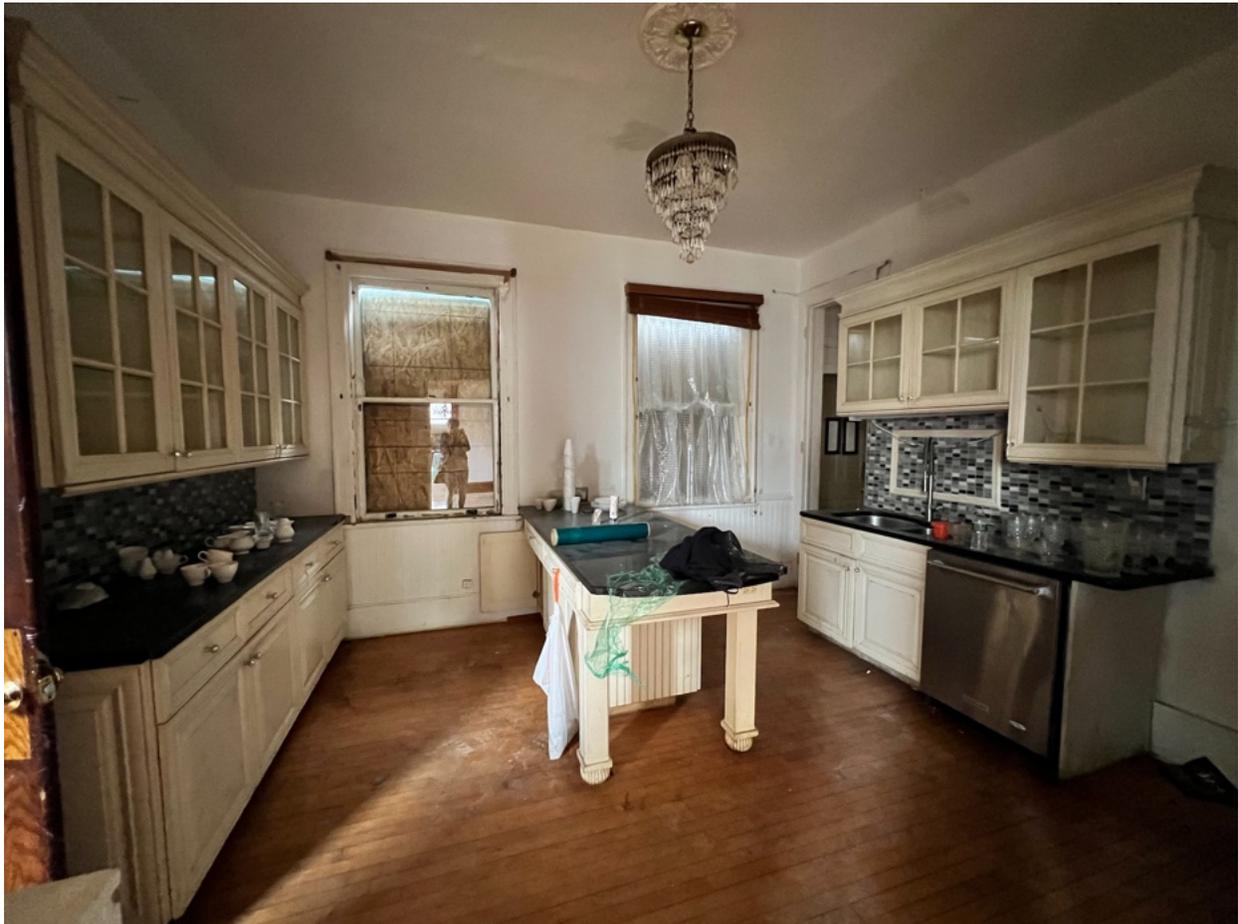
S7 - 2904 W State St Kitchen, facing north. Kitchen cupboards and counter tops are in good shape and are reusable. Two windows are missing storms and missing glazing with some deteriorated wood. Plaster/drywall mostly intact with area of texture imperfections, wood floors are scratched and areas of patches

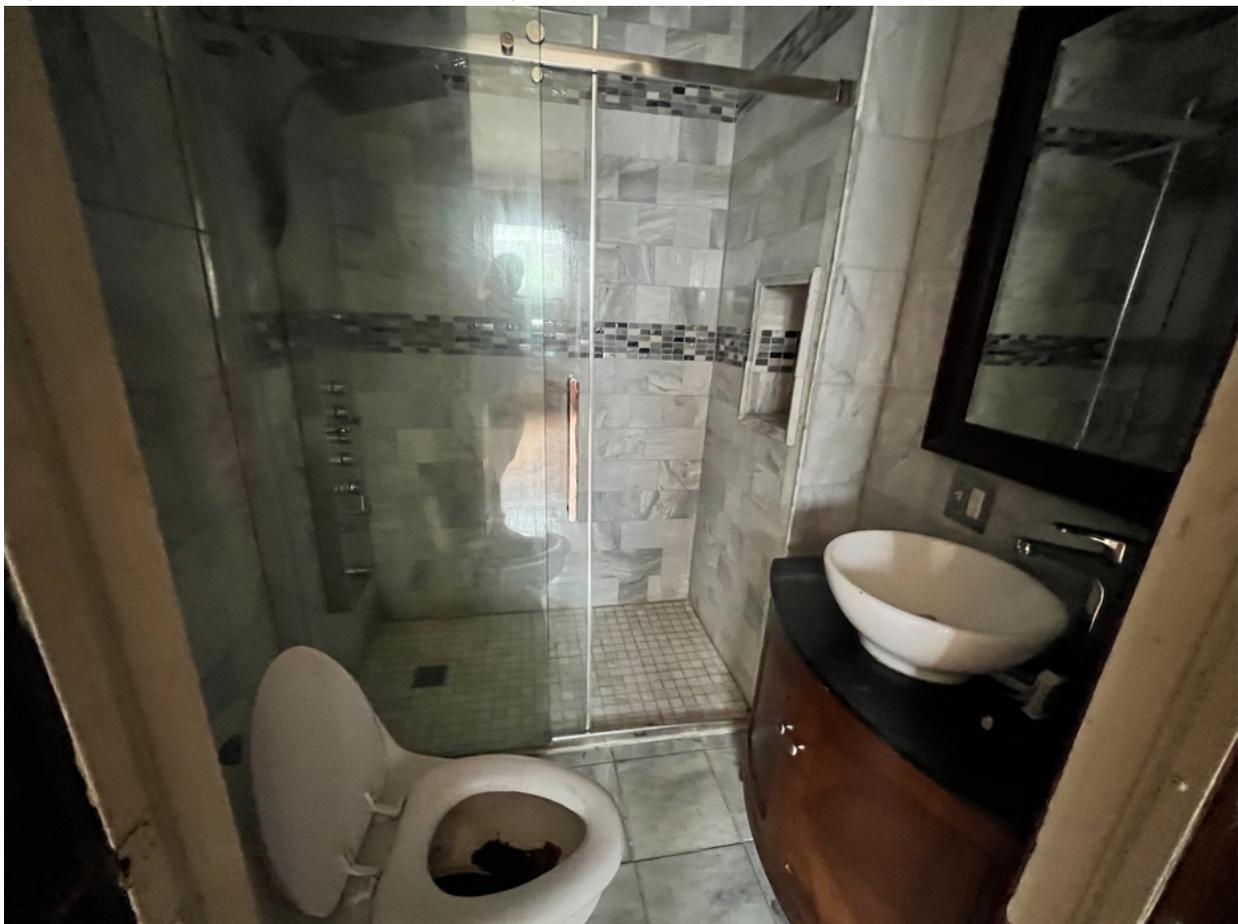
S8 - 2904 W State St lower Bathroom, facing east. First floor bathroom appears to be in decent shape, areas of cracked tile, old toilet and vanity with wear and tear.

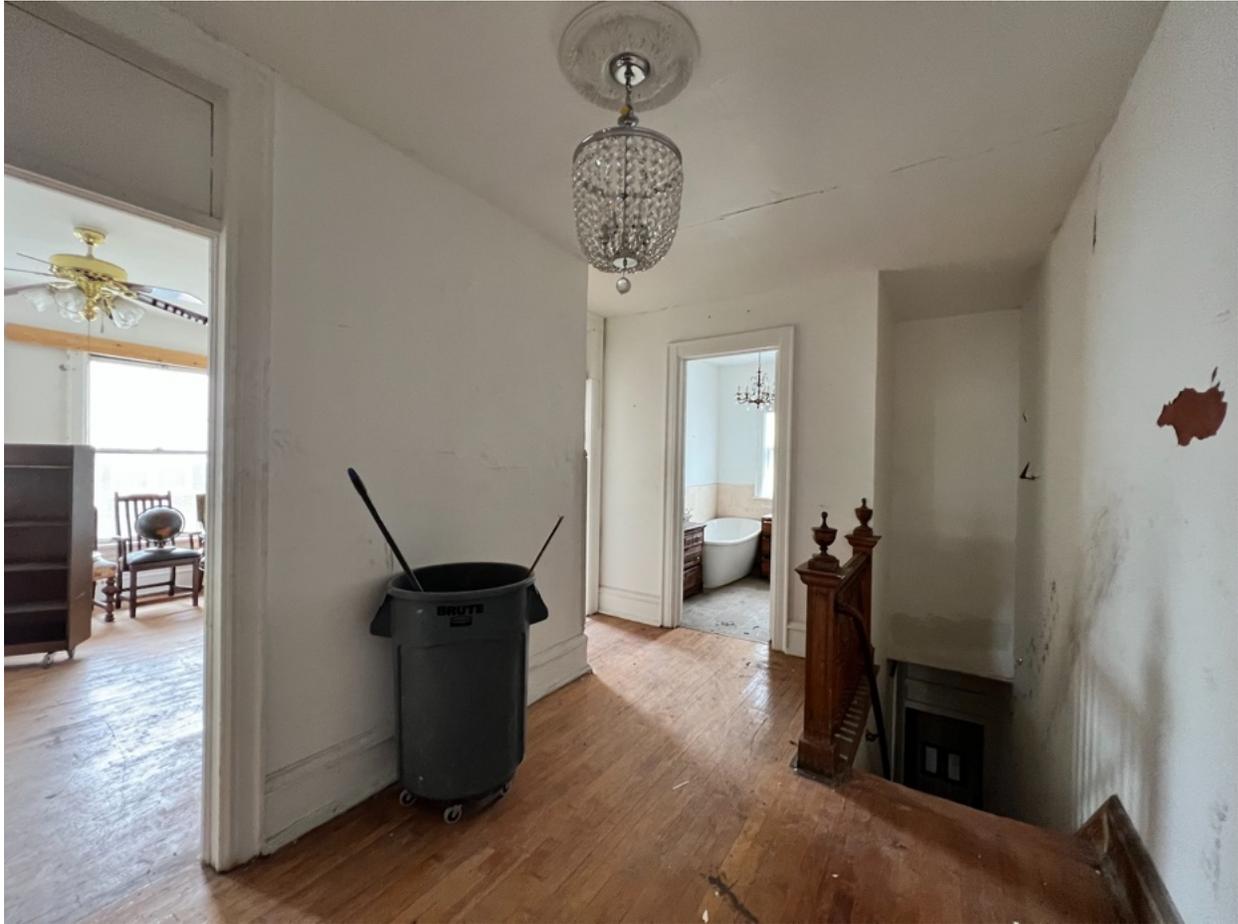
S9 - 2904 W State St top of Grand Staircase, facing north. Missing and cracking drywall/plaster, scratched wood floors, some stairs spindles missing or broken.

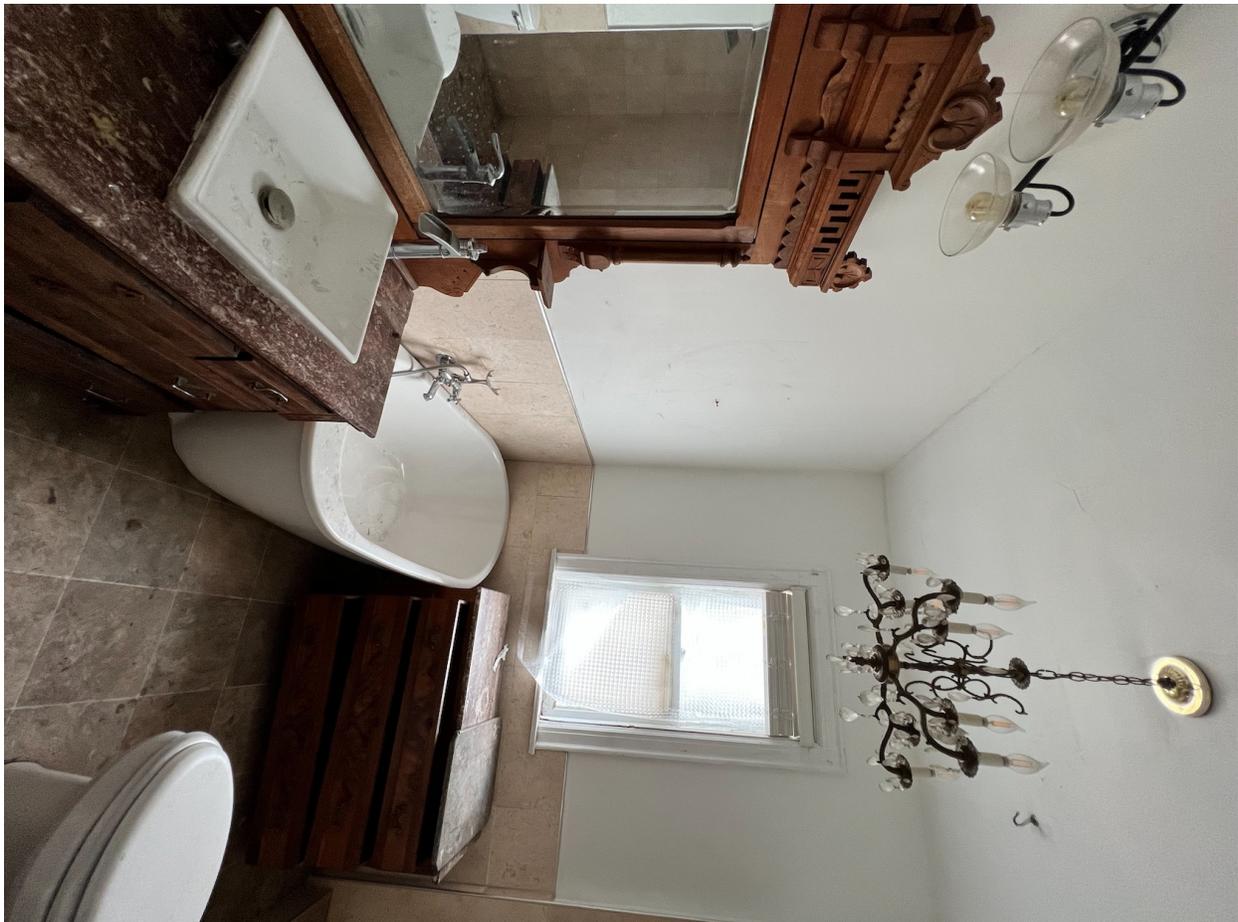
S10 - 2904 W State St upper Bathroom, facing north. Fixtures present but significant wear and tear to vanity, bathtub and toilet. Cracked tile and plaster/drywall throughout.

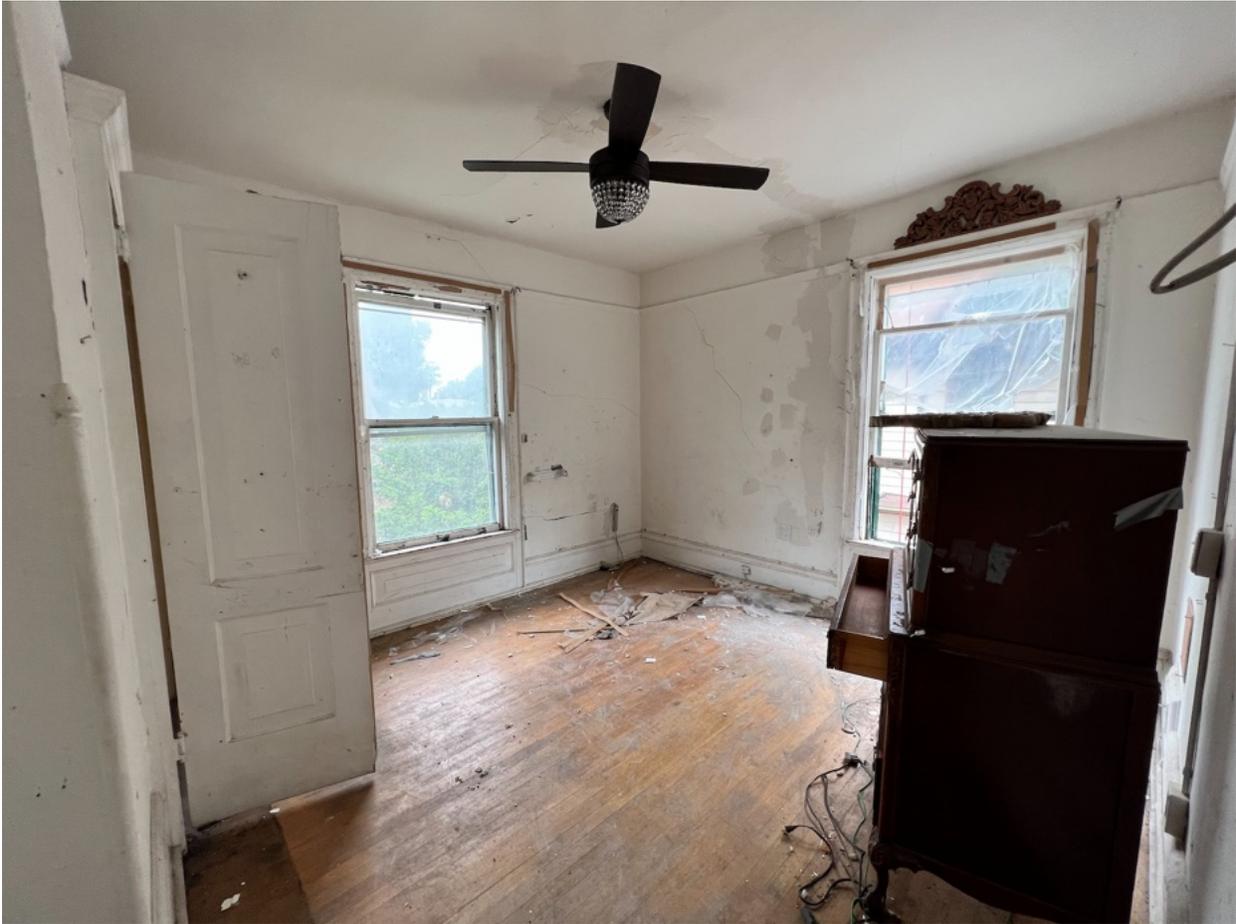
S11 - 2904 W State St Bedroom, facing northwest. Plaster/drywall and wood trim damage throughout. Wood floors are scratched. Windows are missing storms, have broken panes and some rotting wood.

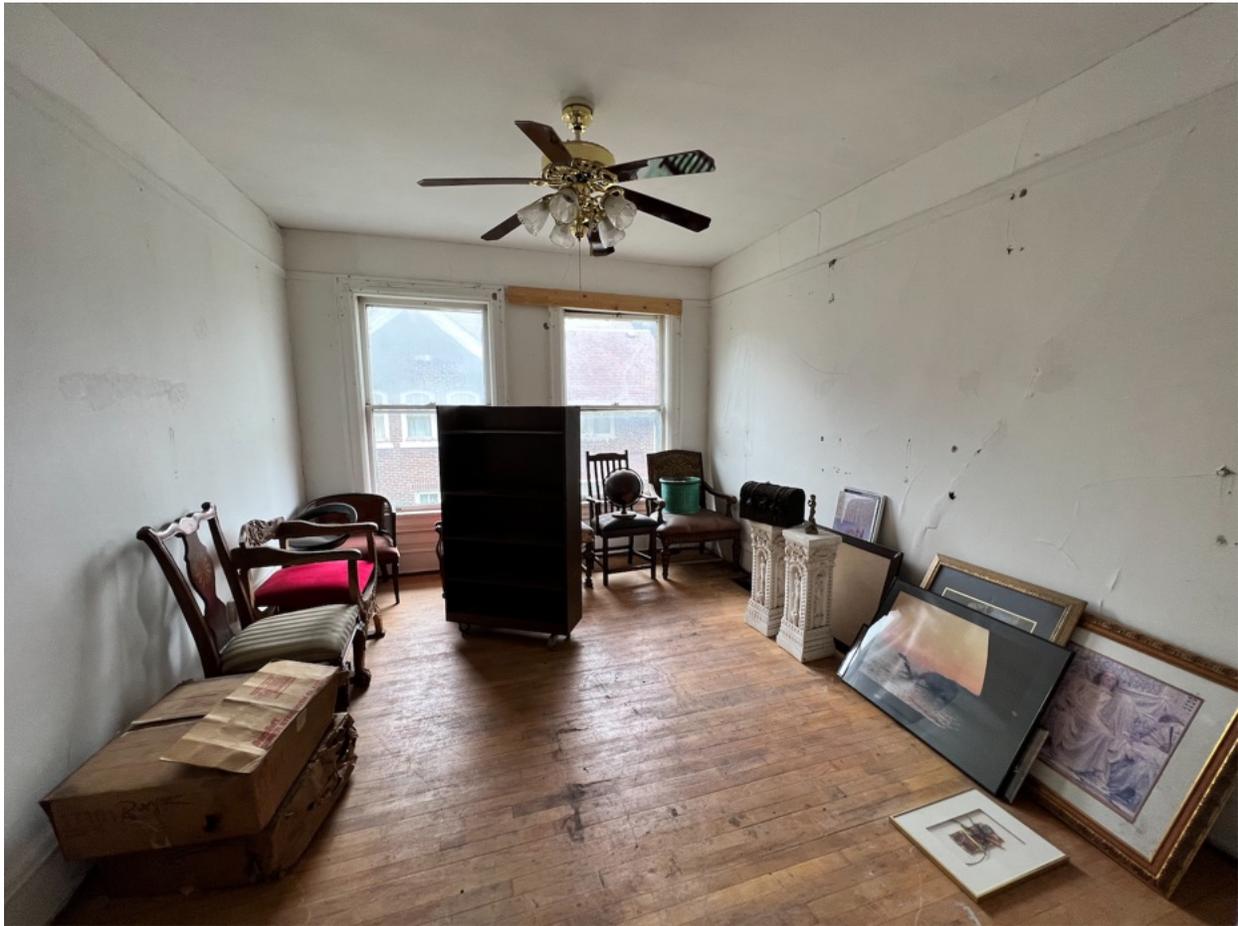
S13 - 2904 W State St second Bedroom, facing west. Plaster/drywall and wood trim damage throughout. Wood floors are scratched. Windows are missing storms, have broken panes and some rotting wood.

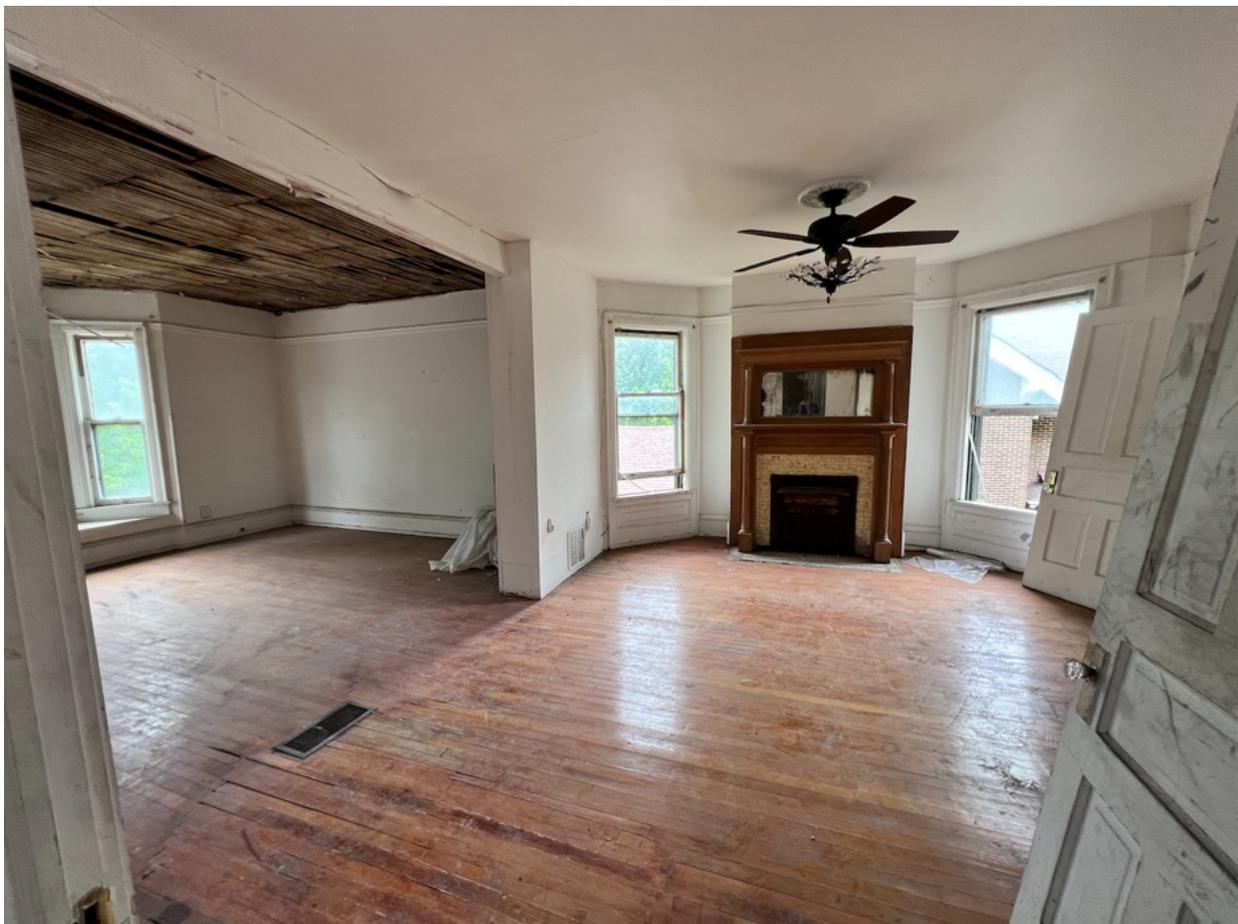
S14 - 2904 W State St third Bedroom, facing southwest. Significant flooring damage and buckling. Plaster/drywall and wood trim damage throughout. Wood floors are scratched. Windows are missing storms, have broken panes and some rotting wood.

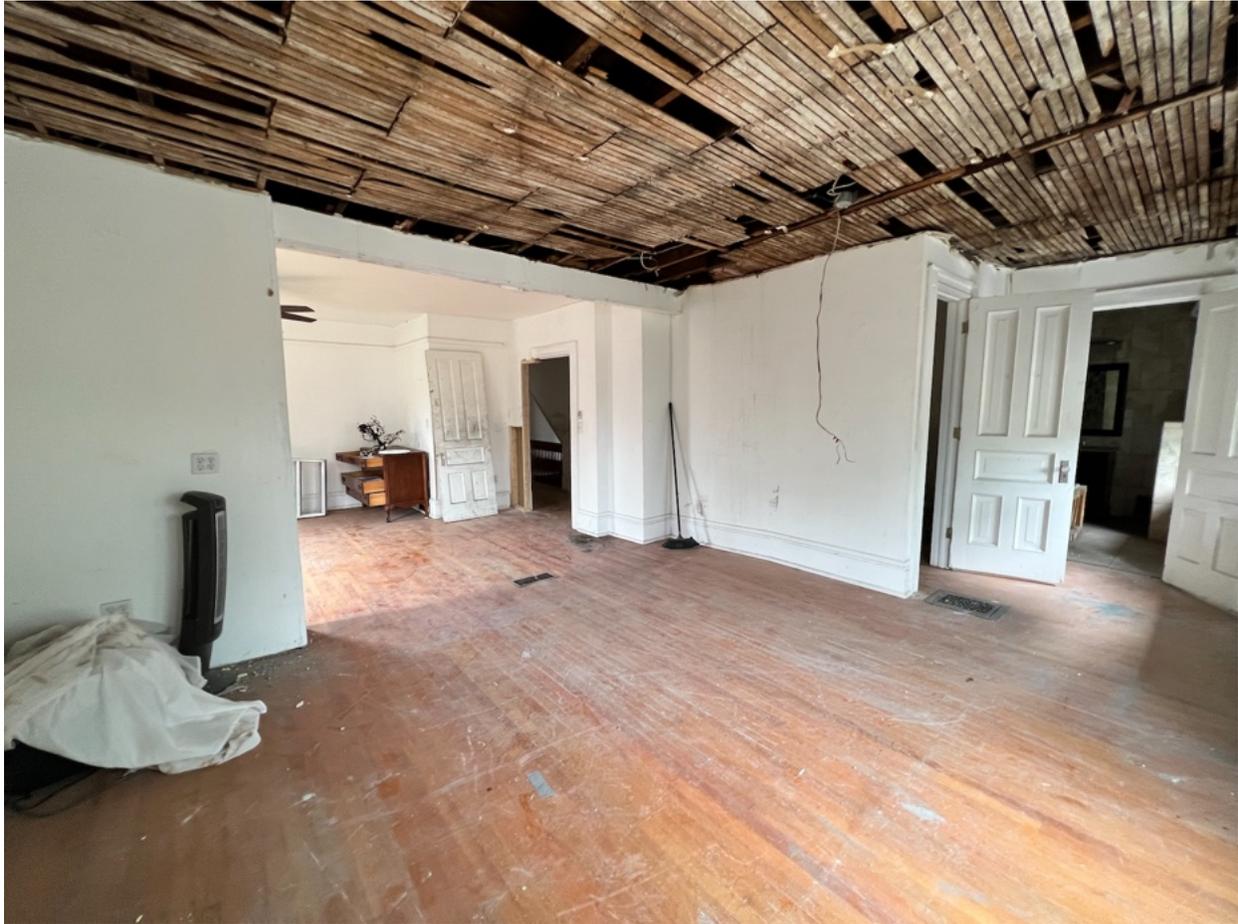
S15 - 2904 W State St third Bedroom, facing northeast. Significant missing plaster/drywall and non-working knob tube wiring. Previously opened up wall to create a master bedroom.

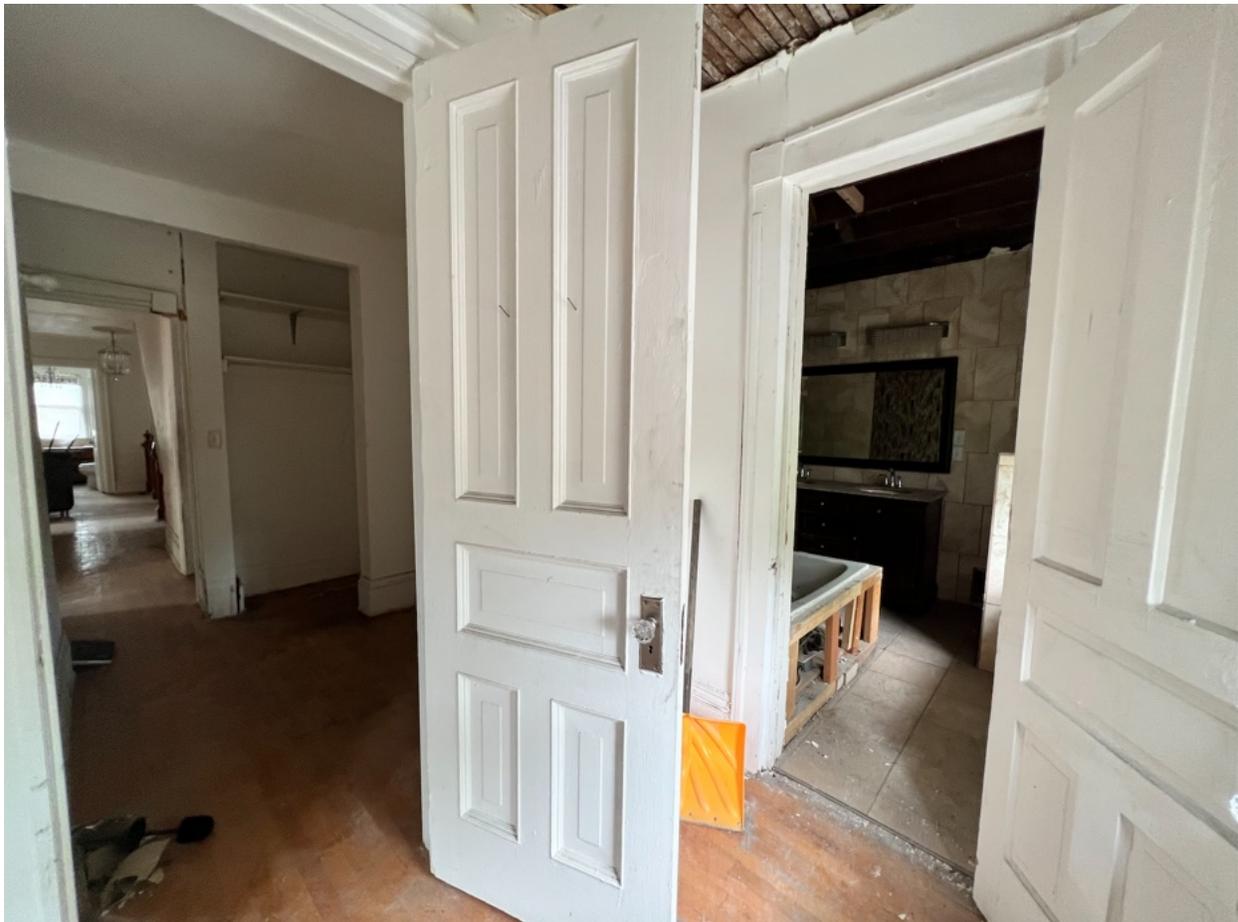
S16 - 2904 W State St third Bedroom, facing northeast - showing entry to upstairs Master Bathroom. Example of 5 panel doors

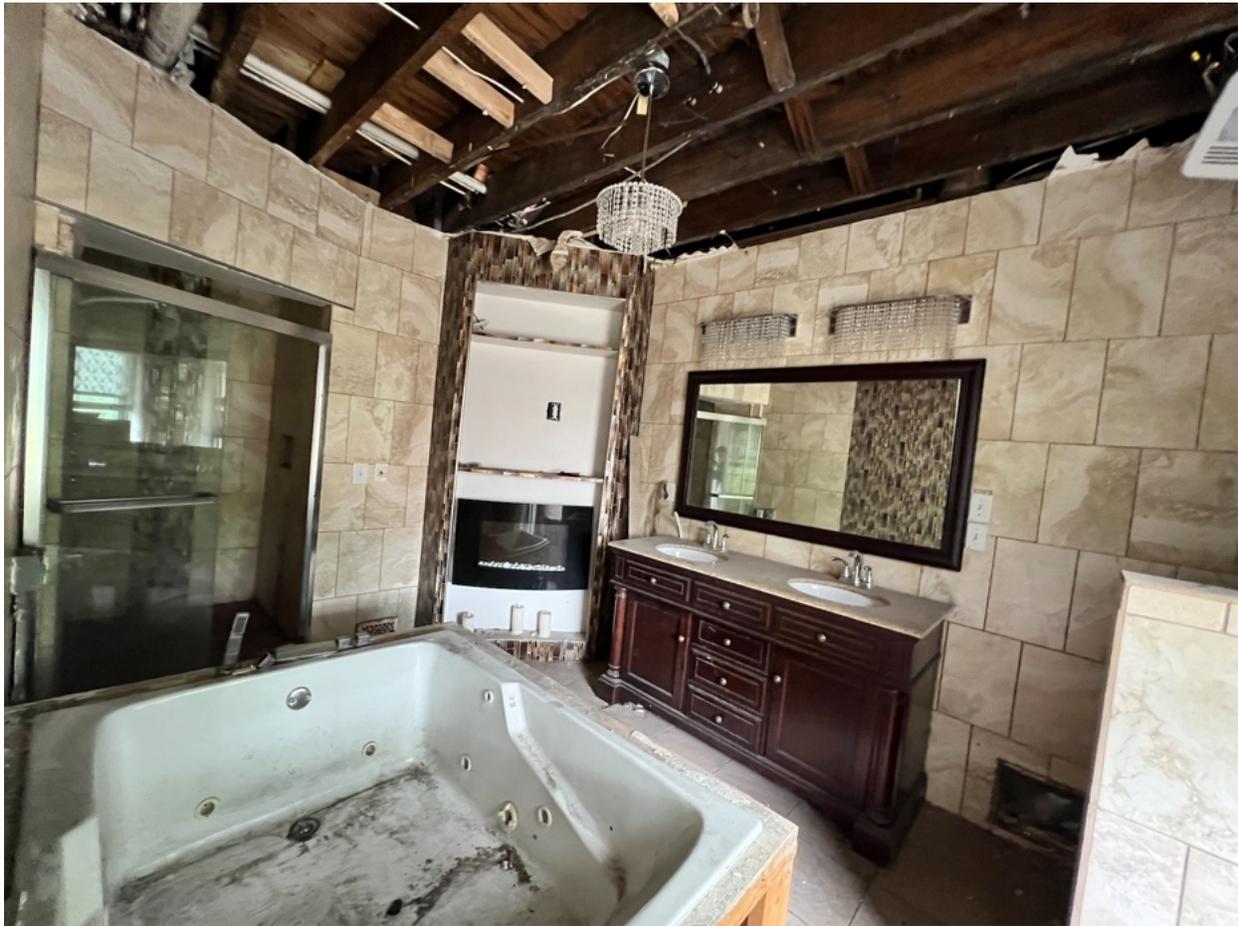
S17 - 2904 W State St Master Bathroom, facing northeast. Significant amount of drywall/plaster missing from ceiling. Tile among walls and floor are cracked. Large tub damaged glazing and inoperable jets, vanity has a decent amount of wear and tear, electric fireplace inoperable, shower tiles damaged.

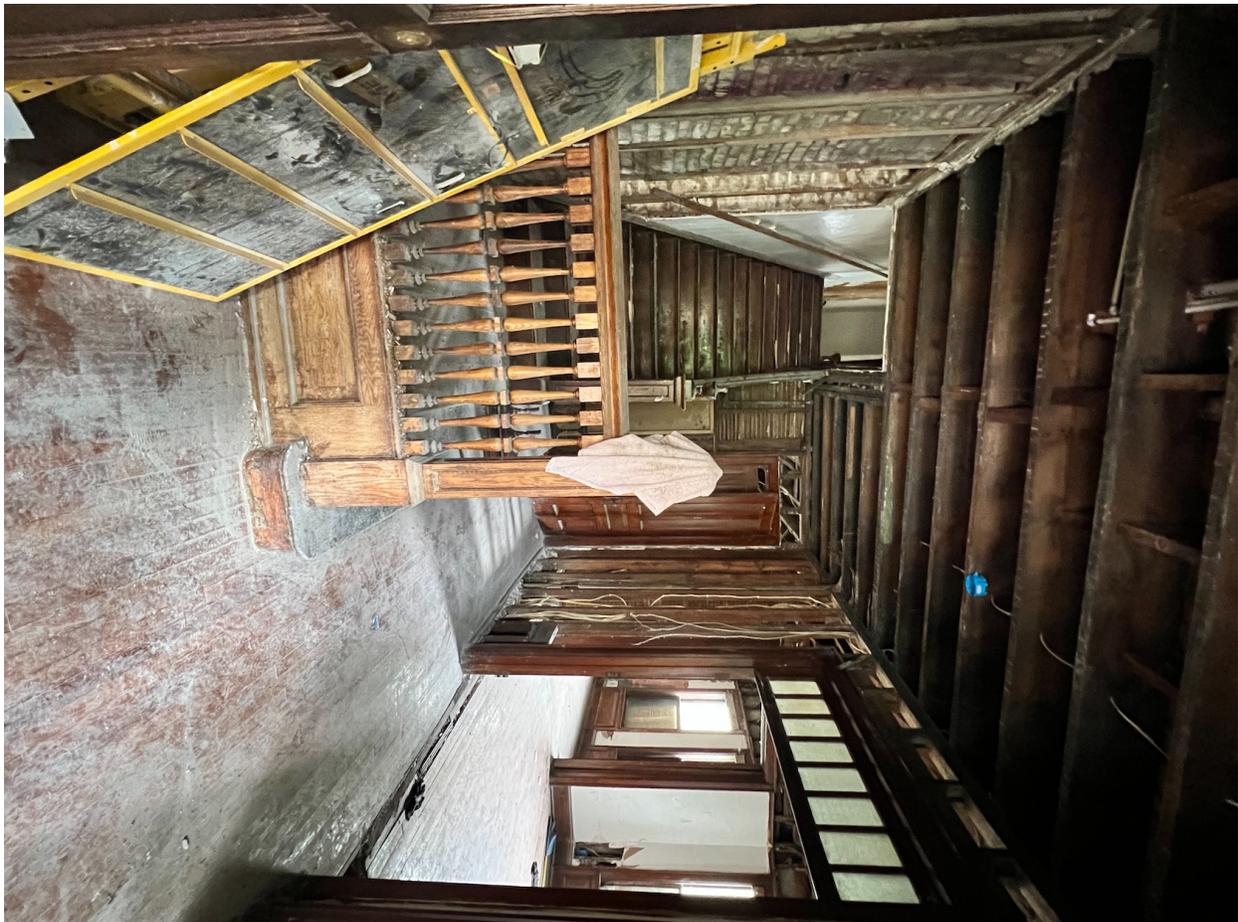
S18 - 2902 W State St Main Entrance and Grand Staircase, facing north. The Foyer has suffered from water damage and a large amount of the ceiling plaster/drywall is missing or damaged. The wood floors are scratched up, there are some missing stair banisters and no working electrical.

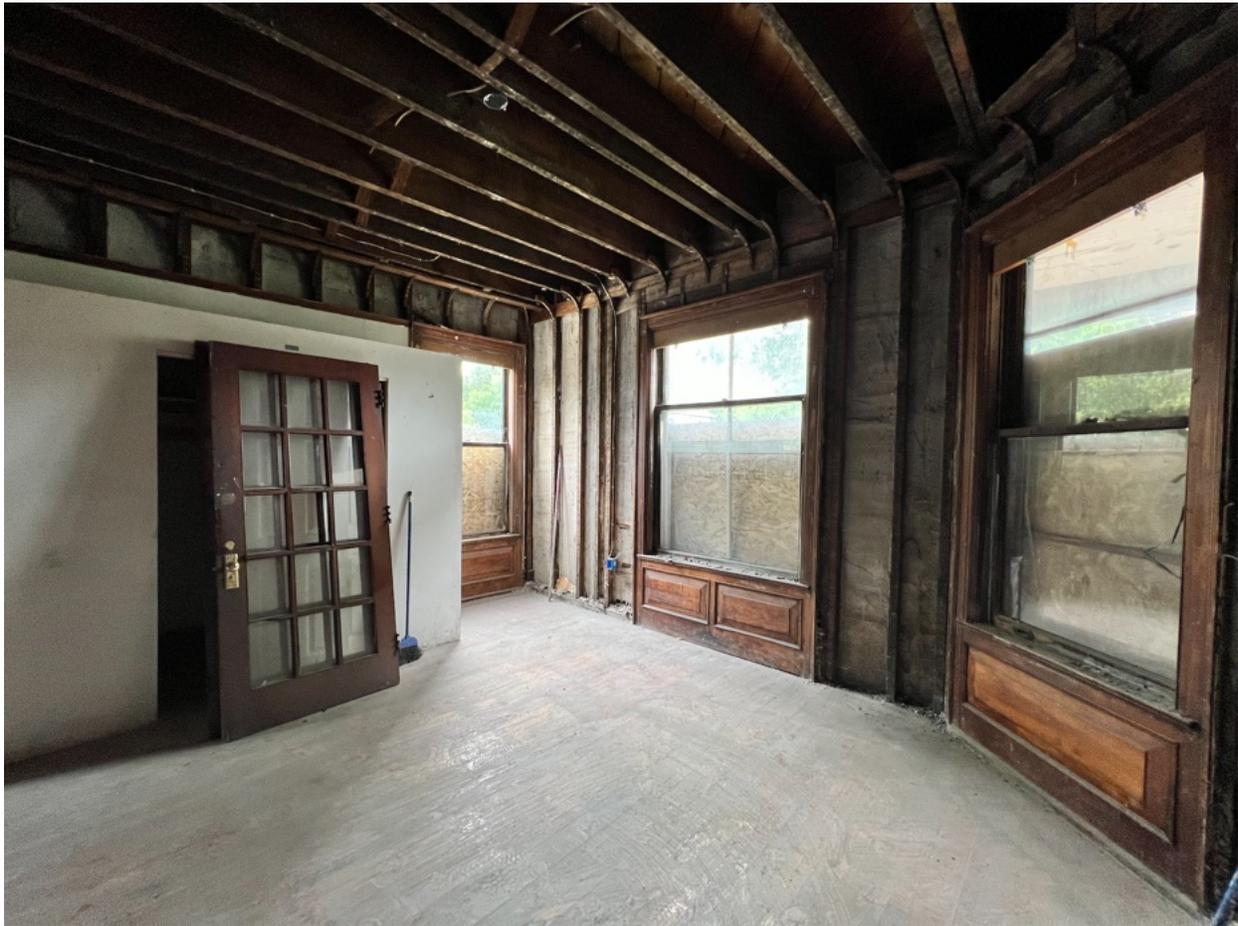
S19 - 2902 W State St Family Room, facing southeast. Majority of the ceiling and wall plaster is missing/damaged due to water penetration. Hardwood floors are scratched, windows are missing storm windows and have broken window panes and deteriorated/rotting wood frames. No working electrical

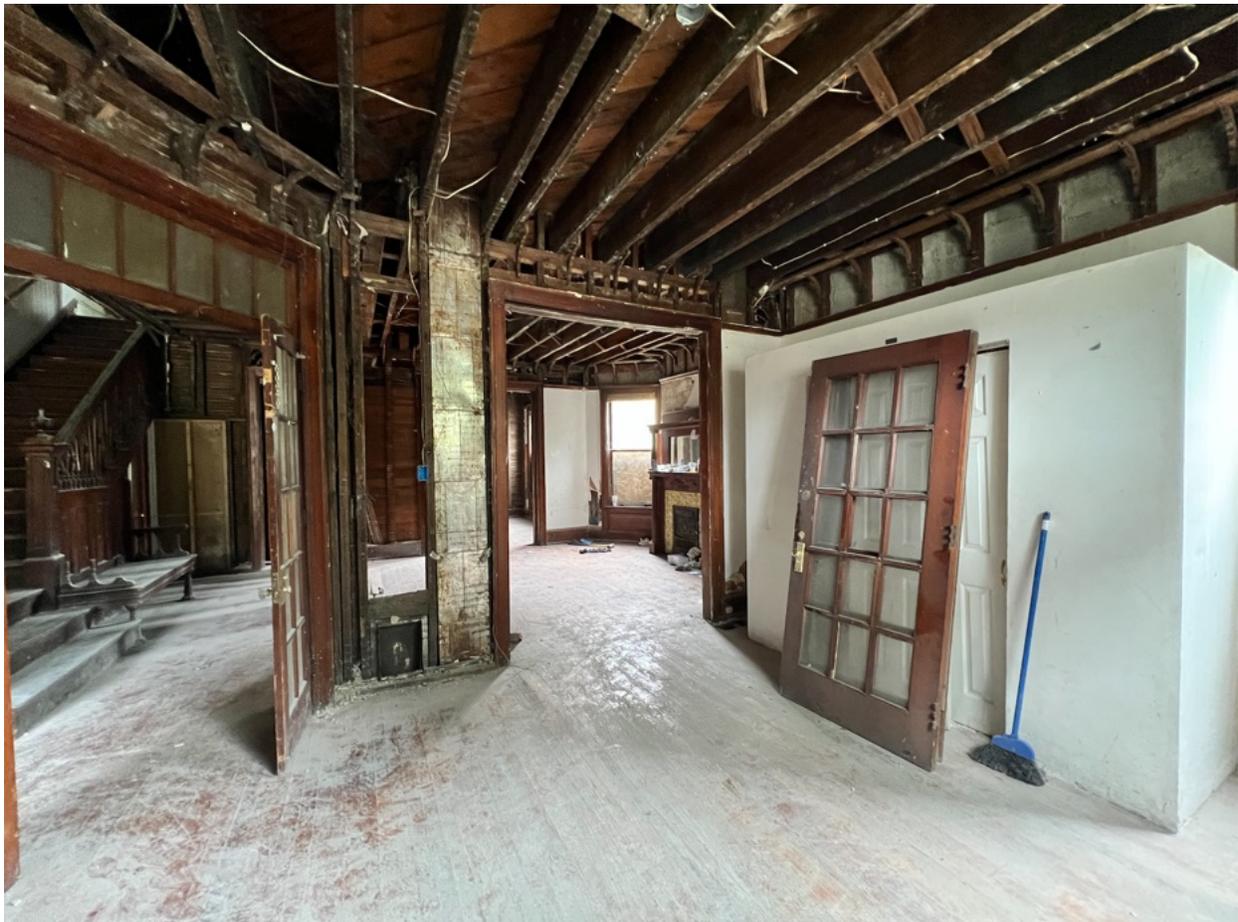
S20 - 2902 W State St Family Room, facing north. Significant missing plaster/drywall and no working electrical. Note cove shaped perimeter.
