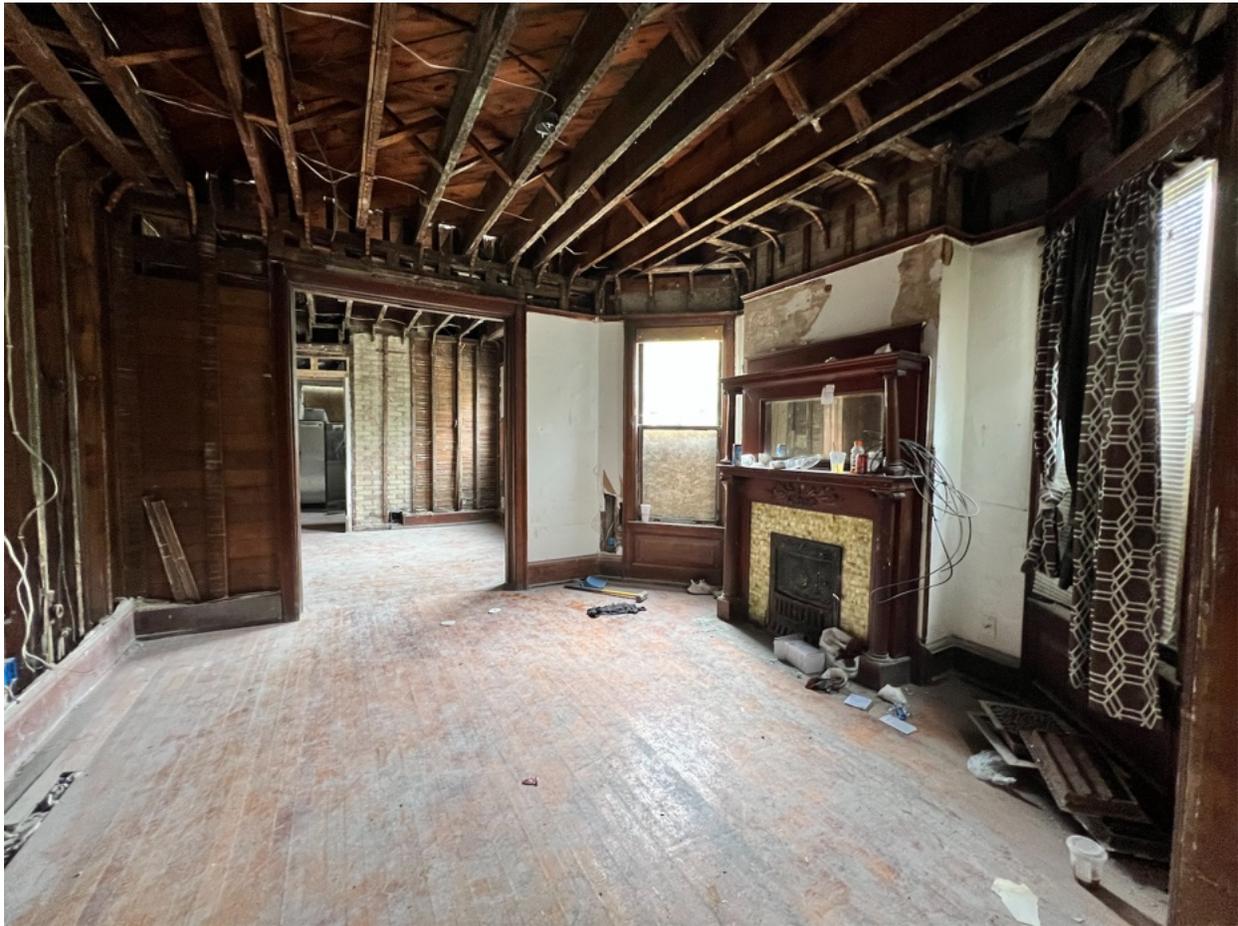
S21 - 2902 W State St Living Room, facing north. All of ceiling plaster/drywall is missing due to water damage. Wood floors are scratched. fireplace mantel is intact but some tile is missing. Windows are missing storms and have deteriorated wood frames.

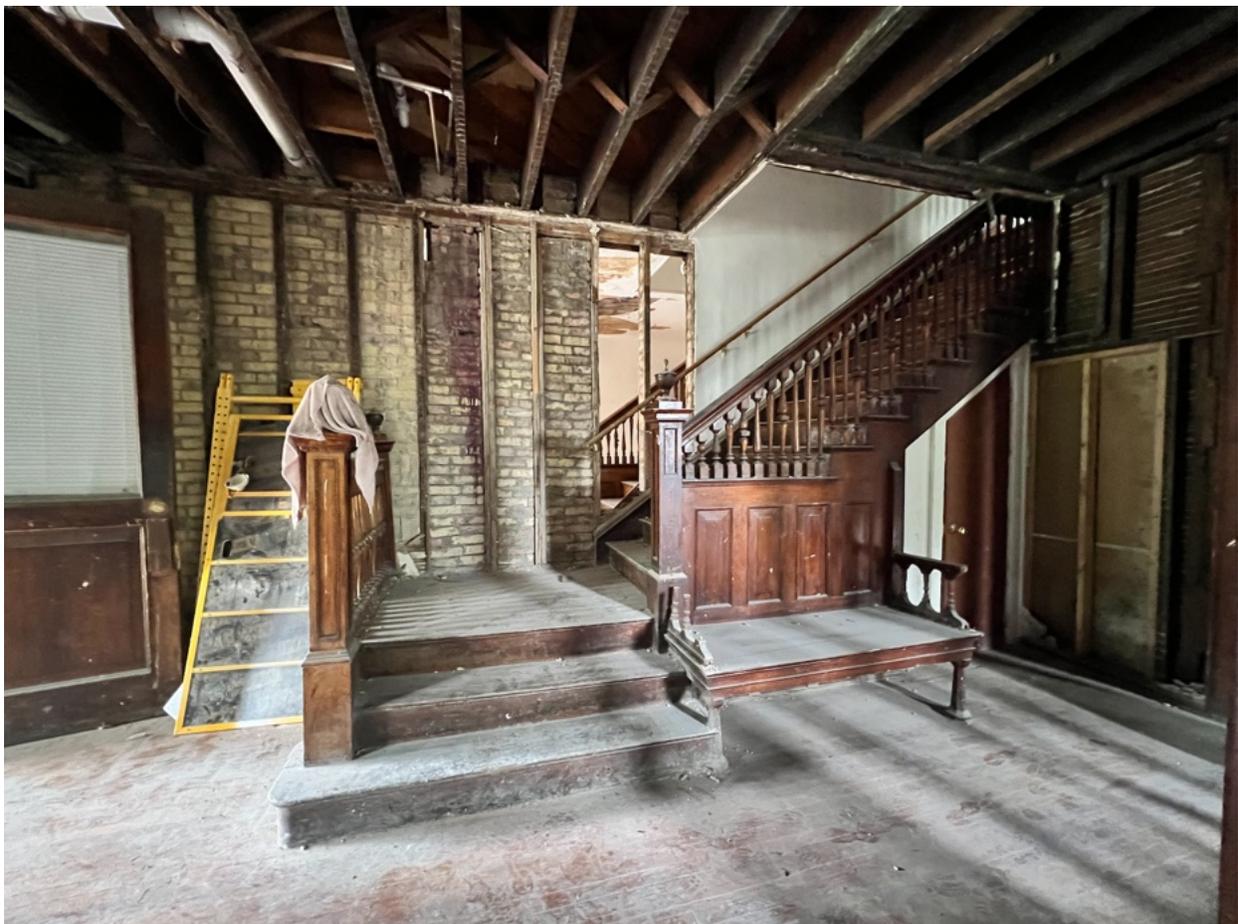
S22 - 2902 W State St Main Entrance and Grand Staircase, facing west. Showing separating wall of masonry (which runs to top floor) and entry bench.

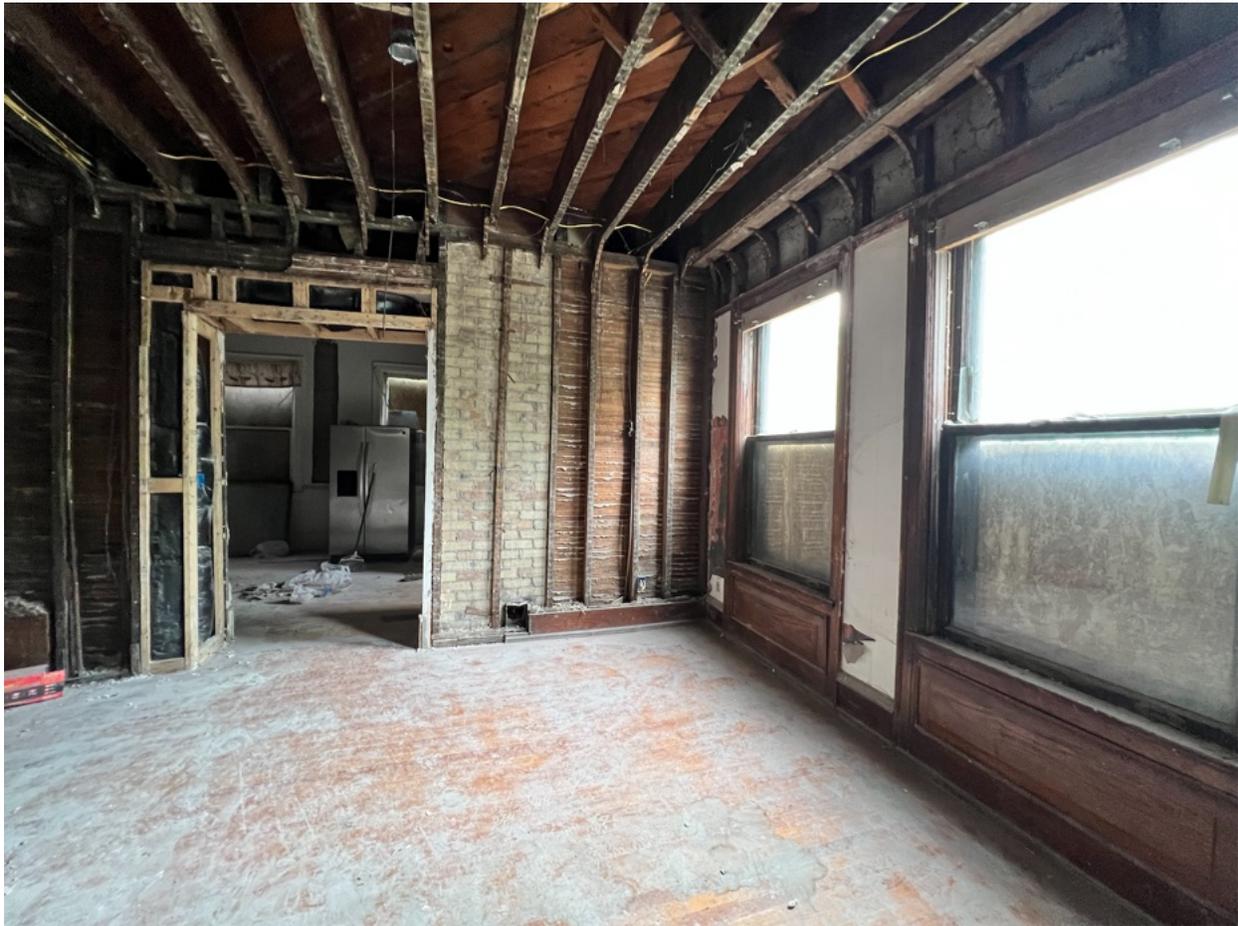
S23 - 2902 W State St Dining Room, facing north into Kitchen. Plaster/drywall is mostly removed, wood floors are scratched, chimney brick is exposed, two windows are missing storms. Windows are missing glazing and have some deteriorated wood.

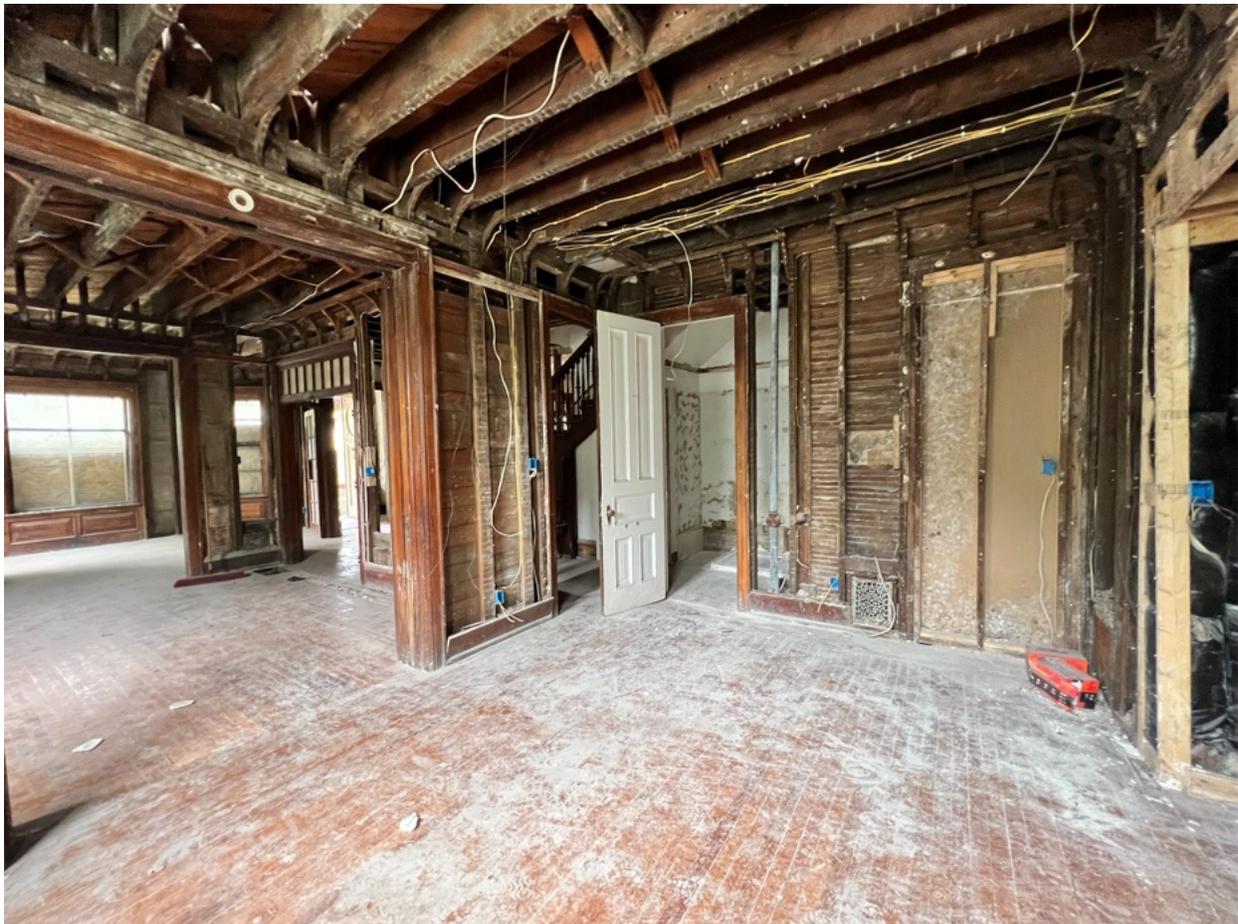
S24 - 2902 W State St Dining Room, facing southwest. No light fixture or functioning electrical. All preexisting handyman wiring was pre-purchase.

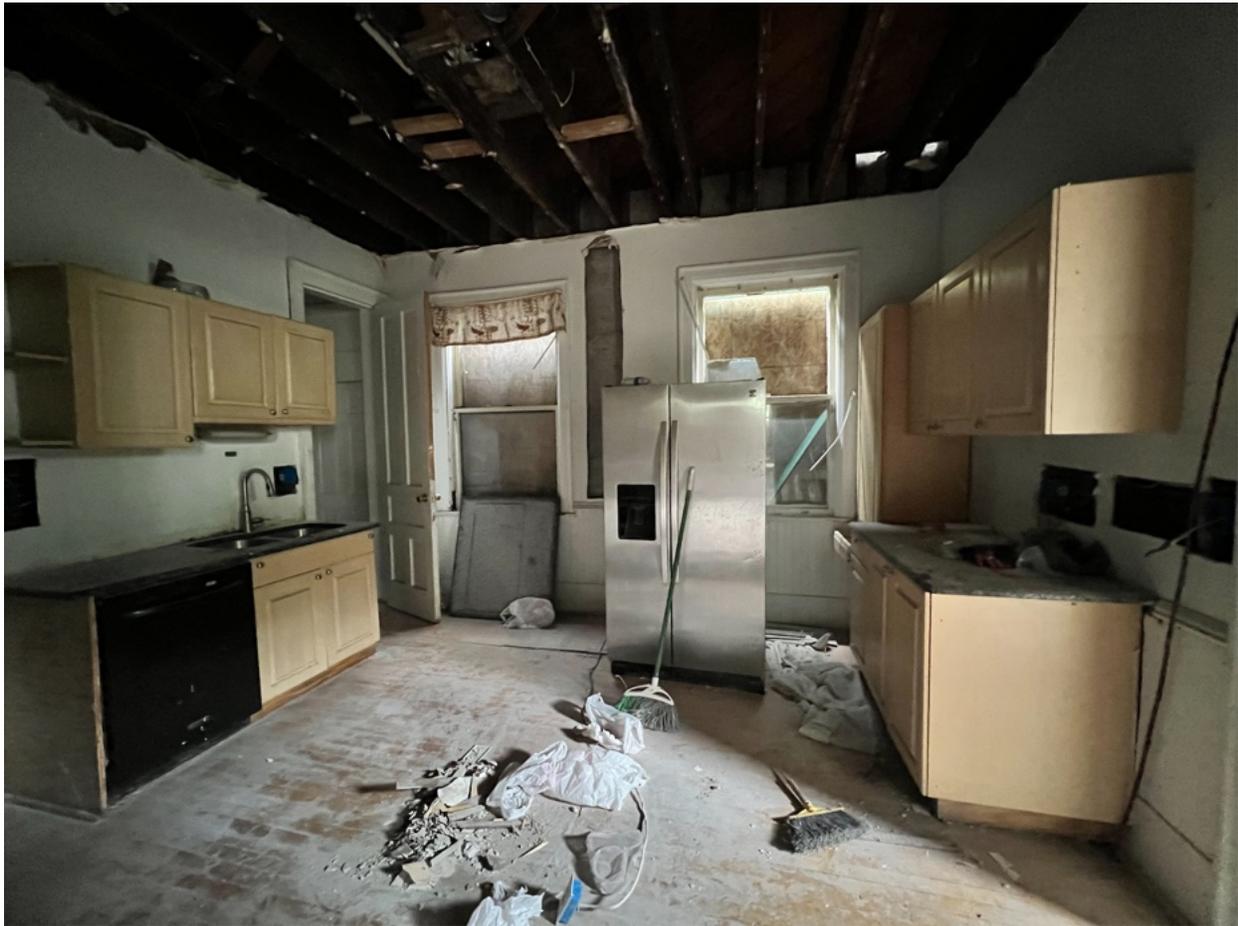
S25 - 2902 W State St Kitchen, facing north. Kitchen cupboards and counter tops are in good shape and are reusable. Two windows are missing storms and missing glazing with some deteriorated wood. Plaster/drywall mostly intact with area of texture imperfections and missing on ceiling, wood floors are scratched with areas of patches.

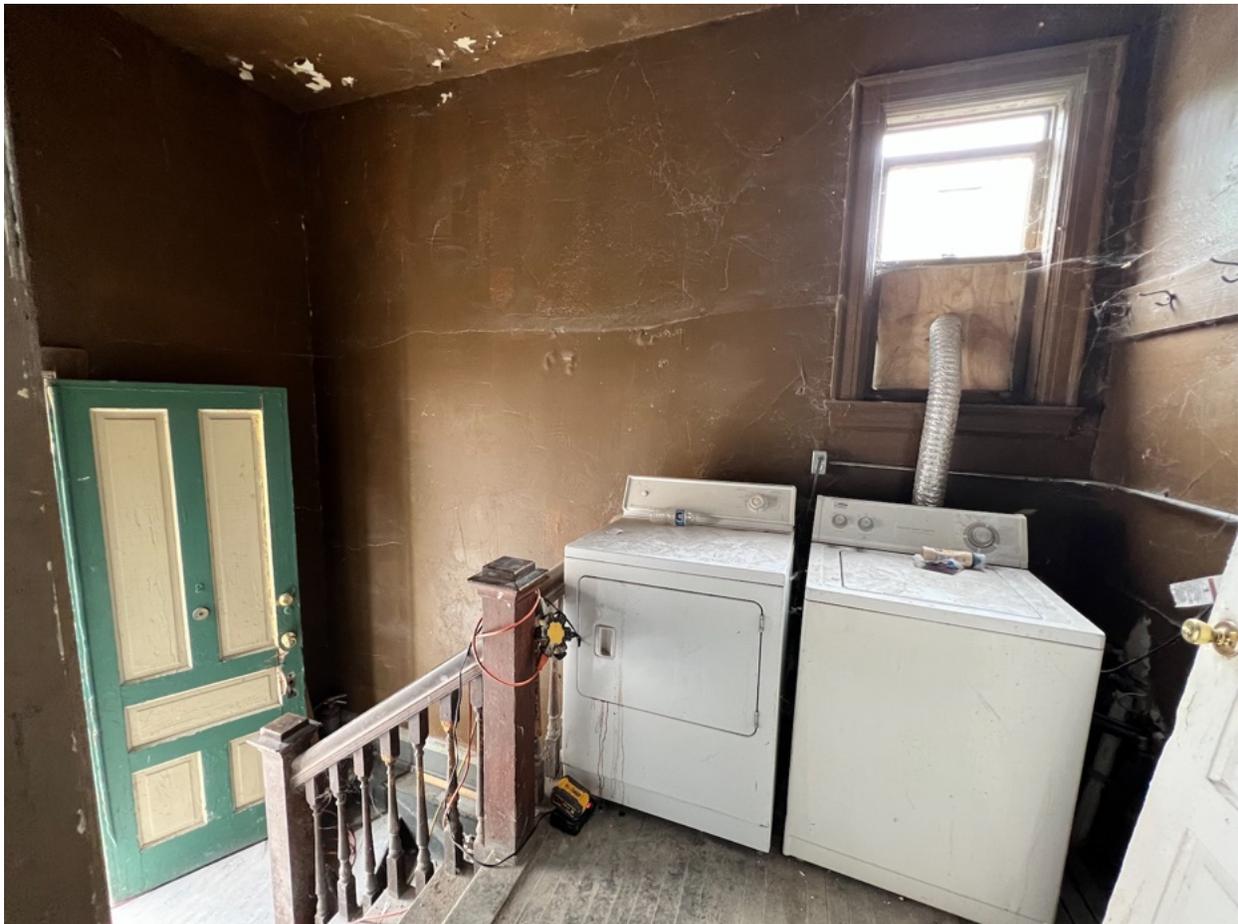
S26 - 2902 W State St back exit, facing east. Plaster/drywall mostly hanging but cracking and crumbling, wood floors are scratched and areas of patches.

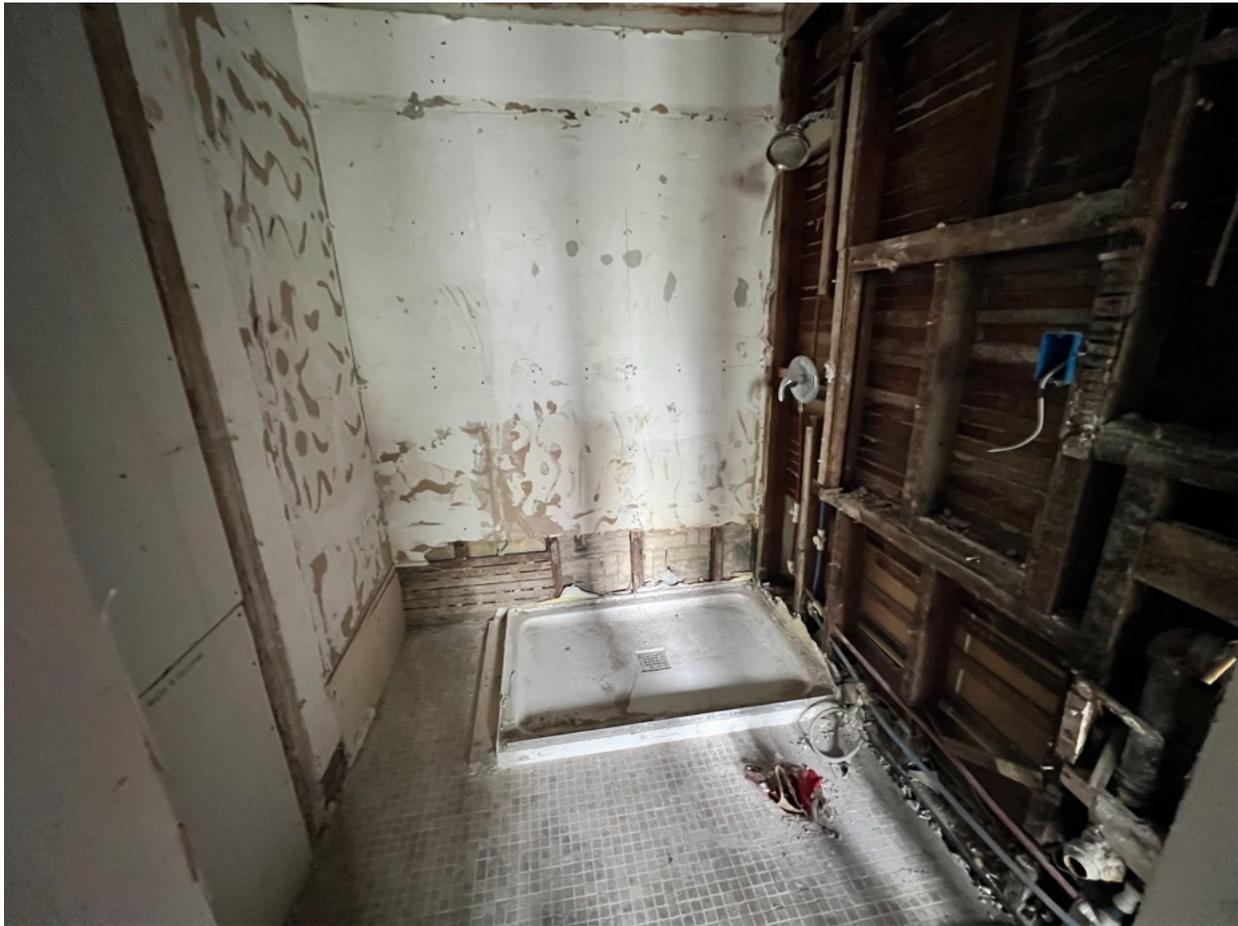
S27 - 2902 W State St Lower Bathroom, facing west. Bathroom has been gutted down to the studs and only has some tile and the bottom of a shower remaining.

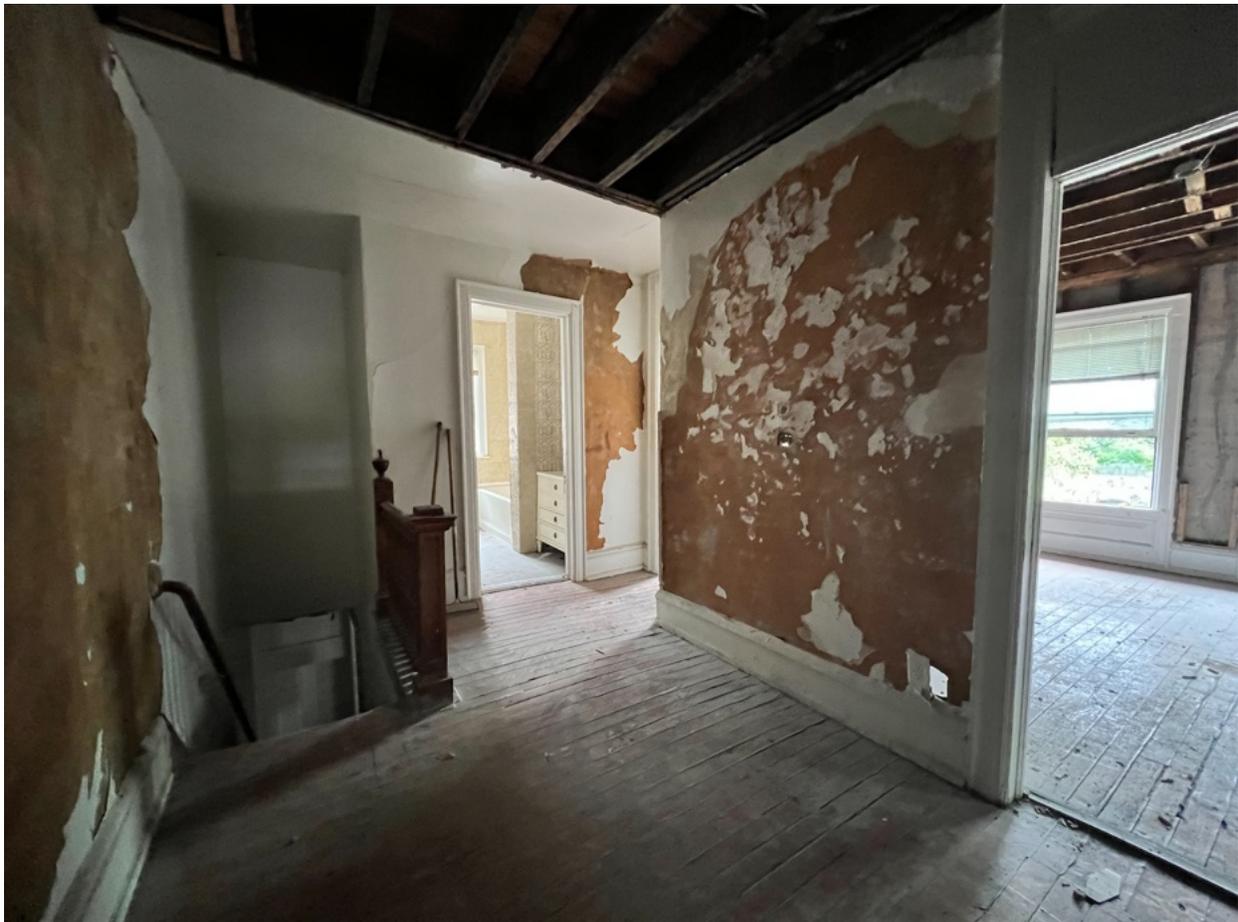
S28 - 2902 W State St top of Grand Staircase, facing north. Missing and cracking drywall/plaster, scratched wood floors, some stairs spindles missing or broken.

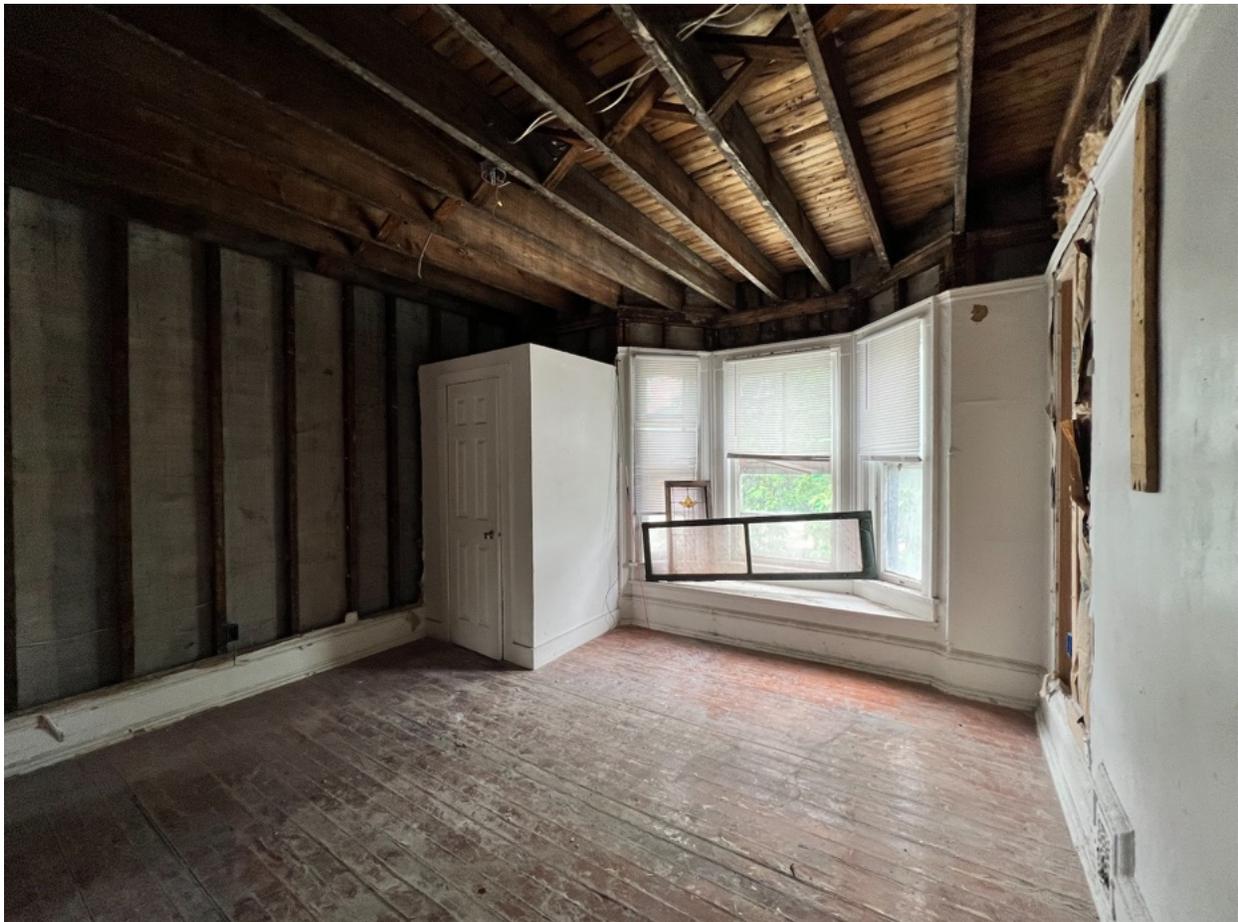
S30 - 2902 W State St Bedroom, facing southeast. Plaster and wood trim damaged/missing throughout. Wood floors are scratched. Windows are missing storms, have broken panes and some rotting wood.

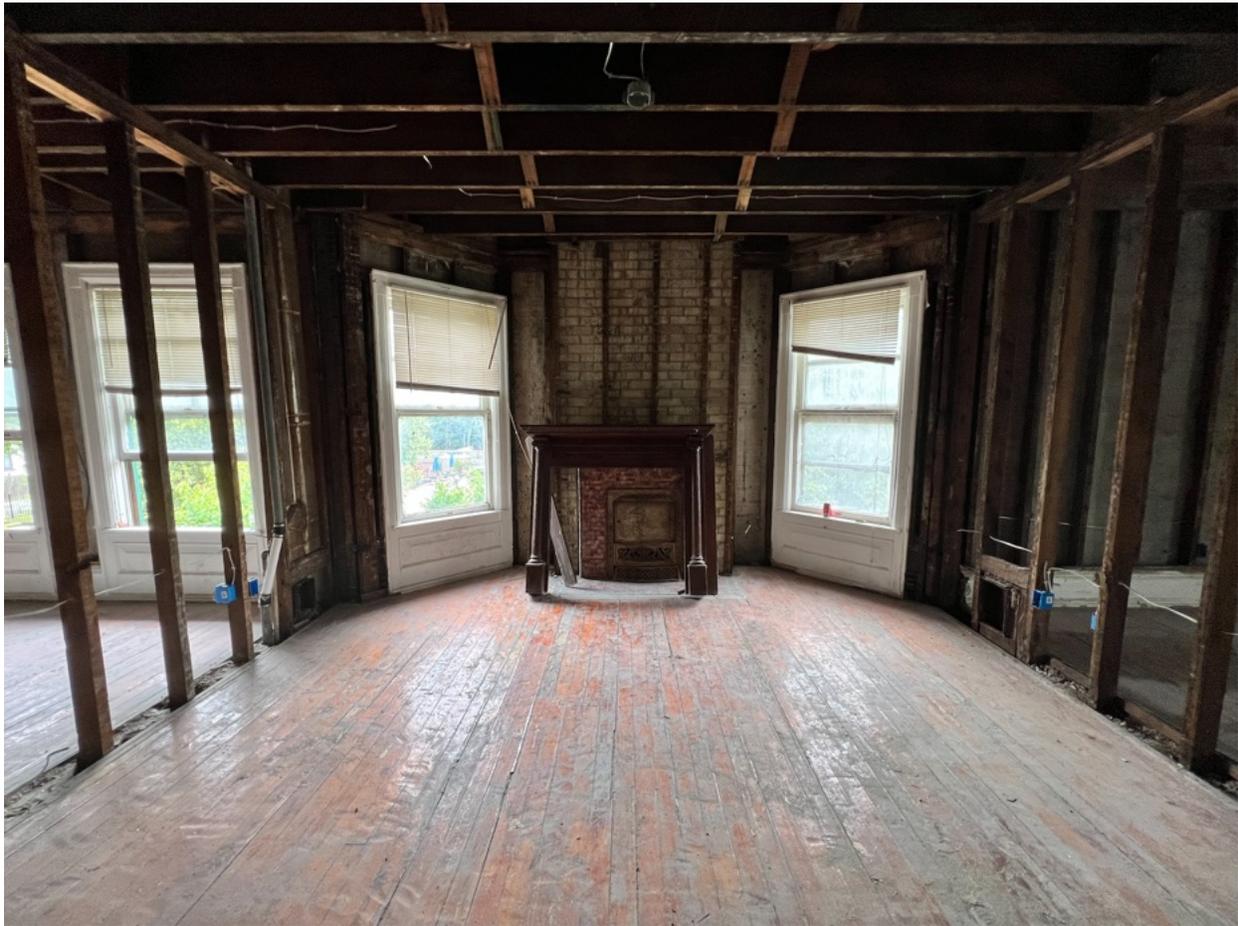
S31 - 2902 W State St second Bedroom, facing east. Plaster/drywall and wood trim damaged/missing throughout. Wood floors are scratched. Windows are missing storms, have broken panes and some rotting wood. fireplace mantel intact but not attached to wall. Fireplace missing some tile.

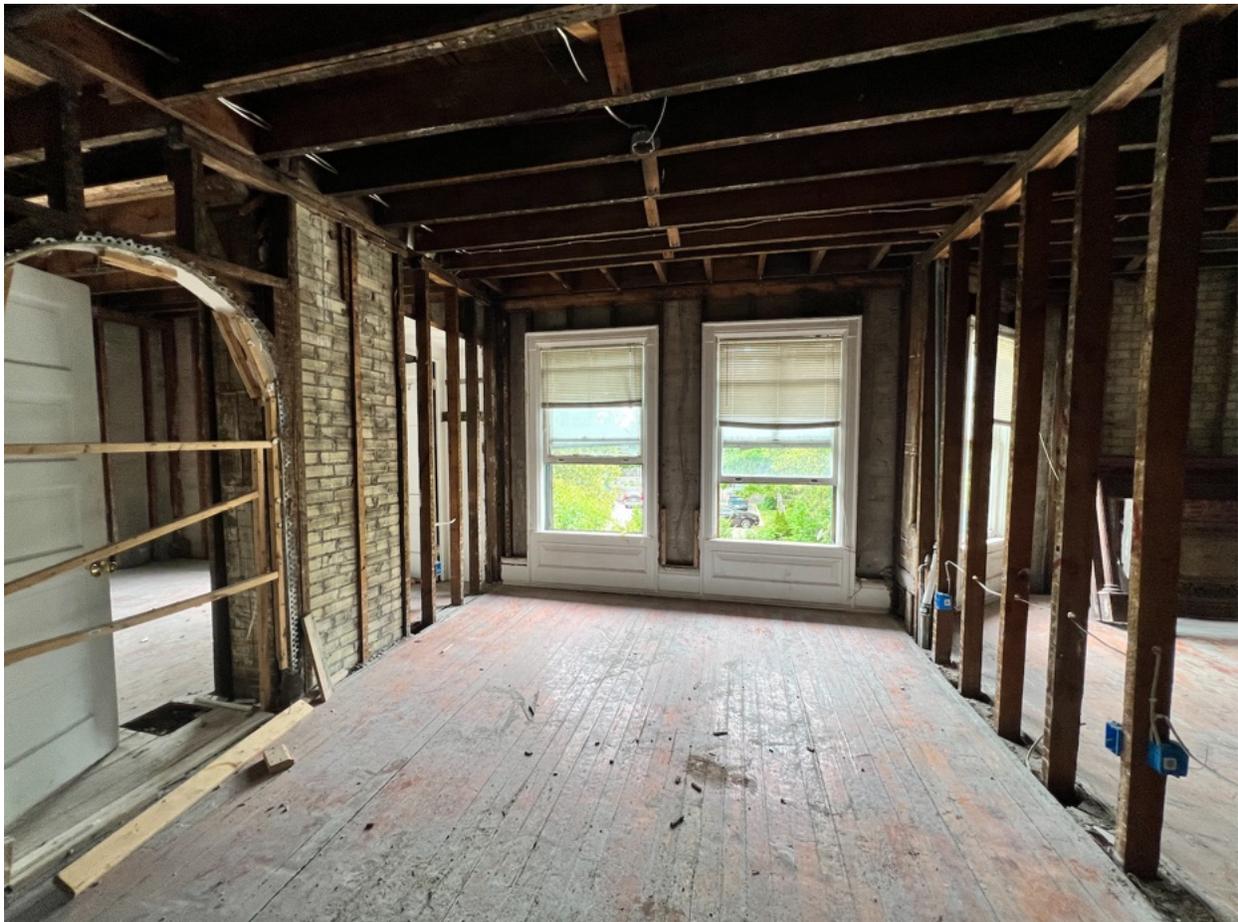
S32 - 2902 W State St third Bedroom, facing east. Plaster/drywall and wood trim damaged/missing throughout. Wood floors are scratched. Windows are missing storms, have broken panes and some rotting wood.

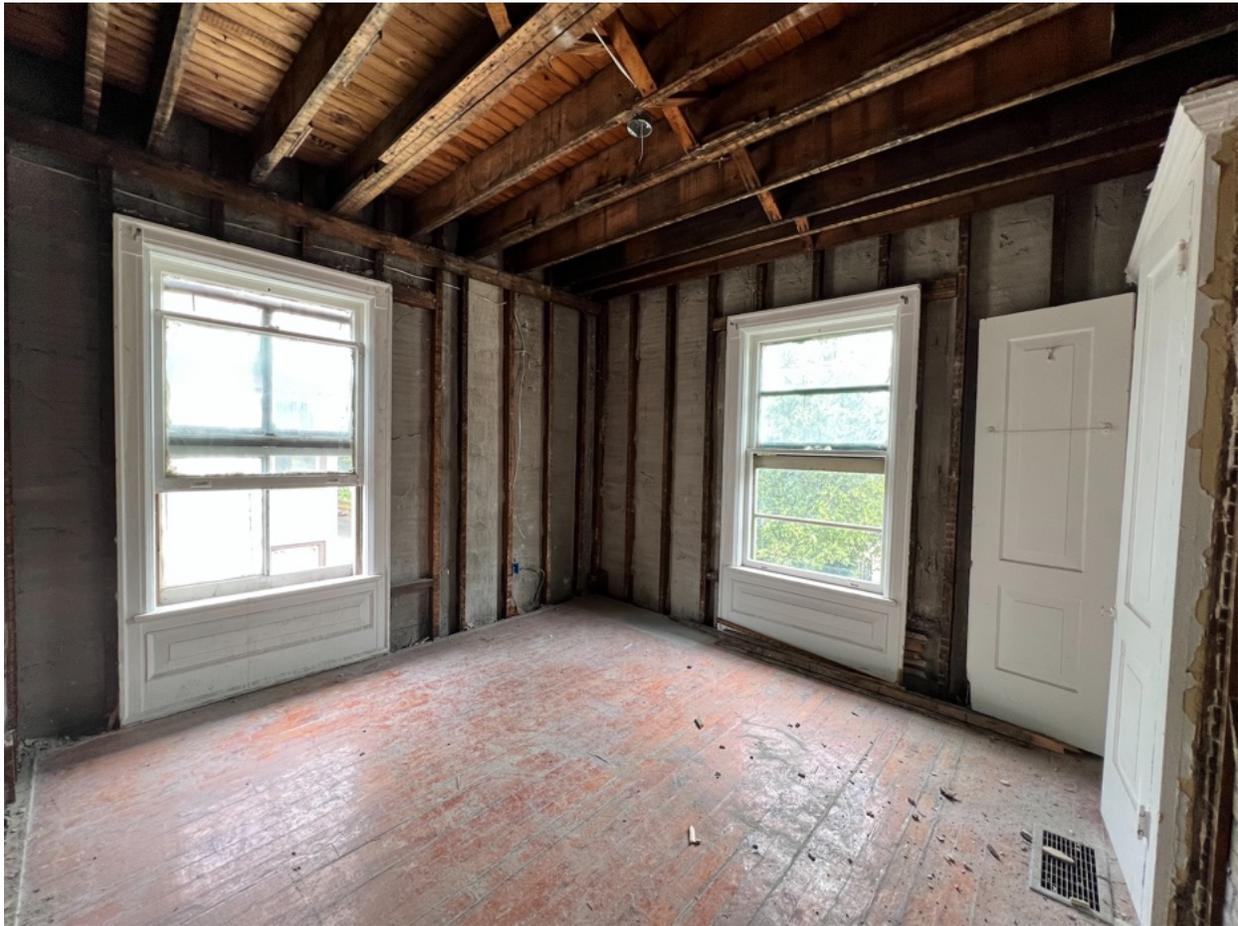
S33 - 2902 W State St fourth Bedroom, facing northeast. Plaster/drywall and wood trim damaged/missing throughout. Wood floors are scratched. Windows are missing storms, have broken panes and some rotting wood.

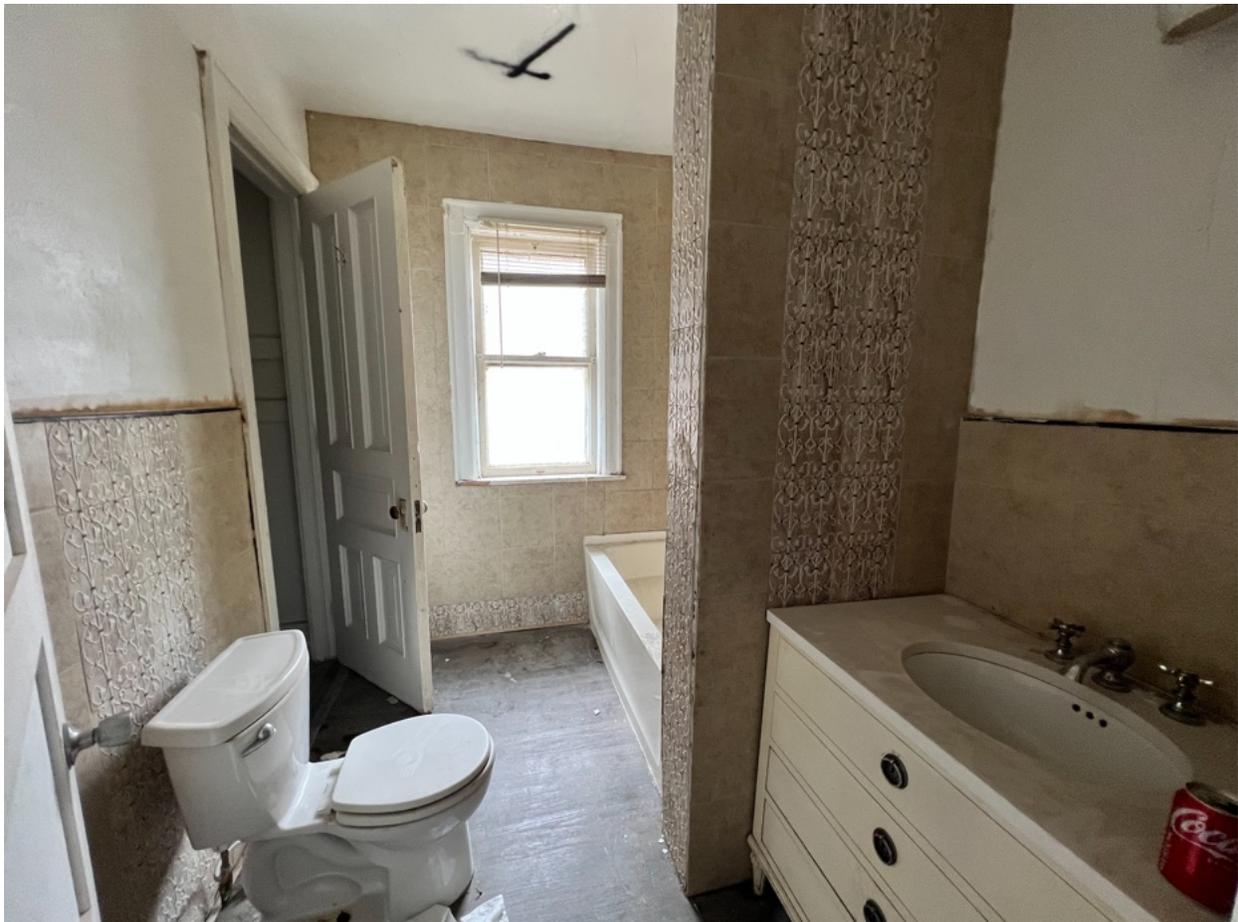
S34 - 2902 W State St upstairs Bathroom, facing north. LVP broken and scratched, vanity, toilet and tub all have wear and tear, tile along wall missing grout and cracked in areas. Window missing some wood framing. Drywall/plaster holes.

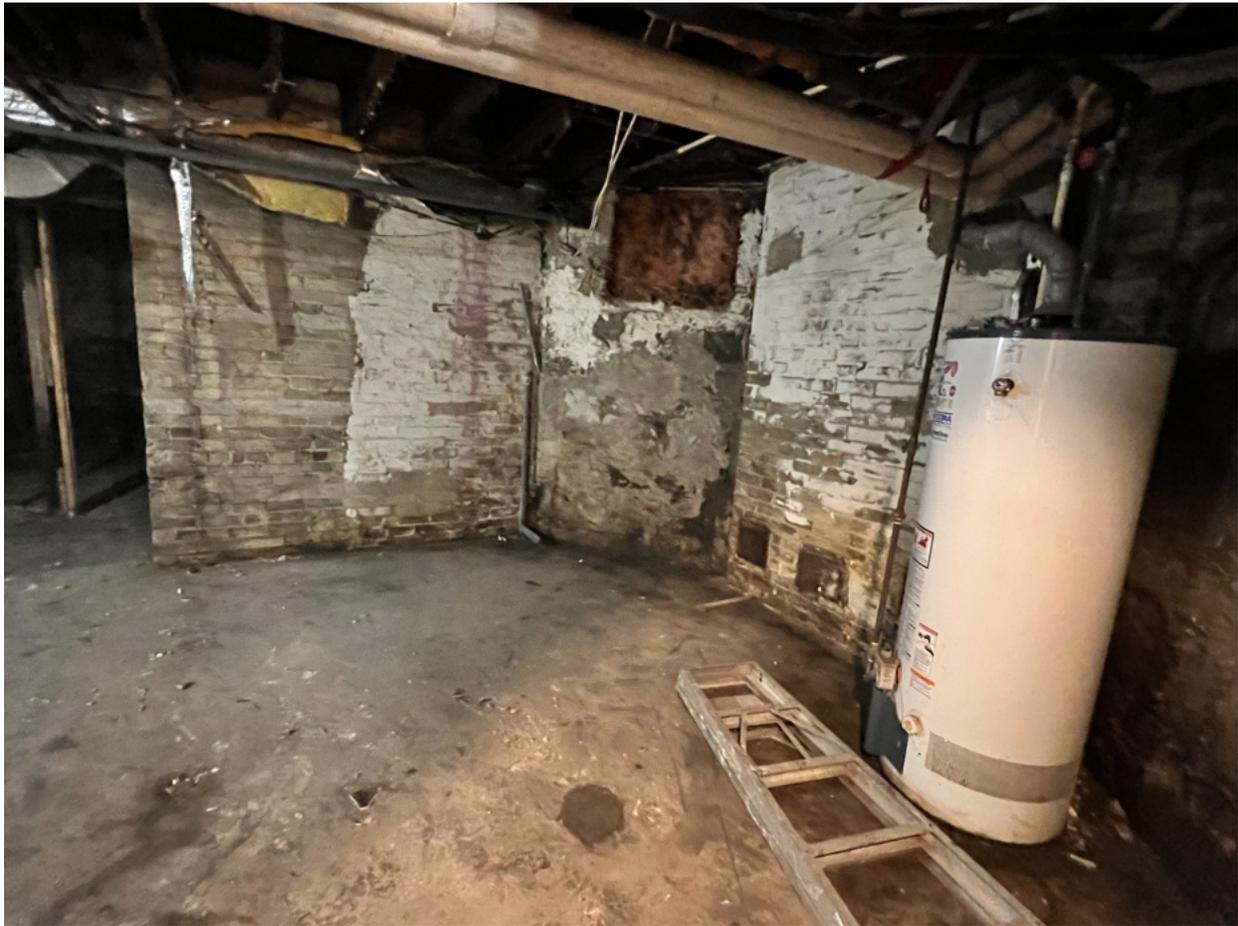
Basement main mechanical room. Showing water damage and brick/stone foundation combination.
