Certificate of Appropriateness

3215 W. STATE ST. Concordia Historic District

PTS ID 104166 COA

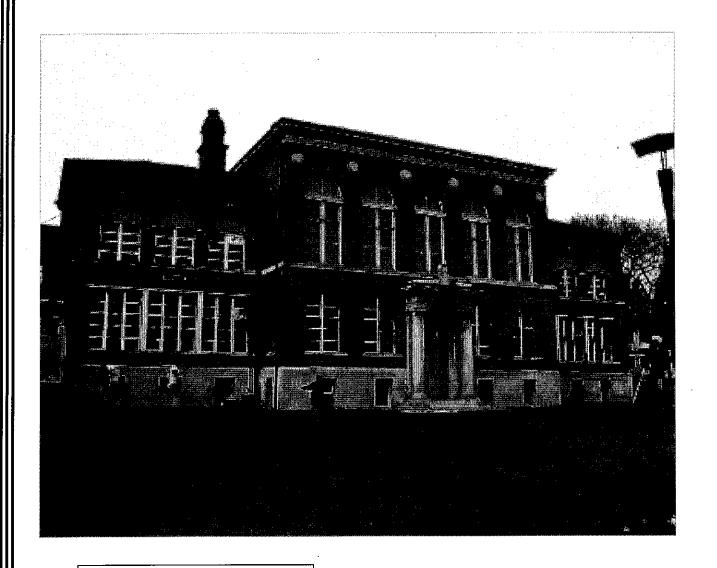
Albrecht Hall is clad with tan iron-spot brick and will be 100% repointed. Spalled Indiana limestone trim will be patched using restoration mortars and the masonry will be cleaned. Steel ventilator caps on the roof will be patched to match the adjacent material, construction, and detailing. Corrosion will be removed by soda blasting the entire metal unit. The metal will then be primed and finished with a rust inhibitive primer and paint. Minor roof repair and patching of existing red asphalt shingles to match adjacent is planned. Cracks in the masonry, efflorescence and failing jack arches will be repaired.

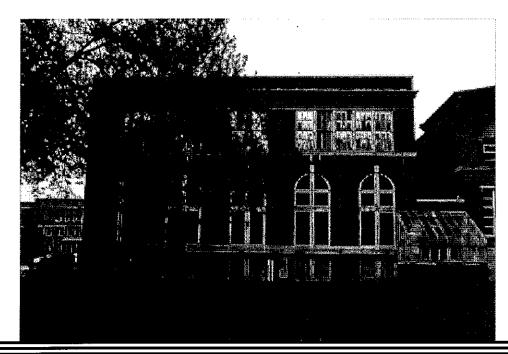
The masonry on the former Library will be repointed in areas, spalling Indiana limestone will be repaired using restoration mortars and the masonry will be cleaned.
