Certificate of Appropriateness

2419 N. Wahl Ave., North Point North Historic District

Deconstruct south chimney down to roof flashing and rebuild in-kind to existing height and design. Reuse chimney cap. Tuck pointing house and east chimney, as needed. Installation of caulking at the metal roof flashing of the east chimney. Removal of four (4) deteriorated windows and limestone sills from the north and west elevations and replacement with new Marvin windows and new limestone.

CHIMNEY REPAIR

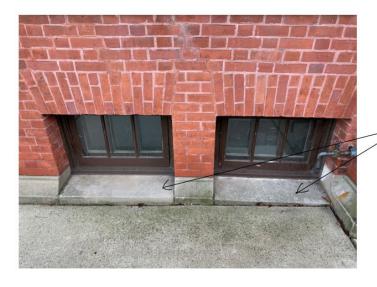
Existing basement windows

Proper drainage on basement windows on NE corner.

The North and West basement windows have been visually inspected by this contractor. It is my opinion the proper procedure for repair should be as outlined in the following specifications.

- Holton Brothers will remove current basement window frames and dispose of (4 on North elevation and 4 on West elevation). Note: Access to basement will be needed during project.
- New limestone shall be laid at base of 8 window openings. Limestone will match adjacent limestone on house AS CLOSE AS POSSIBLE. Note: New limestone will NOT match adjacent limestone perfectly due to age/weathering.
- Limestone shall be laid above current grade line and pitched away from house to prevent water pooling.
 Concrete driveway on North elevation and brick pavers on West elevation may need to be "cut back" to allow proper fit/pitch of stone.
- Windows will be temporarily boarded up until new windows can be installed. Note: Homeowner responsible for hiring window company to work in conjunction with Holton Brothers.
 Cost of new window work is NOT included in quote.

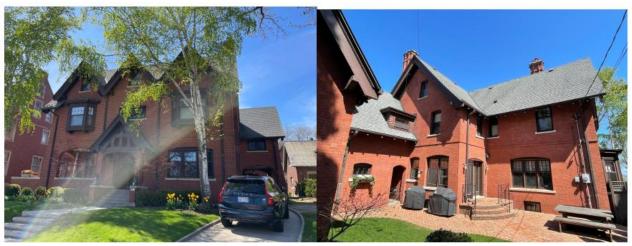
Front | East

Back | West

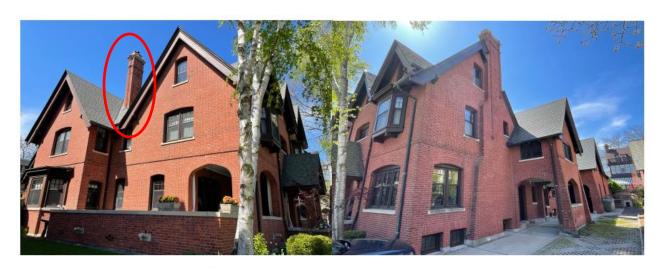
South side

North side

South chimney to be rebuilt

- A scaffold tower will need to be erected from the ground up and onto the roof so as to access the entire chimney.
 NOTE: Outside contractor to provide scaffold access.
- Plywood sheeting and canvas tarps will be used to protect all roof areas adjacent to the chimney.
- Due to the extensive mortar damage at the top of the chimney, we will remove the existing cap and brick masonry down to the roof flashing.
 - Note: Quote assumes inner back-up wall (if present) is solid, in-tact, and needs no work
- All exposed clay tile flue liners shall be replaced where deemed necessary.
- Chimney shall be rebuilt to its original height and dimensions with new brick which shall match existing brick as closely as possible.
- Stone cap will be saved and relayed at top of chimney.
