CTC SUPPLIES INC

Claimant: CTC Supplies, Inc.
3845 N. Bremen St.
Milwaukee, WI 53212
414-332-3401
CEO: Sandra Woycke
sw@ctcsupplies.com

The whole problem was created because our sewer pipe was never connected to the new main city sewer during the construction on Vienna Ave. in 2023. The city and it's contractor should have known that failure to connect this pipe would cause future problems. The expenses that we incurred were a direct result of their actions. This was all caused because of this negligence.

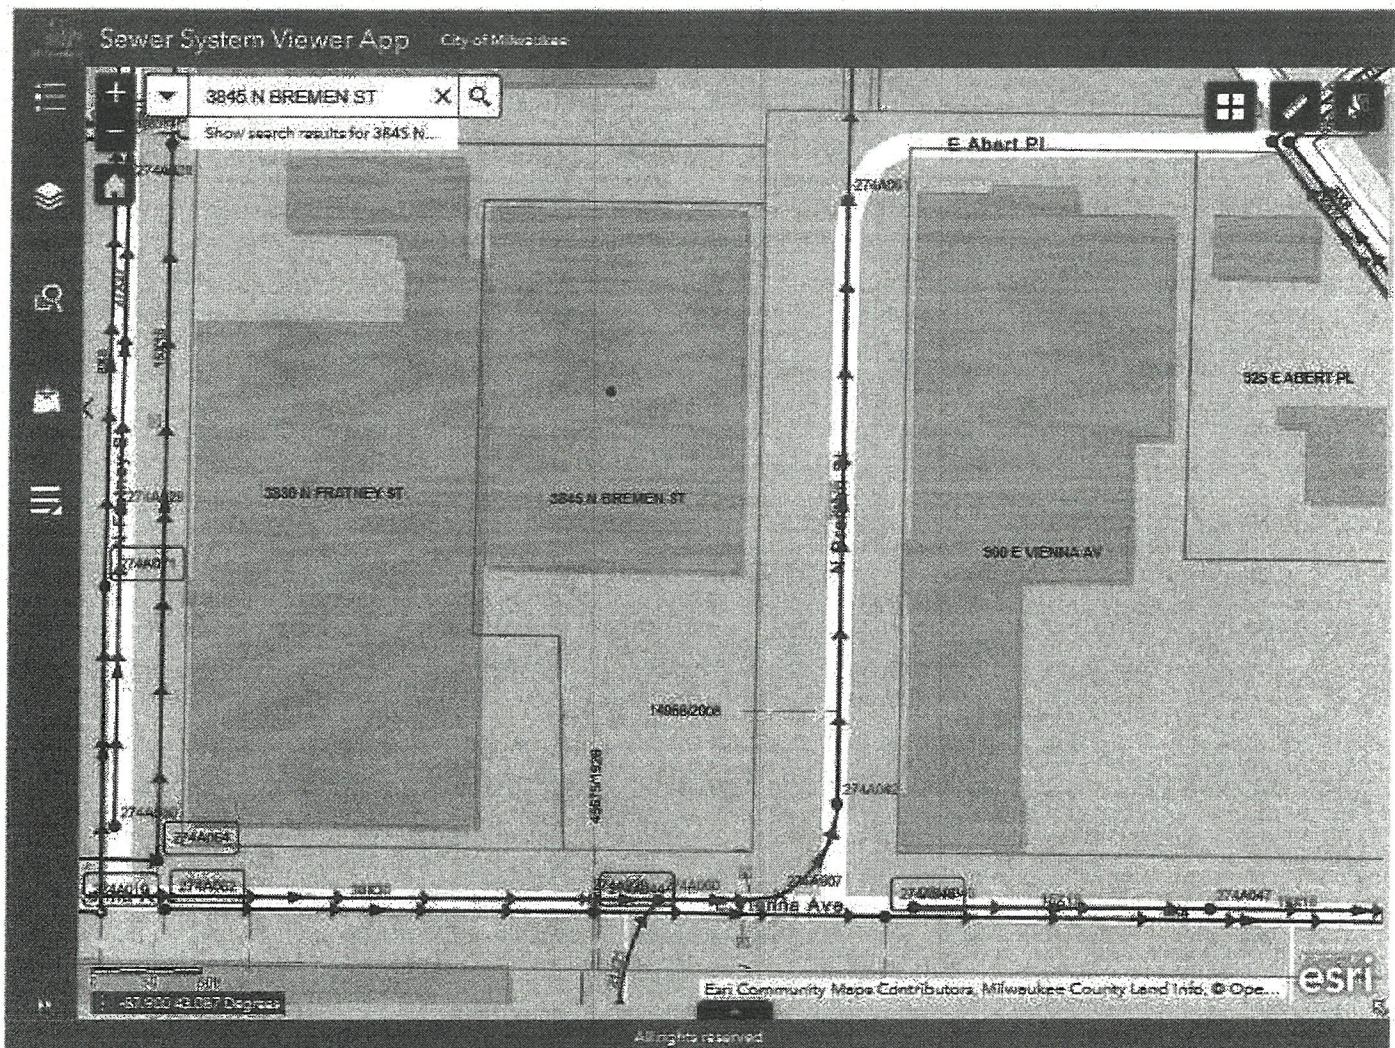
I am sending you 2 different maps as one is from 2006 (for reference) and the laterals along W Vienna are different than what is shown in ESRI. The ESRI Sewer System Viewer Map (color) should be newer as it appears that a sewer lateral was installed in 2008 along N Bremen St.

The RED is 8" Sanitary sewer.

The BLUE is 30" STORM and as it head EAST, it becomes a 36" STORM and continues as a 36" as heads straight North past E Abert Pl.

The sewer lateral numbers are listed as NUMBER #/YEAR (installed). This is not your Water Lateral and is not shown on these maps.

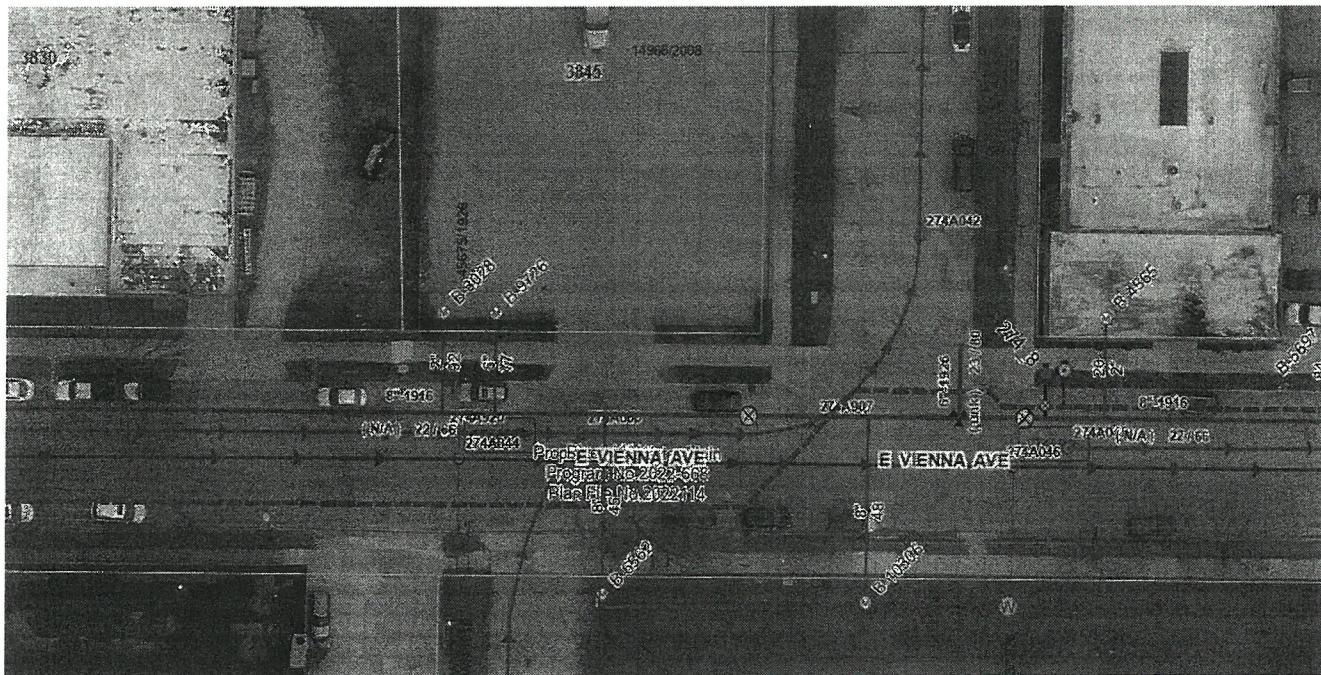
It appears to me that when I look in the Water & Sewer Viewer, there may have been NEW 8" water main put recently in the ROW of W Vienna Ave. I am including a screenshot as well as a PDF. The Purple DASHED line is the new proposed Water Main. You would need to call and speak with the Water Engineering Dept – Construction to see if this is what your referring to. I don't have access to see if this was to inspection reports to verify if this was completed. I am expecting that it was installed but cannot verify it for you.

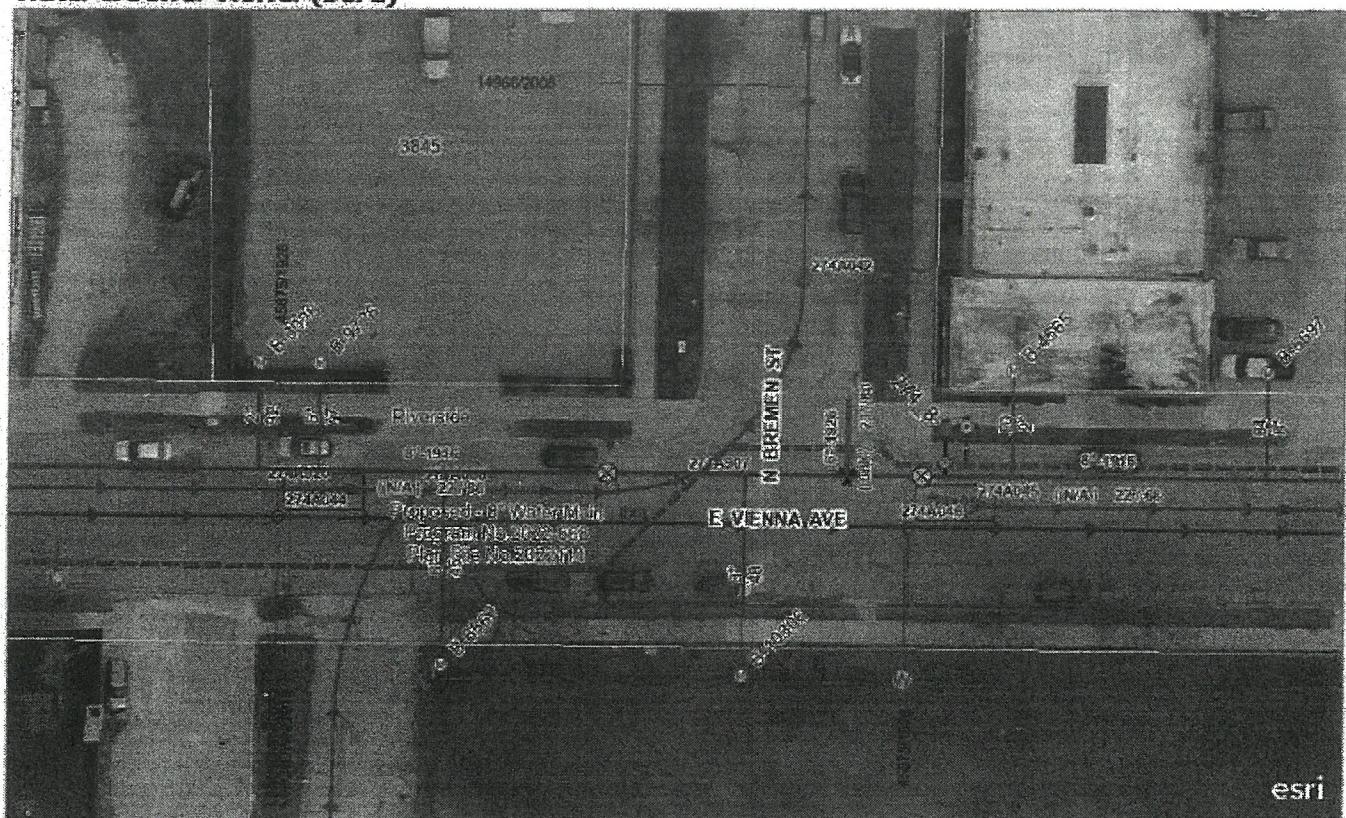
Water & Sewer Viewer (SCF2)

Created to view both Sewer and Water Information

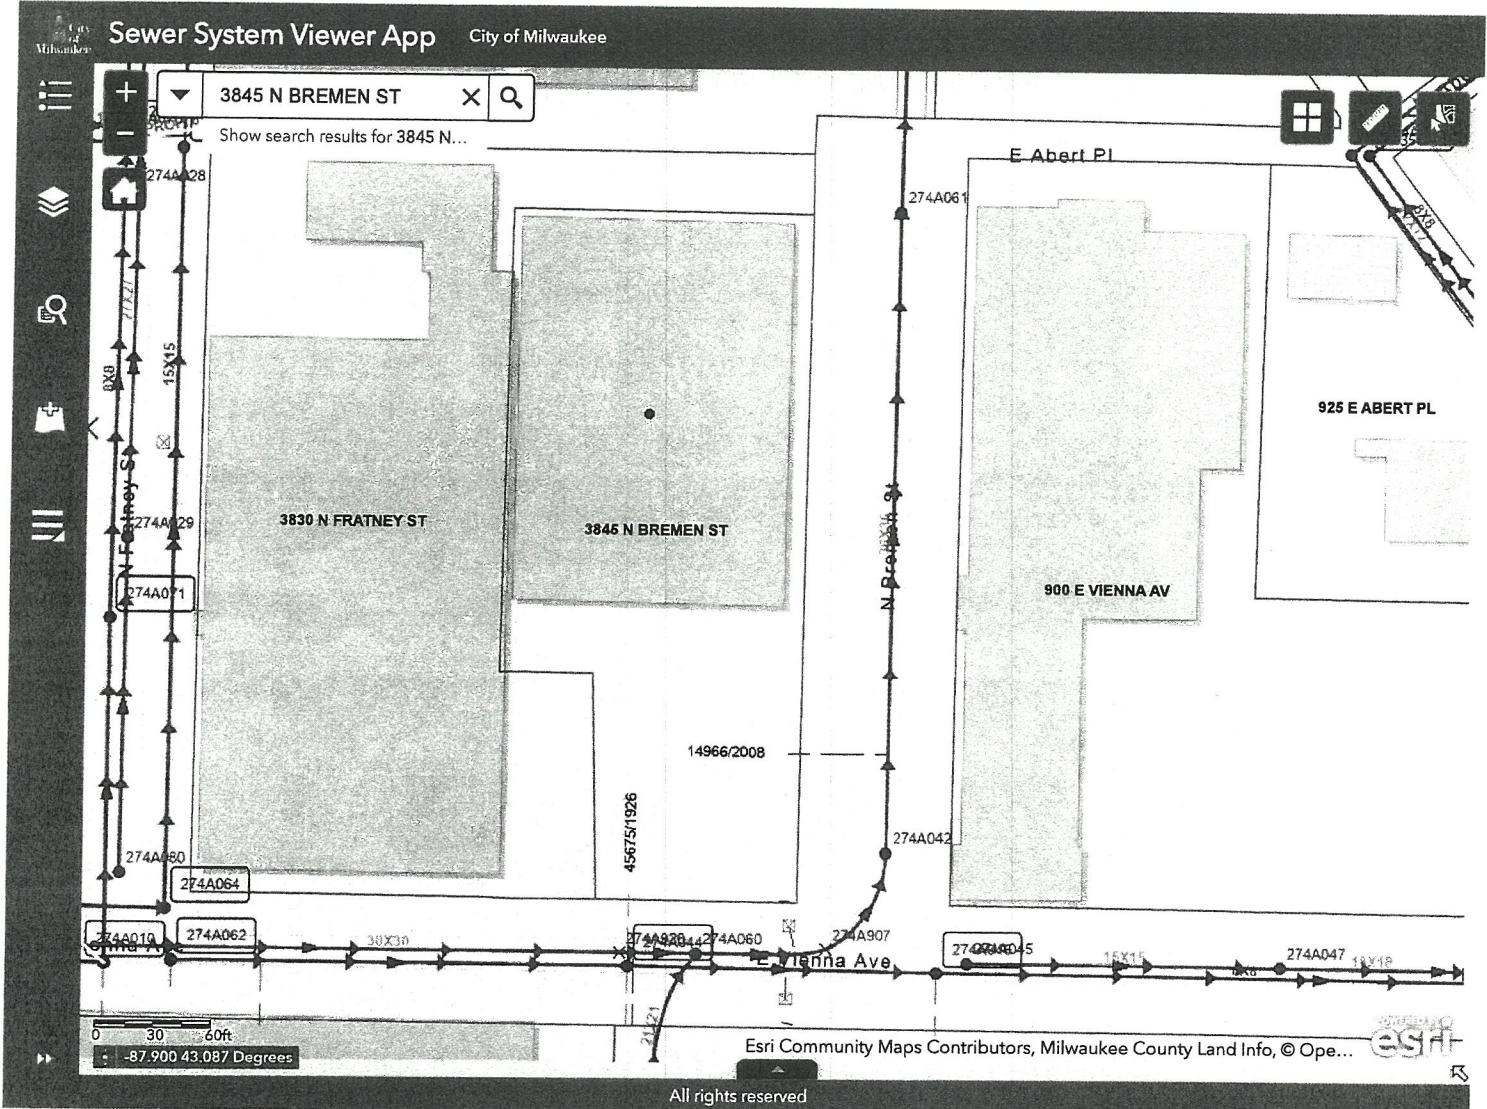
Sewer System Viewer App

3845 N BREMEN ST
