Milwaukee's Lead Service Line Replacement Program Semi-Annual Report

February 2019

Milwaukee
Water Works

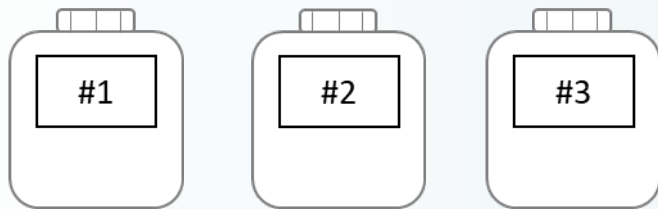
Lead service line replacement results

Lead	2.20	2.10	0.96
Copper	1.70	0.53	0.23
Diff	0.50	1.57*	0.74

- No significant reduction in first draw lead levels following LSLR
 - i.e. home plumbing potential sources of lead
- Significant reduction in lead levels seen after 45 second flush following LSLR
 - Reduction of 1.6 ppb
- Corrosion control has been effective at reducing lead and copper in water, but does not eliminate it
