# Certificate of Appropriateness

**Property** 1937 N. MARTIN L KING JR DR. N. 3<sup>rd</sup> Street NRHD

**Date issued** 4/25/2022 PTS ID 115255 COA: REHAB

Niche Book Bar

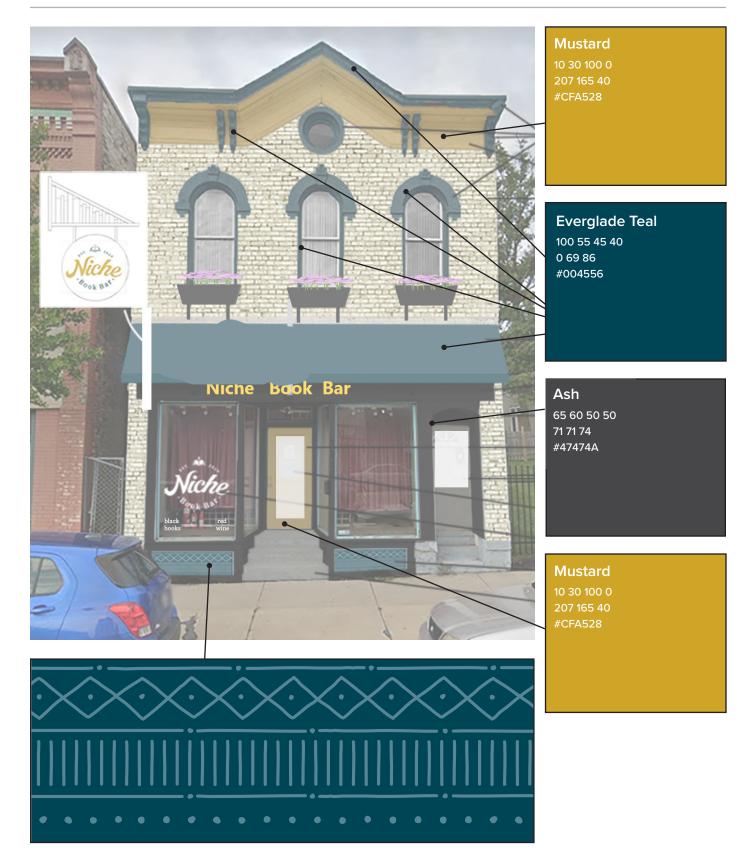
FIGURE A: Rendering of completed primary east facade. Rendering provided by Niche Book Bar.

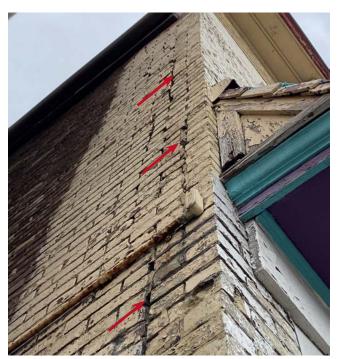
IMAGE 1: Crack at southeast corner showing signs of separation.

- East elevation near apartment unit entrance
  - South elevation at large full-height crack (see Image 1)
  - West elevation at step crack below center secondfloor window (see Image 10)

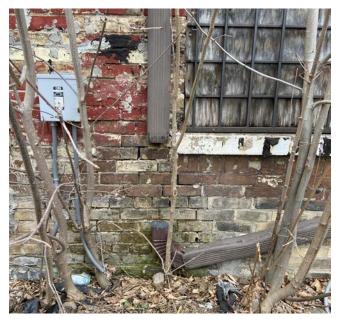
IMAGE 9: Disconnected downspouts and insufficient slope to drainage at rear west elevation near first-floor windows.

- Install new downspout at the rear west elevation
- Inspect and repair all disconnected downspouts
- Connect downspouts to existing sewer inlets

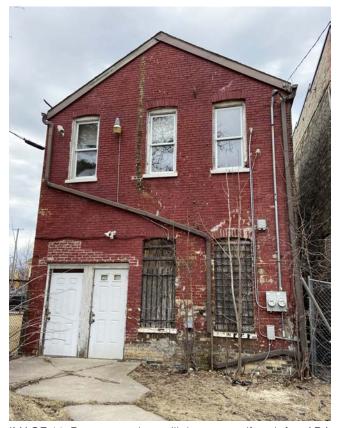
IMAGE 11: Rear area that will be recongifured for ADA entrance, retaining wall, and new parking slab and walk.

- Build retaining wall according to site drawing, A1.1, split-face, dry-stack concrete masonry units to blend in with surrounding grass/sidewalk
- Demo rear walk and parking area
- Create a quarter bubble away from the building to promote positive drainage of the site
- Pour new parking area and walk; walk not to exceed
   1:20 pitch

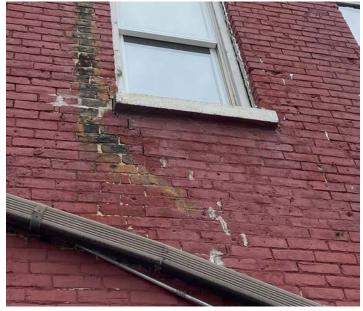
IMAGE 10: Area to be rebuilt below center second-floor window at the west elevation; large step crack and exposure to moisture has resulted in dislodged brick.

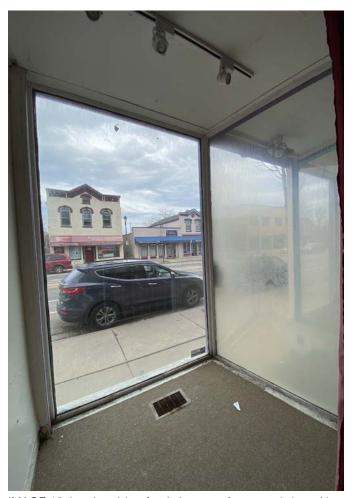
IMAGE 12: Interior side of existing storefront, north bay. New storefronts will preserve existing configuration and daylight openings and configuration.

- Storefront windows are plastic and must be replaced; replace as shown on drawing sheet A1.2
- Retain all existing trim in good condition at storefronts and double-hung units
- Remove all rotted wood frame, sill, and trim members and replace with new wood matching the size and profile of the removed section; splice as necessary; prime and paint
- Install prefinished aluminum flashing at all windows to prevent excess moisture infiltration; match trim color

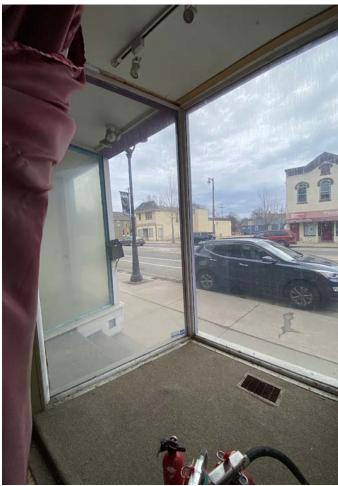
IMAGE 13: Interior side of existing storefront, south bay. New storefronts will preserve existing configuration and daylight openings and configuration.

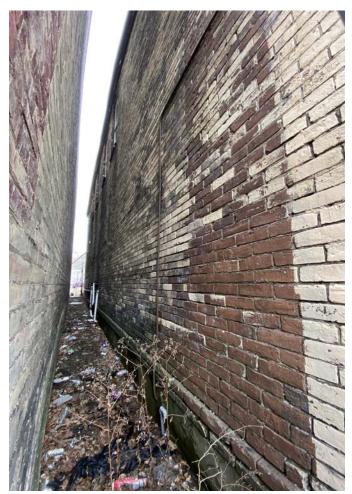
IMAGE 14: South elevation; here work is limited to masonry repairs and flashing at windows as described in the Scope Narrative.

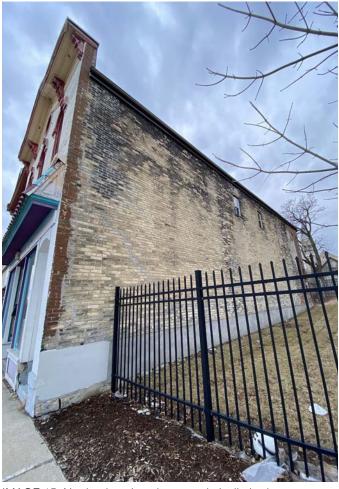
IMAGE 15: North elevation; here work is limited to masonry repairs and flashing at windows as described in the Scope Narrative.

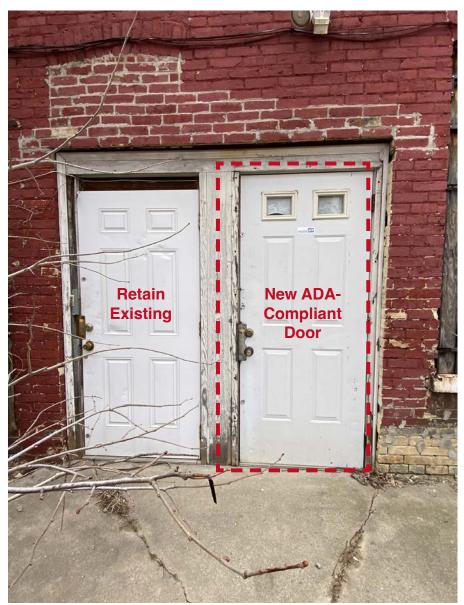
IMAGE 16: Detail view of west elevation doors. The door on the left will be retained and the opening reconfigured to fit more tightly. The door on the right will be replaced with an ADA compliant door as described in the Scope Narrative. Trim around the doors within the masonry opening will be reconfigured and refinished to match the doors and to better address voids. No work is anticipated at the steel lintel.

- Enlarge rough opening to meet ADA requirements and replace rear exit door with steel 6 panel composite frame exterior door, Mastercraft 36"W x 80"H model #4145390 (See Image 6), paint yellow to match front door
- Retain existing second floor exit door at north corner and paint gray to match east apartment entrance
- Install new trim where needed and paint to match doors

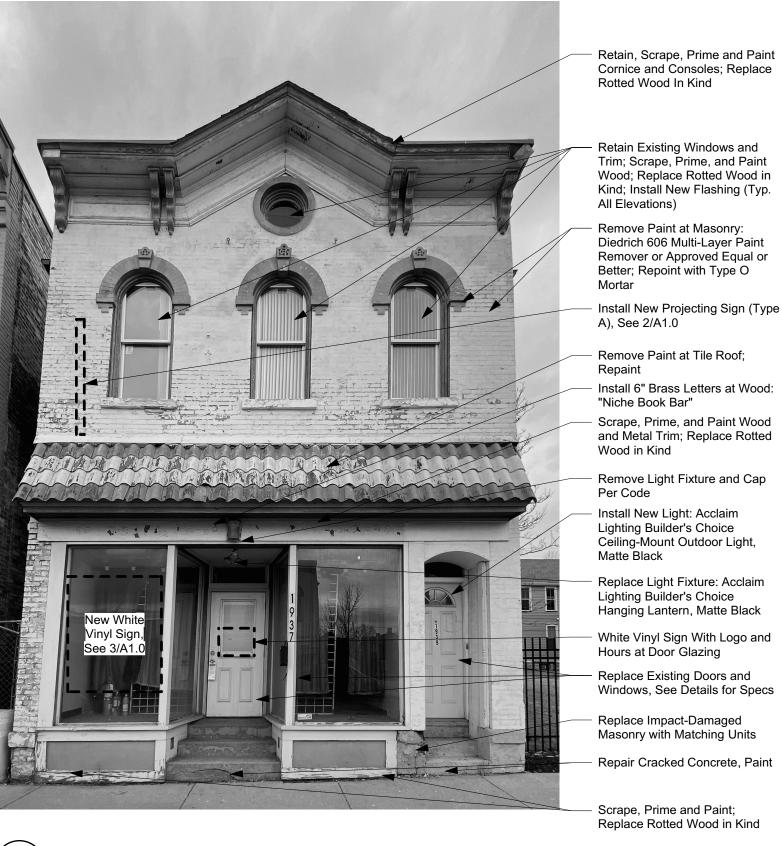
East Elevation - Existing

Retain, Scrape, Prime and Paint Cornice and Consoles; Replace

Retain Existing Windows and Trim; Scrape, Prime, and Paint Wood; Replace Rotted Wood in Kind; Install New Flashing (Typ.

Diedrich 606 Multi-Layer Paint Remover or Approved Equal or Better; Repoint with Type O

Hanging Lantern, Matte Black

White Vinyl Sign With Logo and

3'-8" 2'-2" -Custom Fabricated Metal Bracket -1/2" Sign Grade MDO with Vinyl and Laminate Print, "Niche" in **Dimensional Lettering** Cook Bas 2'-8" Dia. Projecting Sign Scale: 1/2" = 1'-0"

ÉQ. 4'-0" EQ. -Plotter-Cut High Performance Vinyl, White Black Red Books Wine

- 1 East Elevation Scope Diagram
- 2 Projecting Sign Drawing
- 3 Window Vinyl Sign Drawing

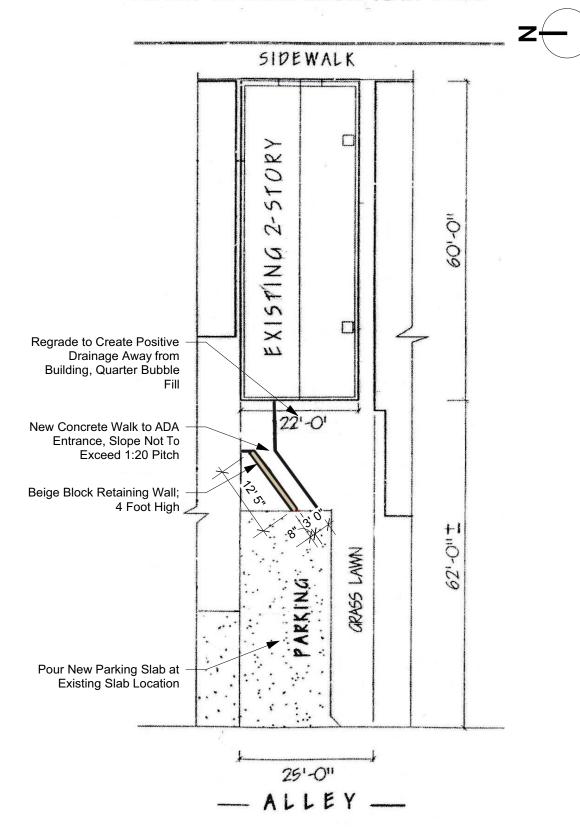
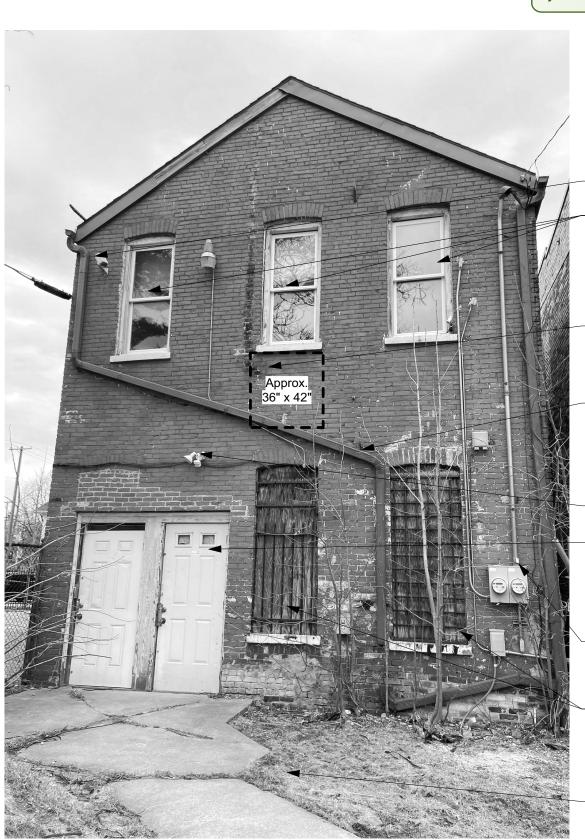
Site Plan - West of Building
1.1) N.T.S.

Retain Existing Windows and Trim; Scrape, Prime, and Paint Wood; Replace Rotted Wood in Kind; Install New Flashing (Typ. All Elevations)

Rebuild Brick at Deteriorated Mortar/Step Crack

Replace Existing Downspout and Repair All Connections; Extend Outlet At Least 8 Feet from Wall

Replace Door with ADA-Compliant Entry Door, 36x80, Steel 6 Panel Composite Exterior Door Such as Mastercraft 4145390 or Approved Equal or Better

Infill Windows with Matching Cream City Brick, Recess Brick 3 Inches From Exterior Wall Face

Install New Retaining Wall and Site Grading, See 2/A1.1

- 1 West Elevation Scope Diagram
- 2 Site Plan

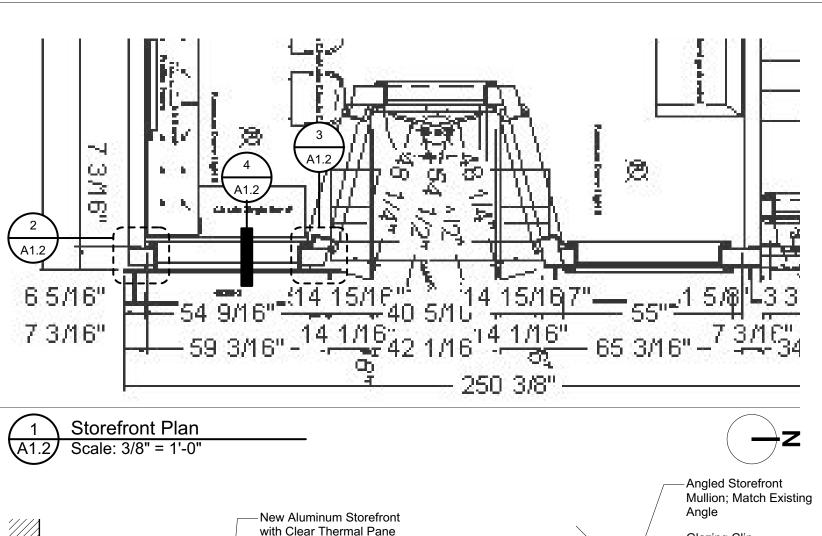
Side Storefront Detail

Glazing; Black Powder-Coat Finish

Backer Rod and Sealant

Existing Trim, Framing,

to Remain, Repaint

and Blocking

- 1 Storefront Plan
- 2 Storefront Side Mullion Detail
- 3 Storefront Angled Mullion Detail
- 4 Storefront Sill and Header Detail

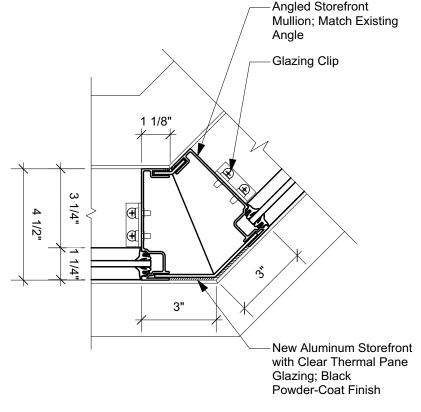
**Angled Mullion Detail**

Scale: 3" = 1'-0"
