Property
Description of work

Date issued

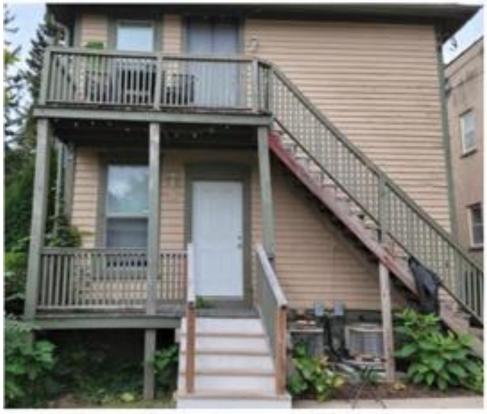
Existing Rear Elevation (Prior to stair failure and demo)

The rear two-story porch collapsed at 1814 N. 1st Street. This is an emergency situation since it is required for access to the upper unit. The contractor needs to do a new layout in order to meet code. The new layout will have a platform near the north edge of the house whereby the upper porch will be attached with a new set of stairs. Then the lower set of stairs will be perpendicular to the house, projecting east and terminate on the patio at grade. Proper footings and landings will be built per code.

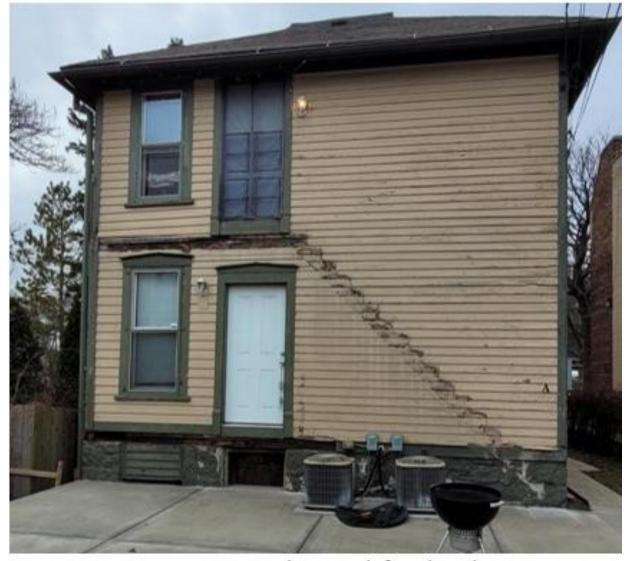
Existing Rear Elevation (After demo)

Note existing non-compliant stair rise and run (slope) on paint.

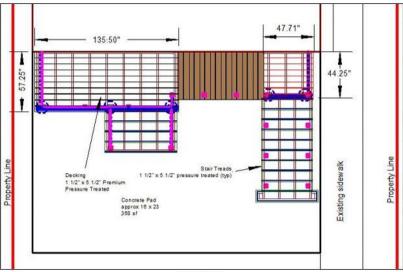
Plan View

NOTE: These are draft plans and may need to be slightly modified in regards to rise and run and number of steps based on actual heights/elevations to meet building codes.

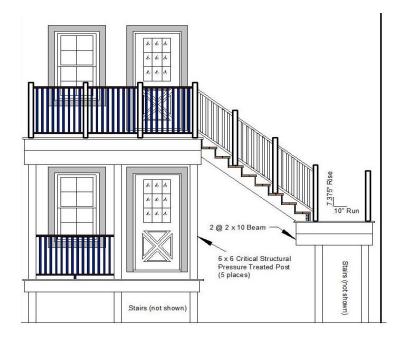
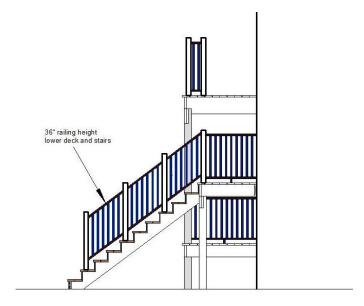
Date: 11/21/22 Scale: 1" = 3" Back Porch North View 1814 N. 1st Street

Back Porch West View 1814 N. 1st Street

Treated lumber will be used for the structure and cedar will be used for the posts, finials, railings, decking and rail bottoms. These elements will resemble those on the front porch.
