# 266 E Erie Street - HPC Existing Conditions | 08.08.2023

THE KUBALA WASHATKO ARCHITECTS

#### SPIRE ENGINEERING

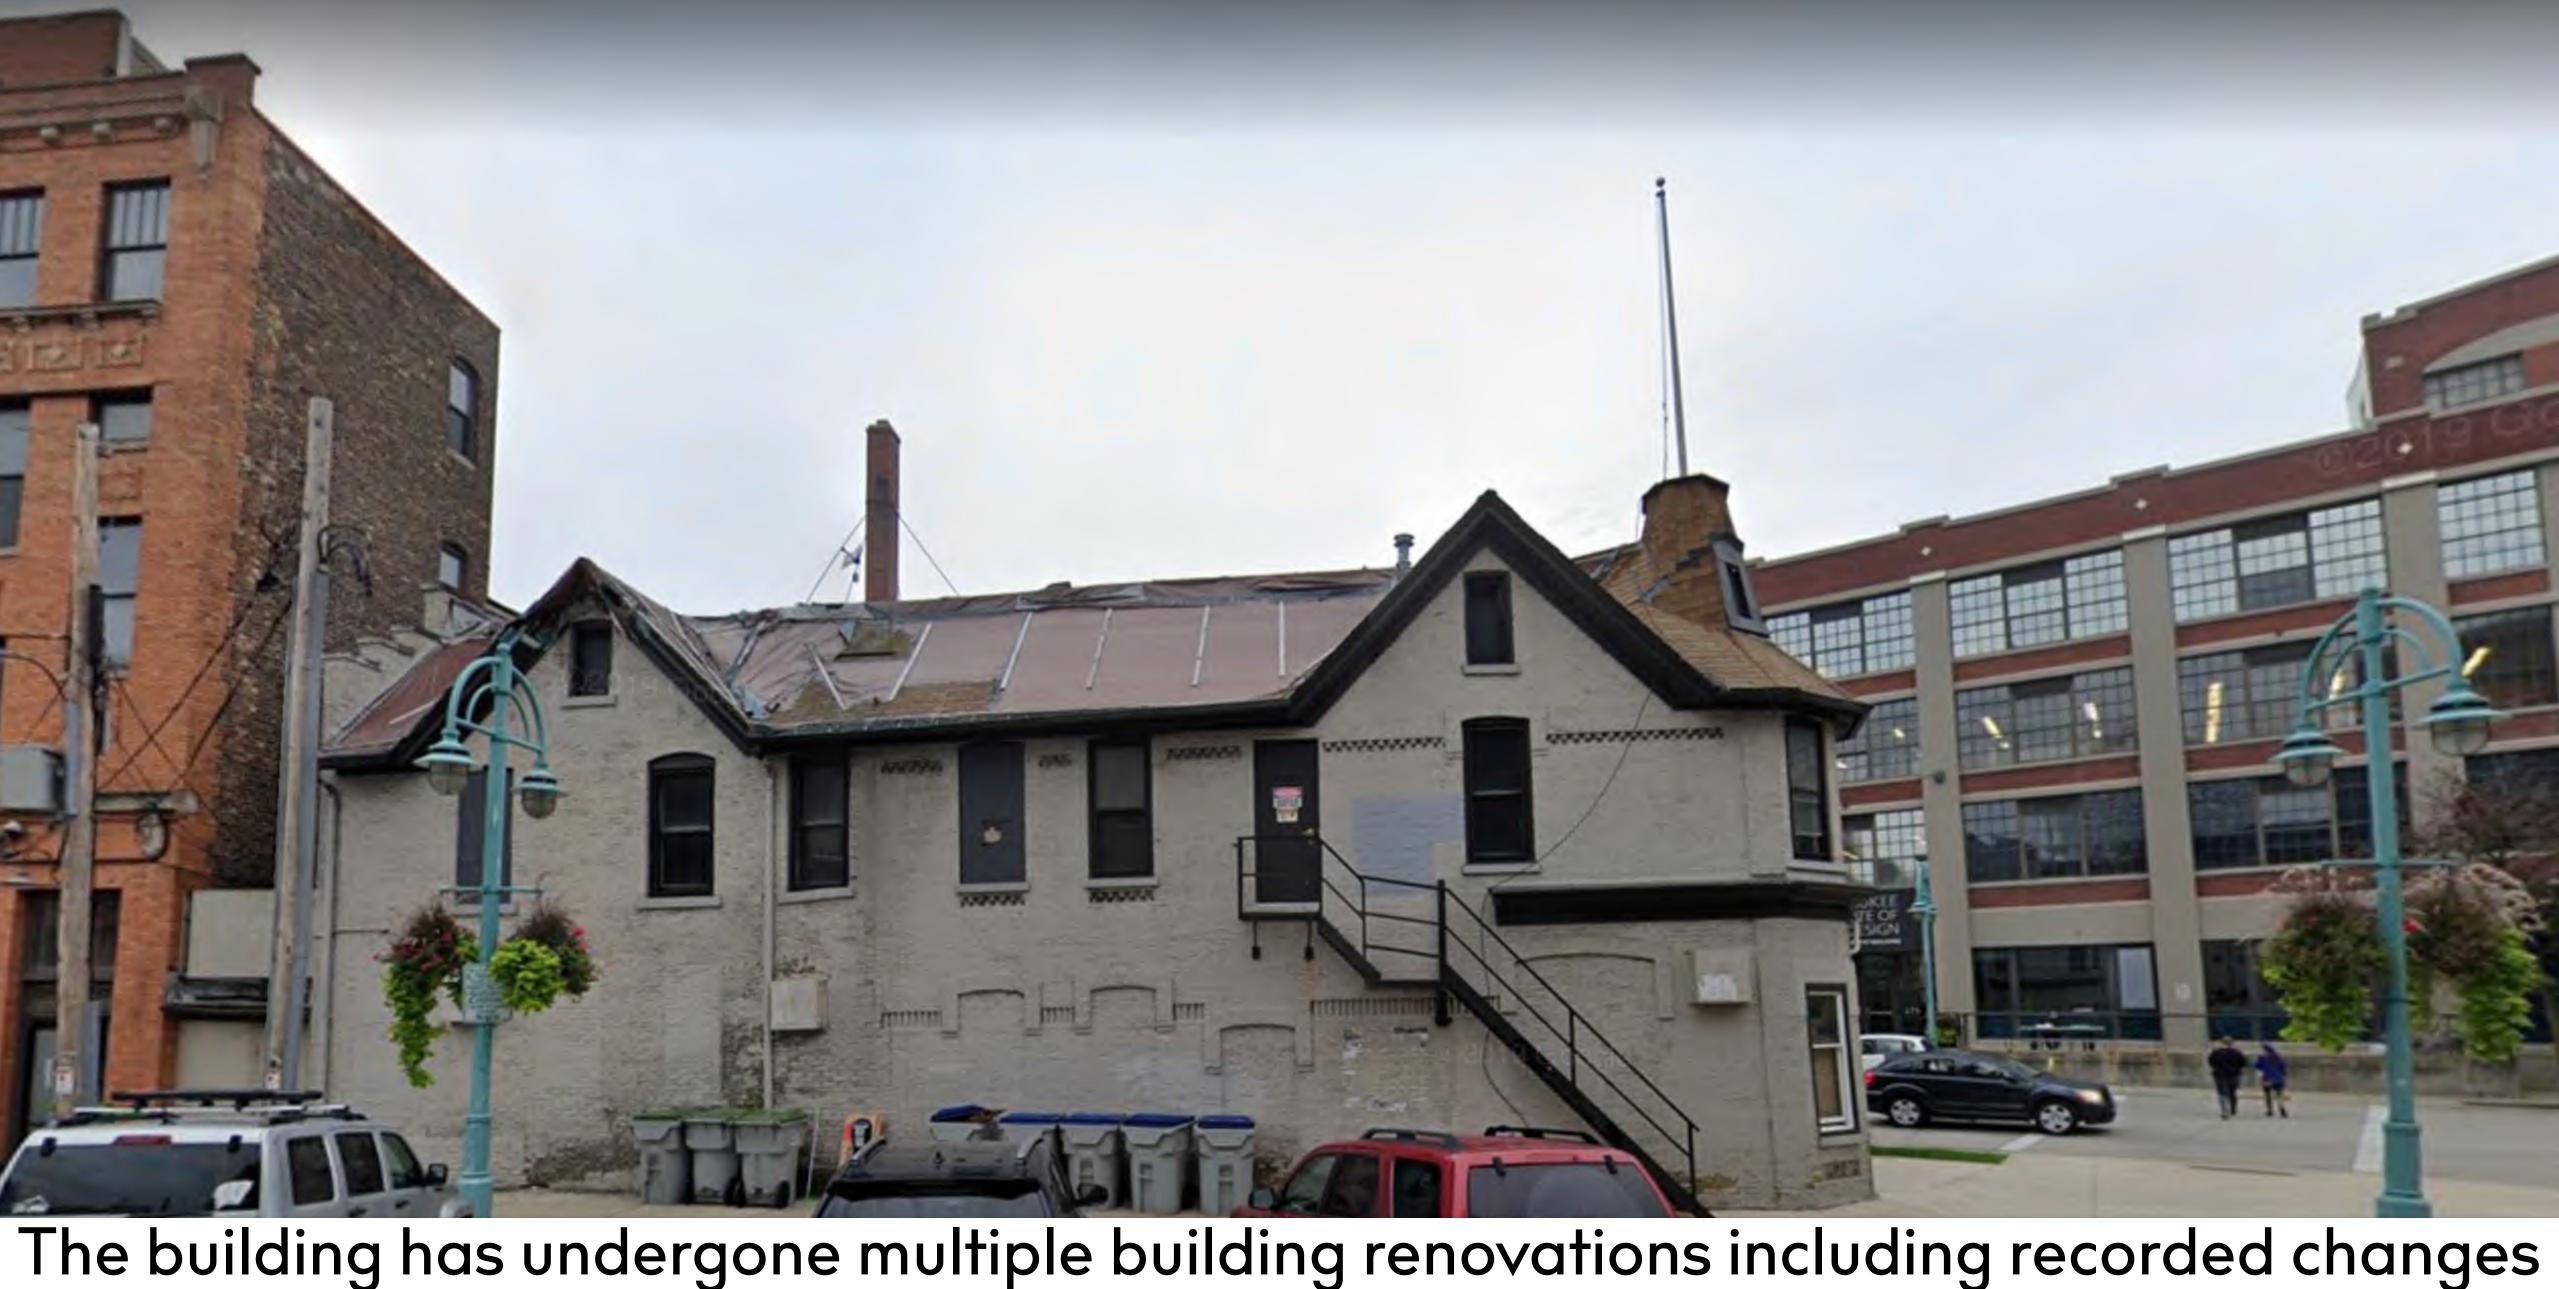
#### North Facade

The building has undergone multiple building renovations including recorded cha occurring in 1912, 1920, 1921, 1935, 1951, 1980, 1996, and 1997.

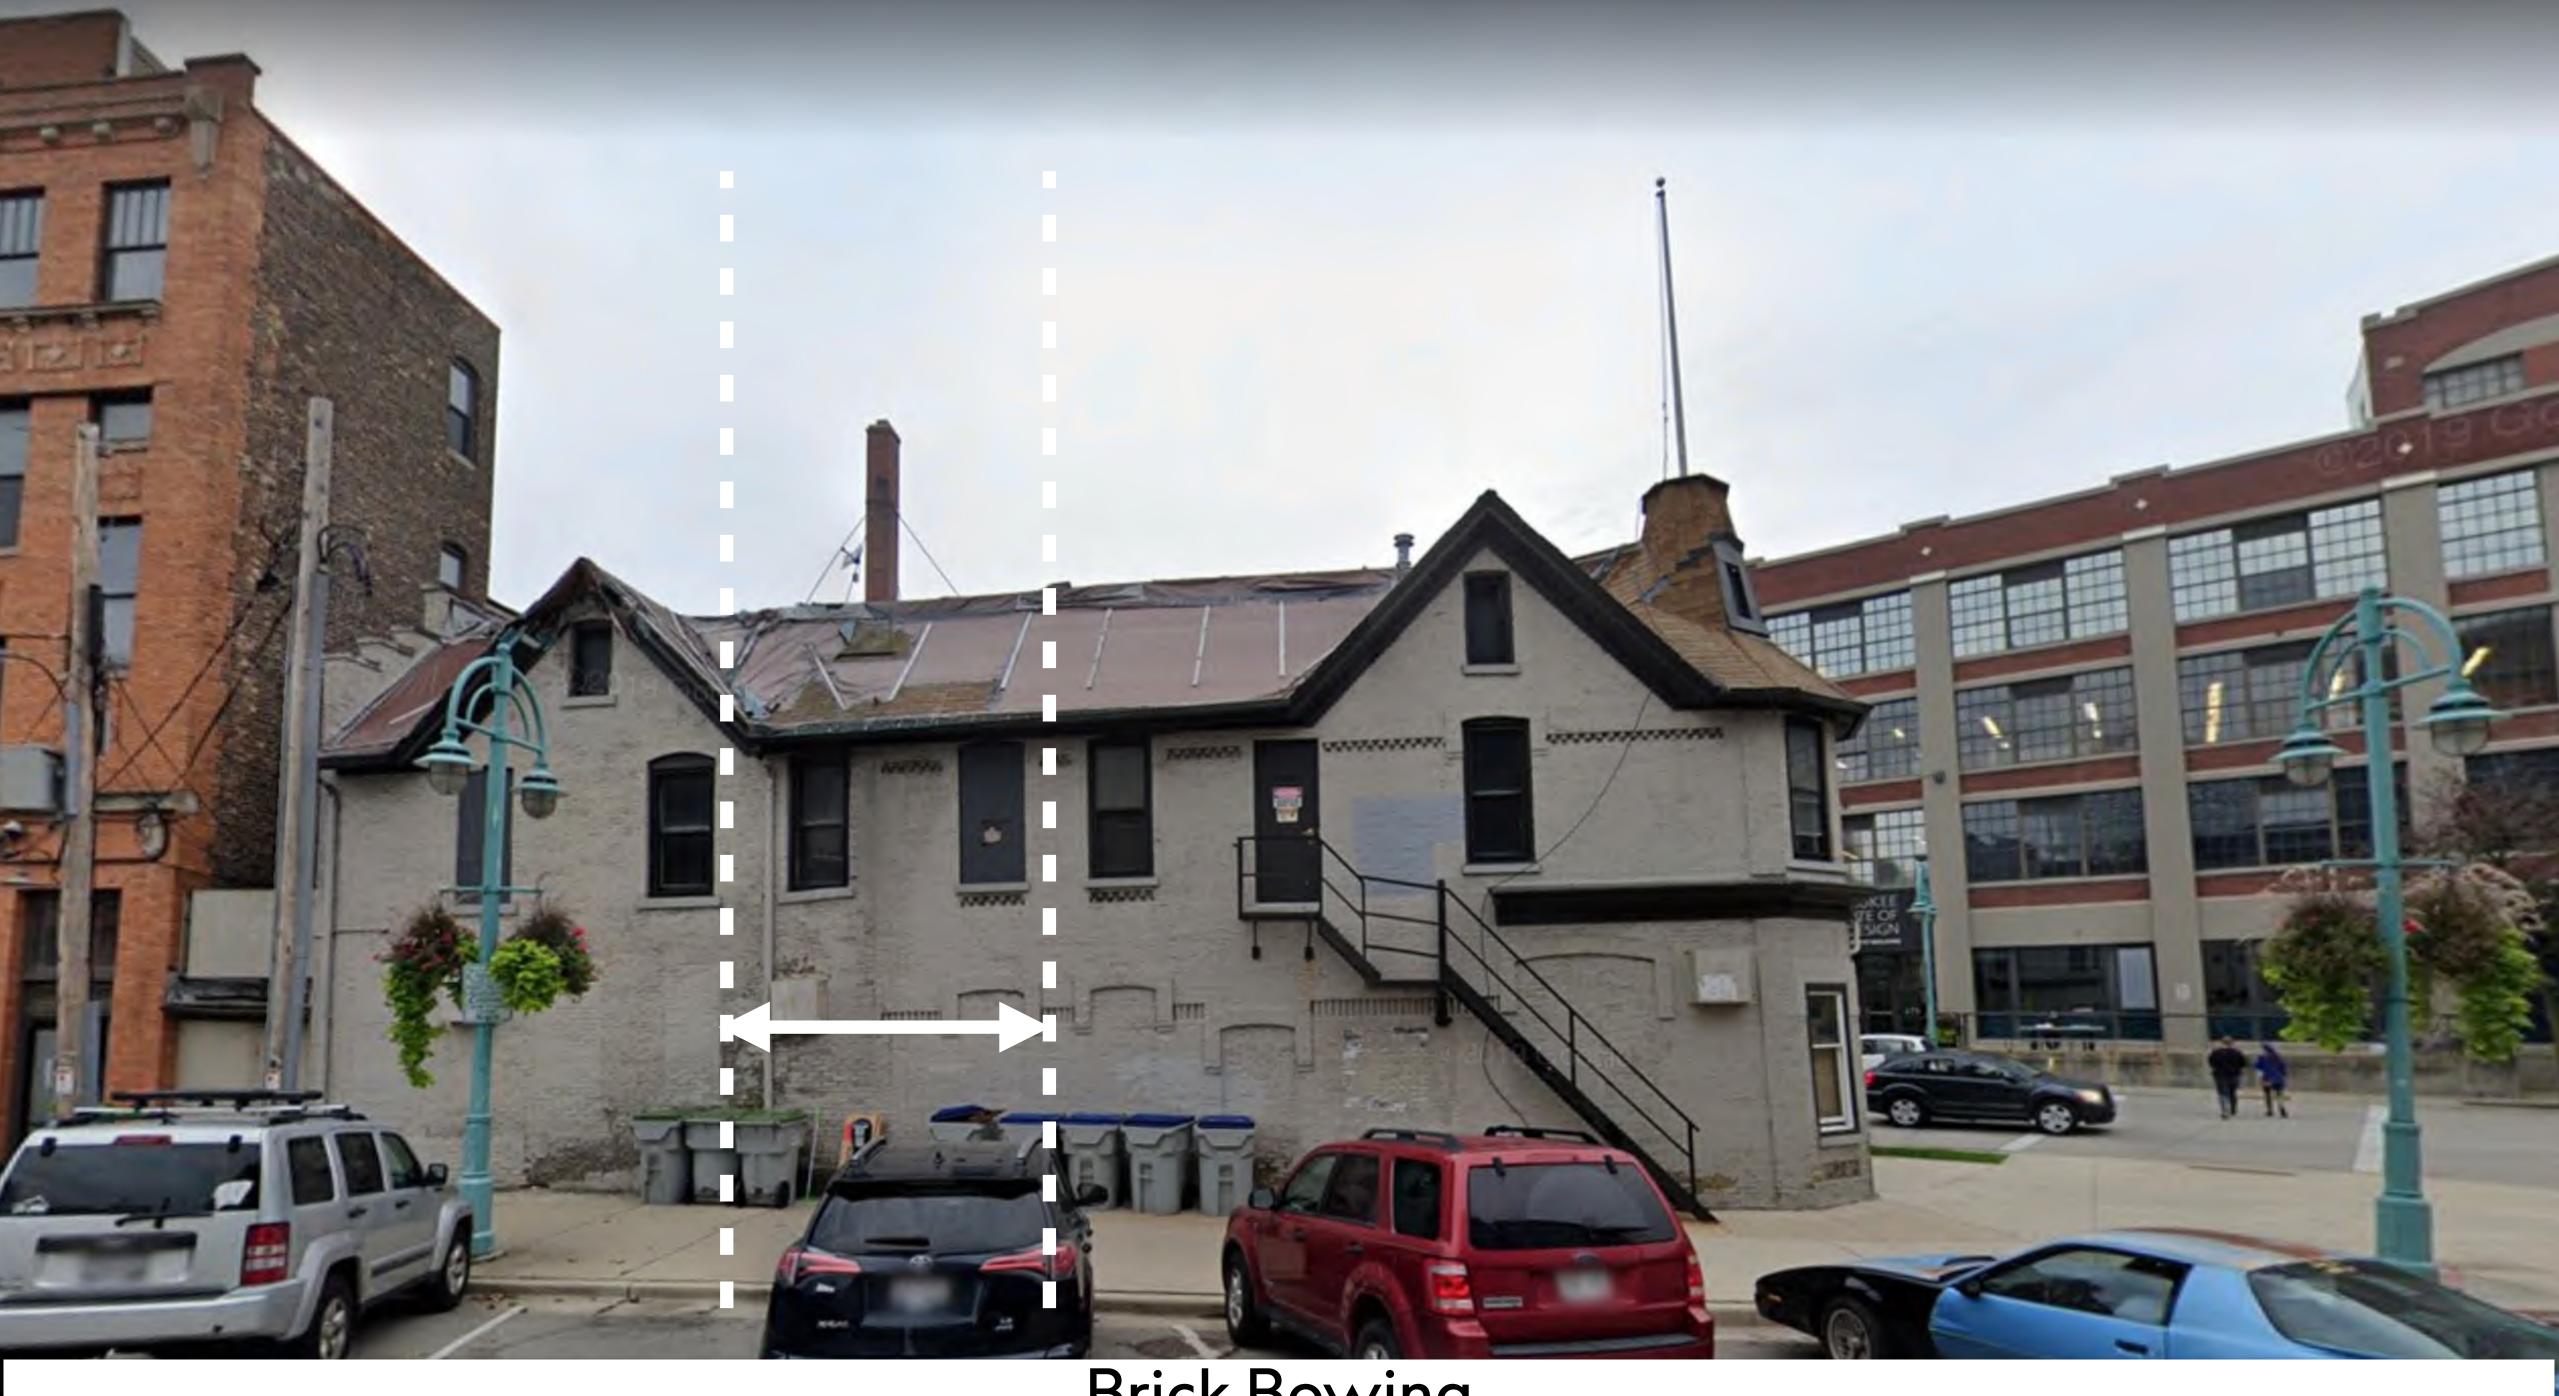
# Bowing Brick

Brick Bowing

- Removal and replacement of large portions of the brick facade/structure
- Rebuilding of parapets
- Replacement of all exterior and interior windows and doors
- Building perimeter will need to be excavated to the bottom of footings to add grade beams and helical piers

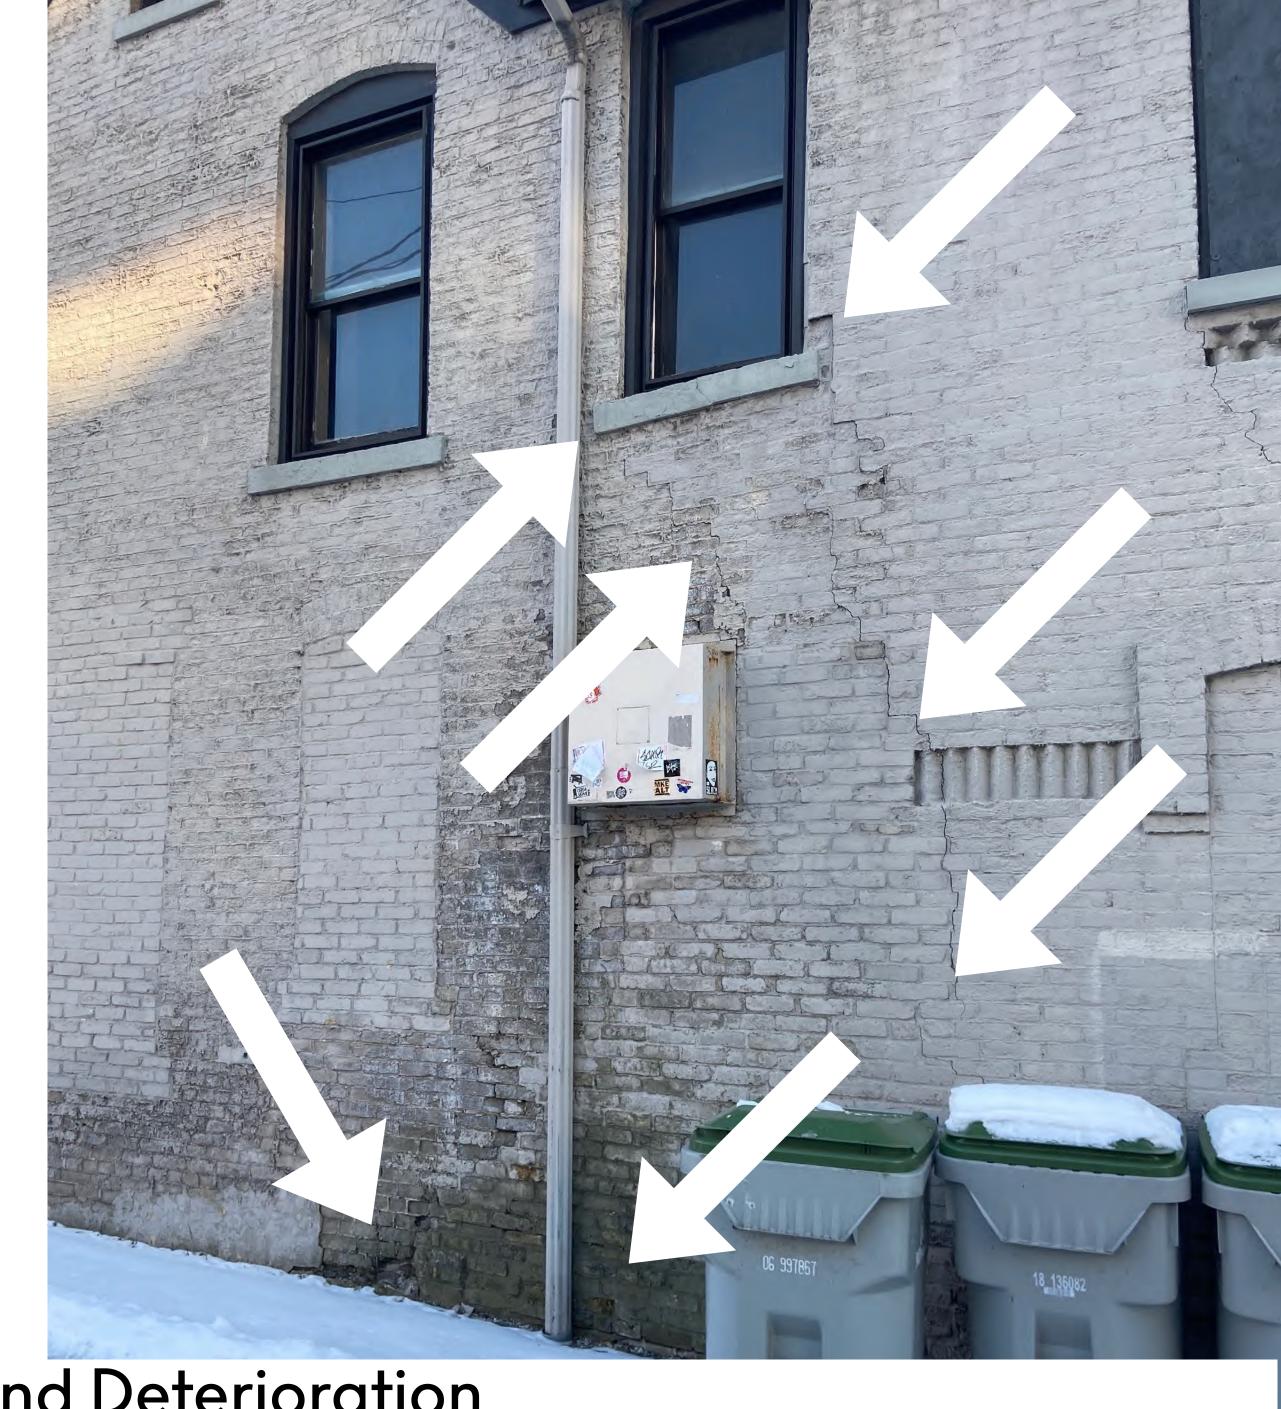
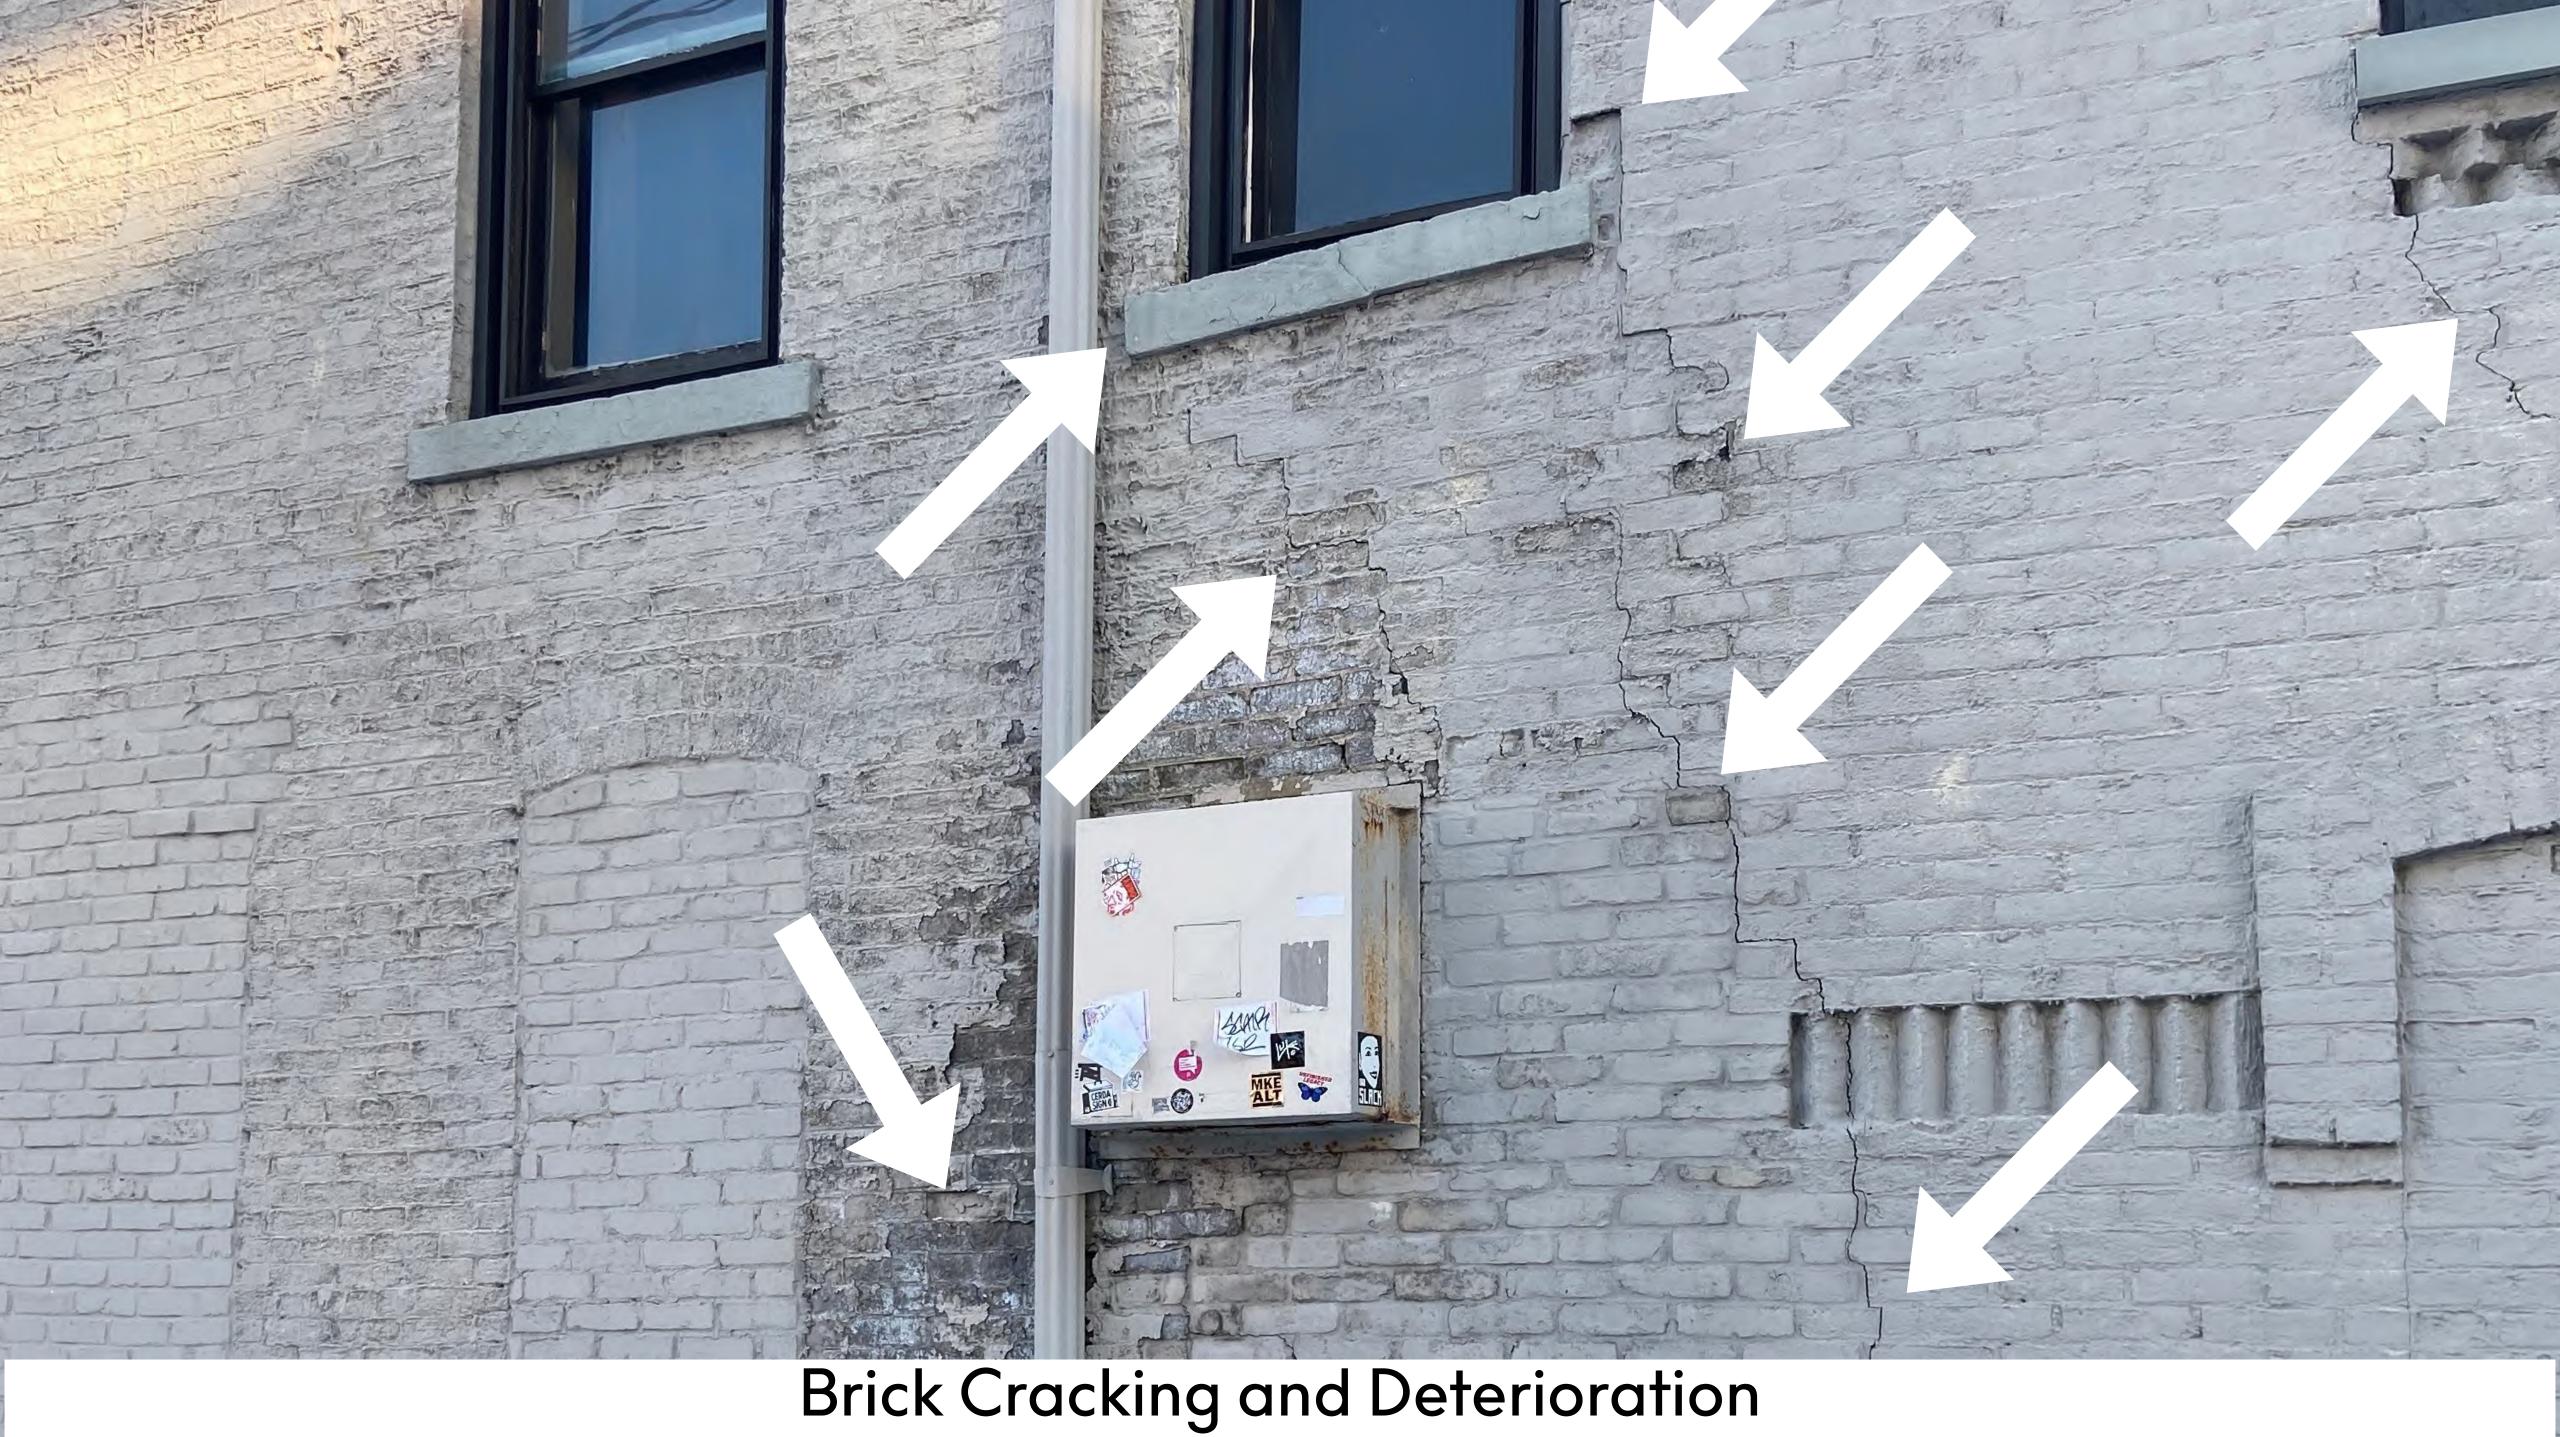
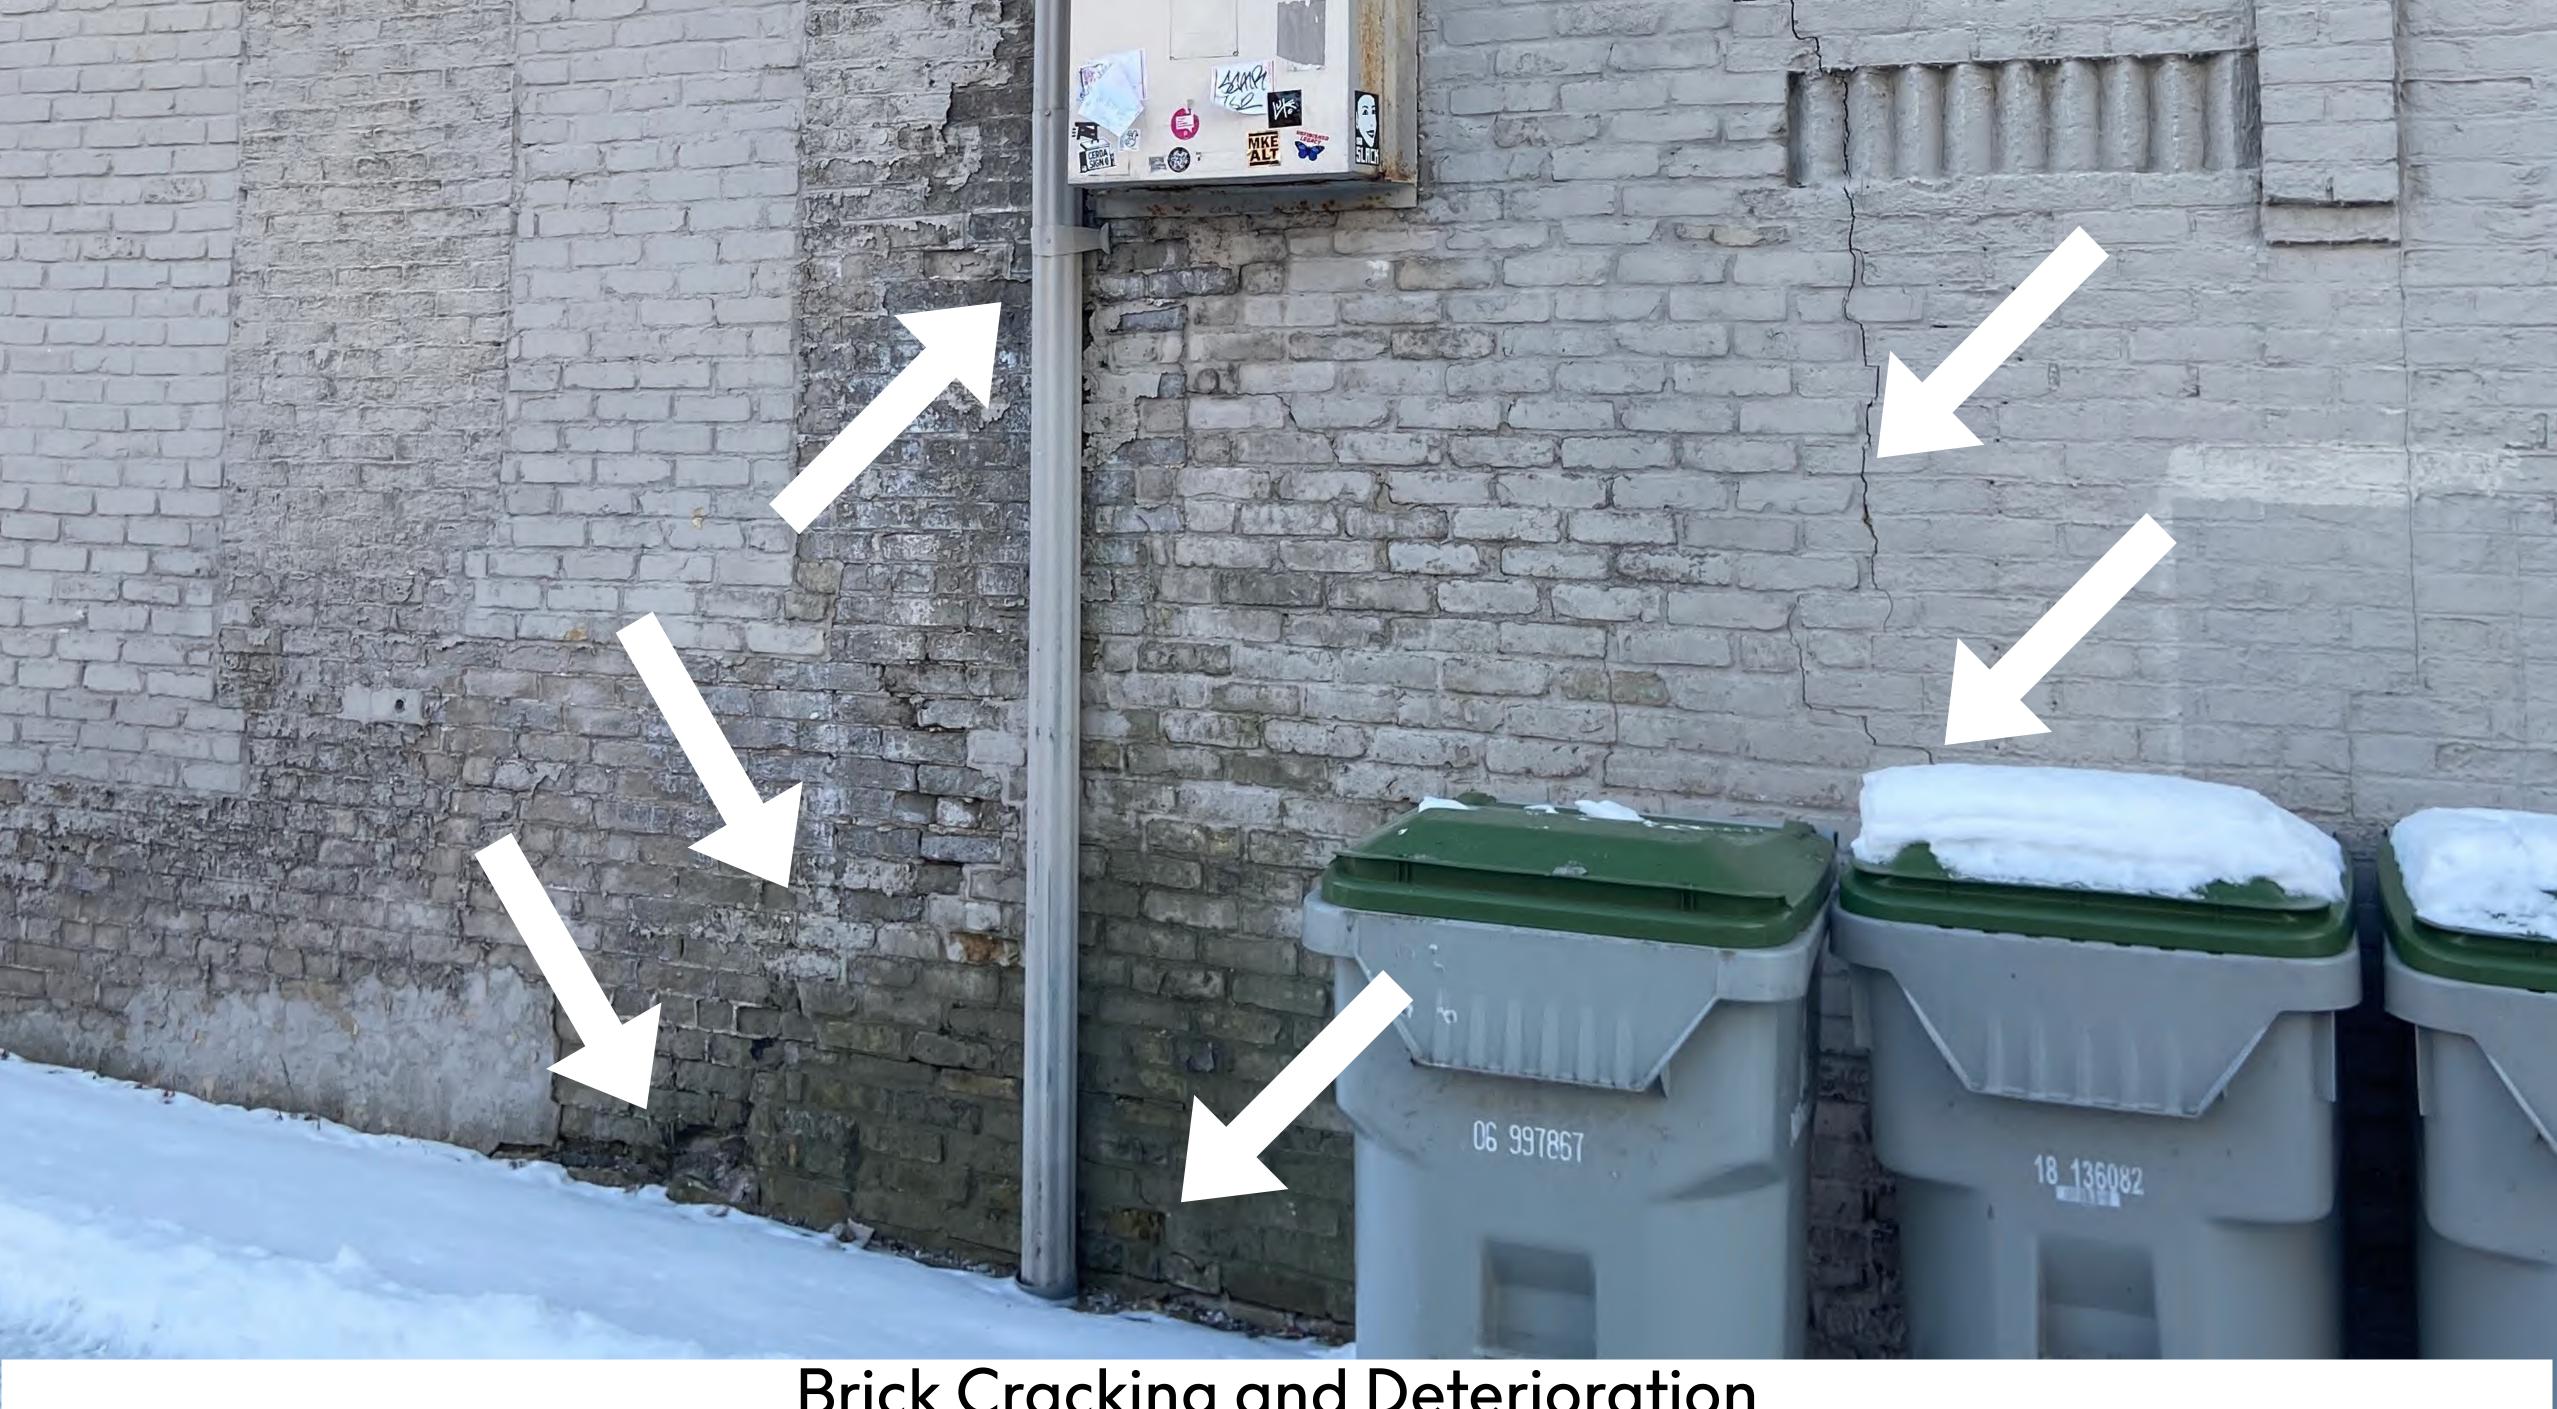
# Brick Cracking and Deterioration

# **Brick Cracking and Deterioration**
