City of Milwaukee Department of Public Works

DNR Stipulated Areas and Noncompliant Tributaries

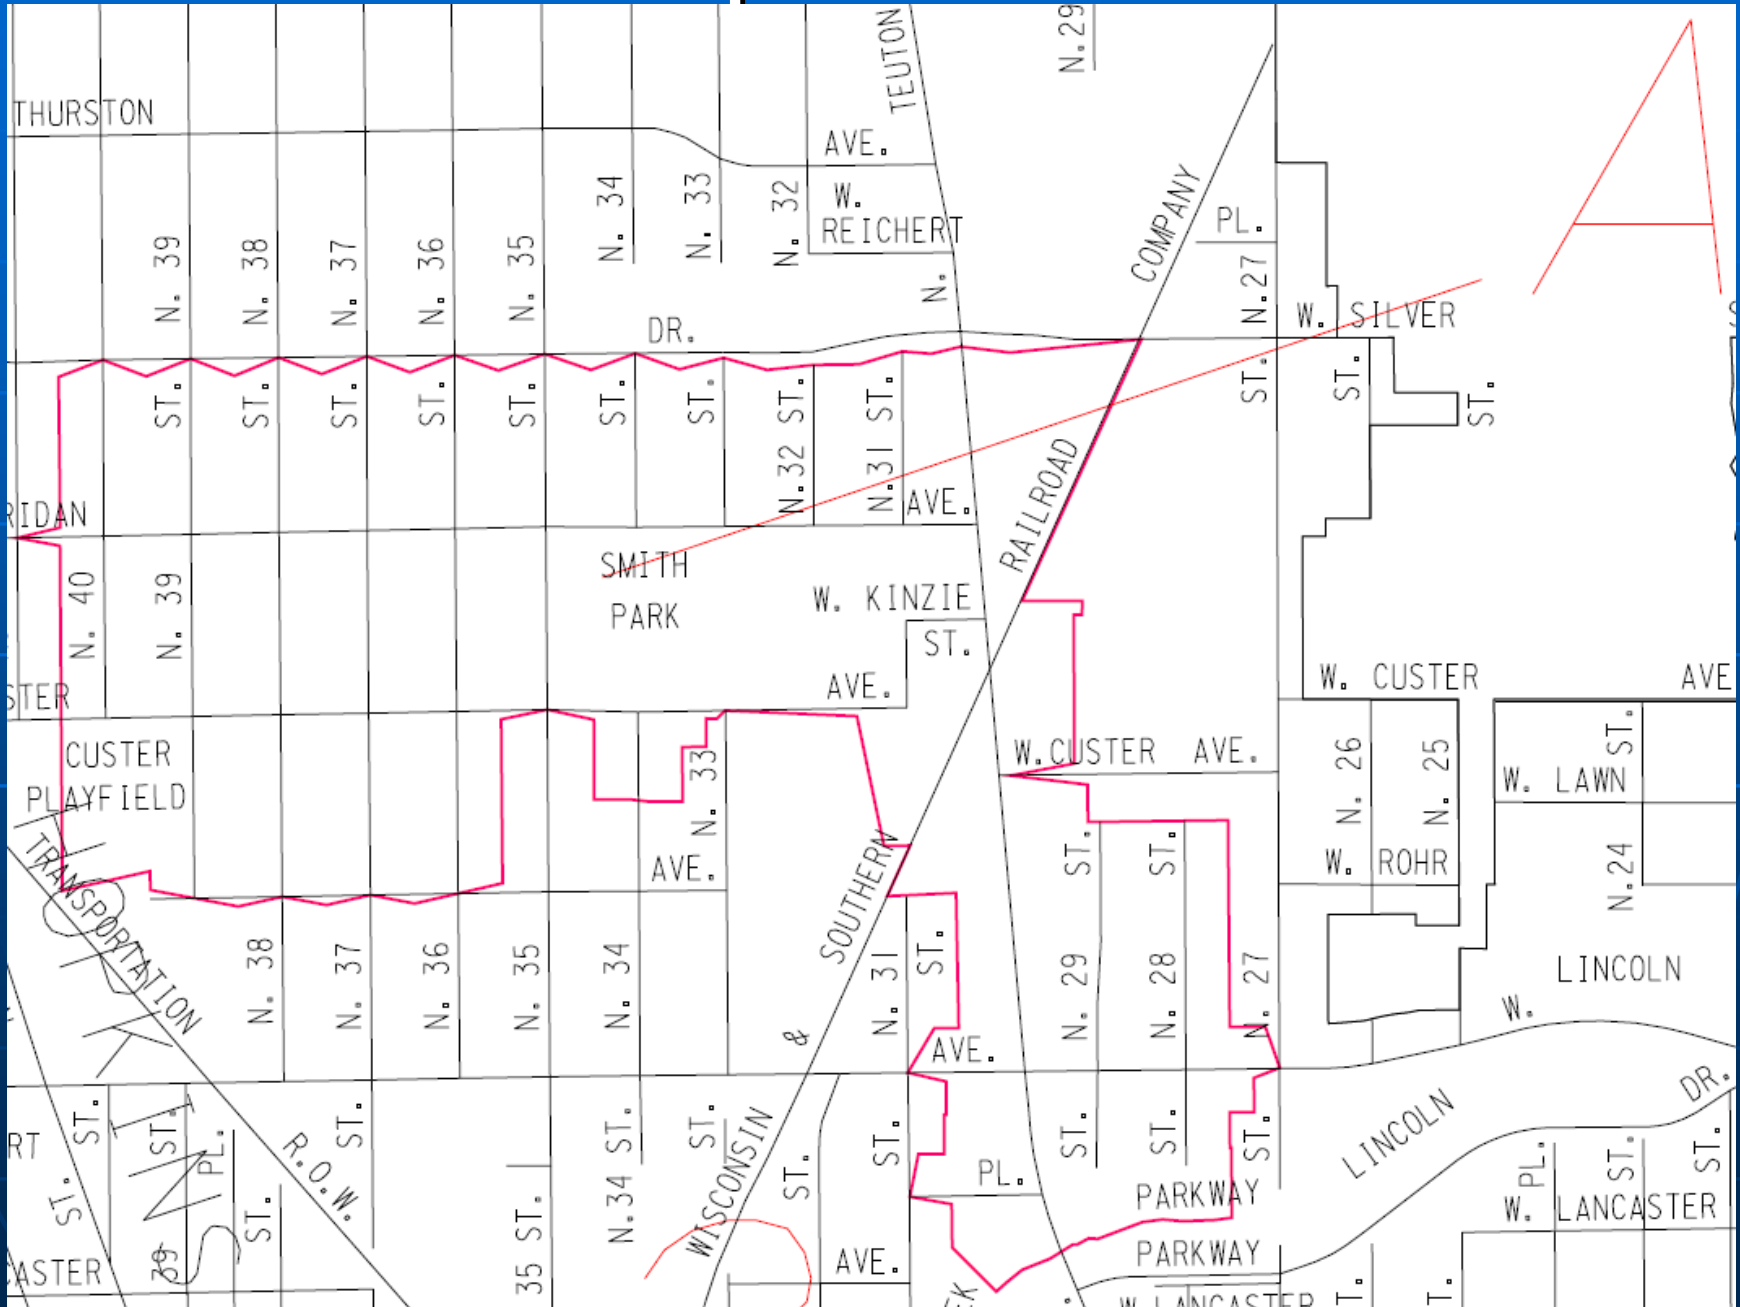
DNR Stipulated Area - A

- 7 Systems were selected based on flow monitoring and modeling data
- All systems exhibiting high levels of Inflow and Infiltration (I/I) were selected

- All work in the 7 critical areas as stipulated by the DNR was bid out between 2007 and 2010
- Total work performed for all area:
 - \$13,421,000 for sewer rehabilitations
 - \$ 9,206,000 for sanitary manhole rehabilitation
 - \$ 1,150,000 for dye water flooding
 - \$ 615,000 for sanitary manhole inspection
- The total cost for the work performed is \$24,392,000

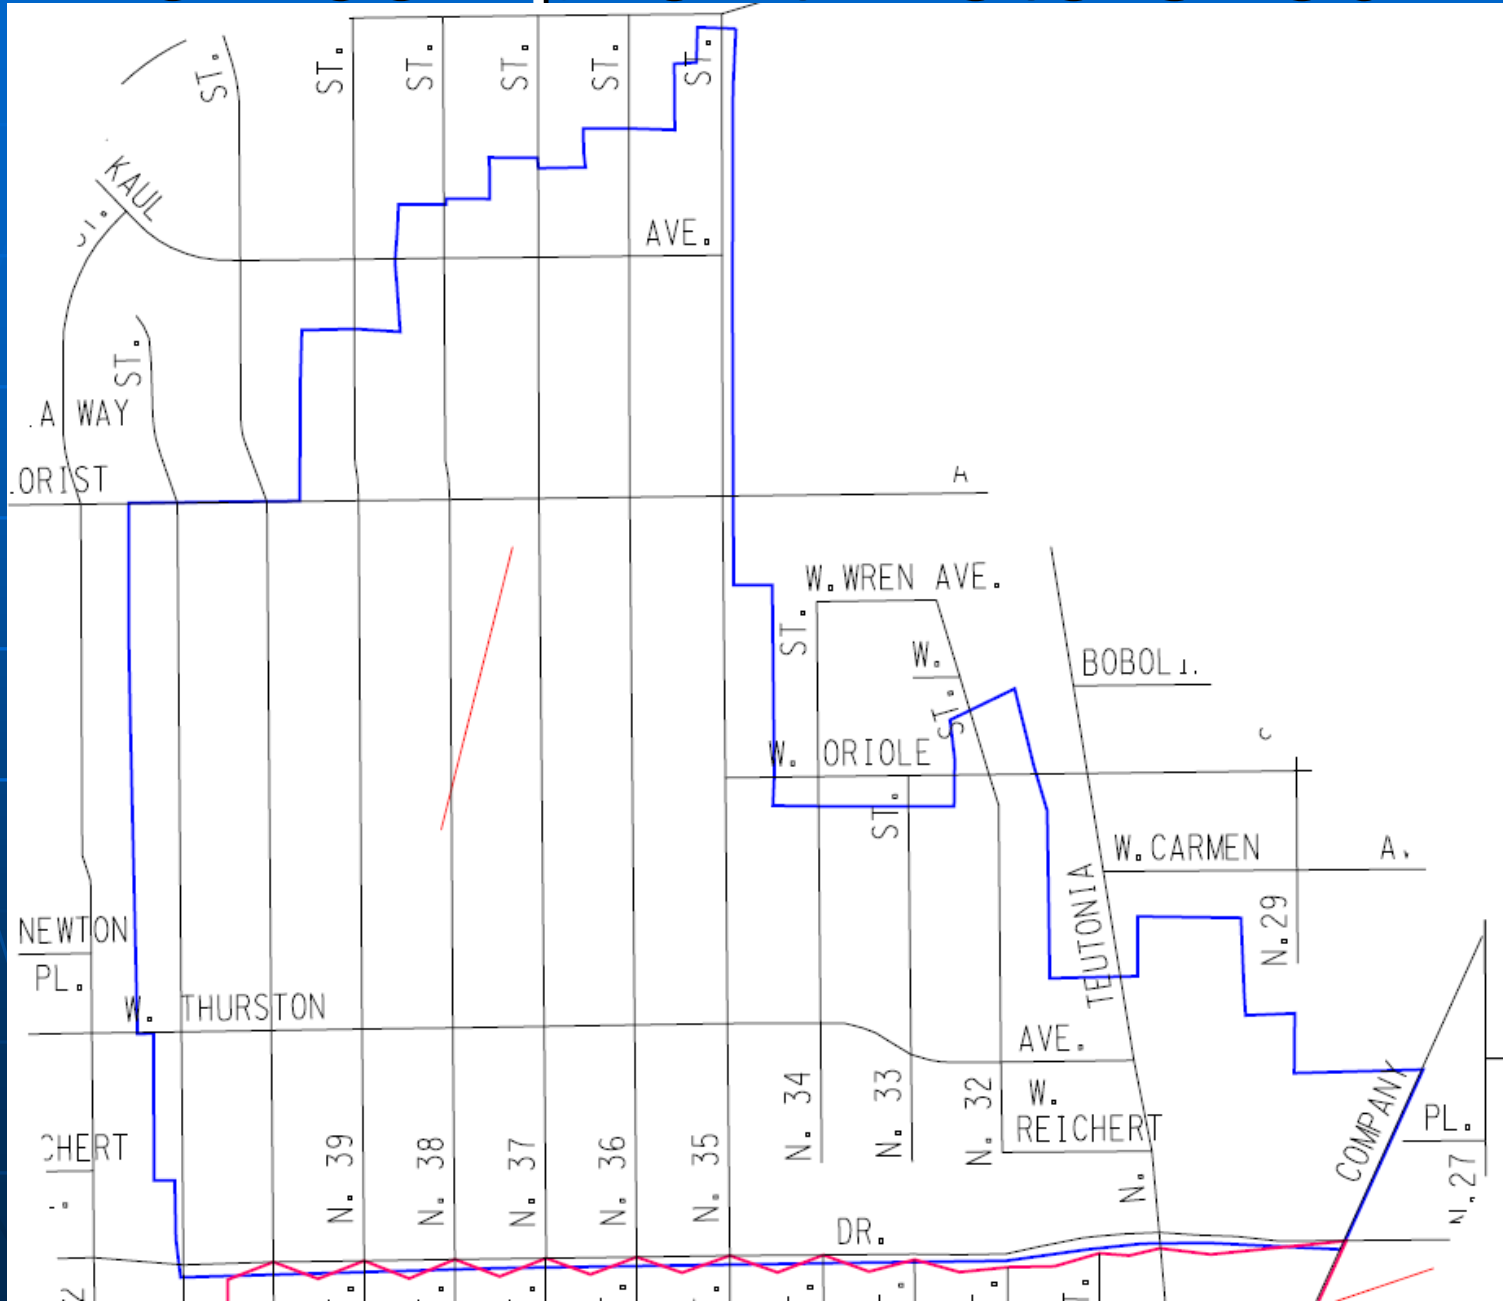
Non-compliant Metershed - 1

- MMSD has selected 15 metersheds that are non-compliant in the City of Milwaukee
- These areas were determined by comparing the peak hourly flow monitoring data with design data

Metershed	MMSD Sewershed	Estimated Sewer Area (acres)	Area-Velocity Data	Limit
1	MS0528	240.9	25,000	22,000
2	MS0538	189.1	29,800	22,000
3	MS0513	142.2	27,700	22,000
4	MS0514	644.0	52,100	19,000
5	MS0418	275.5	26,600	21,000
6	MS0411	168.6	29,600	19,000
7	MS0339	379.3	34,900	21,000
8	MS0338	206.6	24,400	22,000
9	MS0703	365.7	25,200	21,000
10	MS0117	138.5	33,600	22,000
11	MS0608	402.6	26,600	19,000
12	MS0607	49.5	62,800	22,000
13	MS0114	347.2	21,800	21,000
14	MS0305	581.9	16,800	15,500
15	MS0420	111.4	39,300	22,000
