# Collision Analysis & Reconstruction Report

Milwaukee Police Department Incident 140890118
Wisconsin DOT Document QQ56BFG
Crash Date: Sunday, March 30<sup>th</sup>, 2014, 5:40 PM

Location: 3350 North 12<sup>th</sup> Street City of Milwaukee Milwaukee County, Wisconsin

Milwaukee Police Department Neighborhood Task Force Crash Reconstruction Unit

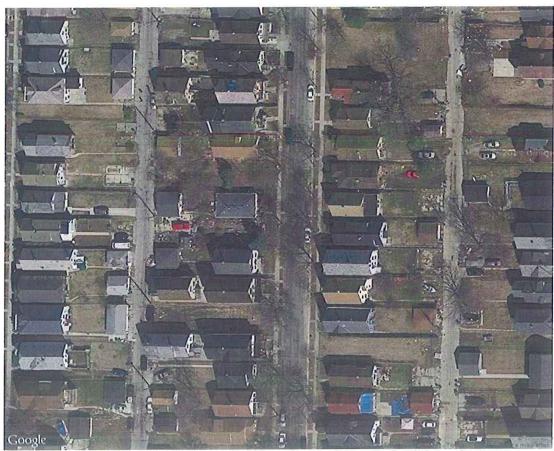
**Figure 1.** This aerial photo obtained from Google Maps via CrashZone shows an overview of the 3300 block of N. 12<sup>th</sup> St. The photo illustrates the general design and setting of the roadway. The photograph was not taken on the day of the crash and is not intended to depict the conditions at that time.

North 12<sup>th</sup> Street is approximately 28 feet 10 inches wide and has a non-posted speed limit of 25 miles per hour. The roadway is relatively straight through the collision area. There is a slight uphill (positive) grade to the north of 0.5% to 1.0%. Figure 1 illustrates the approximate location of the crash upon the map.

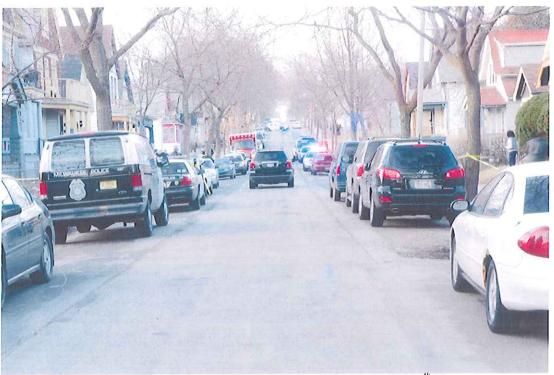
Figure 3. View of the scene looking north in the 3300 block of N 12th St

A pair of white children's shoes were located in the roadway; one in front of the Chrysler and one underneath the Chrysler near the driver's door. Parallel tire marks were located on the roadway leading up to the Chrysler.

A legally parked Chevrolet Astro van was located directly east of where the parallel tire marks began. A Nissan SUV and Hyundai SUV were observed legally parked directly south of the Chevrolet Astro.

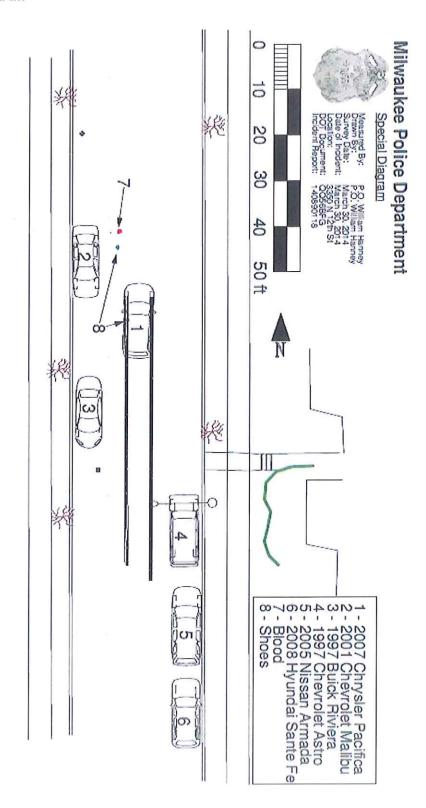
Figure 4. Scaled scene diagram

On Sunday, March 30th, 2014, I, Officer William Hanney, used a Trimble S6 robotic total station to forensically map the given roadway and terrain. The S6 is an electronic instrument composed of a theodolite (angle measuring system), an EDM (electronic distance measuring system), a data collector, and a prism. When data points are collected, they are stored electronically and later downloaded for transfer and creation of scaled scene drawings. These instruments allow for data points to be measured in three dimensions, thereby mapping roadways, evidence locations, and contiguous terrain with a high degree of accuracy. During the mapping operation, visible evidence, roadways, and contiguous terrain were documented.

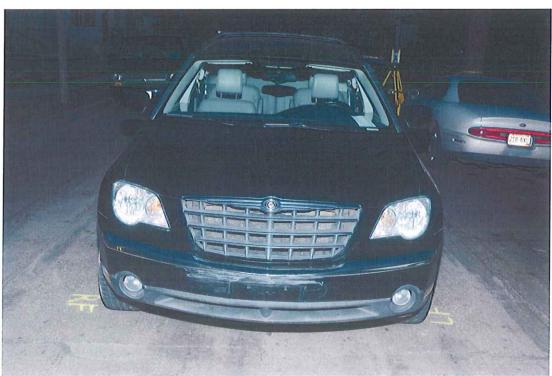
Figure 5. 2007 Chrysler Pacifica used in this offense

The 2007 Chrysler Pacifica is a four-door vehicle powered by a 4.0 Liter, V-6 engine. The engine's power is delivered to the road through an automatic transmission. The vehicle is equipped with four-wheel anti-lock disk brakes. There was an area of minor contact damage to the middle of the front bumper. This area appeared to contain damage from a prior crash. The front tires had poor tread depth. The rest of the Chrysler Pacifica appeared relatively normal.
