# Certificate of Appropriateness

**Property** 1125 N. 9TH ST. Pabst Brewery Historic District  
**Description of work** Completely rehabilitate the exterior of building No. 29 a.k.a 1128 N. 10th Street, Pabst Bottle House, in the Pabst Brewery Historic District.  
**Date issued** 4/1/2015 PTS ID 38588 COA, exterior rehabilitation

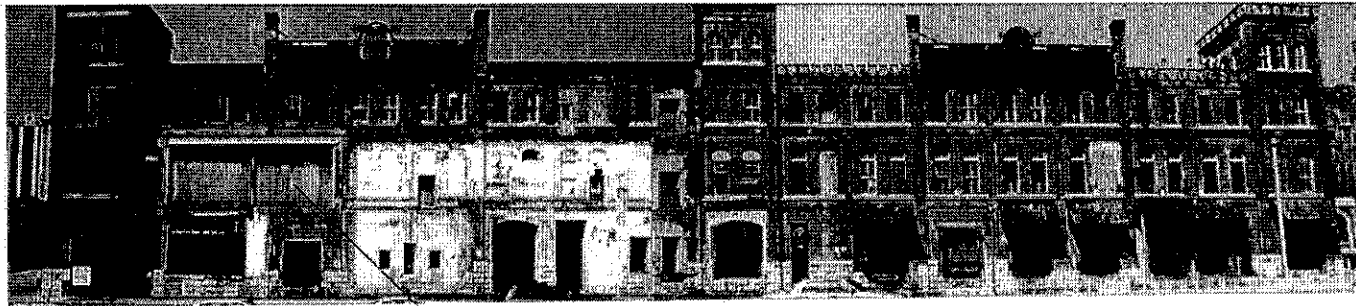
## Proposed East Elevation

Paint will be removed, windows will be reopened, bridge connection area to be restored to original appearance, loading doors outside period of significance will be restored to original condition, parapet to be rebuilt

REMOVED BRIDGE CONNECTION ACROSS 9TH ST.

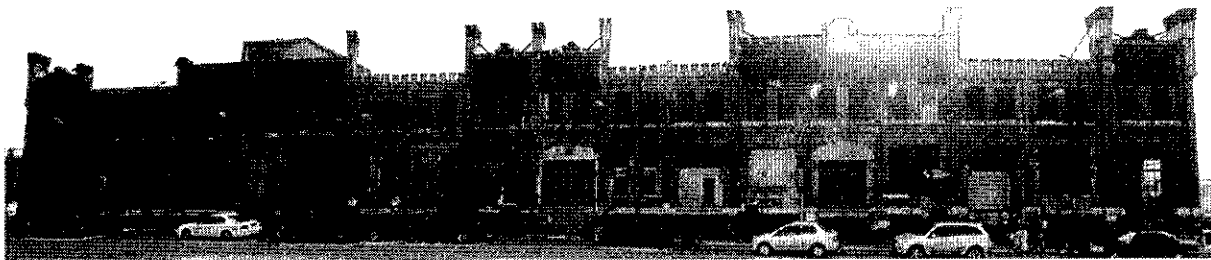
## Proposed West Elevation

Infilled openings to be reopened, original loading doors to be rebuilt and infilled with clear glazing, parapets to be rebuilt, rooftop structure in corrugated metal to remain

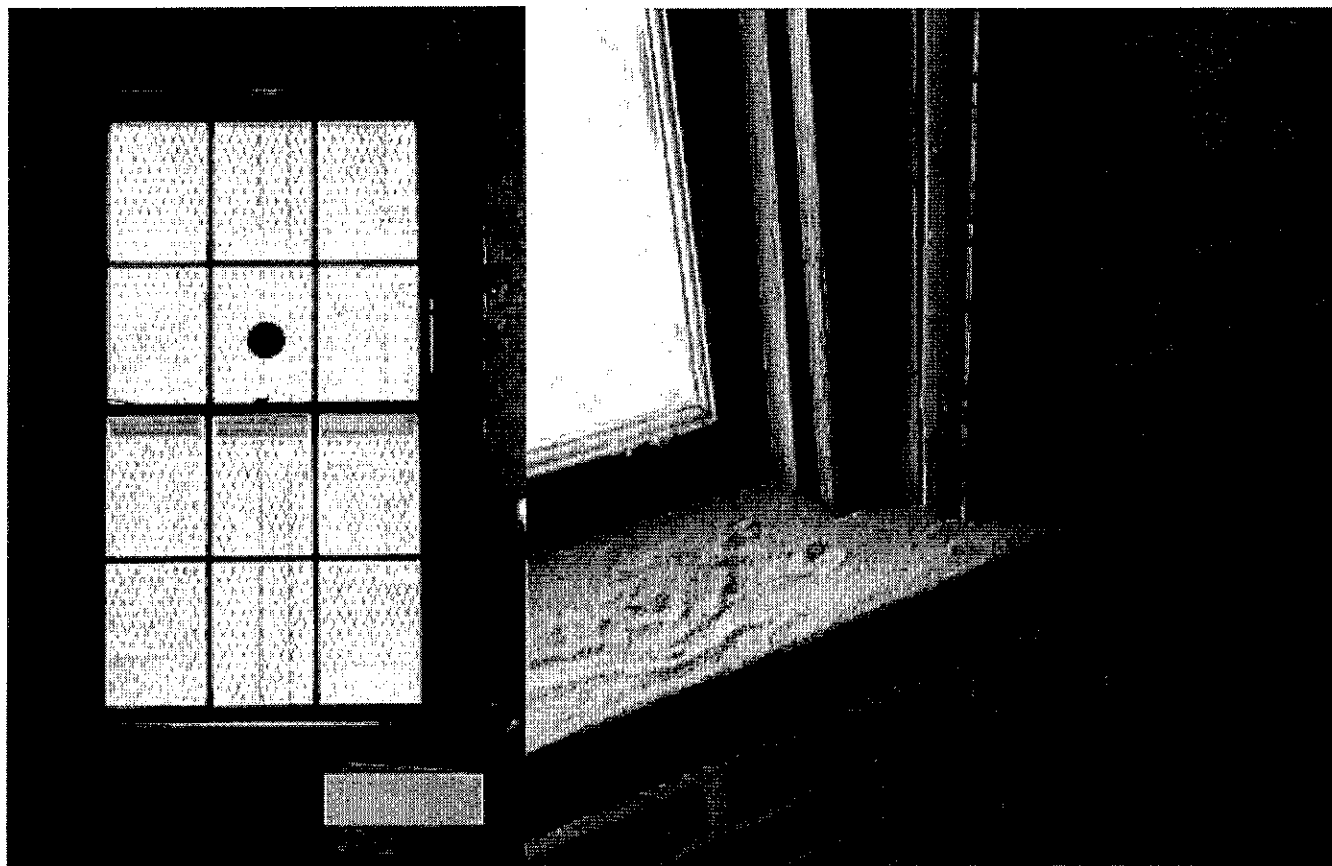
## TYPICAL **WOOD** WINDOW - (*VERY GOOD CONDITION*)

**Existing wood six-over-six windows will be restored or replicated**

Of the existing windows, 81 will be restored and consist of wood and metal that vary in size and muntin configuration. New windows will be installed in openings previously closed up. New windows will be installed at openings where the original sash is too deteriorated to be restored/rehabilitated.

New windows, both wood and metal, will conform to the requirements of the National Park Service. Such details as upper and lower jambs, meeting rails, sills, mullions and muntins, as well as appearance, size, design, proportions and profiles must match historic windows. All windows and glazing to have interior and exterior muntins and have clear glass.

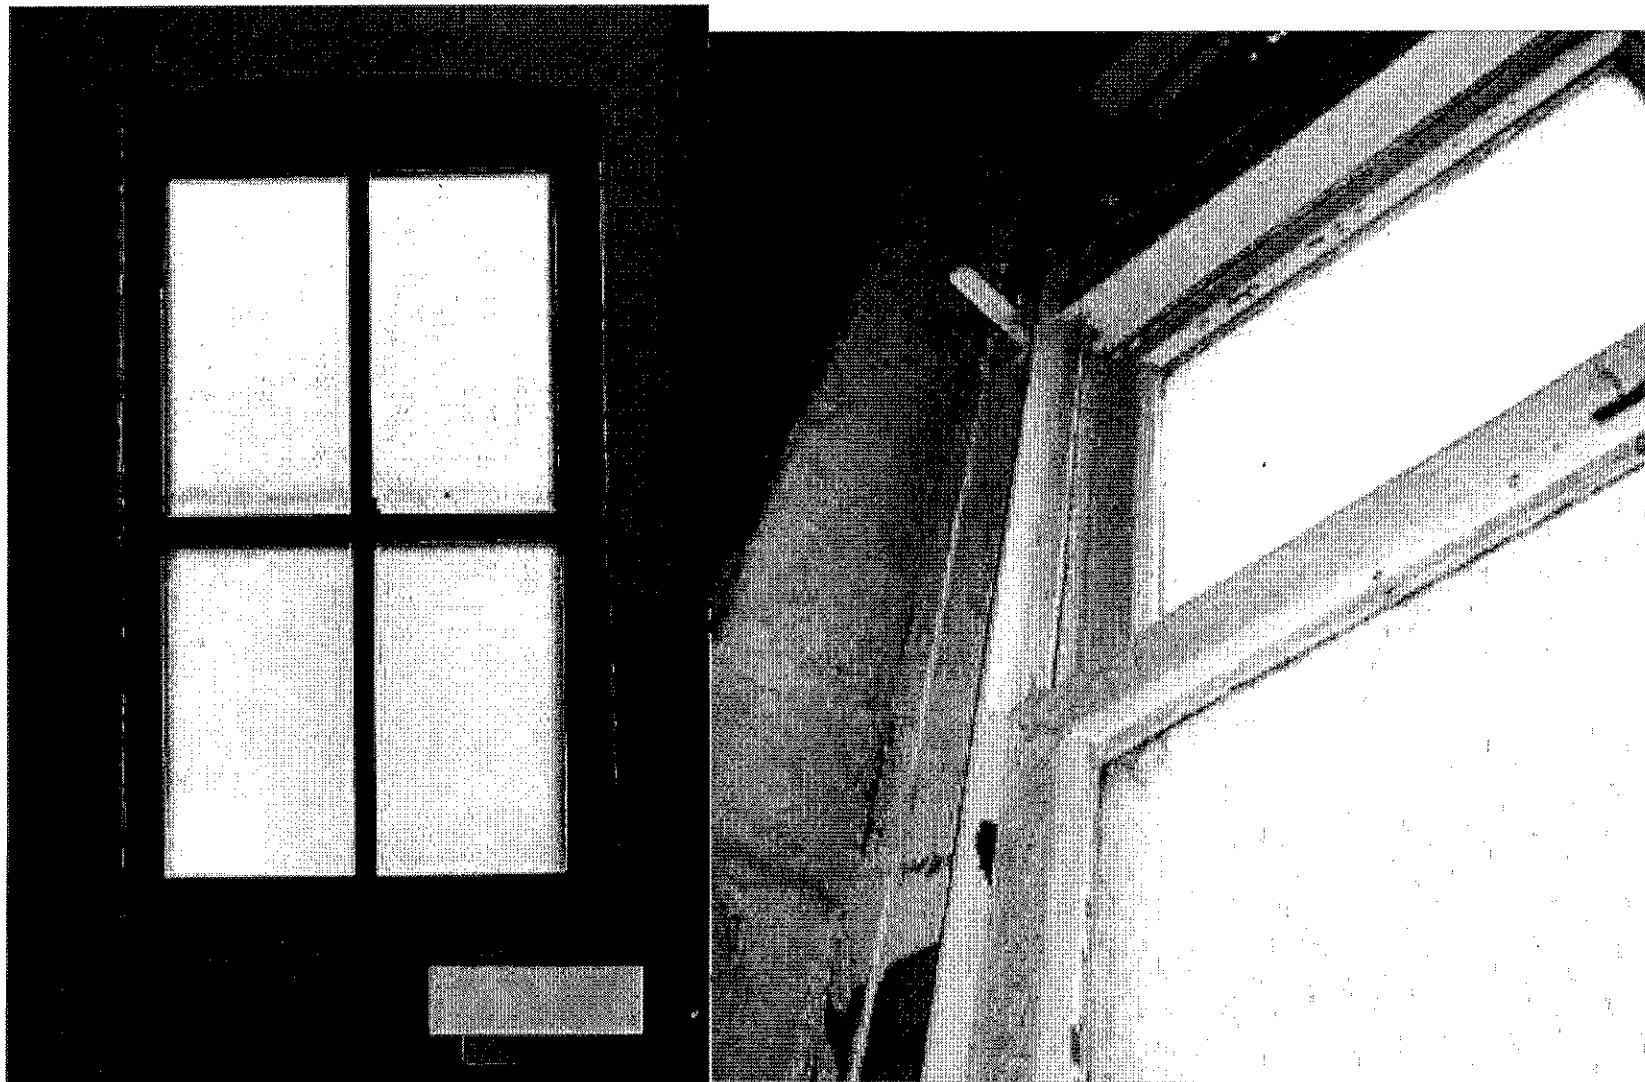
## TYPICAL **STEEL** WINDOW - (*VERY GOOD CONDITION*)

**Existing metal two-over-two windows to be restored or replicated**
