MILWAUKEE CITY HALL

PTS ID 110450 COA Eliminate Stair 8

MILWAUKEE CITY HALL
CERTIFICATE OF APPROPRIATENESS

April 1, 2016
Attachment A

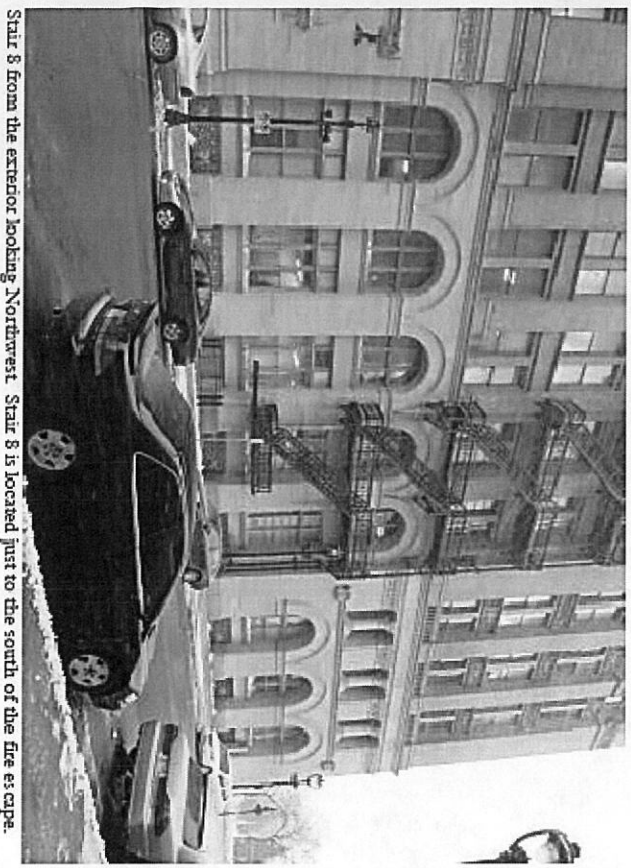
Stair 8 from the exterior looking Northwest. Stair 8 is located just to the south of the fire escape.

to be installed on both sides of the doors at the exterior wall. This would push the stair out an additional 3' (approximately) into the sidewalk. The plan below shows the location of Stair 8 on North Market Street.

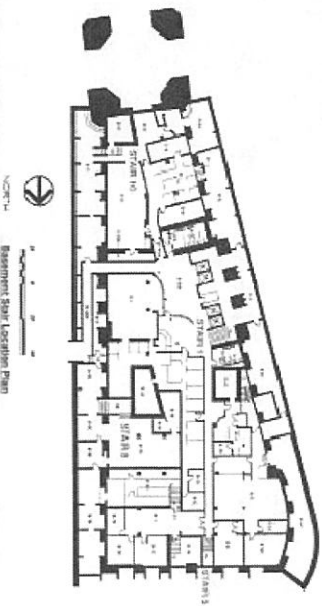
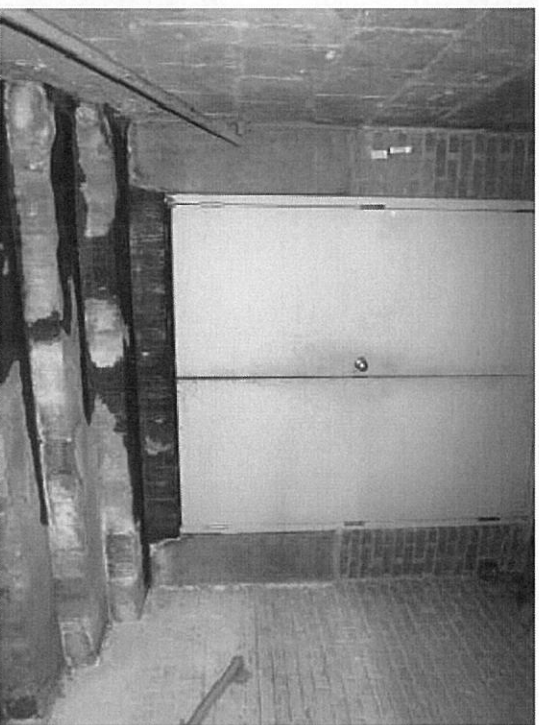
Exterior doors to Stair 8 from the inside. The poured concrete stair and surrounding construction seen here will be demolished in the foundation reconstruction. Stair does not meet current code. The pair of entrance doors swing into the space and a landing is required on both sides of the door.

The plan below shows the location of the stair in the basement of City Hall. The plan is the current, preconstruction layout of the building.

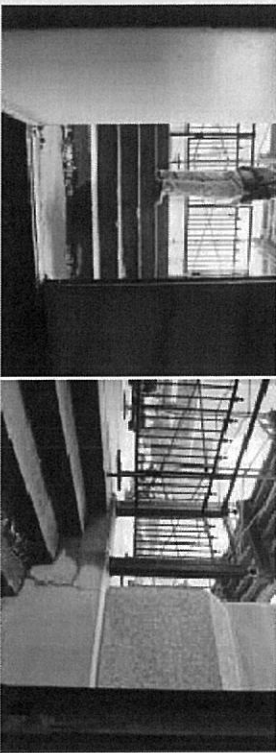
Stair 5 from the inside looking out. The exterior stair and railing will be demolished during the foundation repair work. Note the inadequate size of the exterior landing.

Stair 5 is a service entrance to the basement level Mechanical Room from North Market Street. The door sill sits on a narrow landing approximately 36" below the sidewalk level.

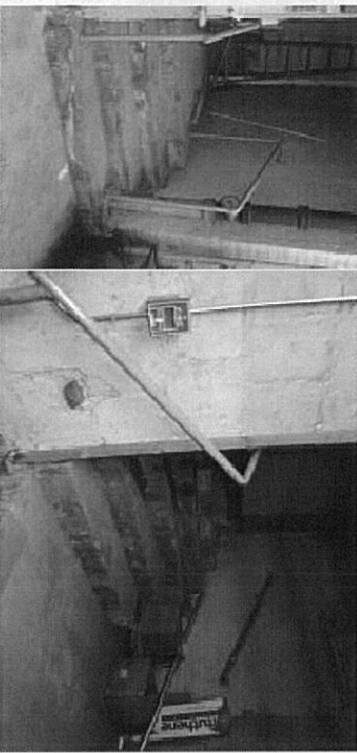
Stair 5 as it enters the Mechanical Room.

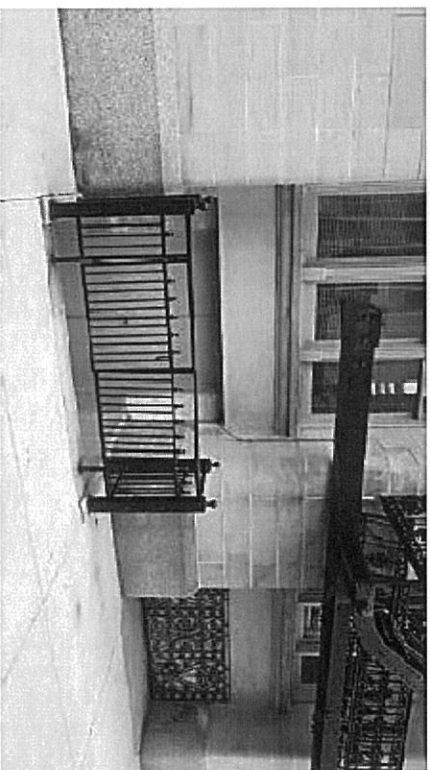
Exterior view in context with the adjacent building construction

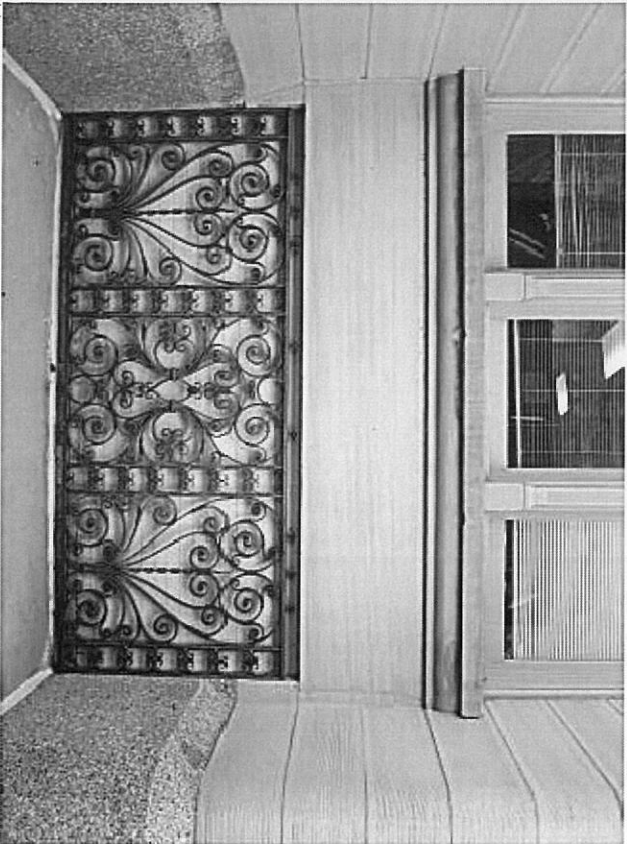
Typical Existing Wrought Iron Grille Work

We propose to eliminate Stair 8 and reconstruct a wall at the Stair 8 location using the same wall system used typically between the masonry piers on the rest of the building in the foundation restoration project. To finish the wall new wrought iron grille work to match the grille work at the adjacent walls would be installed. The new wall will look similar to the photo below.
