**HISTORIC DESIGNATION STUDY REPORT  
BZDAWKA BUILDING  
MARCH, 2017**

Historic: Bzdawka Building

**II. LOCATION** 1112-1114 West Lincoln Avenue

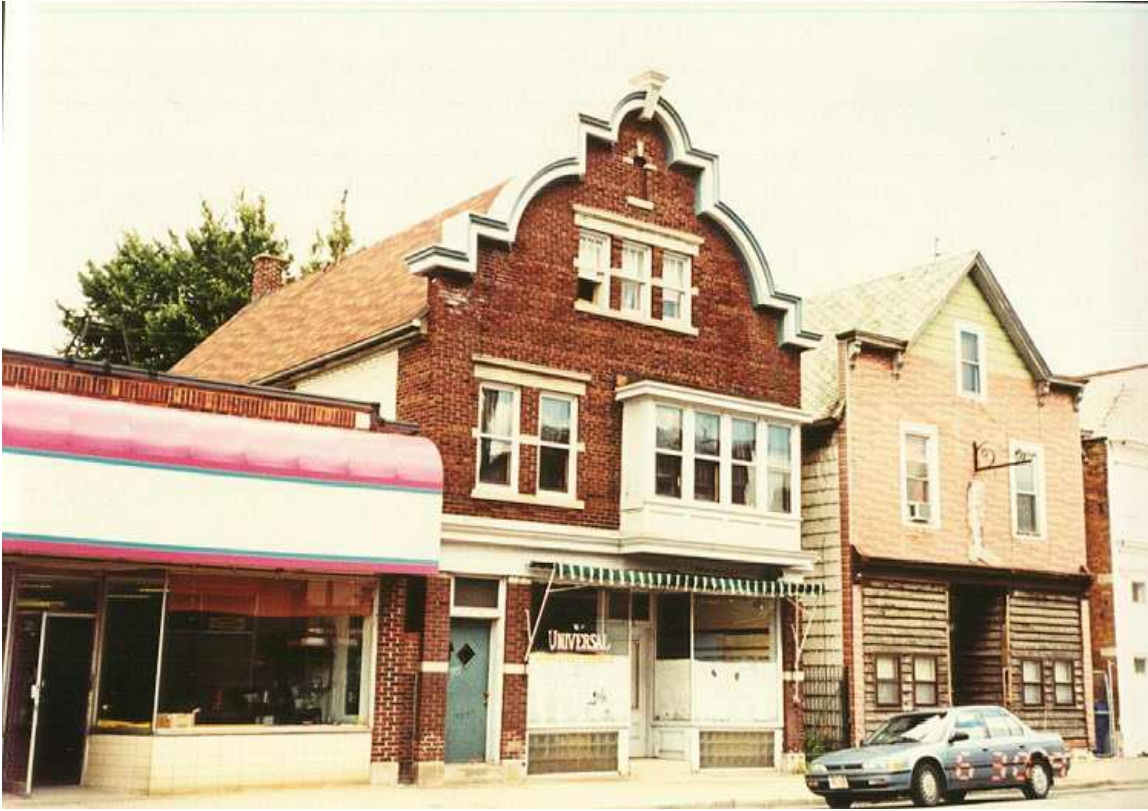
1112-1114 West Lincoln Avenue, Assessor's photo June 30, 1999

Changes to this façade include the installation of glass block to the bulkhead (date unknown, between 1979 and 1999), replacement of the original upper apartment entry door that featured a single light door with recessed panel (date unknown, photos show two subsequent replacement doors, one slab door with a diamond shaped window and a slab door with the current vertical window). Upper floor storm windows have also been replaced with what appear to be vinyl storms. The stiles and rails are narrower than the original wood storm windows. Some of the prime windows have been replaced as well. Likewise, the three-over-one sash at the attic have been replaced with one-over-one sash that appear to be vinyl. There is no documentation for this alteration. The biggest change to the façade has been with the storefront. The two large pieces of glass with delicate glazing bars, flanking the center entrance, have been replaced by four pieces of glass with heavier metal glazing bars. Signage in individual letters has been applied above the storefront in the cornice area and strings of LED lights frame the storefront interior. The front masonry has been repointed with a reddish mortar. It is not known if appropriate mortar was used in the repointing.

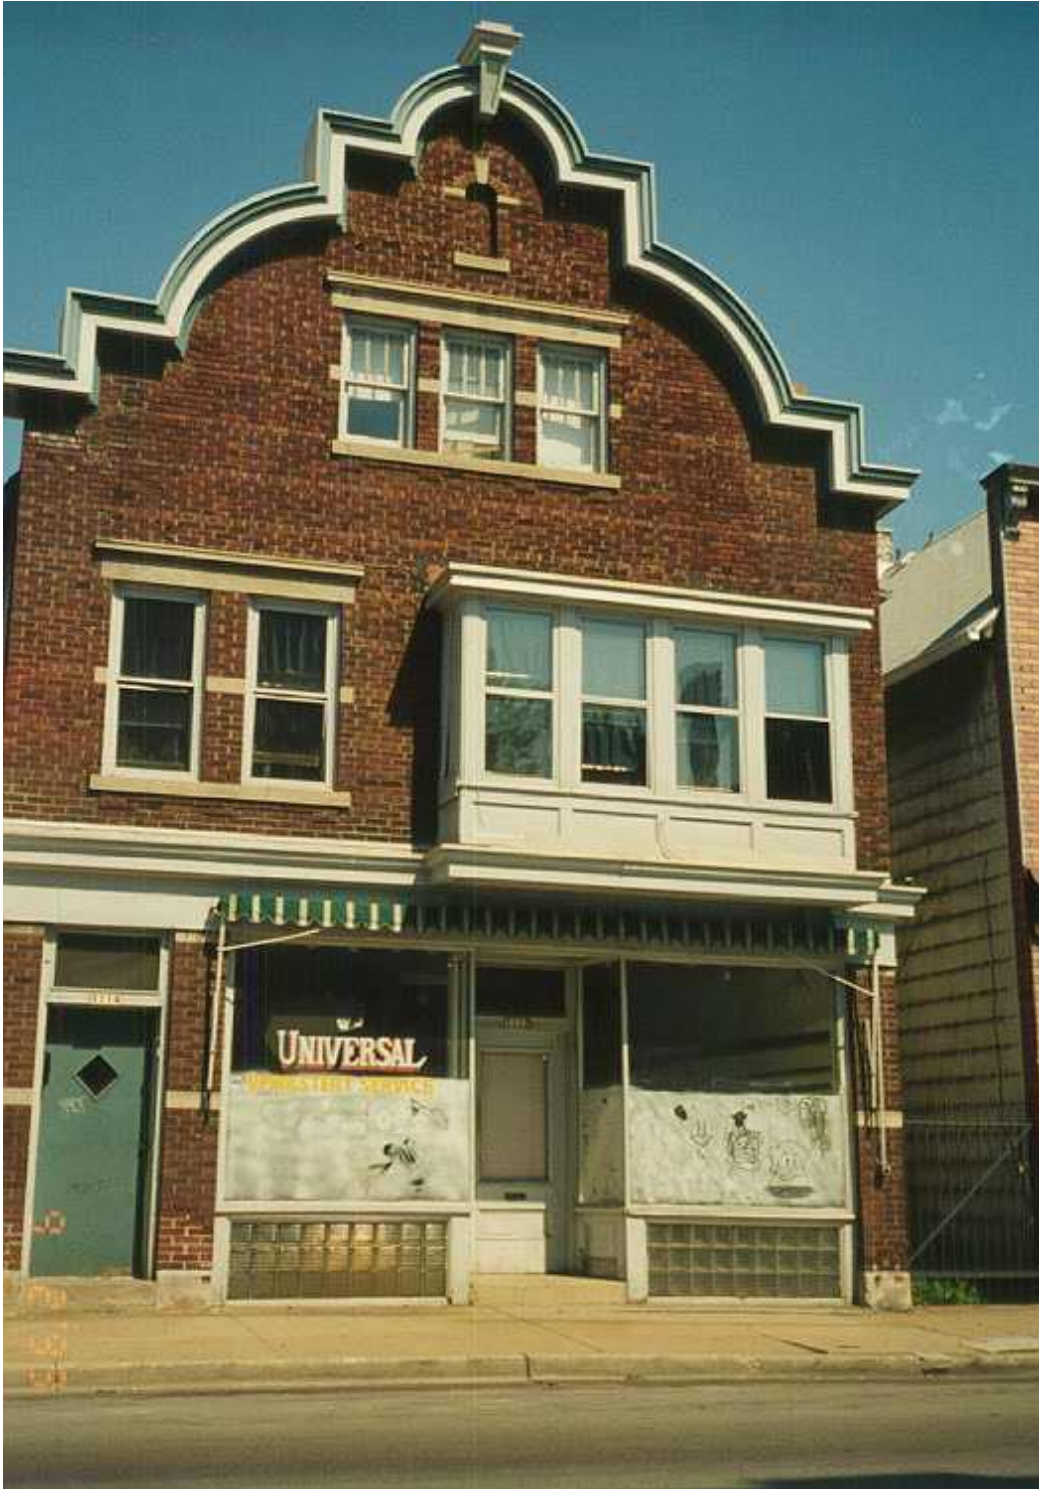
1112-1114 West Lincoln Avenue Assessor's Photo September 2, 1999

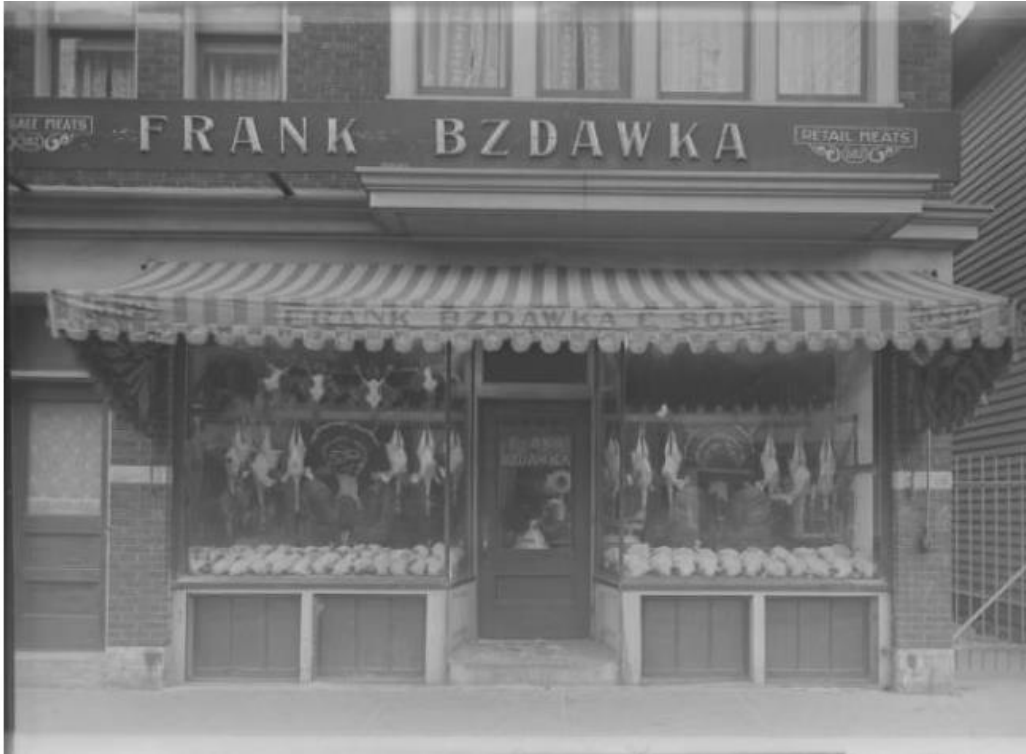
Photo December 30, 1927. Roman B. Kwasniewski photographer. UWM Manuscript Collection 19. Box 289.

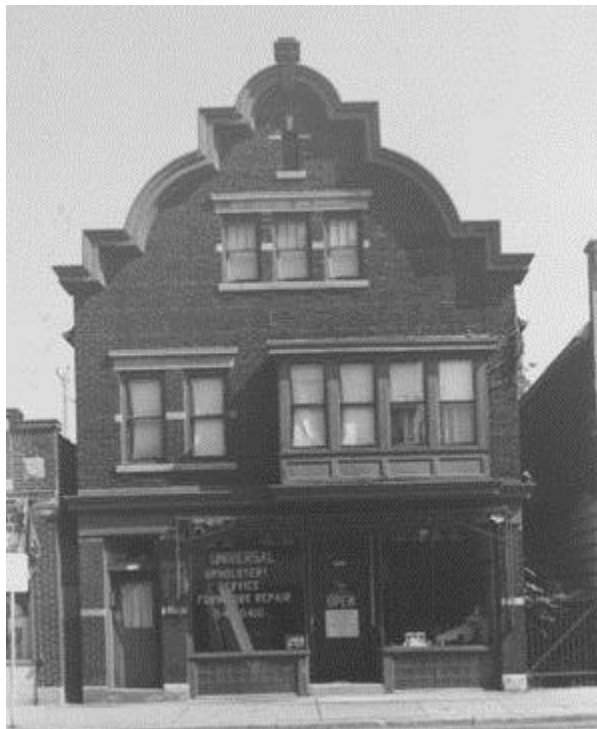
Survey Photo 1993
