Certificate of Appropriateness

Property 3002 W. STATE ST. Concordia Historic District
Description of work Replace windows on all three sides of second story sleeping porch with all-wood replicas of surviving original windows on the rest of the house. Windows to be Marvin Ultimate Wood double hung 6/1 sash with simulated divided lite with exterior and interior wood muntin grid and interior spacer bar. New window bands will be placed into existing openings. Spacer bars are recommended to be other than white metal.
Date issued 5/25/2017 PTS ID 114289 COA: Replace sleeping porch windows CCF # 170306

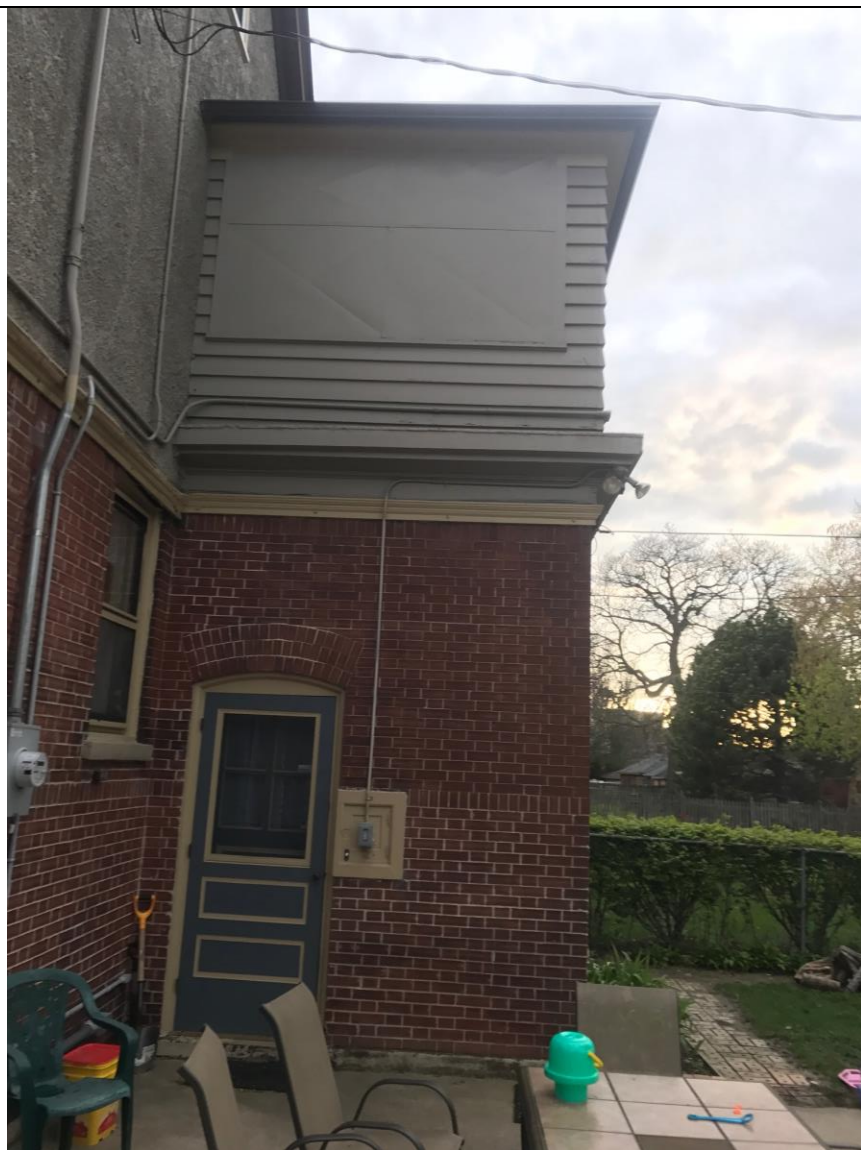
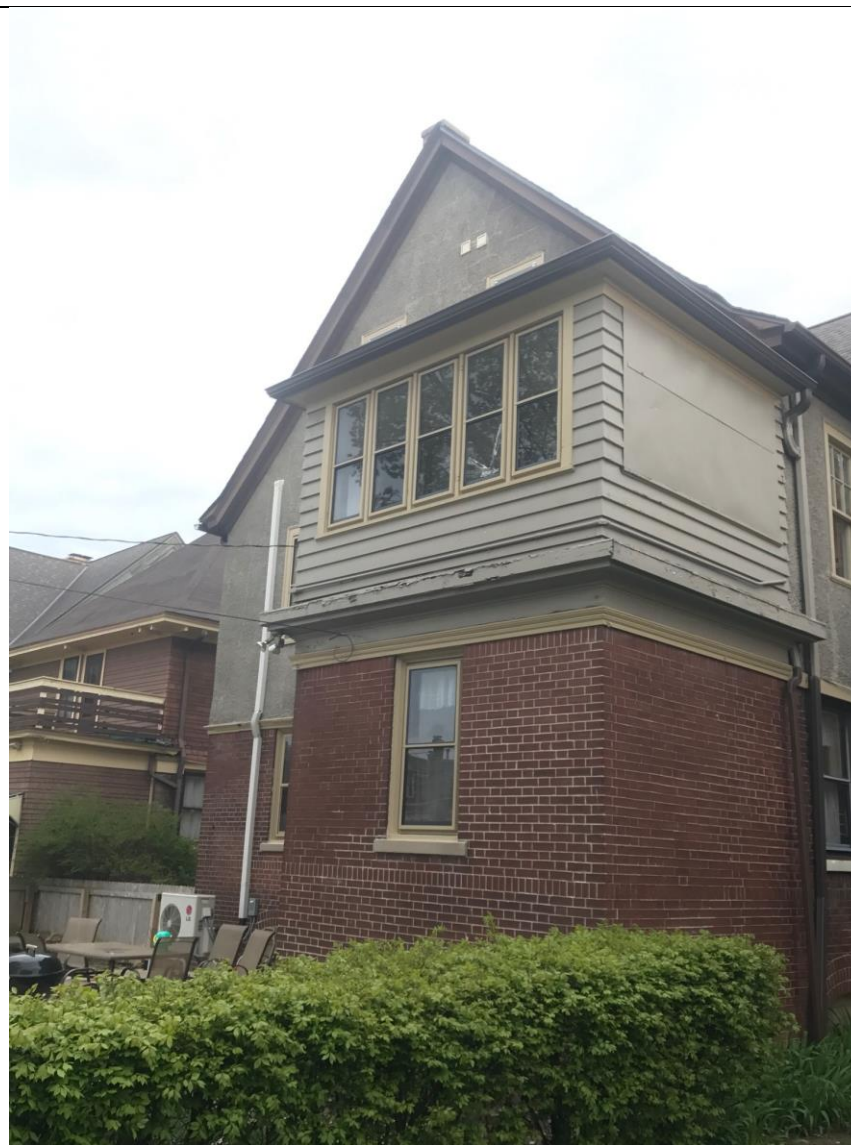
Sleeping porch exterior details

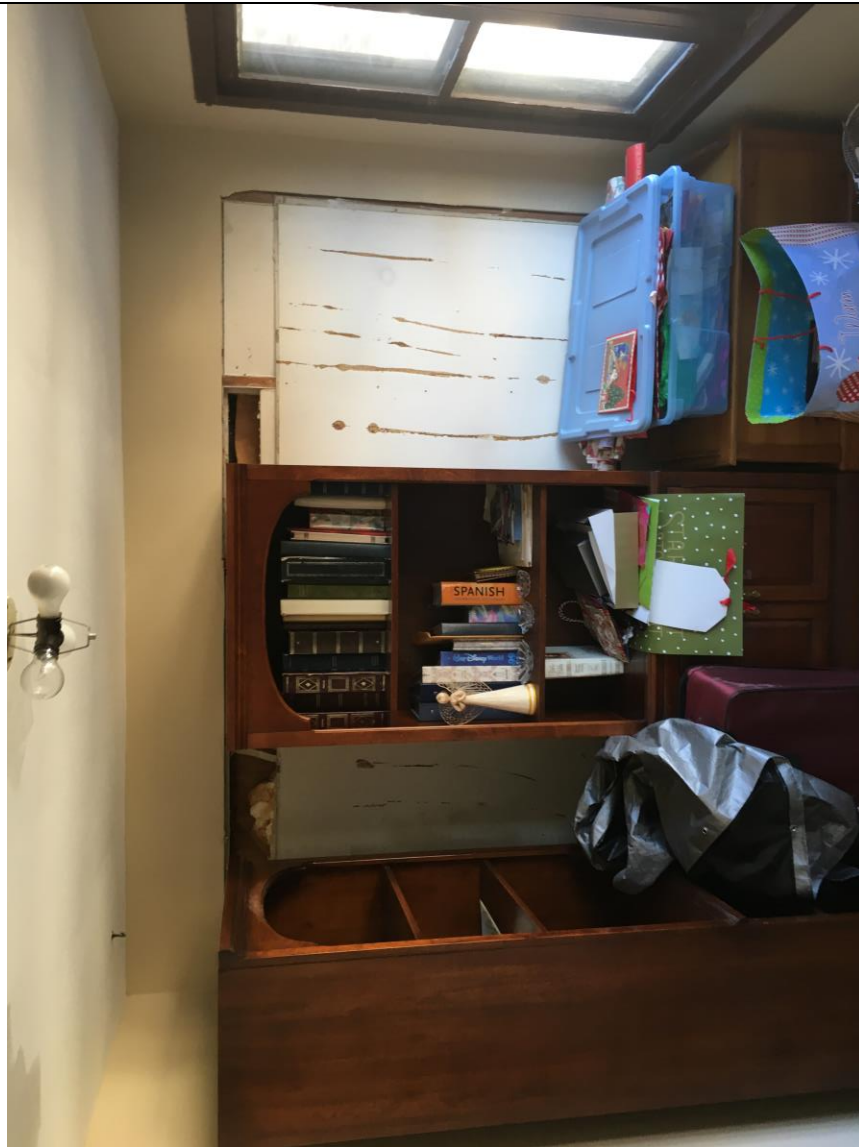
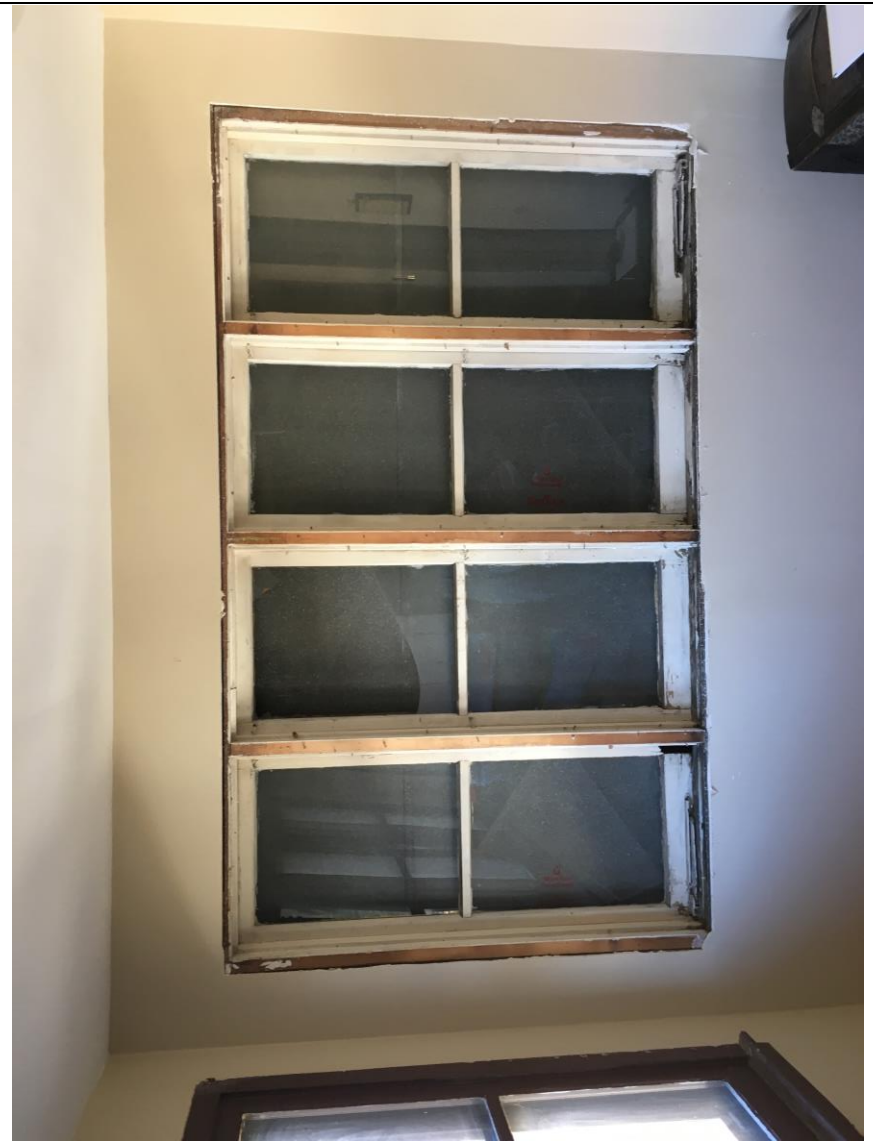
Sleeping porch interior. Some windows are boarded up on both interior and exterior. These are typical existing windows that are clearly not original to the building
