Certificate of Appropriateness

Property 1841 N. PROSPECT AV. Sanford Kane House
Description of work Repair/replace damaged shingles on north elevation, approximately 30 sq ft at area between second and first floors. Details attached.
Date issued 7/26/2017 PTS ID 114312 COA: siding repair

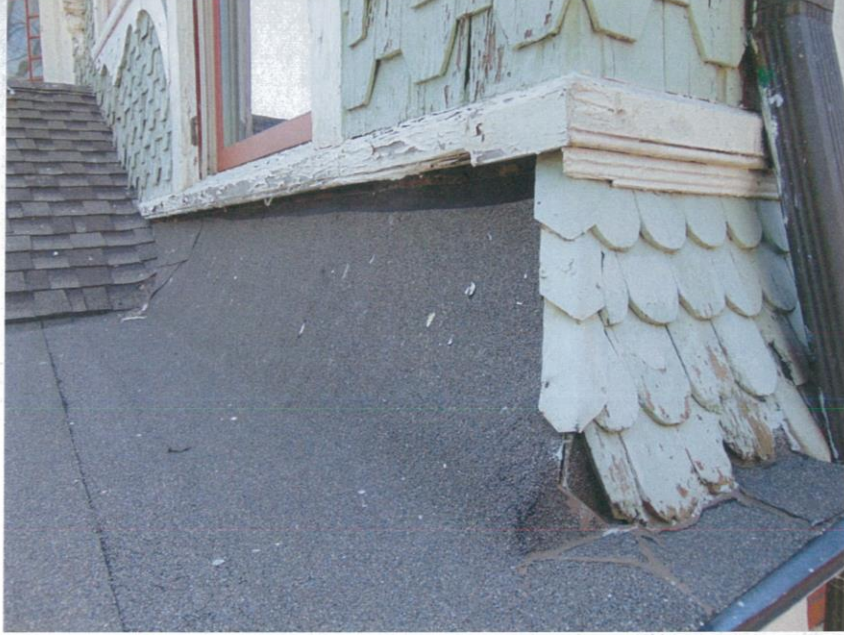
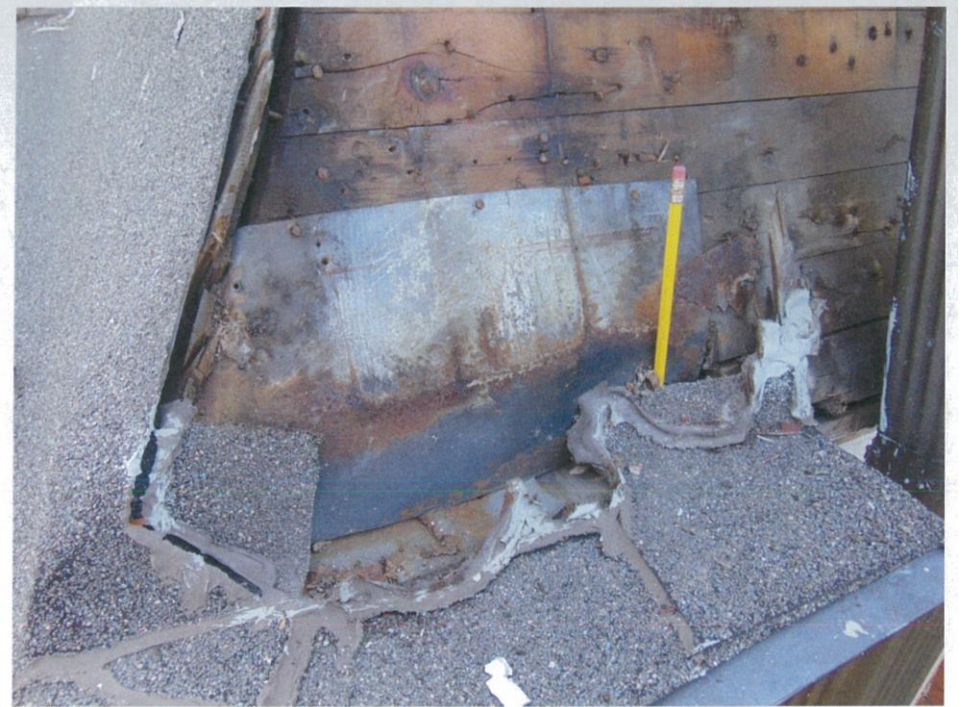
Exterior Repair before Photos

1. The first is to replace deteriorating shingles on the north side of the building where water has worn them away. Project is small in scope as most shingles are in good condition and focuses only on two areas of approximately 14' x 2' between the first and second stories of the building. Using the original pattern and paint color, cedar replacement shingles are hand milled to match existing historical pattern and then installed with finishing nails. A fresh coat of paint is applied when necessary to prevent further water damage.

Shingles must be natural wood and match existing shape.
